**Draft Integrated Feasibility Report
and Environmental Assessment and Draft Finding of No Significant Impact**

APPENDIX E: CULTURAL RESOURCES

Whittier, Alaska

June 2018

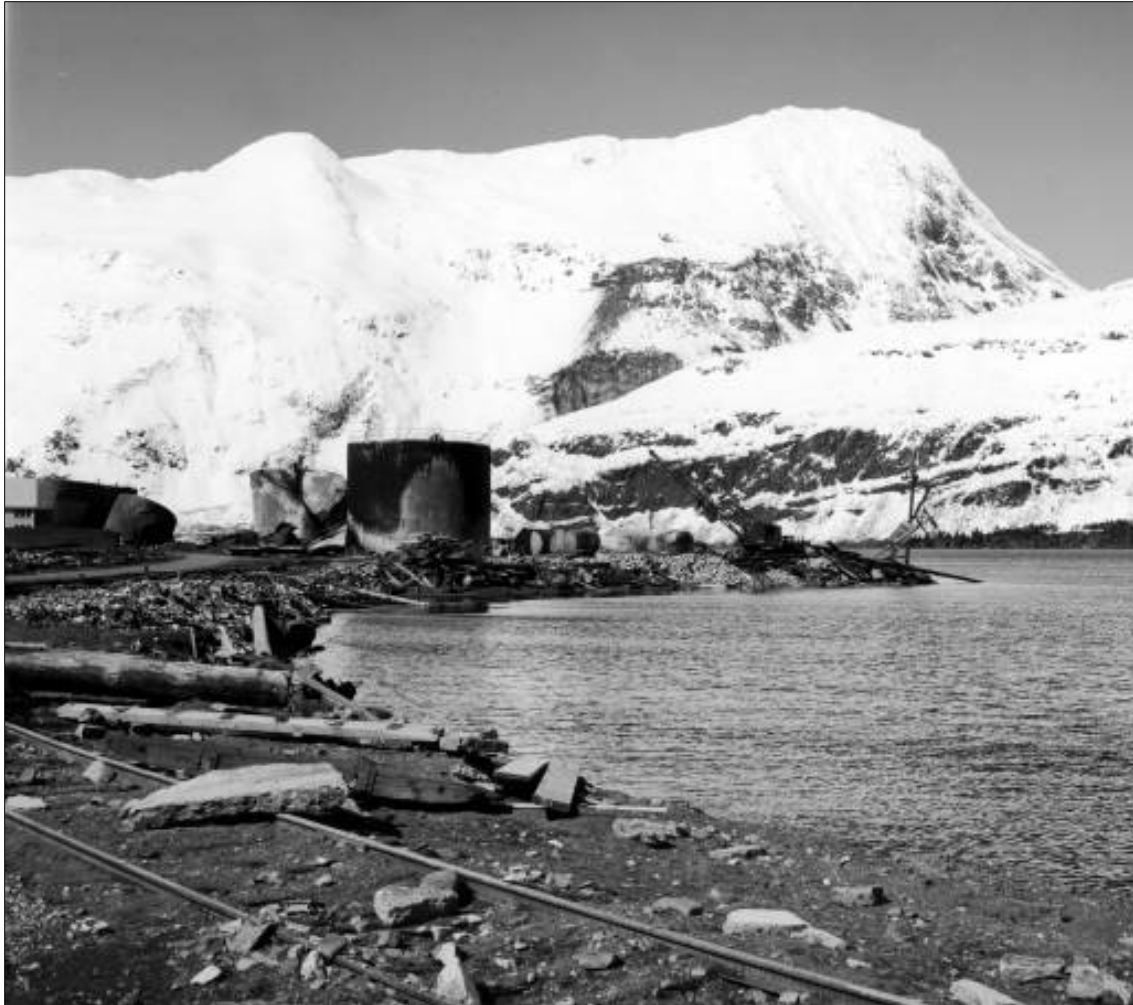
Figure E-1: March 27, 1964, Photo Showing Damage to Fuel Tanks After Earthquake [photo appears to be facing northwest into the head of passage canal (ADA 2018).]

Richardson once the Anton Anderson Memorial Tunnel was completed. War construction also included a temporary dock, construction camp, landing strip, ordnance storage area, sawmill, and gravel pit at the site (Figure E-1) (Yarborough 1993:2; Mighetto and Homstad 1997:64-65). In 1946, the Army declared the Whittier facilities surplus, the railroad connection was turned over to the Alaska Railroad and facilities to the General Services Administration for disposal.

On the morning of March 27, 1964, at 5:36 am, a 9.2 magnitude earthquake struck Alaska devastating towns and villages along the coast. Fuel storage and port facilities in Whittier collapsed; tanks were breached and caught on fire. M.J. Dixon, a resident of Whittier, reported “water in Passage Canal began to rise about one minute after the onset of the quake...about two or three minutes after the quake began, a wave hit the shore and ran up to an estimated 26 feet above lower low water” (pre-quake elevation) (Chance 1966: 27). Damage to Whittier was extensive, the majority of the fuel infrastructure at the Port had collapsed or burned (Figure E-1). As a result of damage to Whittier’s fuel infrastructure and the limited space for fuel in the Anchorage Port, military operations at Elmendorf Air Force Base and Fort Richardson suffered. In 1966, to make up for the loss of facilities, congress authorized the construction of the Whittier-Anchorage pipeline, which created a line connecting the Whittier Terminal to the Anchorage Terminal. The pipeline was in operation between 1967 and 1996.

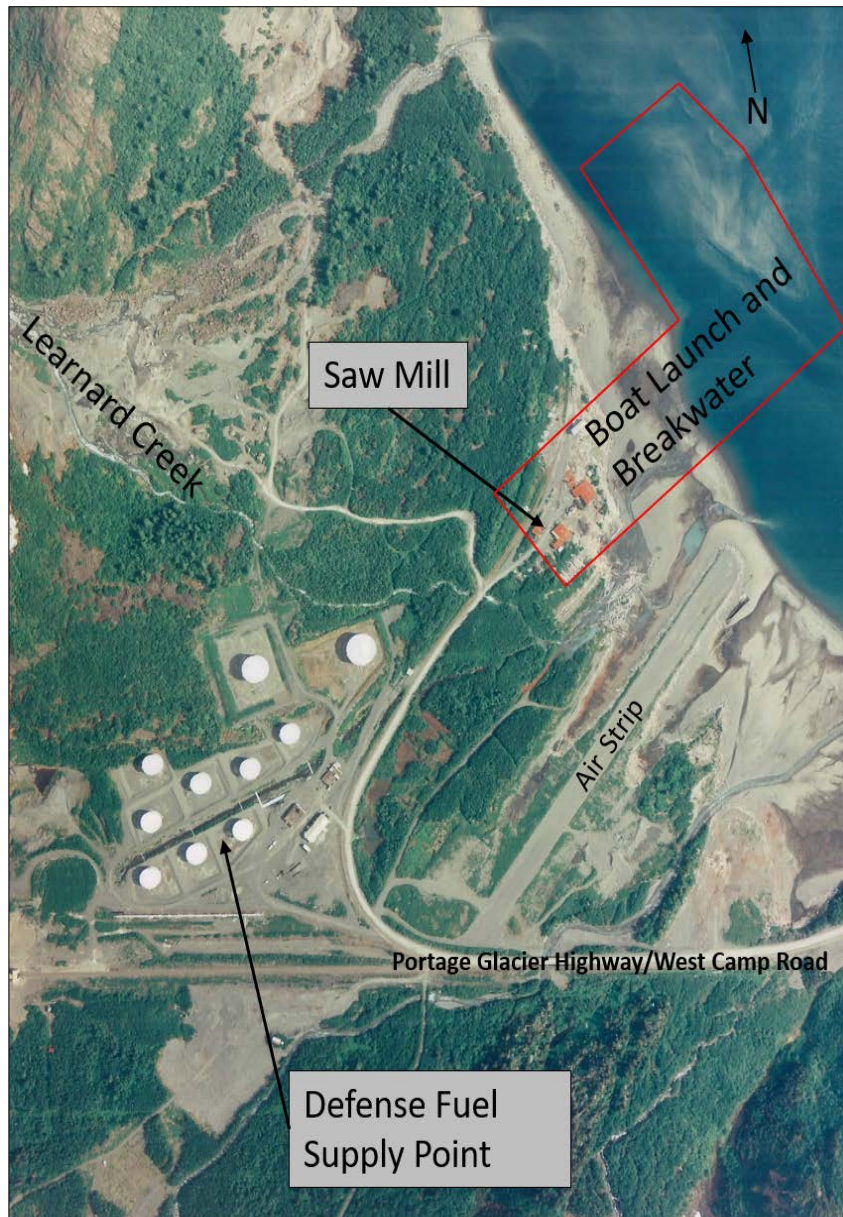
Figure E-2: Aerial Photo Taken in 1980 of the Head of Passage Canal
Note the sawmill, beach disturbance, defense fuel supply point, and approximate alignment of proposed boat launch and breakwater.

The Whittier Terminal also known as the Defense Fuel Supply Point (Figure E-2) operated as a bulk fuel-handling and storage terminal for the Army from 1949 to 1996. The terminal was originally built to receive petroleum products from oil tankers, which were then transported by railroad to Elmendorf Air Force Base. The facility consisted of eight above ground storage tanks, a manifold building, offices, shops, and train infrastructure for loading and transportation. A second tank farm was located closer to the east of the Defense Fuel Supply Point next to an Army dock; both of which were completely destroyed during the 1964 earthquake.

The area of potential effect (APE) for this project encompasses the shoreline, waters, and parking lot just north of the current airstrip (Figure E-5). Four known cultural resources fall within the APE (Table E-1). Site SEW-00104 is the former location of Griset’s Roadhouse (Figure E-2). SEW-00104 was located in what is now a parking area, it is not clear when the roadhouse was demolished. A sawmill and salt-water pump house also stood at the former location of the roadhouse, presumably after the destruction or modification of Griset’s Roadhouse. Michael Yarborough (1993:4) described the results of a survey “no evidence of either a Native camp or a historic roadhouse was found during the survey. All of the cultural material that was located appears to date no earlier than World War II.” Griset’s Roadhouse is considered ineligible for the National Register of Historic Places (NRHP).

Much of the coastline around the project area was disturbed during construction of a temporary boat harbor, runway, ordnance storage area, sawmill, and gravel pit during World War II, and was disturbed again during the 1964 earthquake. An aerial photograph from 1980 (Figure E-2) also shows disturbance along the coastline near the former sawmill in the form of discarded lumber and two artificial channels dug along the beach east of the former sawmill. The USACE's Formally Used Defense Site (FUDS) Program has previously removed the former Army Tank Farm and other associated former military structures in the area during the 1980s, 1990s, and 2000s. Given the magnitude of disturbance along the current coastline within the project area during World War II, and subsequent destruction caused by the 1964 earthquake it is unlikely that cultural resources exist along the shoreline selected for the harbor installation. Additionally, de Laguna (1956) discusses the placement of historic permanent villages in Prince William Sound as, "no permanent villages were located at the heads of bays, in spite of the tempting presence of some of the best salmon streams, because these were dead ends from which no escape by water would be possible in the event of an attack." Temporary camps, however, were made at fish streams during salmon runs (de Laguna 1956). Shakespeare and Learnard Creeks are located to the north and south of the project area, outside the APE.

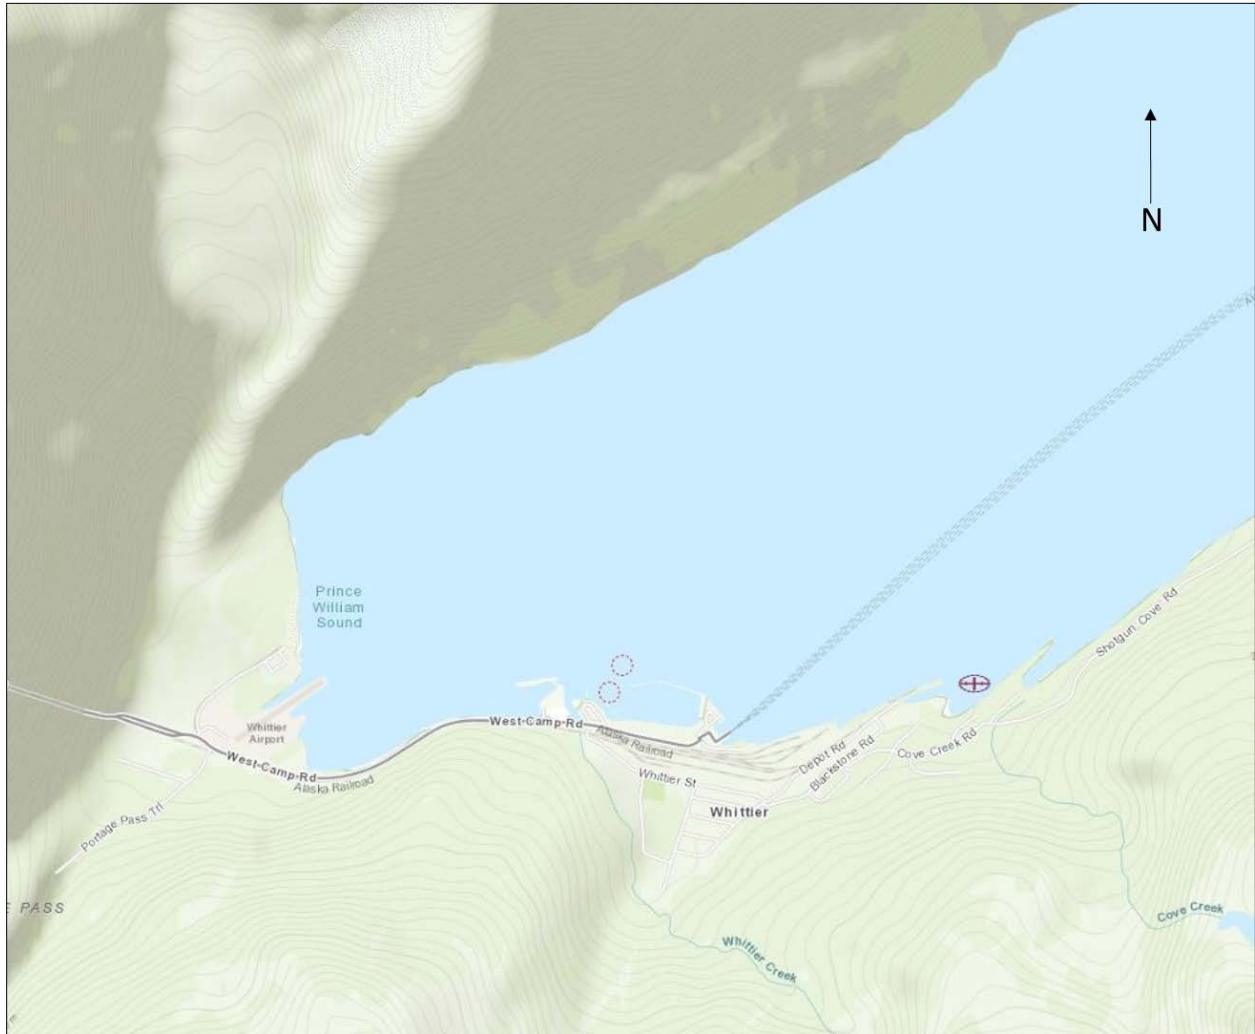
Figure E-6: National Oceanic and Atmospheric Administration Wrecks and Obstructions Map
Obstructions in dashed-red circles at harbor entrance, and submerged wreck in solid red circle
with cross in Shotgun Cove, project area in red box (NOAA 2018).

A search of the National Oceanic and Atmospheric Administration's wrecks and obstructions database shows no known wrecks or obstructions within the footprint of sediment sampling, dredging, in-water dredge spoils disposal area, or harbor construction area (Figure E-6). A search of the Bureau of Ocean Energy Management (BOEM) shipwreck database shows six known wrecks and two incidents in the area (Table E-2, Figure E-6). However, no wrecks were reported to be at the head of the passage canal within the APE. A letter dated received by OHA on July 18, 2006 detailing plans by the City of Whittier to develop facilities at the Head of Passage Canal similar to the proposed project resulted in a finding of no historic properties affected under 36 CFR § 800.5(b) (Whittier 2006).
