Appendix A

Mobilization Report

eTrac Inc. used the supplied charter vessel Miss Alyssa for hydrographic and geophysical survey operations for the Channel Navigation Improvements Feasibility Study in Dutch Harbor, Alaska. Vessel Miss Alyssa is a 43-foot all fiberglass twin diesel powered commercial fishing/dive support and charter vessel (see Figure 1). The Vessel Miss Alyssa has the following specifications:

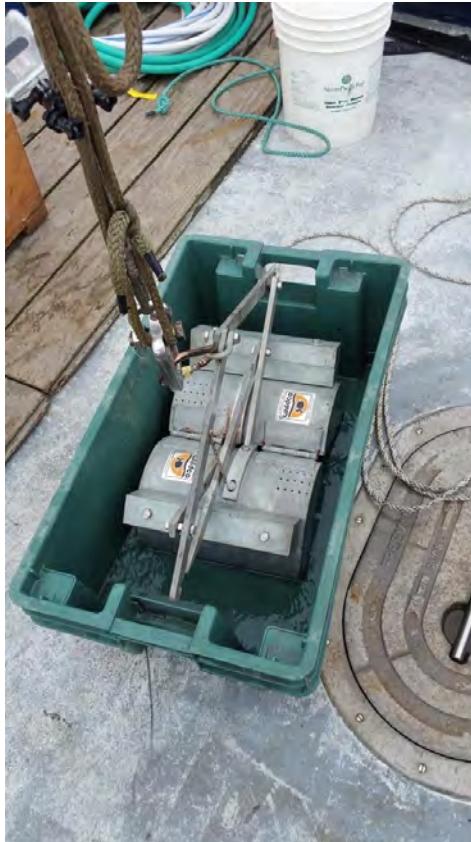
Figure 18 WILDCO Ponar Grab Sampler on Vessel Miss Alyssa

A WILDCO Ponar grab sample system was mobilized onto Miss Alyssa (see Figure 18). The sampler was deployed and retrieved via the onboard hydraulic winch. The IMU and GPS antennas that were used during multibeam acquisition remained mounted on the VOOP with the top center of the IMU as the Reference Point (RP). An offset from the vessel reference point to the winch was input and used to calculate the eventual, estimated sample position (see Table 5).

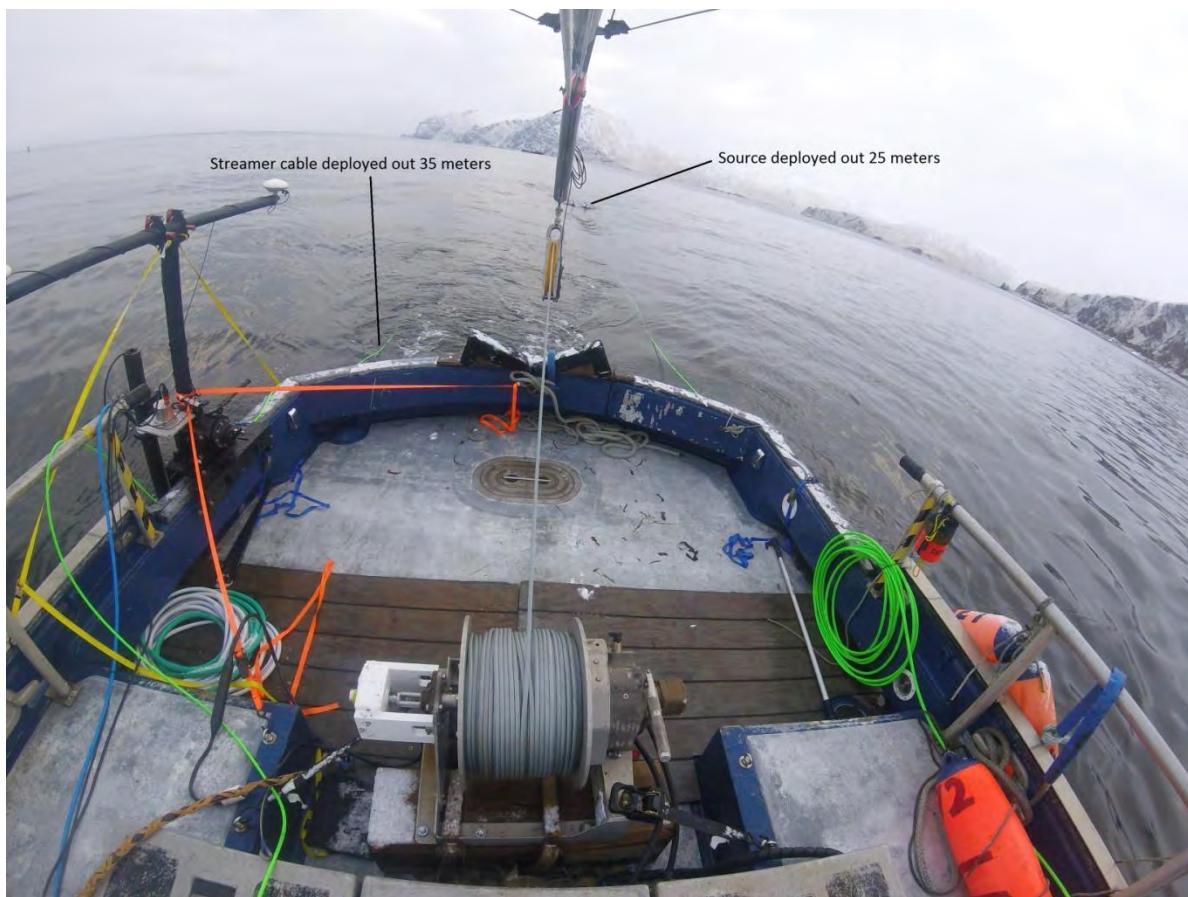
Figure 19 Bubble Gun Deployed

A Falmouth HMS-620 Bubble Gun with single acoustic source was mobilized onto Miss Alyssa. The source is created with an electromagnetic acoustic transducer and the receiver is a hydrophone streamer. The Bubble Gun was towed from two tie points on port and starboard sides of the stern. The source was connected on a 25 m cable to the port side tie point and the streamer was connected on a 35 m cable on the starboard side tie point (see Figure 19). The IMU and GPS antennas that were used during multibeam acquisition remained mounted on the VOOP with the top center of the IMU as the Reference Point (RP). The reference points are shown in Figure 20. Offsets were measured from the vessel reference point to the tie point of the streamer, receiver. The tow point was directly in line with the IMU reference point along the starboard port axis. This allowed a simple bow, stern offset to be input (see Table 6). In addition to the tow point offsets and cable out offset was calculated in post processing using a layback test. See below for details.

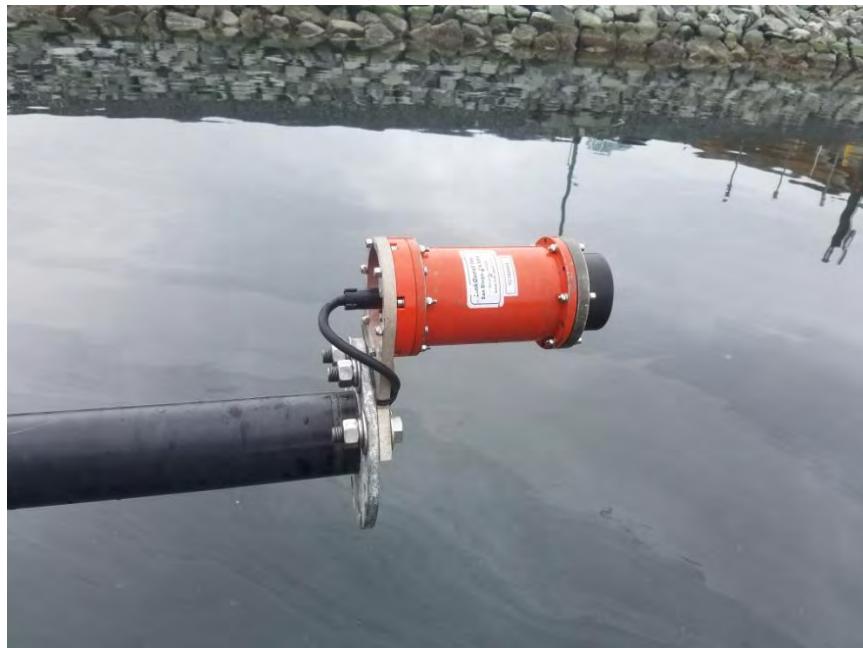
Figure 25 USBL Mounted on end of VOOP USM

A Link Quest 1500 was mobilized onto Miss Alyssa. The USBL was mounted onto the VOOP kit in place of the R2Sonic 2024. The IMU and GPS antennas remained mounted on the VOOP in their previous locations with the top center of the IMU chosen as the RP. An offset to the acoustic center and thus the reference point of the USBL was measured and used to position the system. Figure 25 below shows the USBL system mounted onto the VOOP USM set up. Table 7 lists the measured offsets for the USBL system from the vessel reference point.

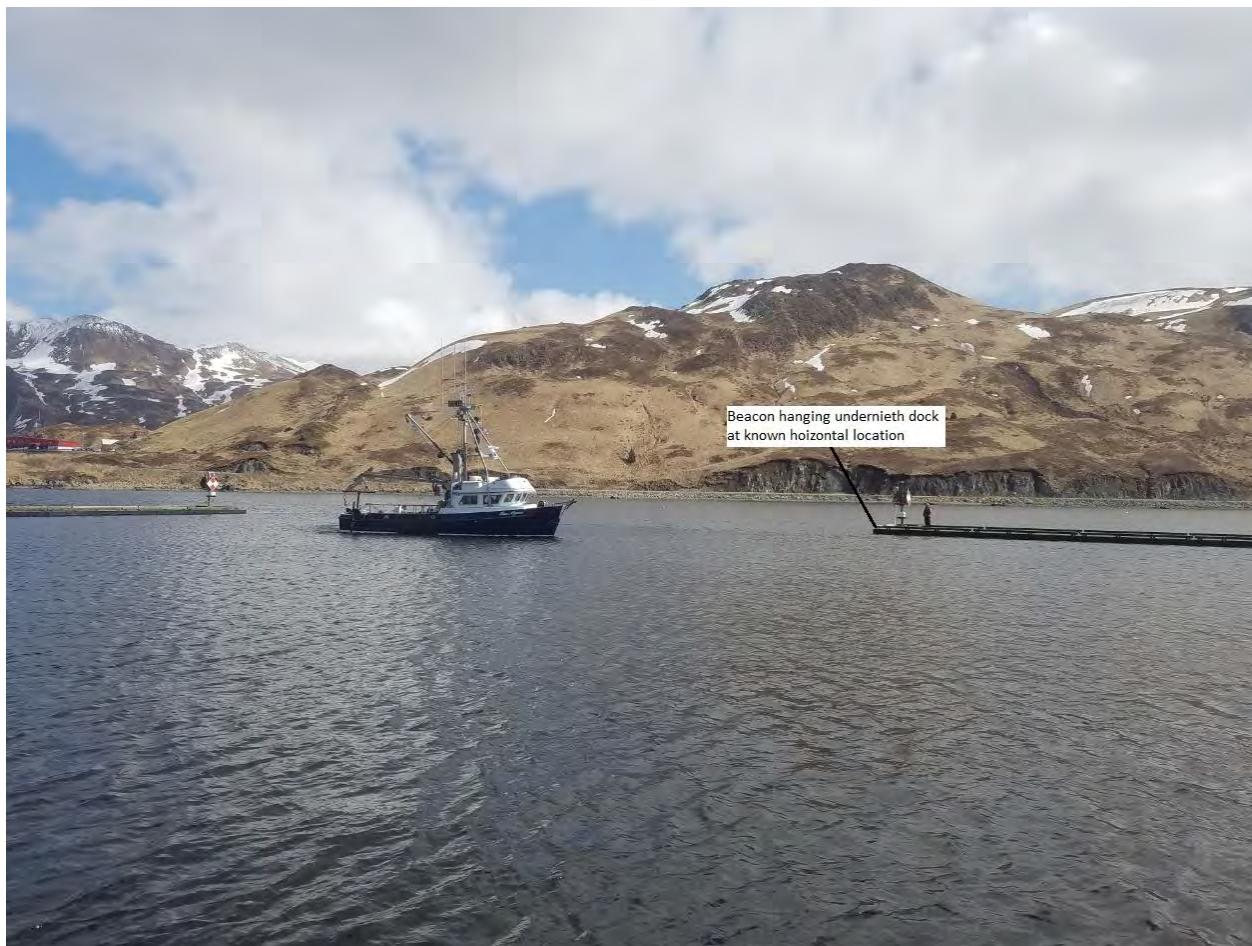
Figure 26 Vessel performing USBL Calibration

A beacon was hung underneath a dock and a position taken for the beacon using an RTK rover. This became the known position for the USBL calibration. The edge of a floating dock was used (see Figure 26).

The USBL system was calibrated using the QINSy USBL calibration utility with two known positions. The beacon was set at a known horizontal location (edge of dock that was RTK shot with a rover). For each position Miss Alyssa maneuvered around and across the transponder beacon at different angles in the Omni or tracking transducer head pattern. Upon completion of the pattern, using the QINSy USBL calibration utility a least squares calibration was run. The known point was then added into the data to complete calibration.

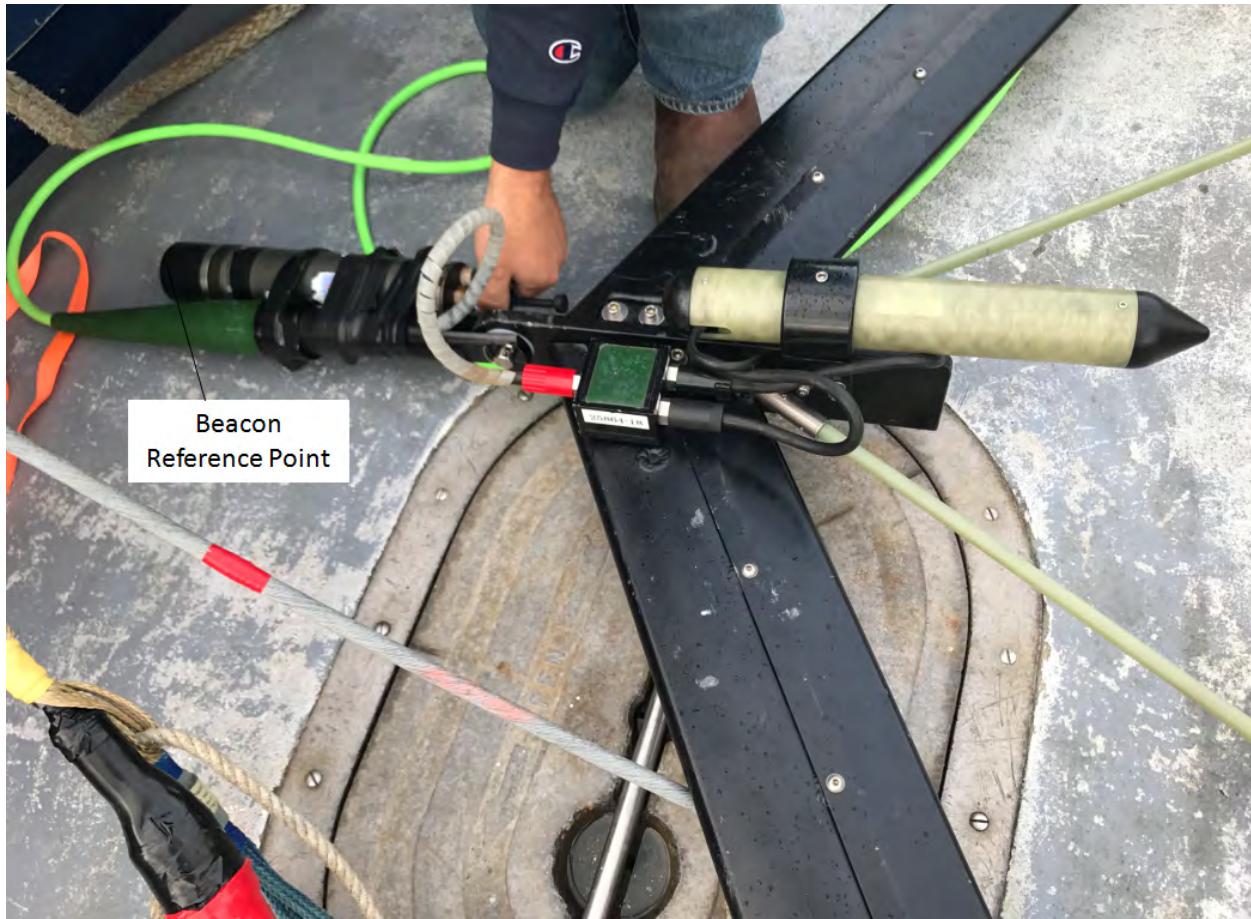
Figure 39 Beacon reference point on the Gradiometer system

The reference point for the gradiometer system was selected as the midpoint between the 2 magnetic sensors. The beacon was positioned on the tow clamp at the front of the system (see Figure 39). The offsets to the gradiometer RP from the beacon positioning system were measured. These are shown below in Table 11 and visually in Figure 38. The altimeter and depth sensor offsets were measured from the gradiometer reference point.

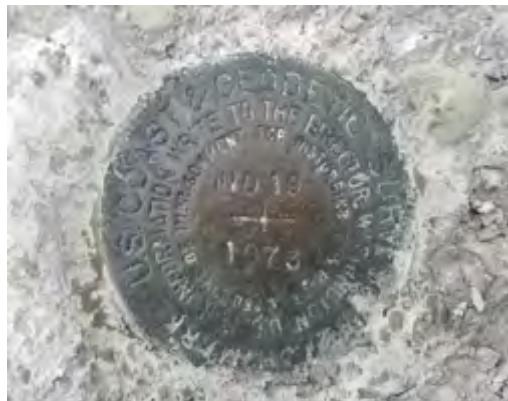
Close-up View

Shared Solution

REF_FRAME: NAD_83(2011)	EPOCH: 2010.0000	SOURCE: NAVD88 (Computed using GEOID12B)	UNITS: m	SET PROFILE	DETAILS
LAT: 53° 52' 28.05077" ± 0.020 m					
LON: -166° 31' 58.04711" ± 0.018 m					
ELL HT: 21.307 ± 0.013 m					
X: -3664901.510 ± 0.024 m					
Y: -877646.964 ± 0.016 m					
Z: 5128535.396 ± 0.014 m					
ORTHO HT: 5.083 ± 0.022 m					
UTM 3 SPC 5010(AK10)					
NORTHING: 5970642.885m 360787.918m					
EASTING: 399227.853m 1620896.037m					
CONVERGENCE: -1.23818018° 7.54463093°					
POINT SCALE: 0.99972461 1.00001286					
COMBINED FACTOR: 0.99972127 1.00000952
