**CRAIG HARBOR
ALASKA**

CRAIG HARBOR, ALASKA
(CWIS NO. 87246, 87666, 13804)

Condition of Improvement 30 September 2007

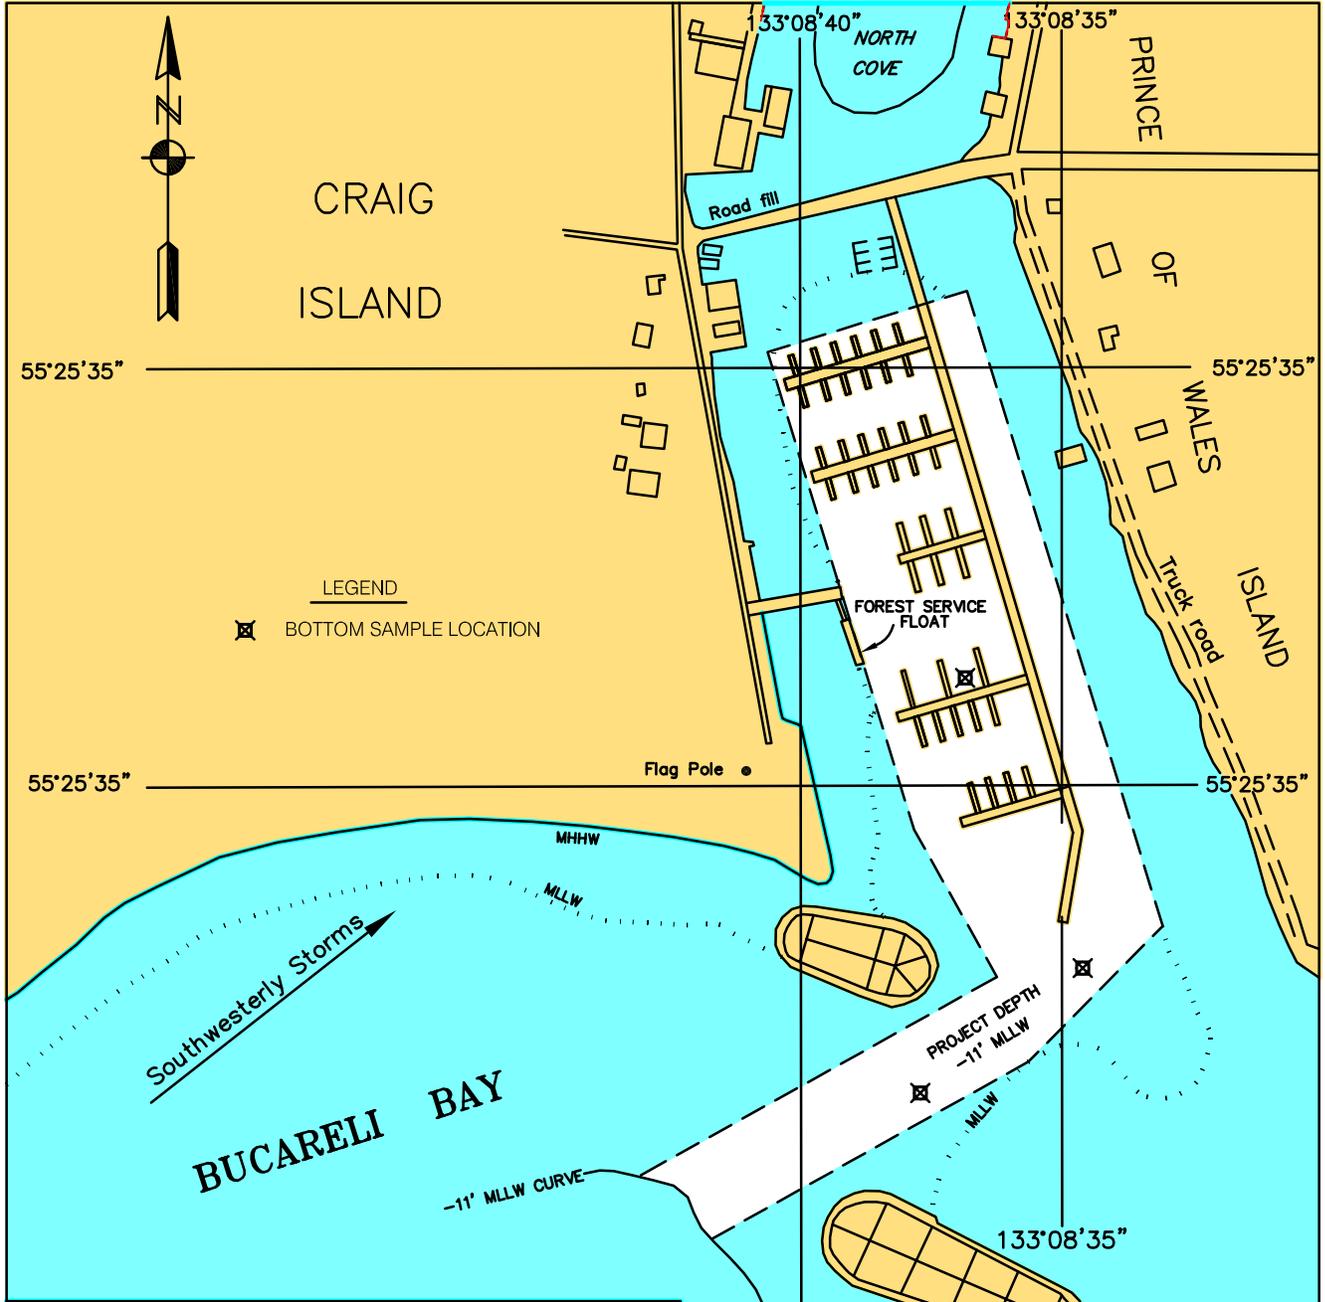
CRAIG HARBOR

PROJECT DEPTH
-11' MLLW

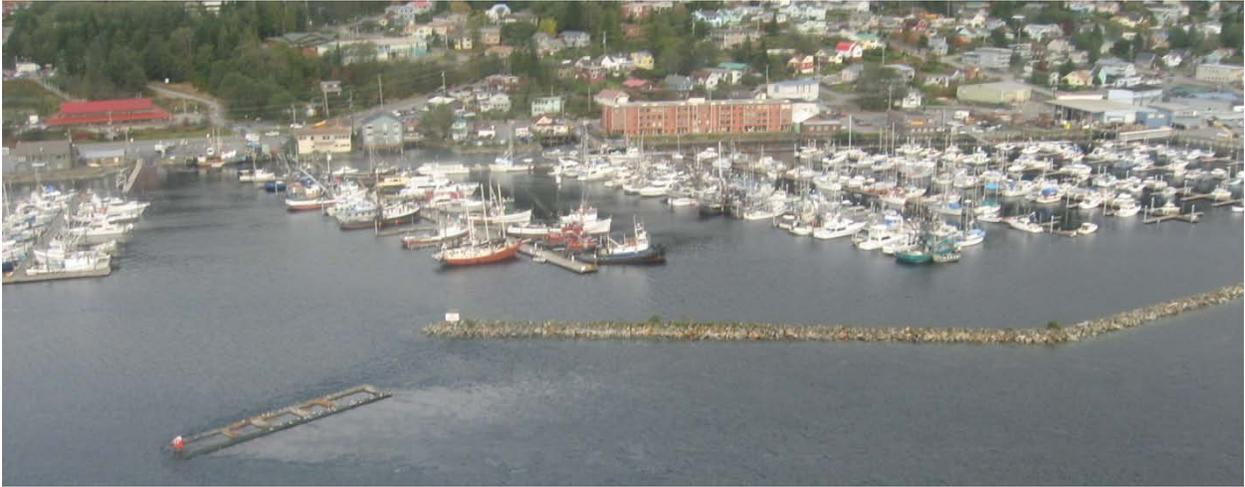
Floating breakwater and the outer breakwater at Craig SBH in 2009.

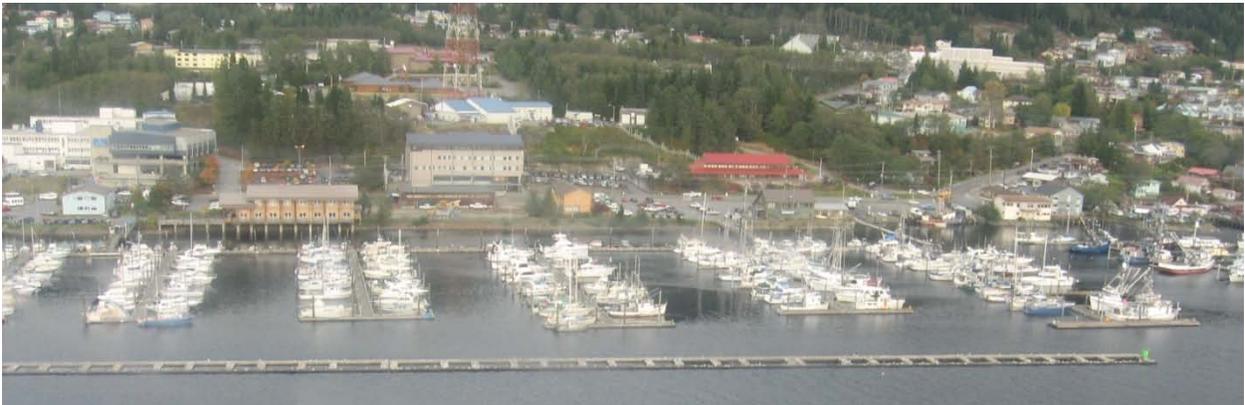
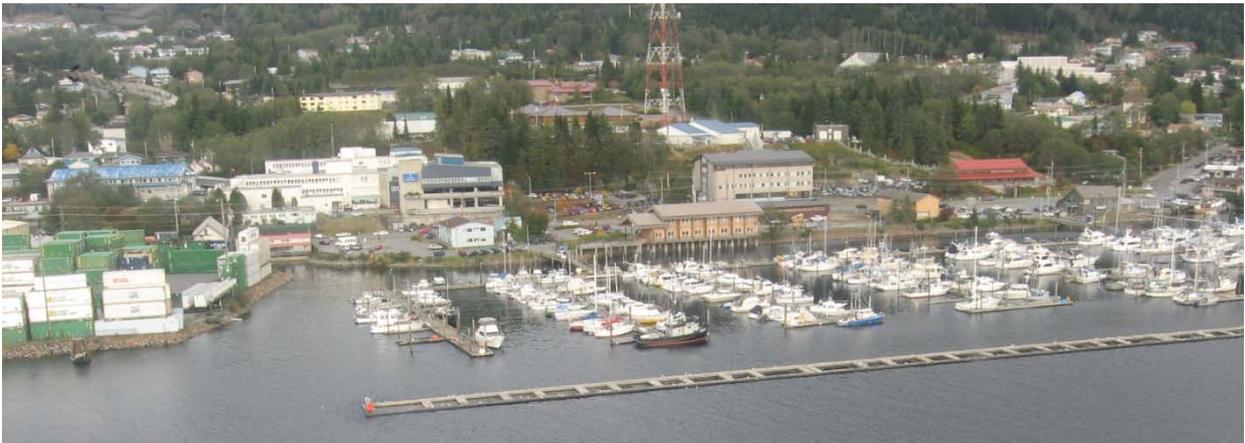
Long floating breakwater at Craig 2009.
