**KAKE  
BREAKWATER**

**KAKE HARBOR, ALASKA**  
(CWIS NO. 72739)

Condition of Improvement 30 September 2011

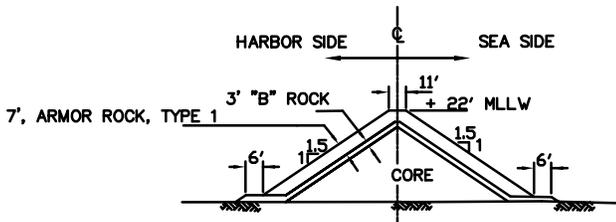
**C BREAKWATER TRUNK SECTION**  
 STA. 5+00 TO STA. 6+50  
 STA. 11+50 TO STA. 16+00

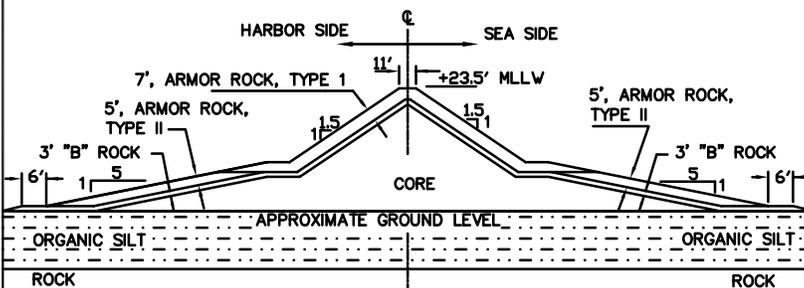
**B BREAKWATER TRUNK SECTION**  
 STA. 6+50 TO STA. 11+50

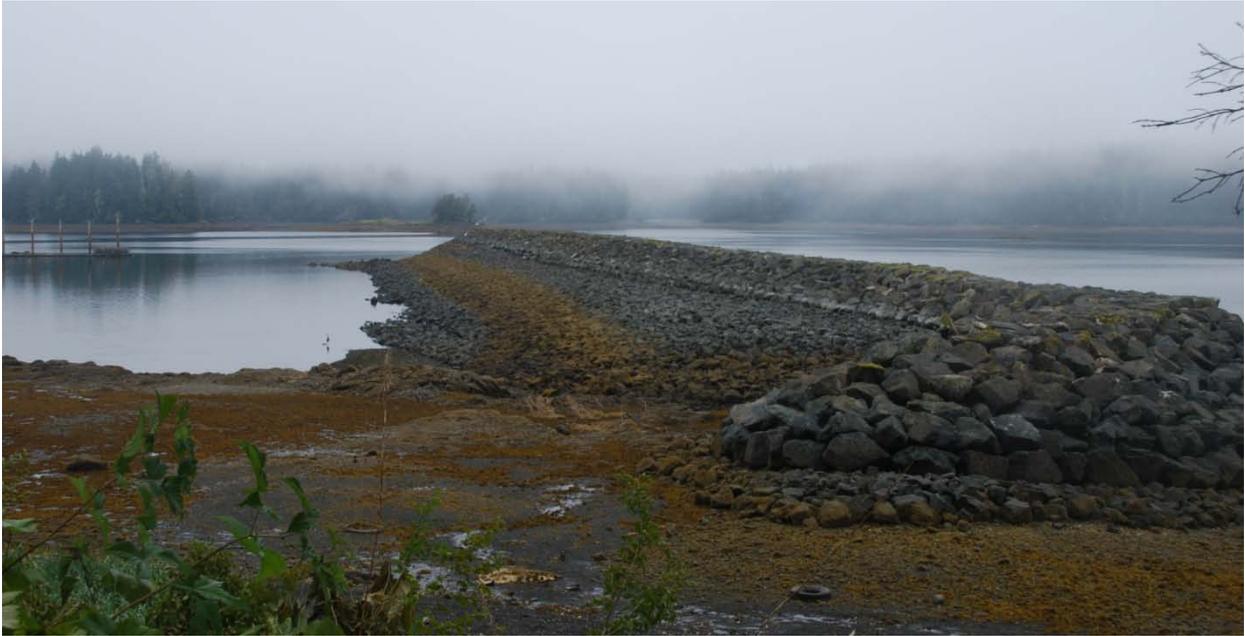
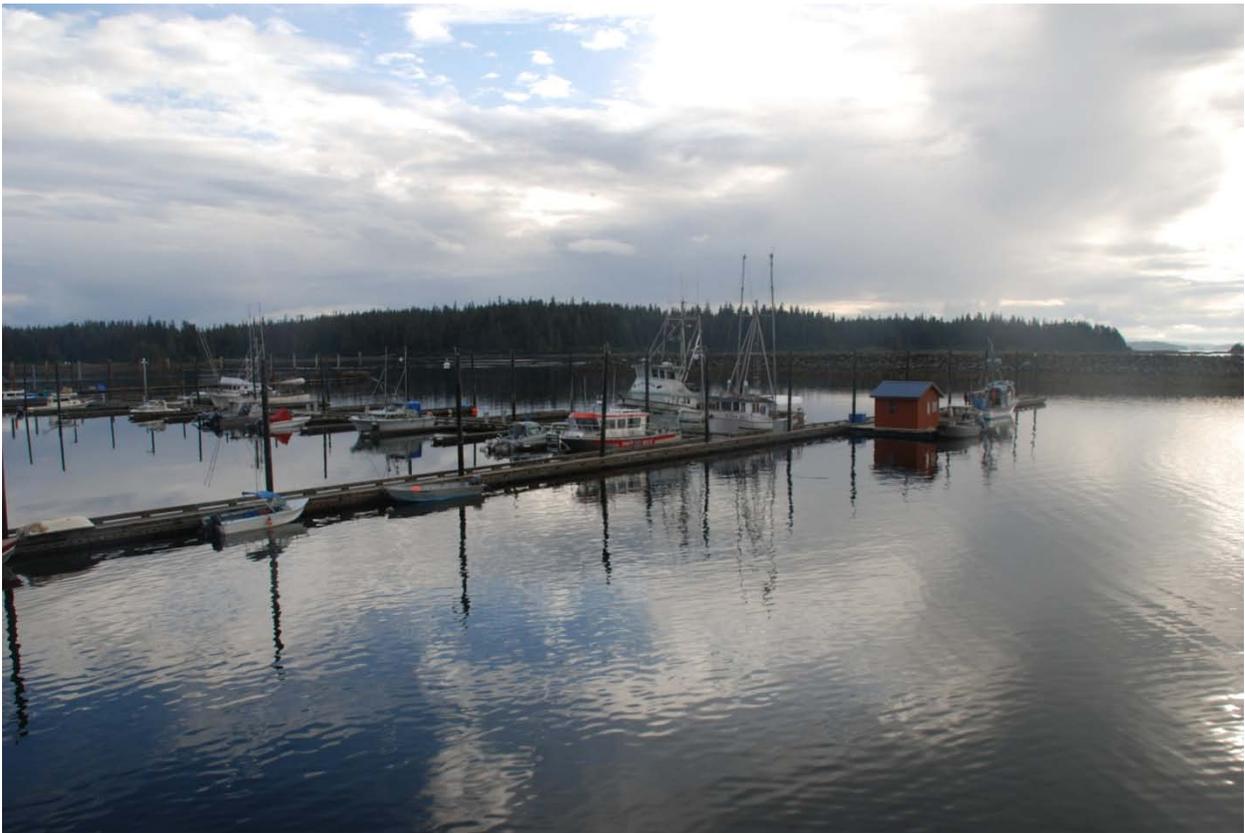
Kake breakwater (top) and Kake marina (below) photographs taken in 2010.

- 2010 - A project condition survey was accomplished in July.
