**KETCHIKAN HARBORS
(THOMAS BASIN
BAR POINT)**

**KETCHIKAN HARBOR
ALASKA**

KETCHIKAN, ALASKA
 (Thomas and Bar Point Basins)
 (CWIS NOS. 00631 & 87071)

Condition of Improvement 30 September 2011

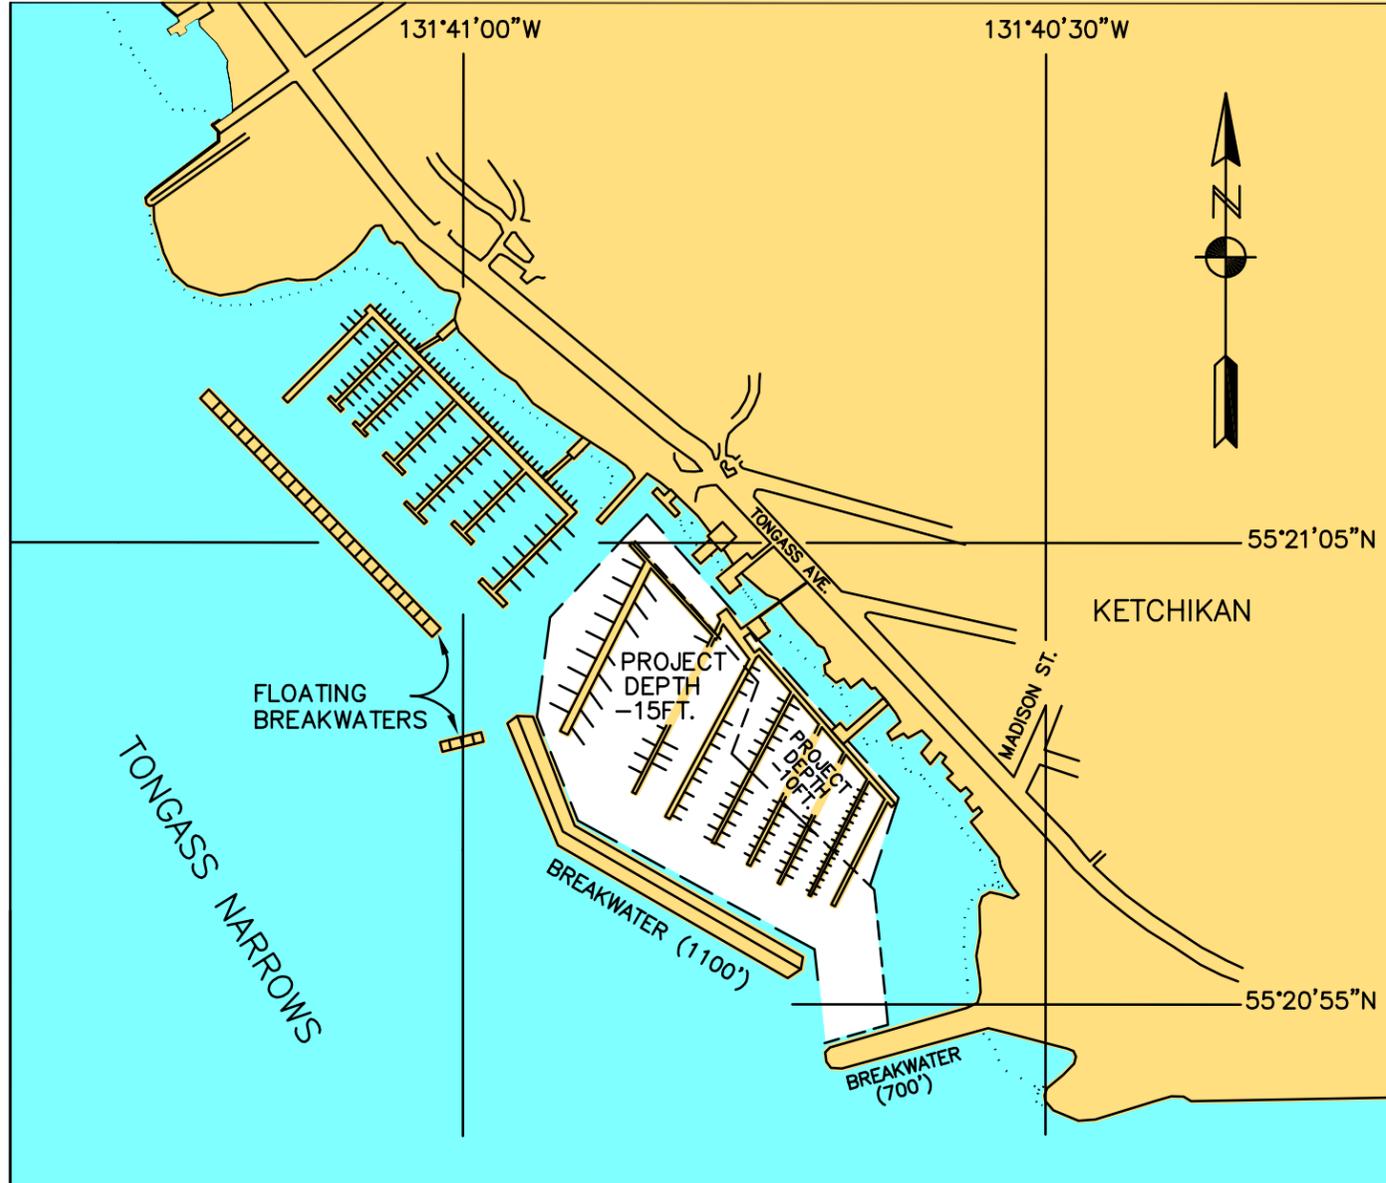
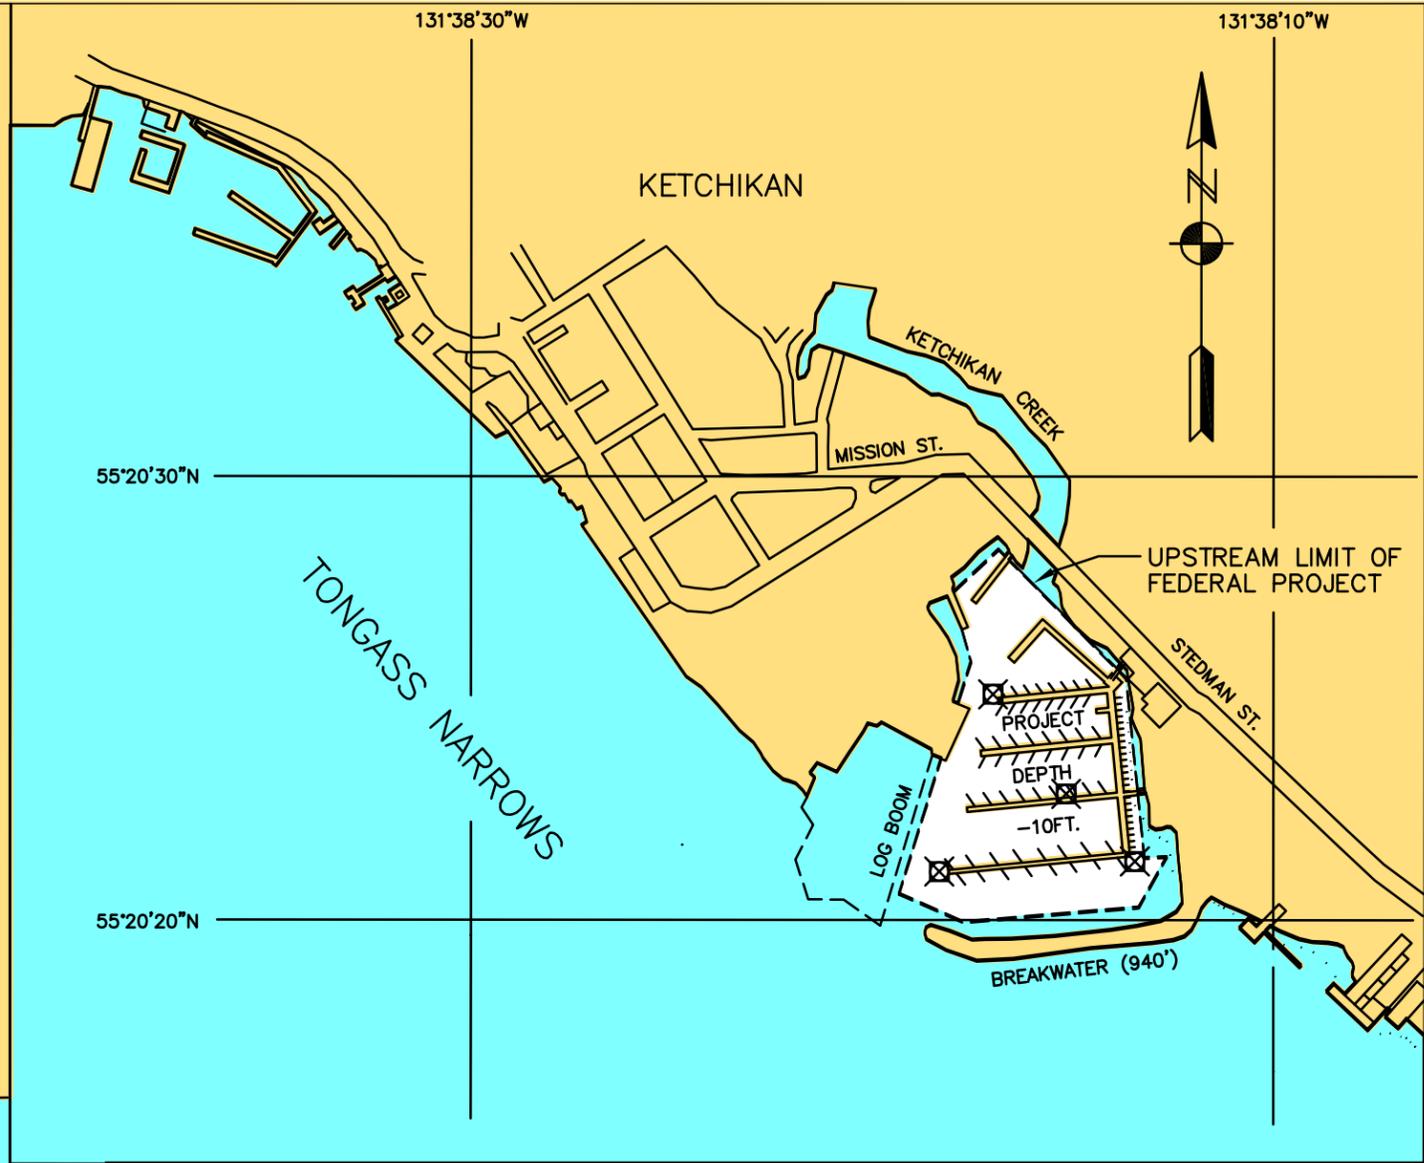
BAR POINT AND THOMAS BASINS

1. ELEVATIONS AND DEPTHS ARE IN FEET AND REFER TO MEAN LOWER LOW WATER (MLLW = 0.0').
2. THIS LOCALITY IS SHOWN ON USC & GS CHART NOS. 17430, 17420, & 16013.

EXISTING PROJECT:	<u>LENGTH</u>	<u>DEPTH</u>	<u>WIDTH</u>
• Thomas Basin	11.35 acres	-10 ft	N/A
• Breakwater (Thomas Basin)	940 ft		
• Bar Point Basin	17.91 acres	-10,-15 ft	N/A
• Southeast Breakwater	700 ft		
• West Breakwater	1100 ft		
• Floating Breakwater	963 ft		
• Floating Breakwater	120 ft

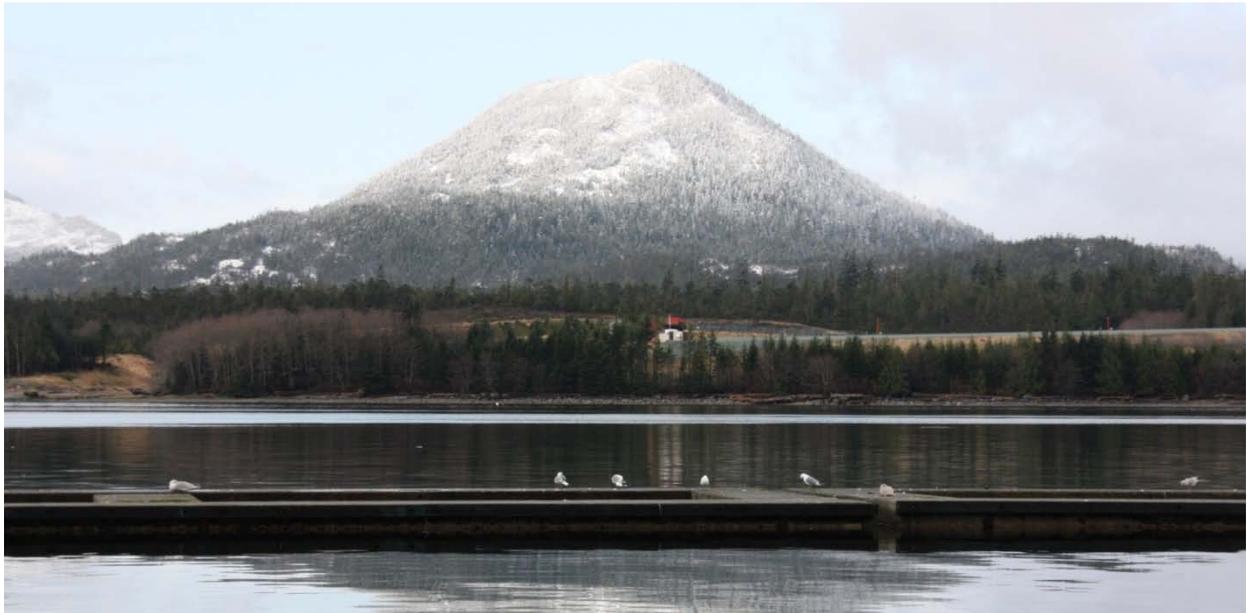
Bar Point Harbor floating breakwater in the summer of 2009.

- 2008 - The floating breakwaters at Bar Point Harbor were inspected by the U.S. Army dive team.
- 2009 - Repair to the floating breakwater by the Army dive team includes realignment/replacing the wire tension ropes, replaced missing and badly corroded anchor chains, repositioned anchor blocks, adjusted slack in anchor chains, replaced wooden fender system, and repaired concrete damage.

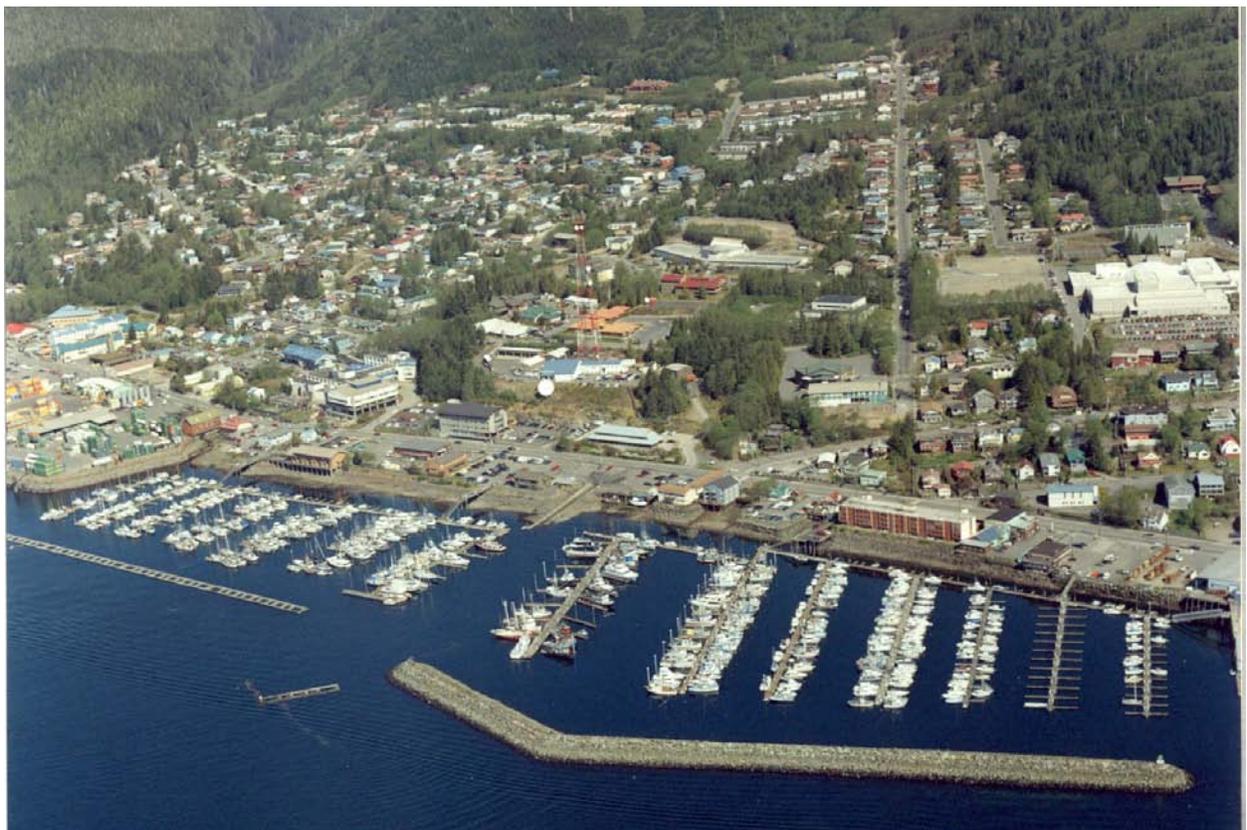
Bar Point Harbor aerial taken in 2005.

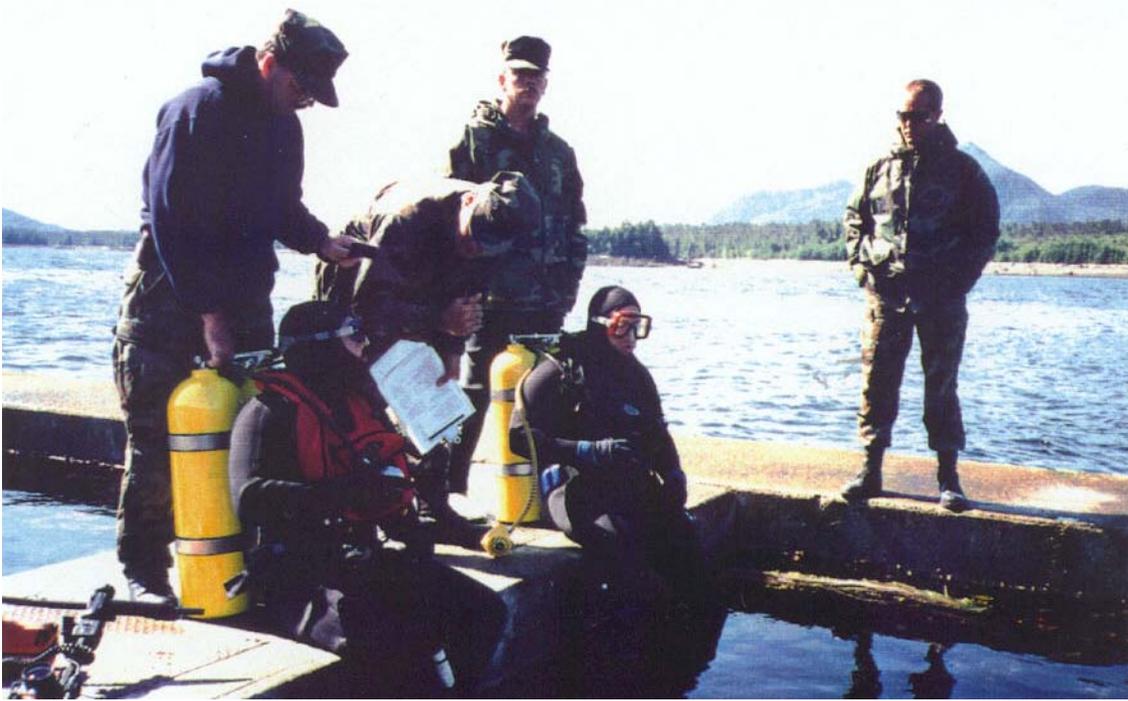
Bar Point Harbor floating breakwater inspection and repair in 2009.

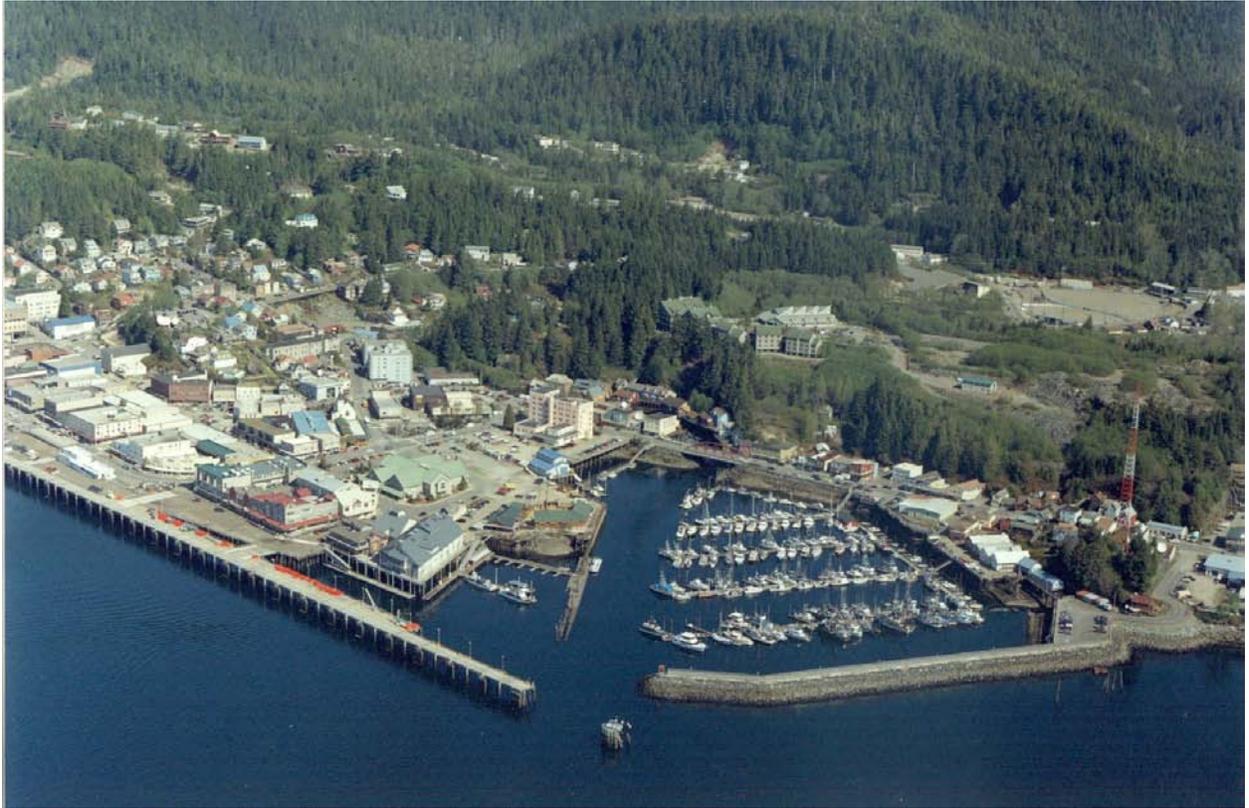
Thomas Harbor aerial photograph taken in 2005.
