NINILCHIK HARBOR

NINILCHIK HARBOR, ALASKA
(CWIS NO. 12640, 87345)

Condition of Improvement 30 September 2011

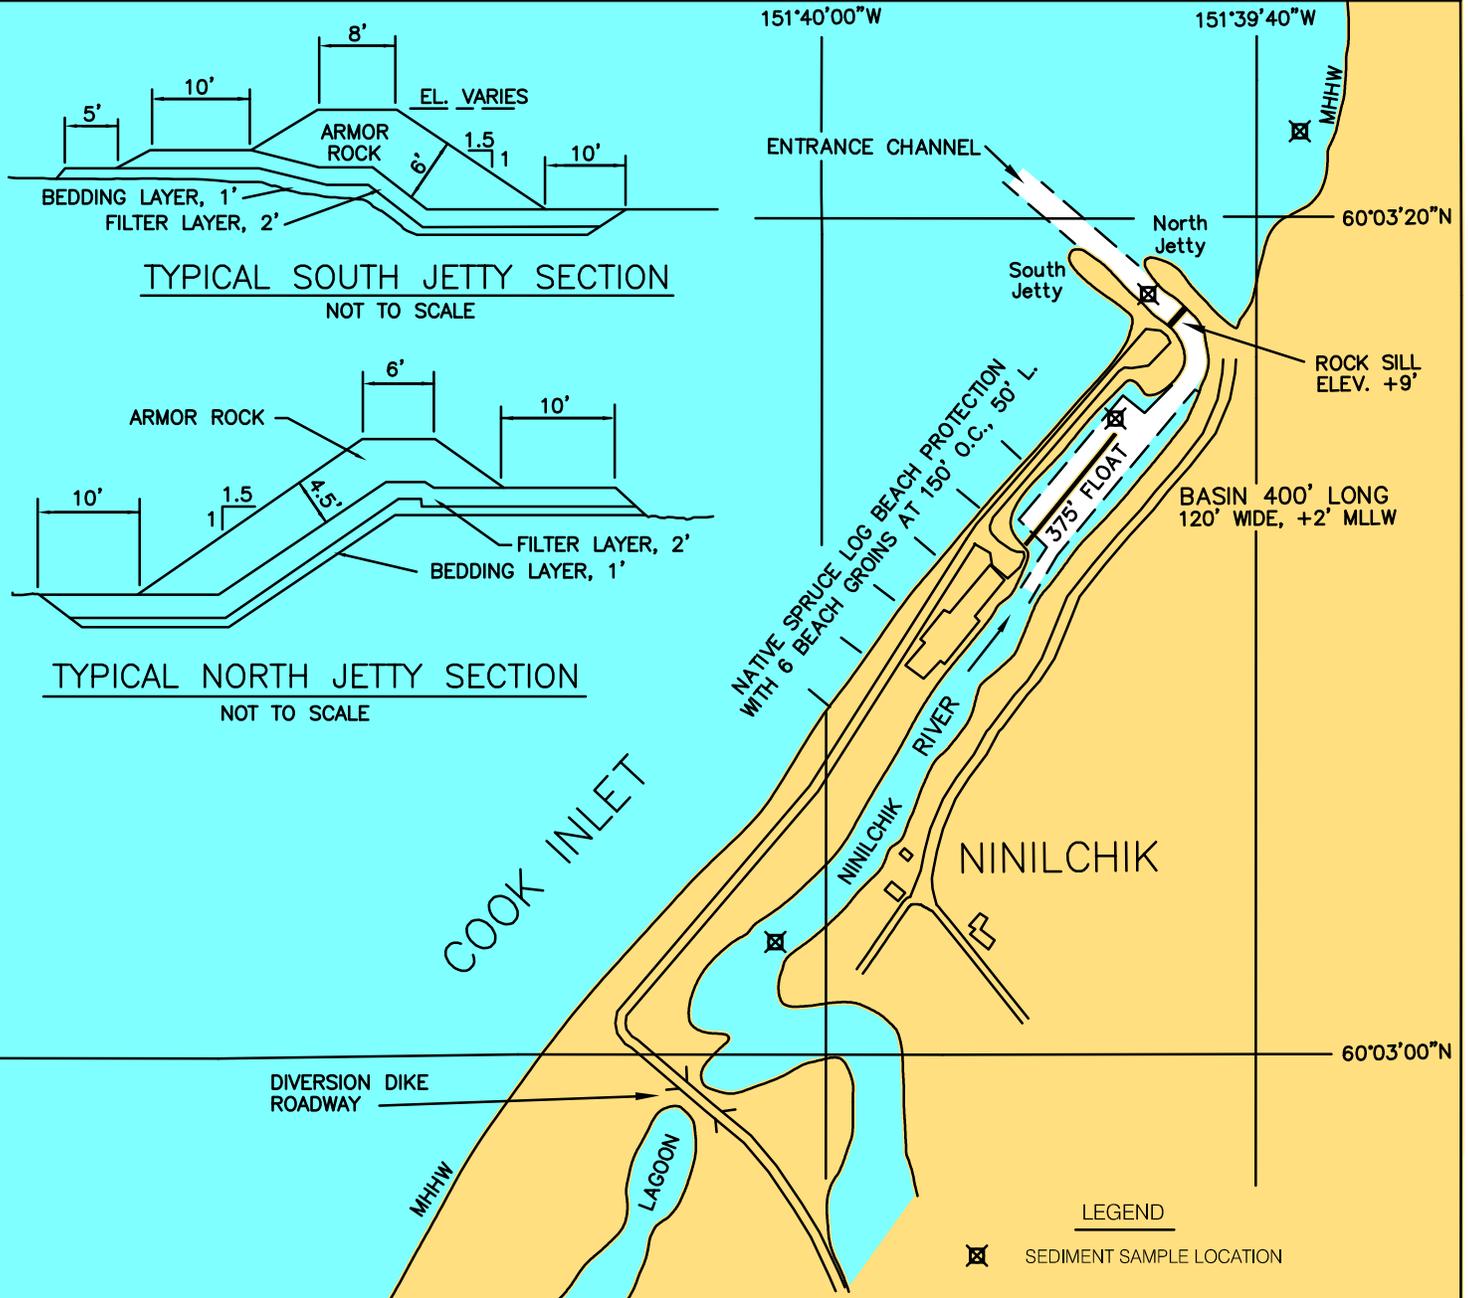
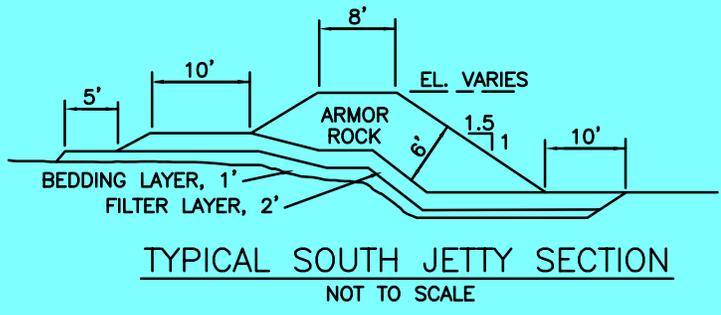
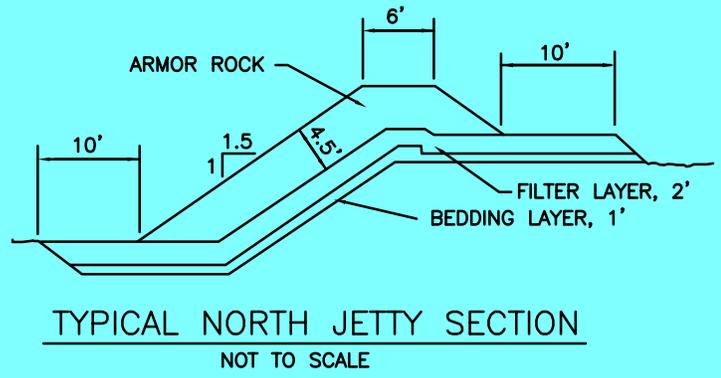
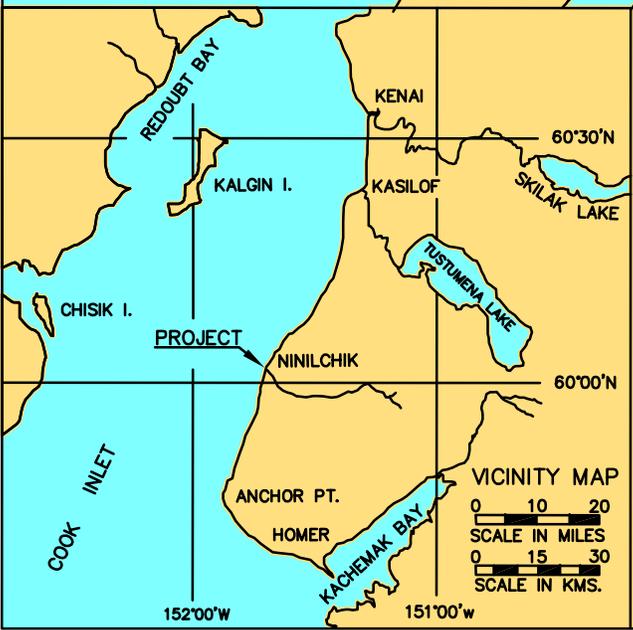
NINILCHIK HARBOR ALASKA

☒ SEDIMENT SAMPLE LOCATION

1. ELEVATIONS AND DEPTHS ARE IN FEET AND REFER TO MEAN LOWER LOW WATER (MLLW = 0.0').
2. THIS LOCALITY IS SHOWN ON USC & GS CHART NOs. 16640, 16013.

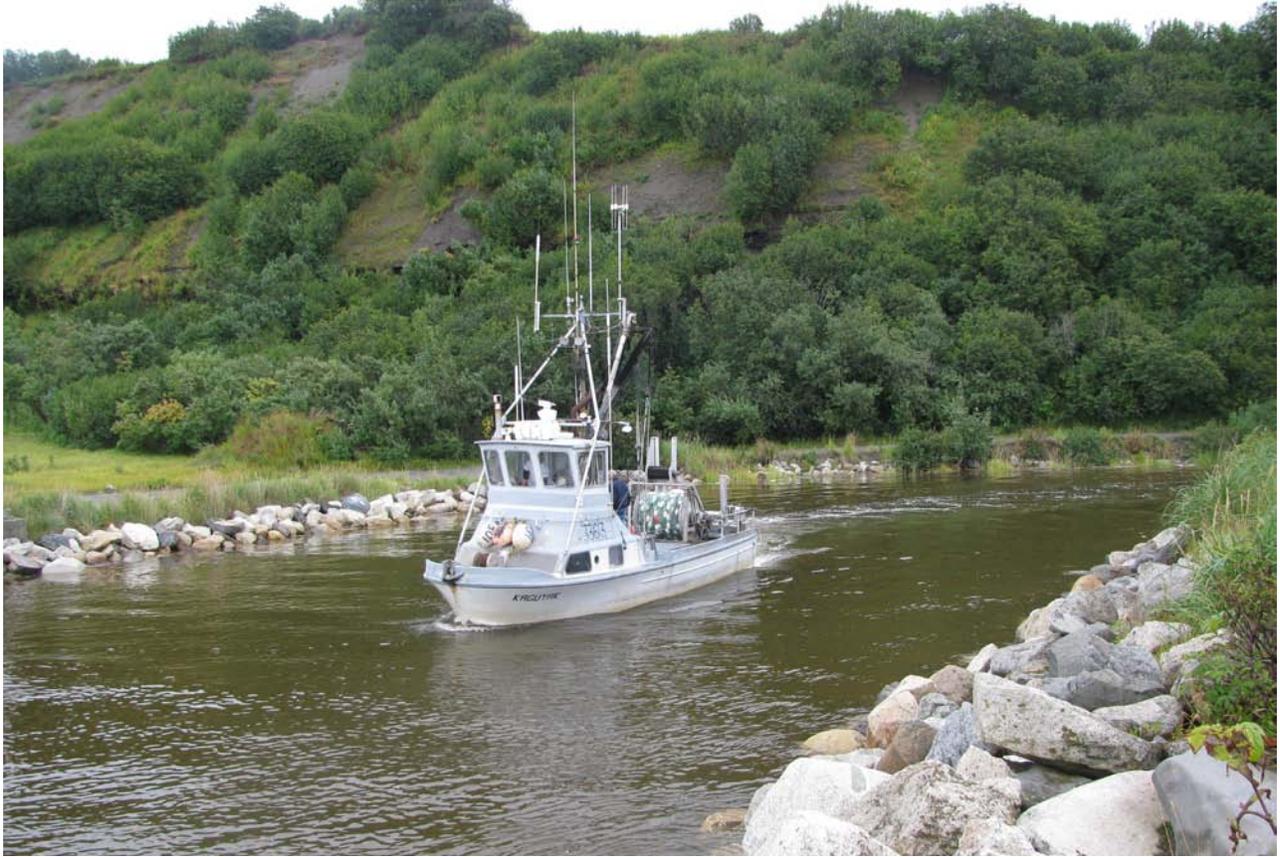
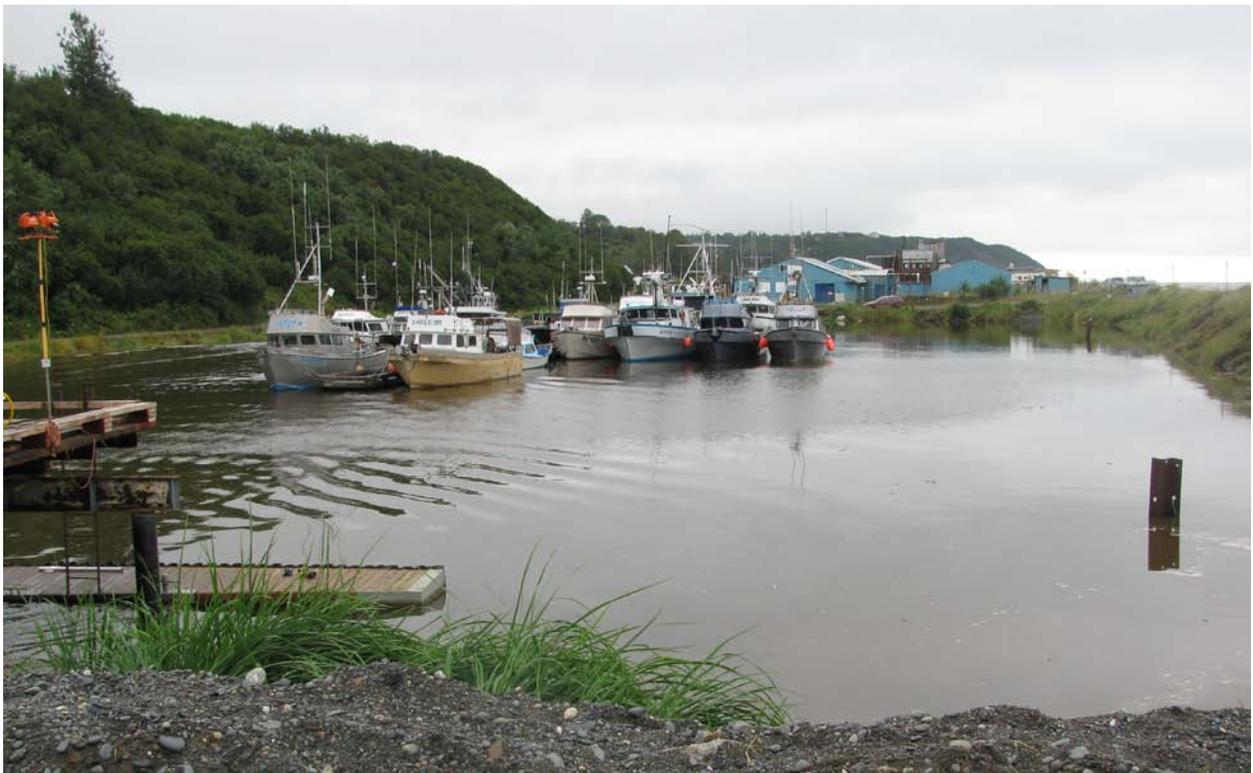
Ninilchik entrance channel (top) and Ninilchik Harbor (bottom) in September 2011.

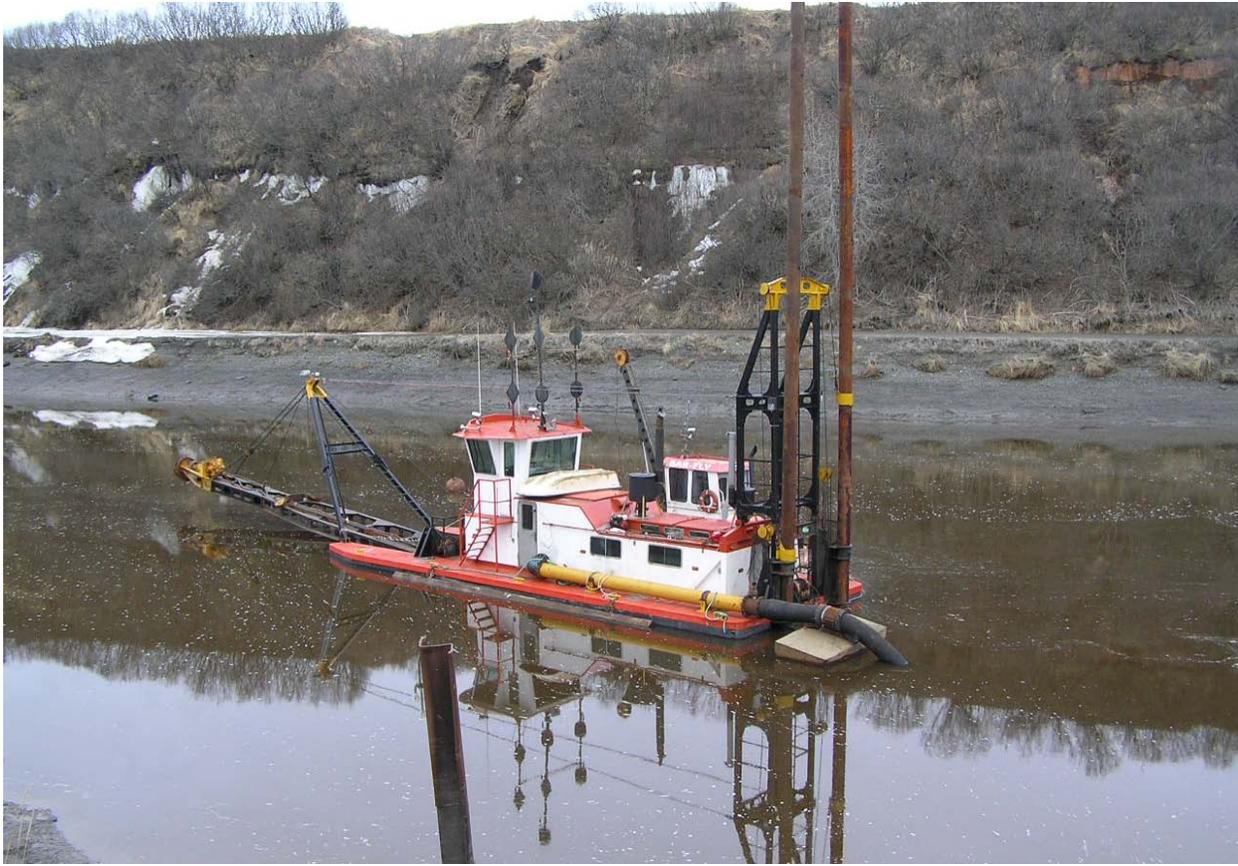
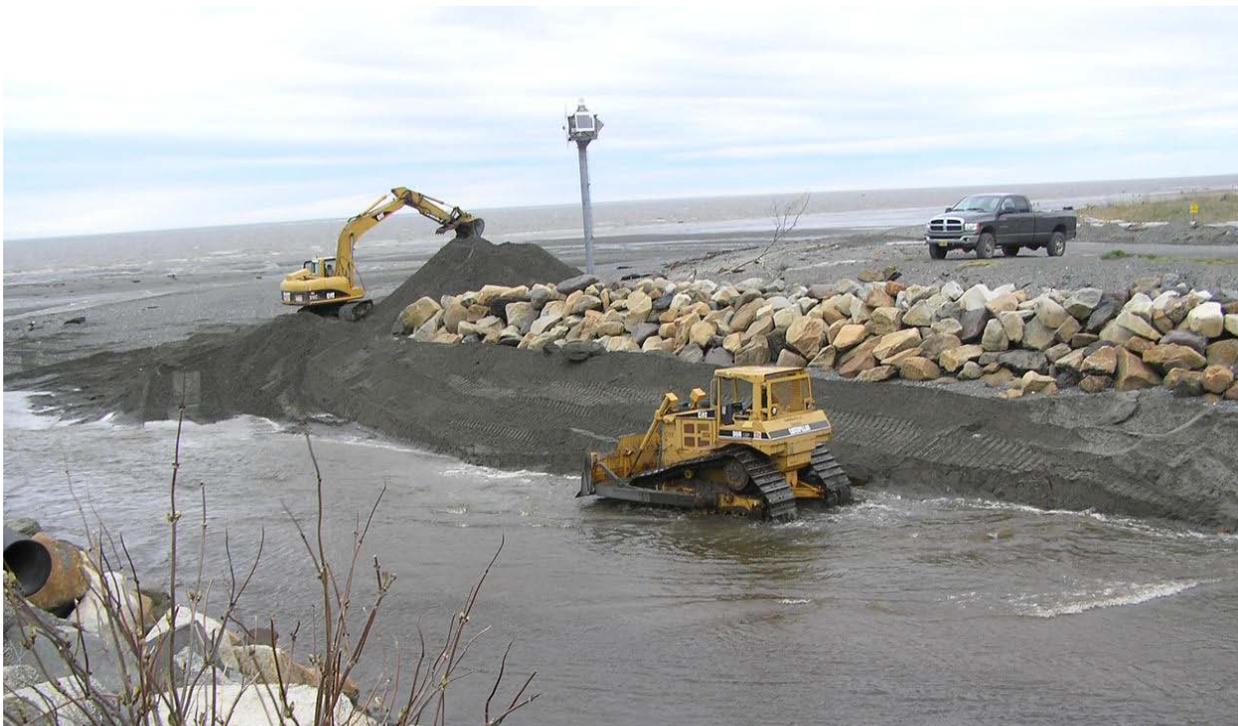
Ninilchik Harbor

Ninilchik dredge with “BAR FLY” dredge (top) and entrance channel dredging in 2010.

- 2010 - Maintenance dredging removed 13,996 cubic yards of material from the harbor basin and entrance channel. The harbor basin was hydraulically dredged and material in the entrance channel was removed with a dozer. A post-dredge survey revealed that project depth was not achieved in several areas. In late June, an extended dredging effort removed about 2,000 cubic yards in the entrance channel from the rock sill seaward.

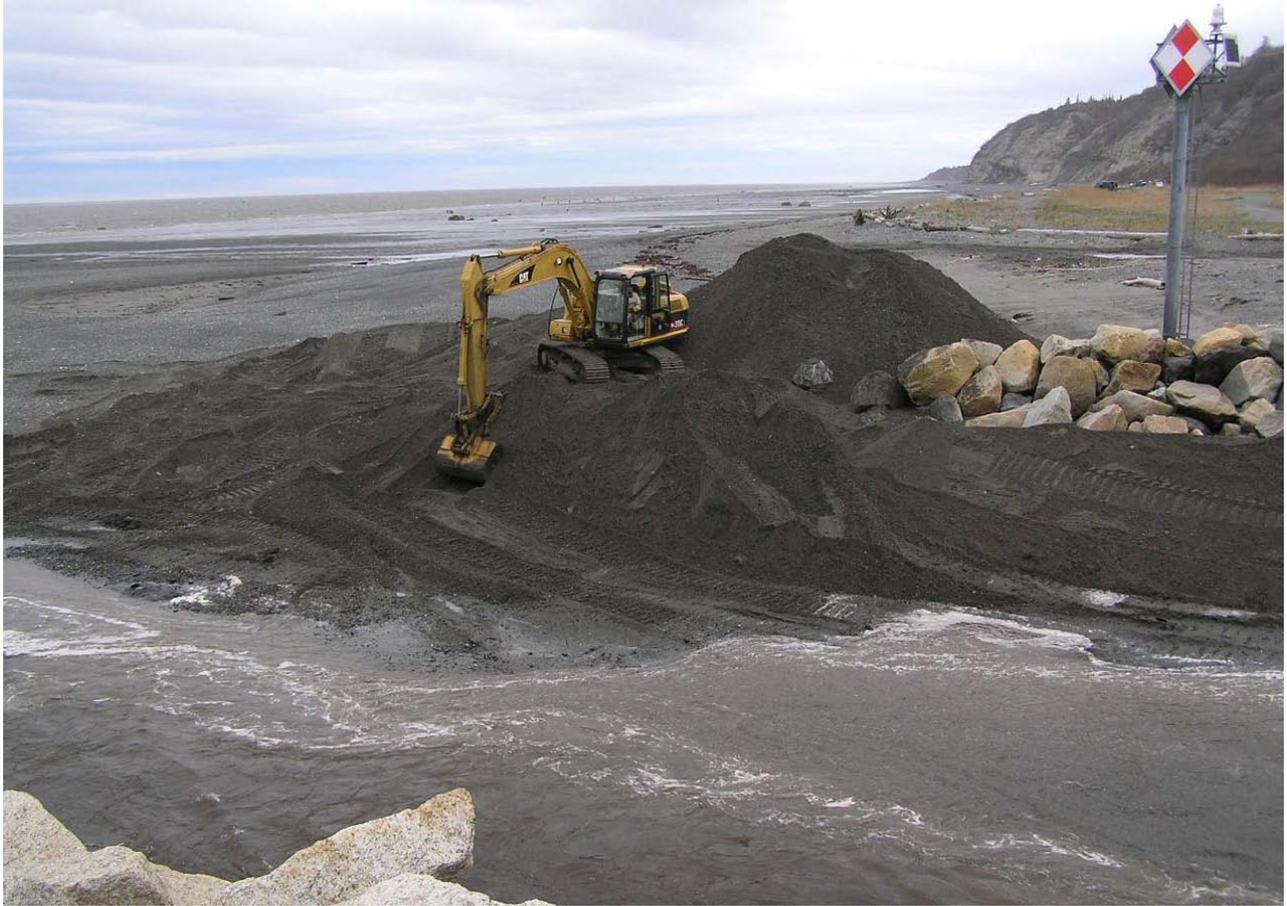
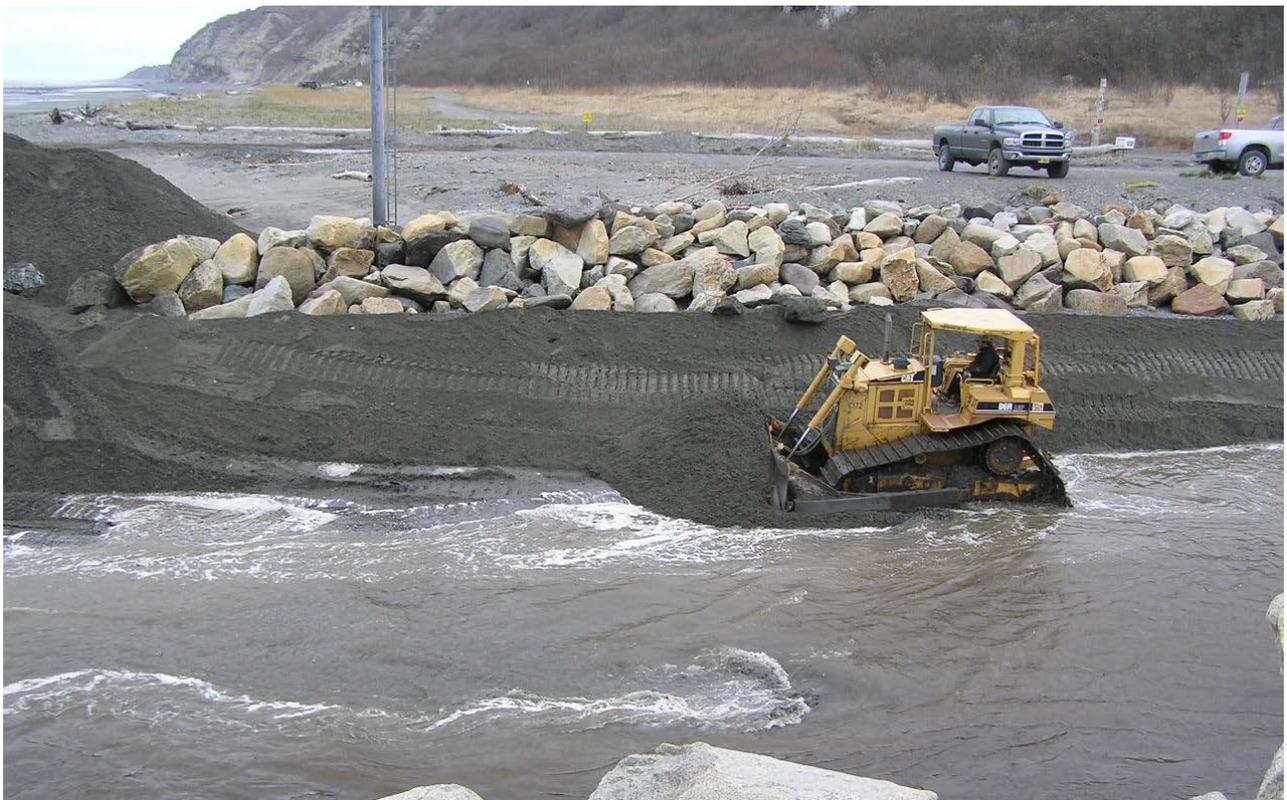
Ninilchik Harbor

Ninilchik entrance dredging in 2010.
