NINILCHIK HARBOR ALASKA

NINILCHIK HARBOR, ALASKA
 (CWIS NO. 12640)
 (CWIS NO. 87345)

Condition of Improvement 30 September 2009

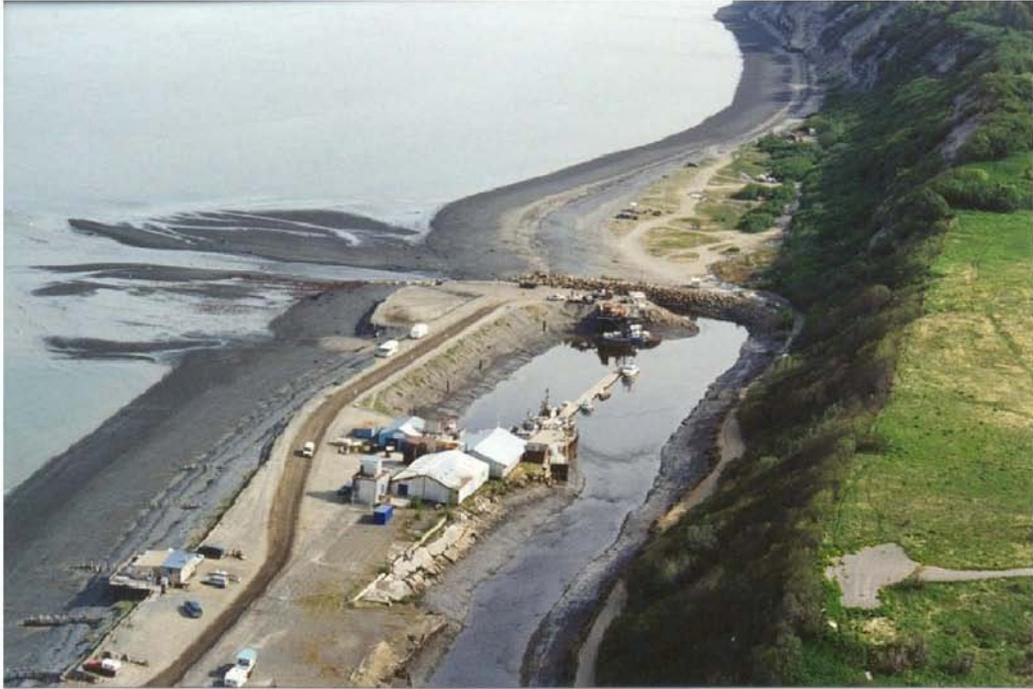
Northerly aerial view of the small boat harbor, June 2000.

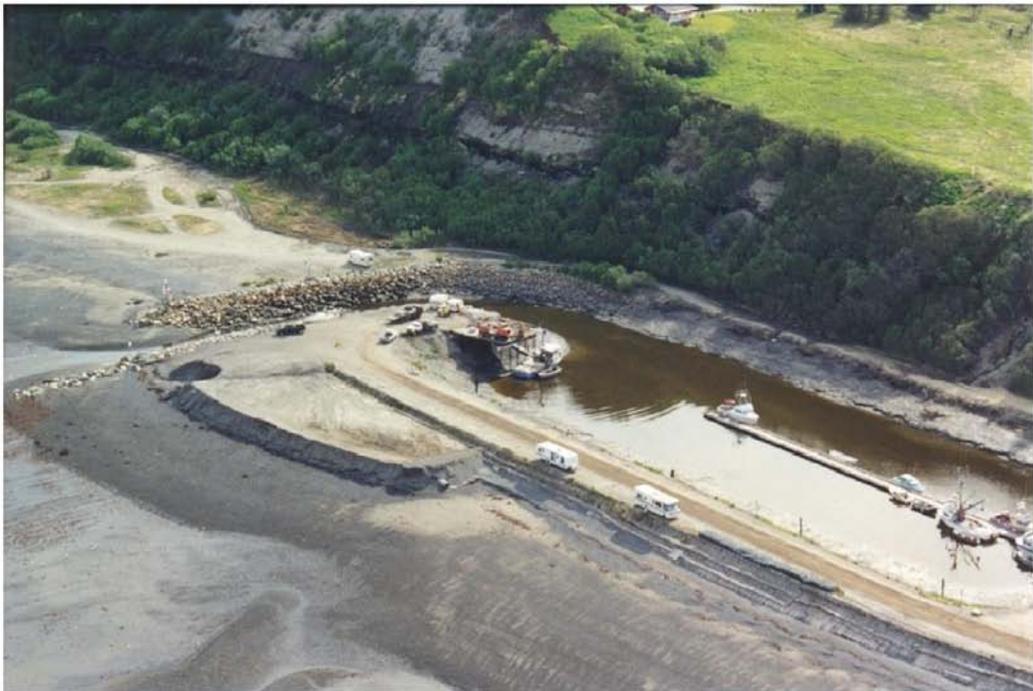
The contained upland disposal site is shown in the left center, photograph June 2000.

1. Sediments are conveyed via suction pipeline from the basin to enrich the beach north of the project or may be contained for use on local roadways. Material bulldozed from the entrance channel is now used as a containment dike for dredge spoils from the basin.
2. The traditional disposal site is located a minimum of 350 feet north of the project and below the +10 foot MLLW tide level (60°03'24"N lat. & 151°39'40"W lon.). Material dredged during the 1995 through 2002 seasons was contained on the upper beach seaward of the project (center, 60°03'16.381"N 151°39'51.234"W) and removed for use on road construction.
3. Arrangements were made with ADOT for their continued use of the dredged material temporarily stock-piled at the upper beach site.

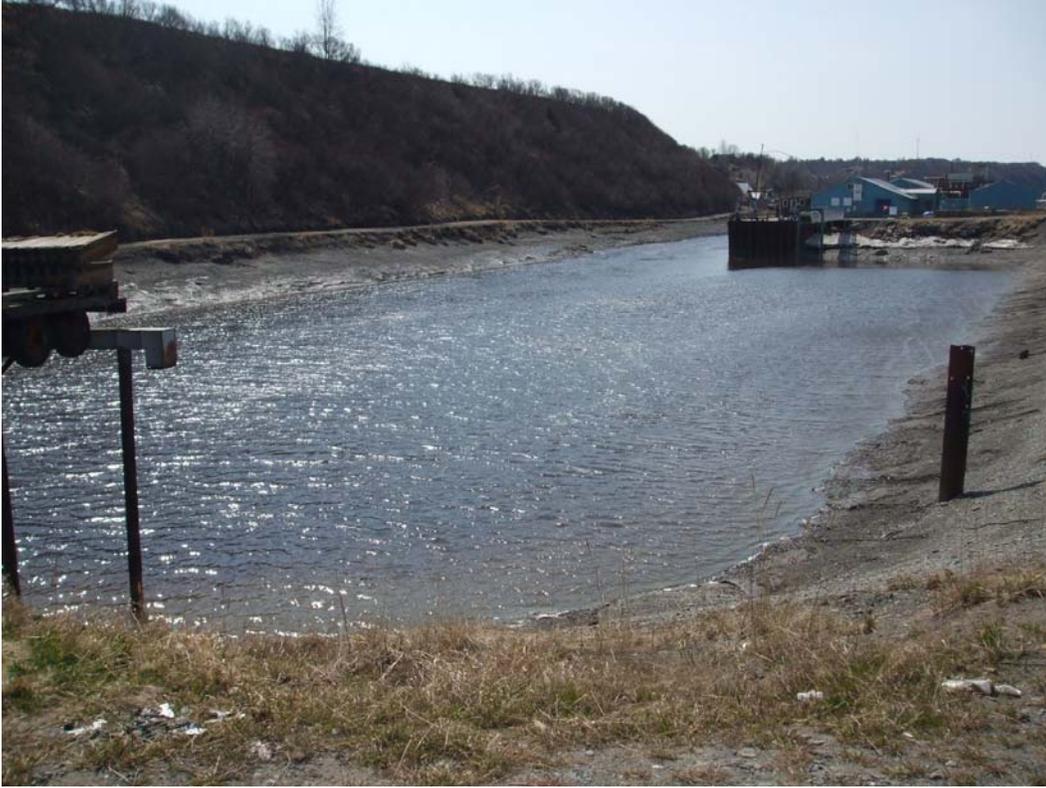
View of the small boat basin in 2009.

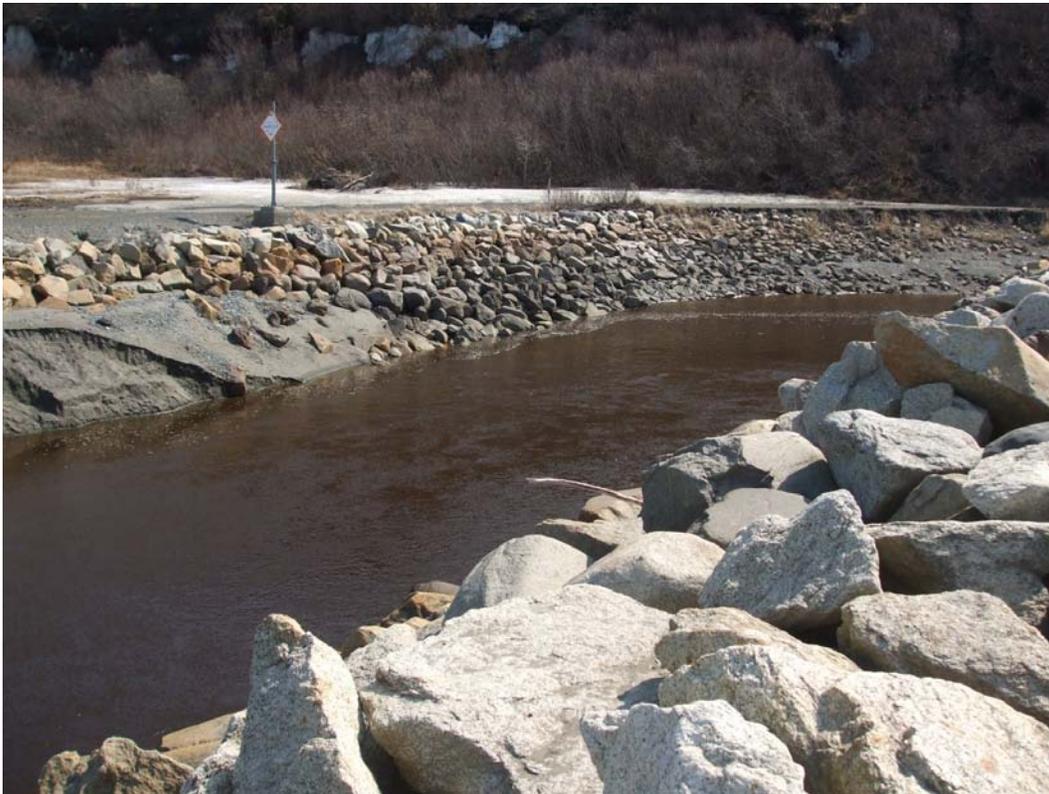
View of the entrance channel near the rock sill in 2009.

1. Ninilchik small boat harbor is an annual dredging project under a two year contract; Homer harbor is awarded under the same contract.
2. Shoaling is most prevalent in the boat basin and outer entrance channel, which is subject to littoral drift and major change from storm events.
3. The dredging window runs from 1 December to 15 May, usually commencing with ice out and ending as soon as possible to avoid conflicts with the in-coming salmon run.
4. The basin area is dredged from a floating plant with a hydraulic cutterhead, and the effluent conveyed by suction pipeline to an upland or low intertidal site. The outer entrance channel, seaward of the rock sill, is maintained by bulldozing the material out and away from the project.
