Appendix A
ADF&G Trip Report
September 6, 2016

MEMORANDUM

SUBJECT: ARRC Mitigation Bank

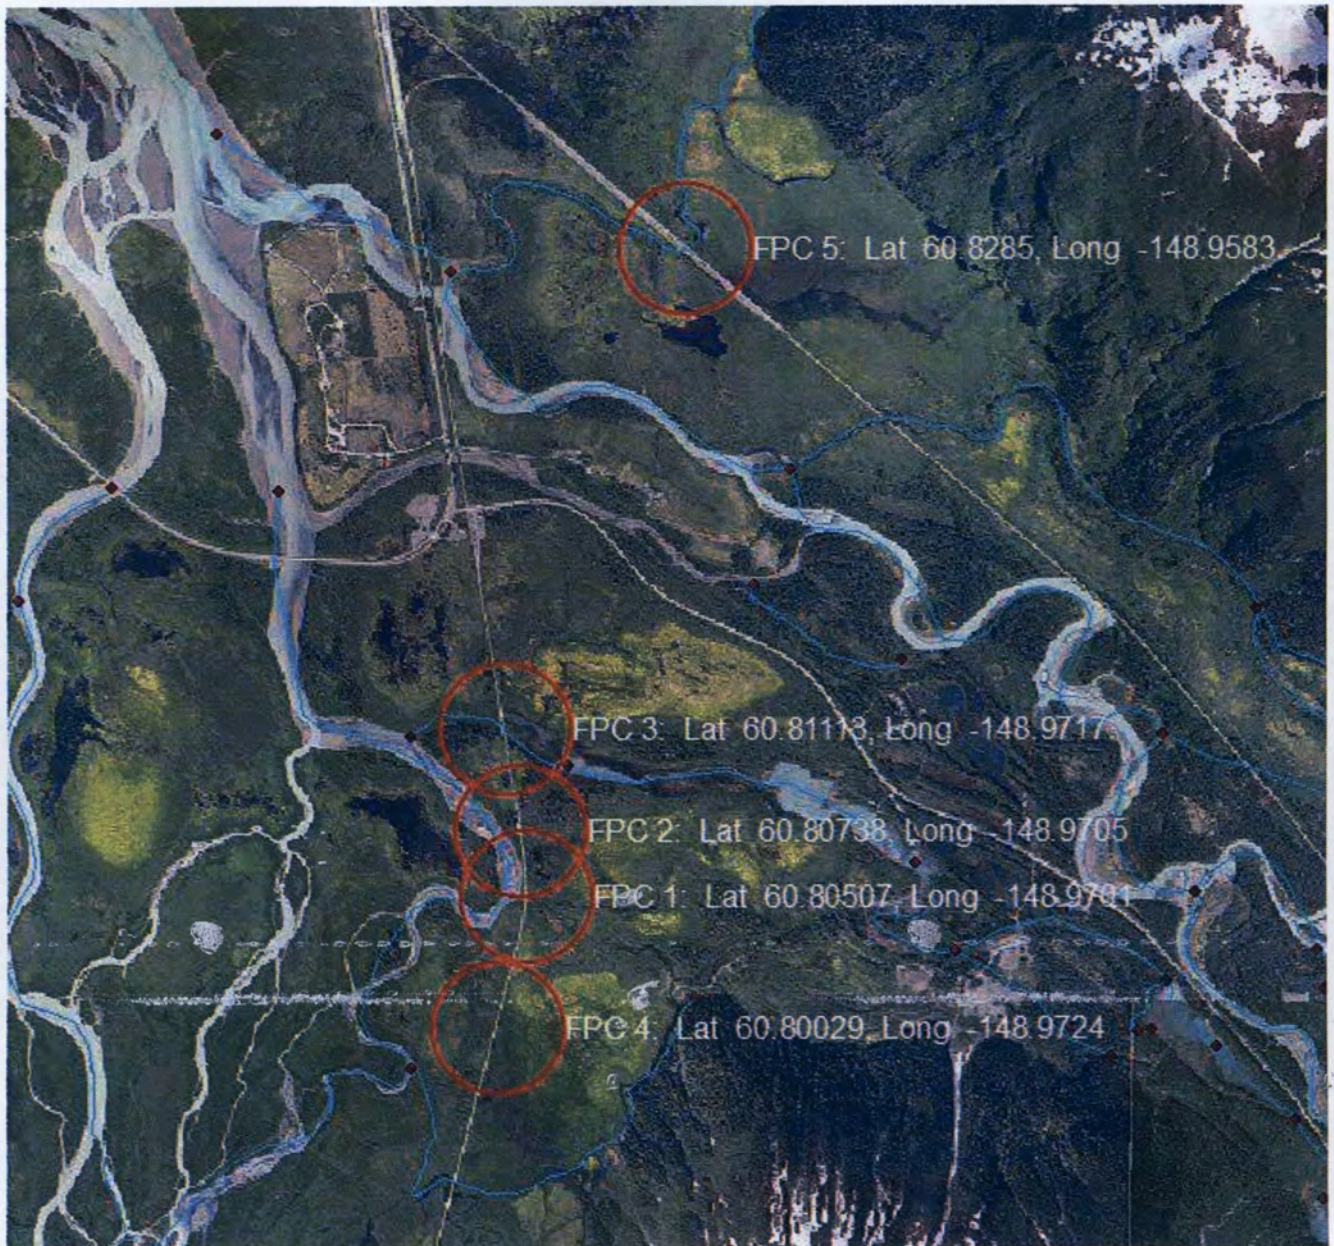
Figure 1. FPC locations. Figure courtesy of HDR.

On September 6, 2016, I joined Blake Adolfae and Jeanette Greenbaum, Alaska Railroad Corporation (ARRC), and Malcom Salway, HDR, Inc. for a field review of proposed mitigation bank replacement culverts in the Portage Creek Valley and Placer River Valley. We met at the Lower Engineers Camp in Portage and departed for the culverts at 8:30 a.m., in a High Rail Car. The weather was rainy and cool. The fish passage culvert (FPC) locations are identified on Figure 1.

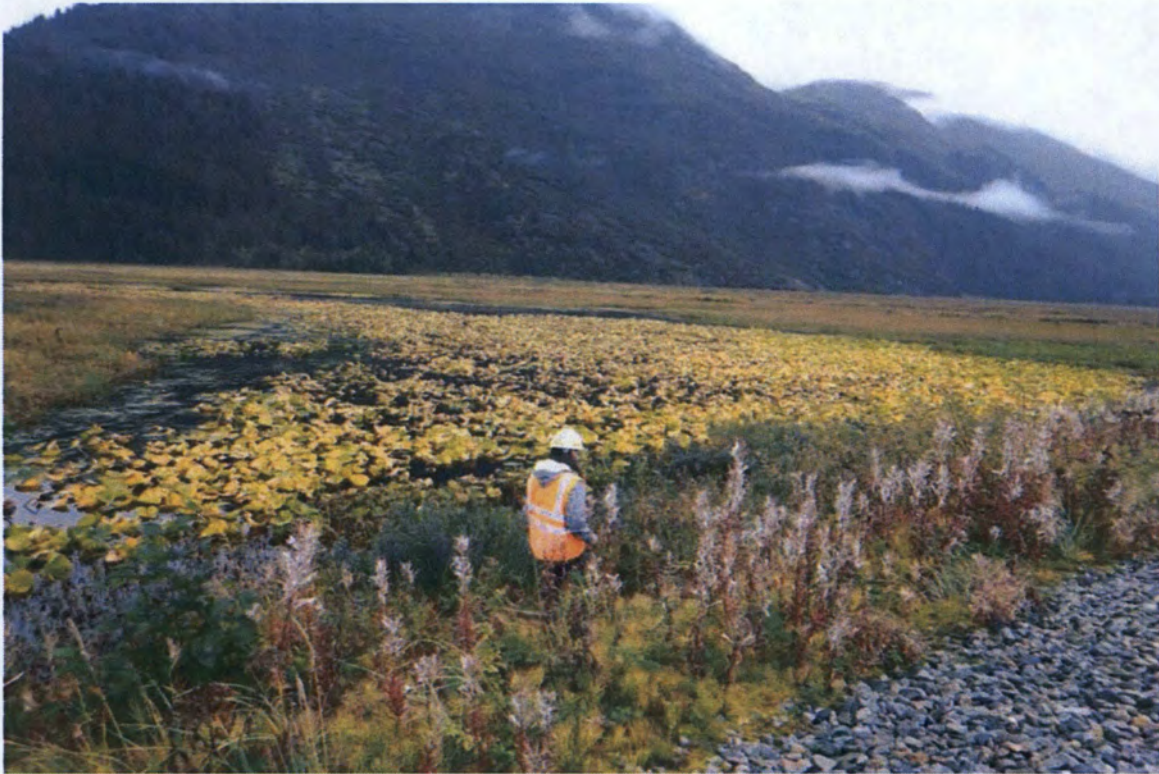
We drove to Stream No. 247-60-10220-2009 (FPC 5). The upper specified reach of the stream is located on the north side of the railroad embankment at 60.8285 N, 148.9583 W. We did not find a culvert under the railroad embankment in the area of the specified reach. We used an electrofisher to sample the upstream (north) side of a wetland area along the railroad embankment (Figure 2). No fish were captured or observed. We sampled a pond on the south side of the railroad embankment (Figure 3). The pond flows into Stream No. 247-60-10220-2009. The pond is located at 60.8260 N, 148.9564 W. No fish were captured or observed. The Anadromous Waters Catalog may be incorrect and no fish passage under the railroad embankment exists at this location. The wetland habitat on the north side of the railroad embankment is high value rearing habitat. The Alaska Department of Fish and Game (ADF&G) recommends the installation of a structure under the railroad embankment designed for fish passage.

Figure 2. FPC 5, wetland habitat located on the north side of the railroad embankment.

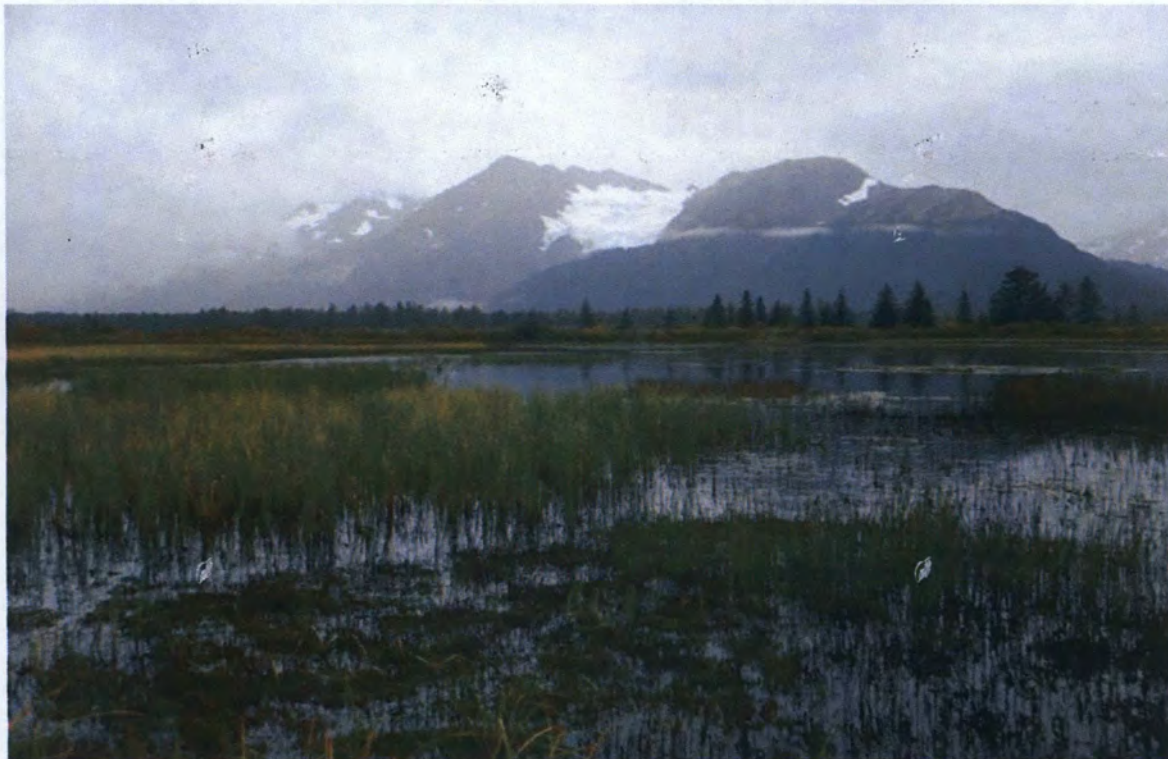
Figure 3. A pond located on the south side of the railroad embankment.

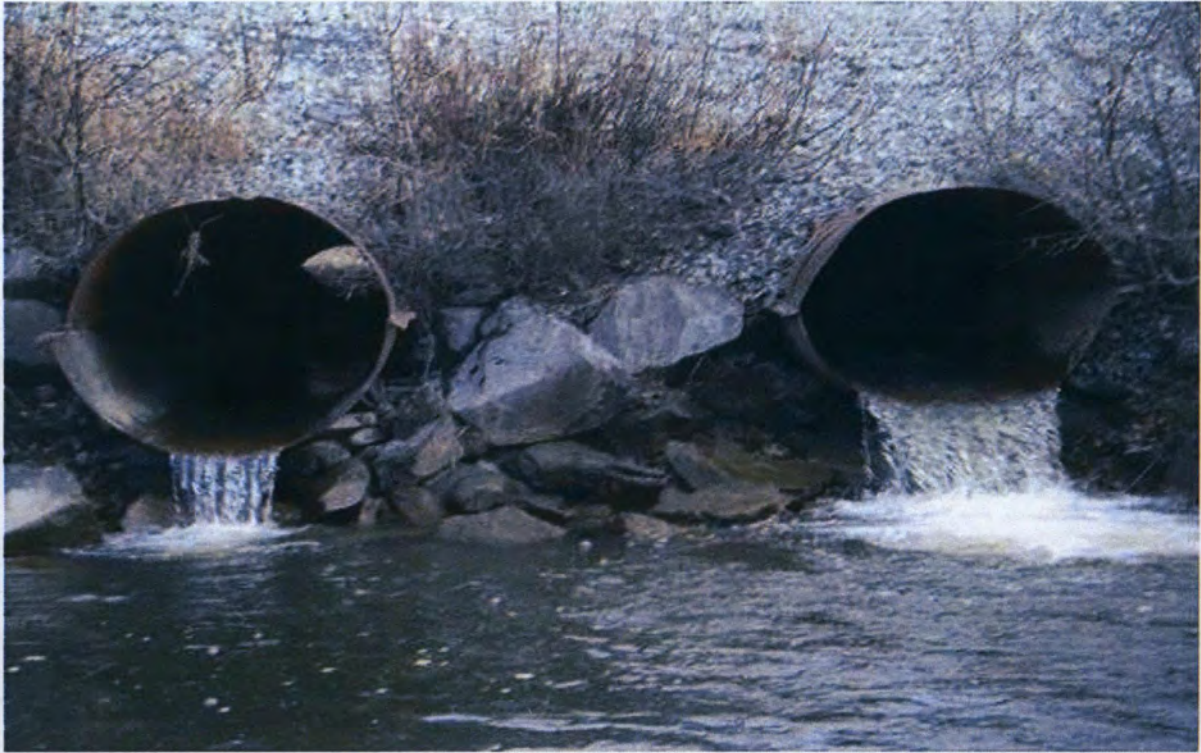
We drove to Explorer Creek (Stream No. 247-60-10210-2015) (FPC 3). Two 48-inch diameter culverts are located in Explorer Creek at 60.8111 N, 148.9717 W (Figure 4). The culverts are perched approximately 3 feet and are tidally influenced. A large scour pool is located below the culverts. During low tide, this location is subject to poaching from snagging of sockeye and coho salmon. The ARRC has installed bridge supports (bents) in the railroad embankment for a future bridge that will replace the culverts.

Figure 4. FPC 3, Explorer Creek culverts, outlet view. Photograph taken October 2008.

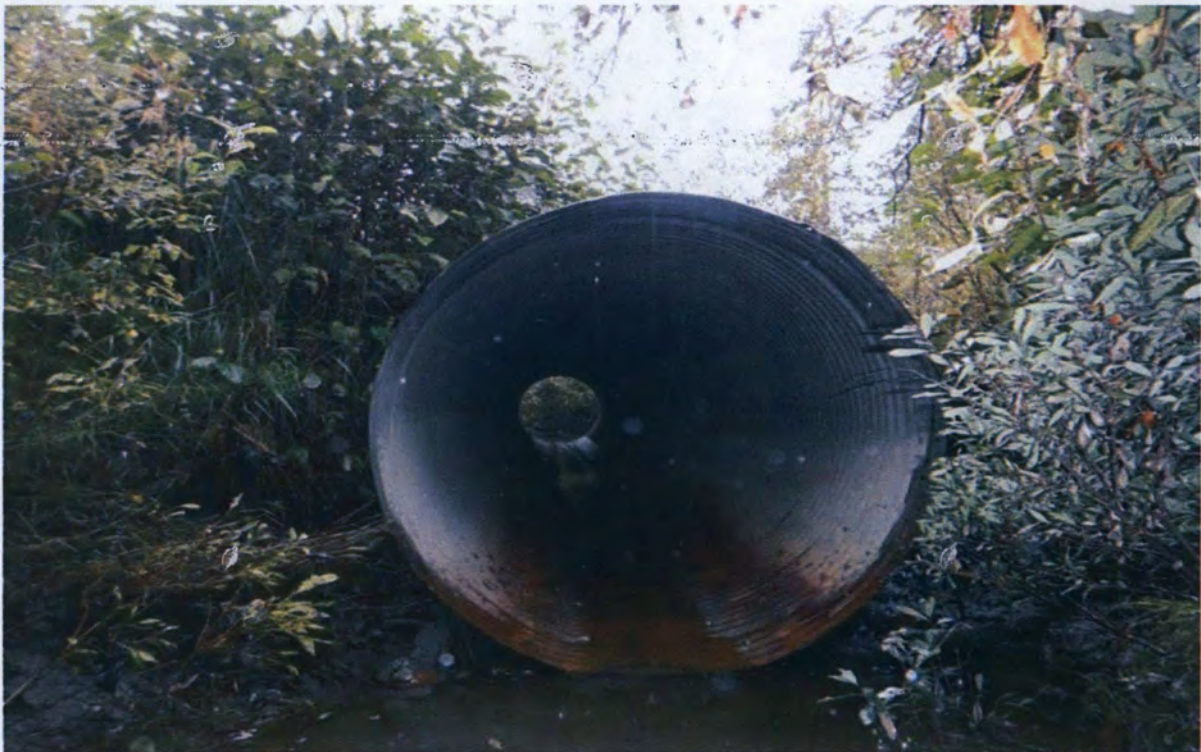
We drove to an unnamed tributary to the Placer River (Stream No. 247-60-10210) (FPC 2). A perched 60-inch diameter culvert is located under the railroad embankment at 60.8074 N, 148.9705 W (Figure 5). The culvert is tidally influenced. I sampled below the culvert outlet and captured 5 juvenile coho salmon. I sampled above the culvert inlet and no fish were captured or

Figure 5. FPC 2, culvert inlet view.

observed above the culvert. The ADF&G recommends that the existing culvert is removed and replaced with a structure designed for fish passage. The unnamed stream below the culvert will be nominated to the Anadromous Waters Catalog.

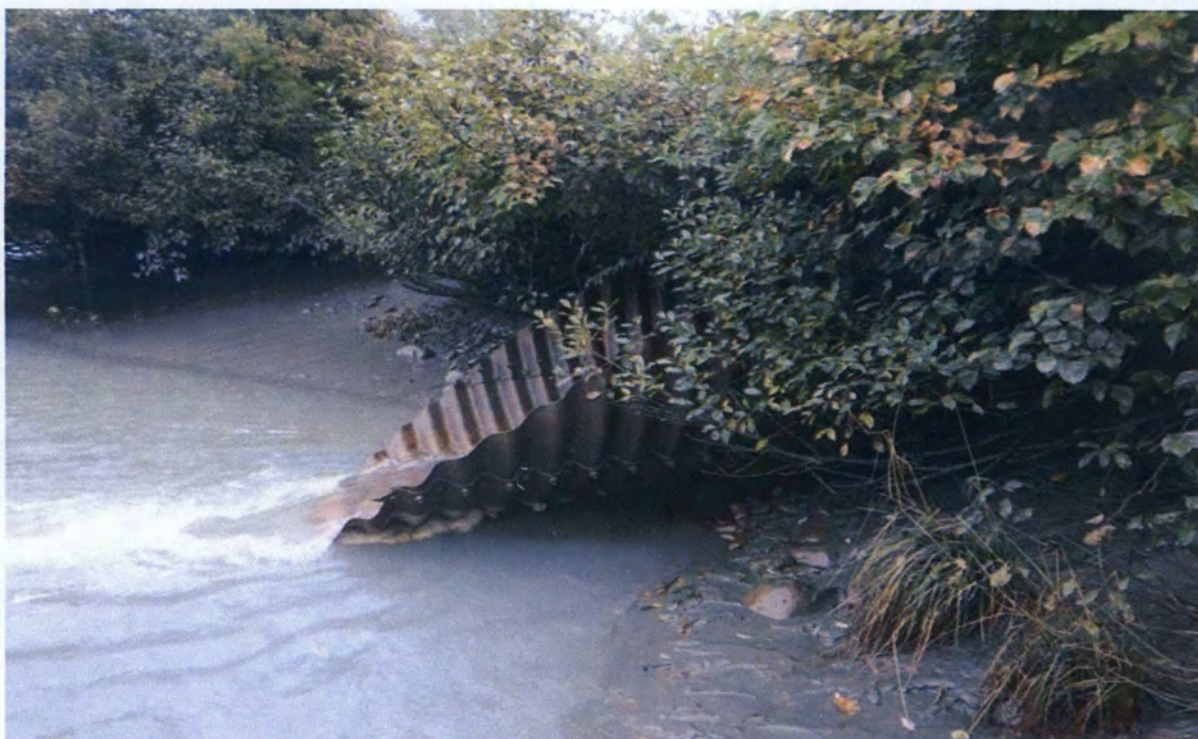
We drove to an unnamed tributary to the Placer River (FPC 1). A 48-inch diameter and 72-inch diameter culvert are located under the railroad embankment at 60.8050 N, 148.9701 W (Figures 6 and 7). The culvert is tidally influenced. I sampled above the culverts and captured 5 juvenile coho salmon. Fish passage through the 72-inch culvert may be possible only during high tide. The ADF&G recommends that the existing culverts are removed and replaced with a structure designed for fish passage. The unnamed stream will be nominated to the Anadromous Waters Catalog.

Figure 6. FPC 1, 72-inch culvert, culvert outlet view.

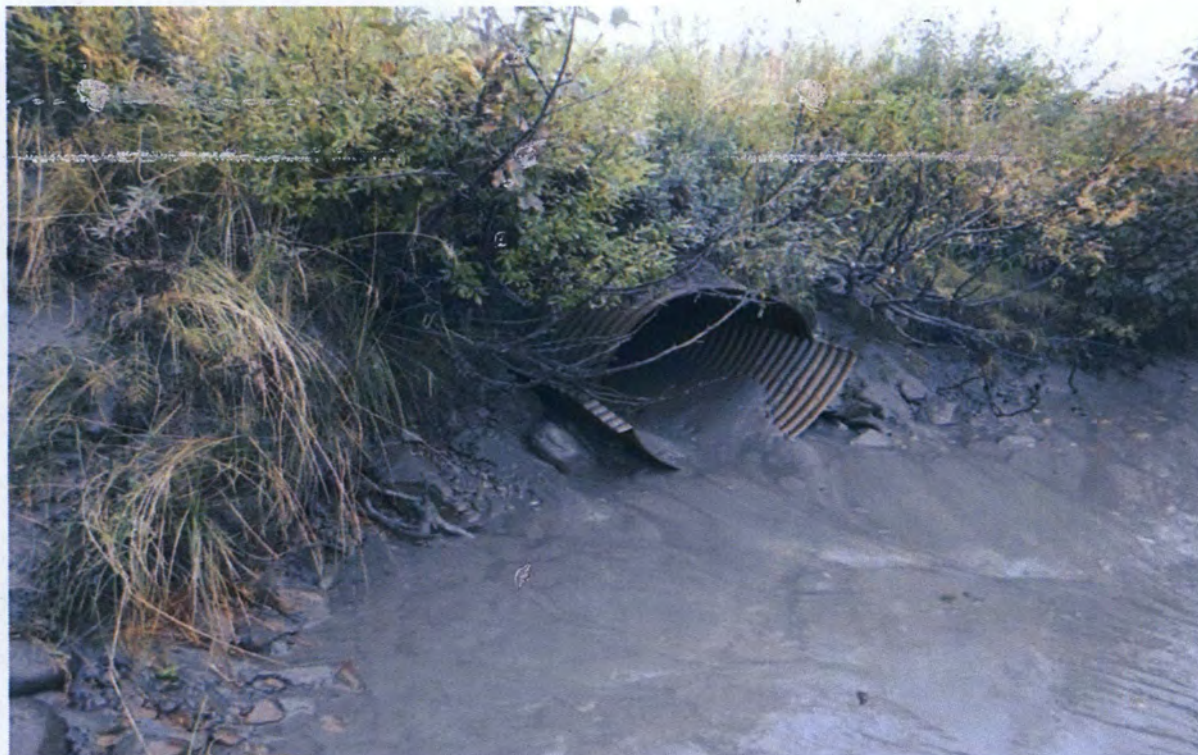
Figure 7. FPC 1, 48-inch culvert, culvert outlet view.

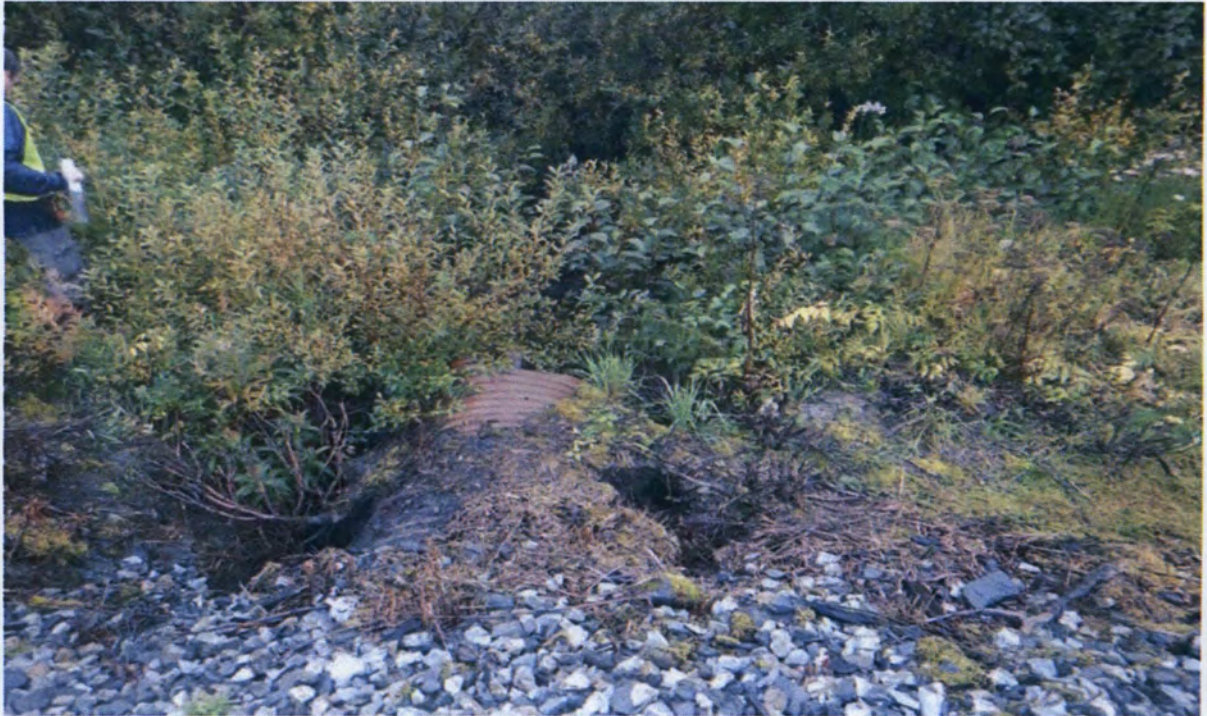
We drove to an unnamed tributary to the Placer River (FPC 4). A 48-inch diameter culvert is located under the railroad embankment at 60.8002 N, 148.9724 W (Figure 8). I sampled a pool below the culvert and captured 1 stickleback. Because of heavy brush no additional sampling was conducted downstream of the culvert. The wetland habitat on the upstream side of the railroad embankment is high value rearing habitat. The ADF&G recommends that the existing culvert is removed and replaced with a structure designed for fish passage.

Figure 8. FPC 4, culvert outlet view.

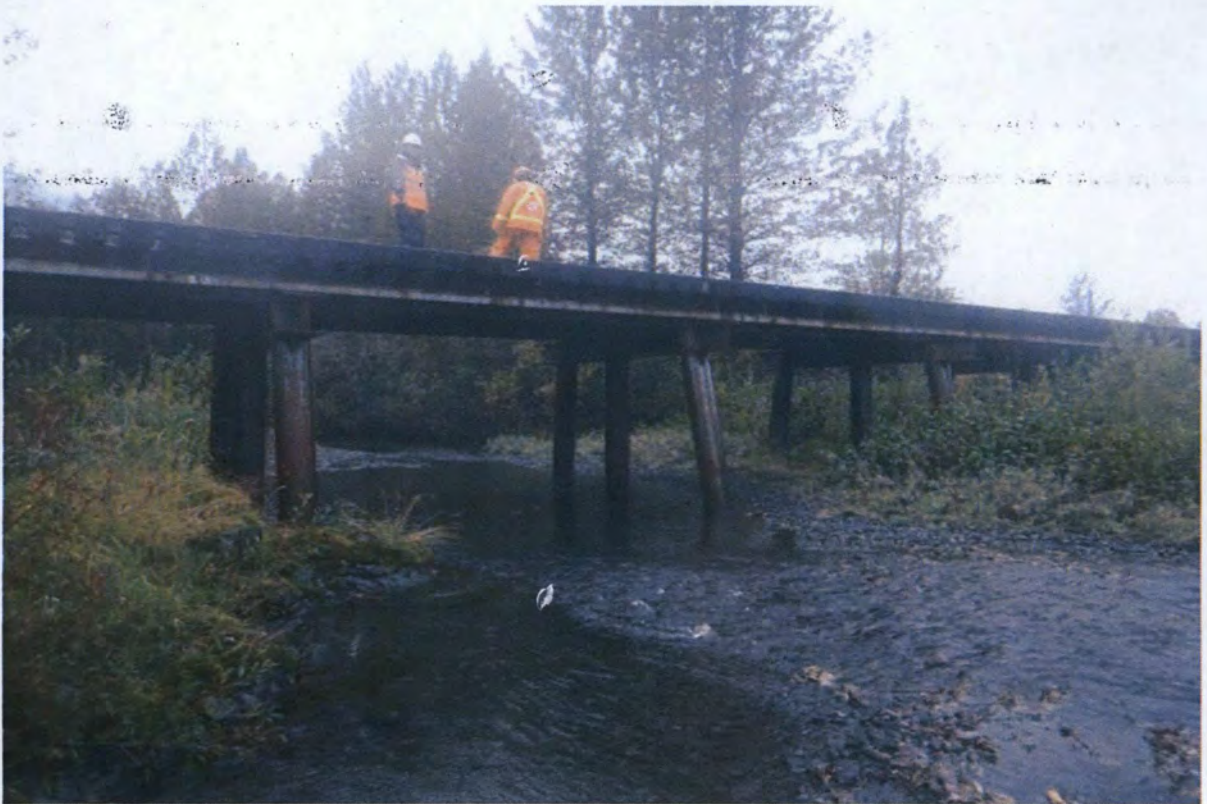
We drove to Clear Skookum Creek, a tributary to Skookum Creek (Stream No. 247-60-10210-2025). A trestle bridge is located over the creek at 60.7809 N, 148.9839 W (Figure 9). I sampled above the bridge and captured 10 juvenile coho salmon and observed one chum salmon carcass. The juvenile coho salmon will be nominated for update to the Anadromous Waters Catalog.

Figure 9. Clear Skookum Creek Bridge. Downstream view.
