# PROSPECTUS

***James Toman Mary Redmond Reserve***

## **Umbrella Wetland Mitigation Bank**

Upper Kenai Peninsula Watershed (HUC 19020302)  
Turnagain Arm, Cook Inlet  
Municipality of Anchorage, Alaska

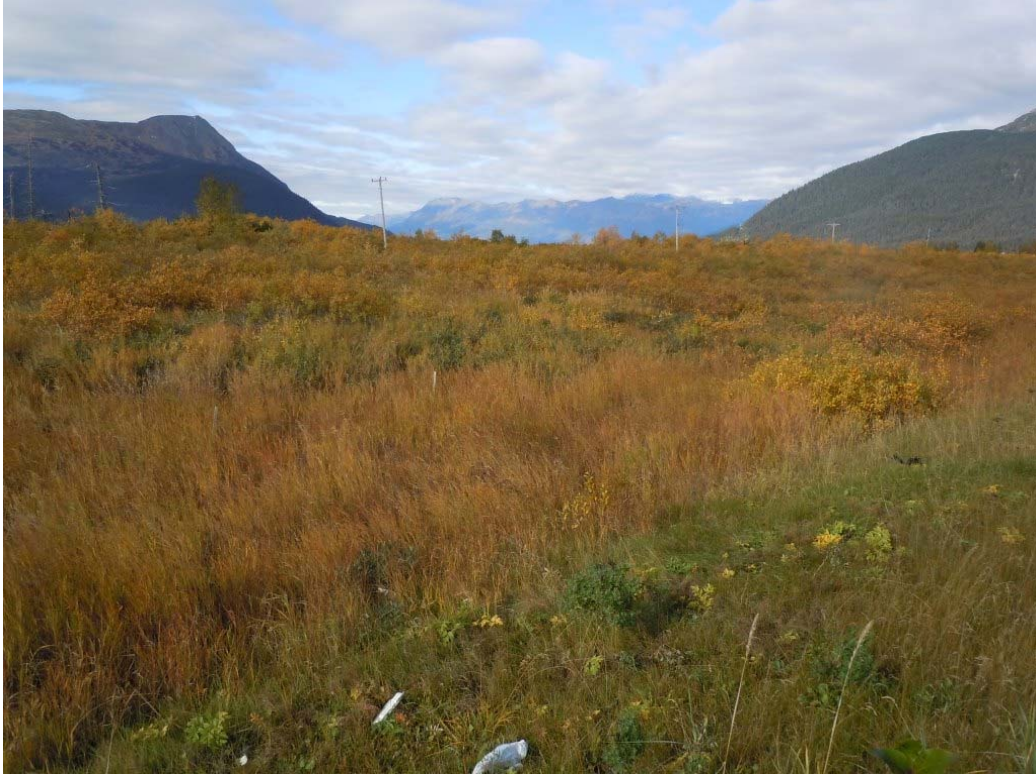
**Recent photo of the Bank property to the northwest from near the southeast corner (20130929).**

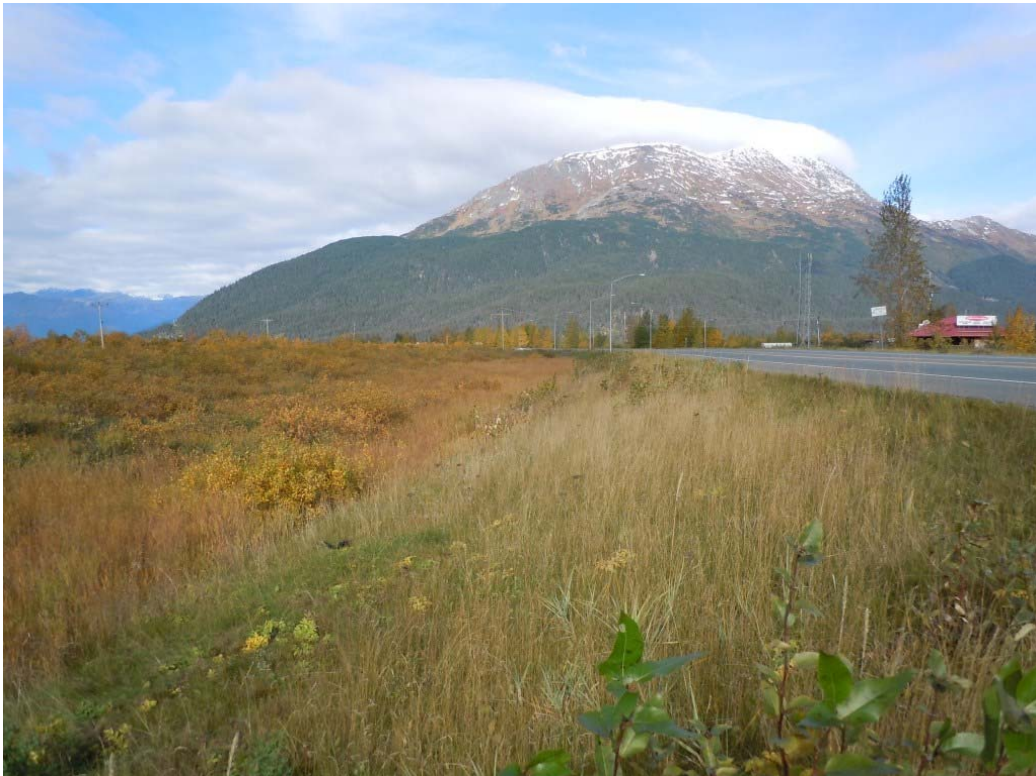
**Recent photo of the Bank property to the north from near the southeast corner (20130929).**

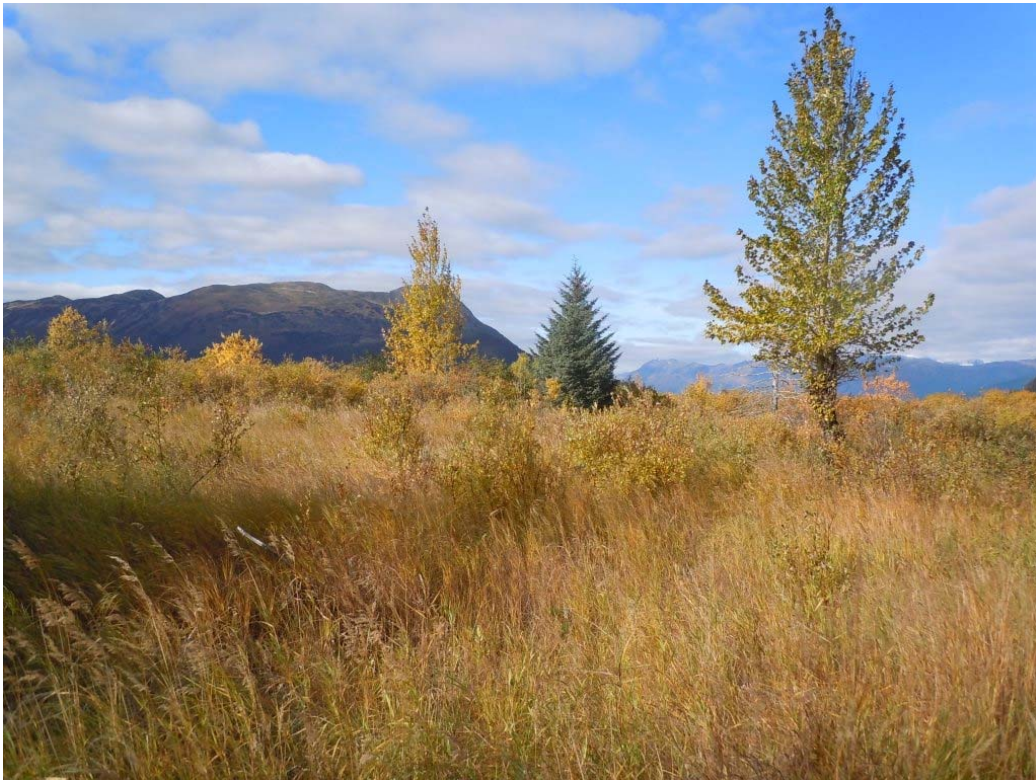
**White spruce and poplar trees have re-invaded a small area on the south side of the Bank (20130929).**

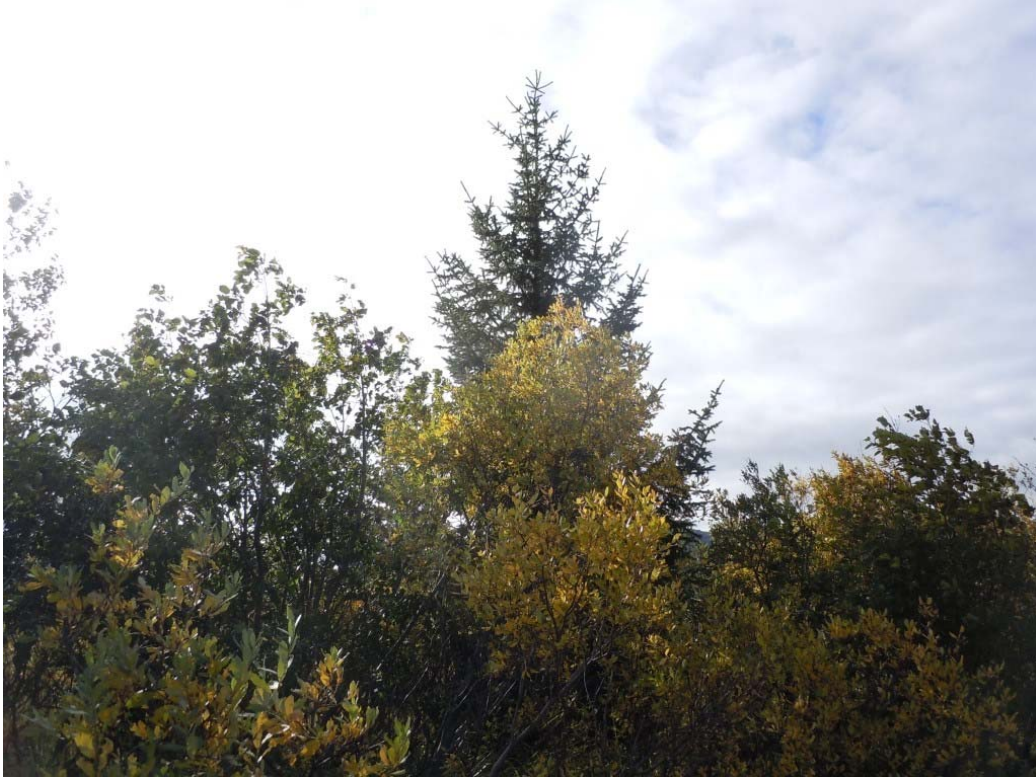
**A small area on the south side of the Bank supports a mature white spruce tree despite being inundated several times a year by tidal flooding (20130929).**

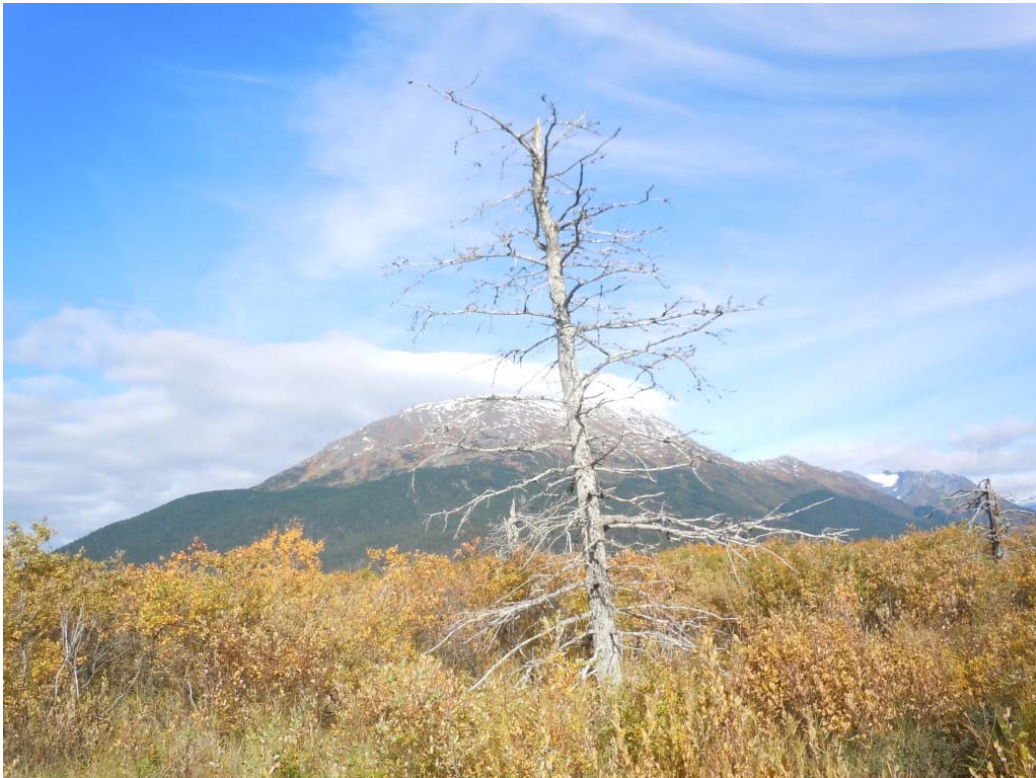
**Remnants of a Sitka Spruce tree that was killed by the tidal flooding stands among thriving willows and graminoid meadows (201309329).**

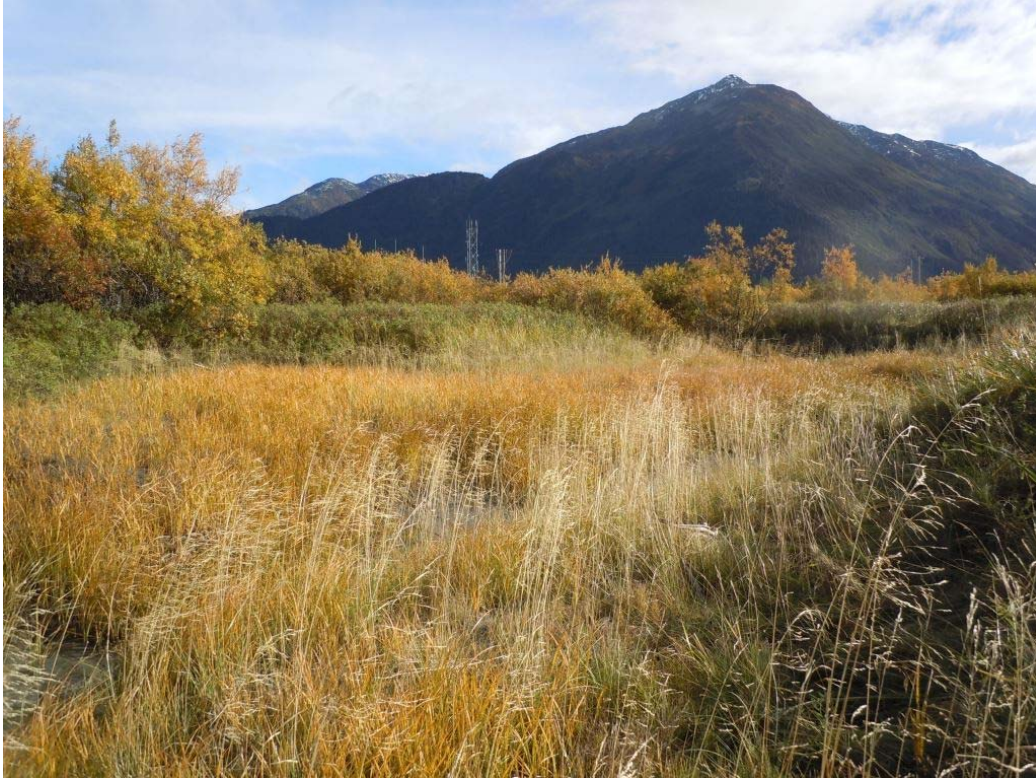
**Sedges and grasses line the edges of tidal guts that extend into the Bank property, providing a diversity of cover and forage conditions for small mammals and birds (201309329).**

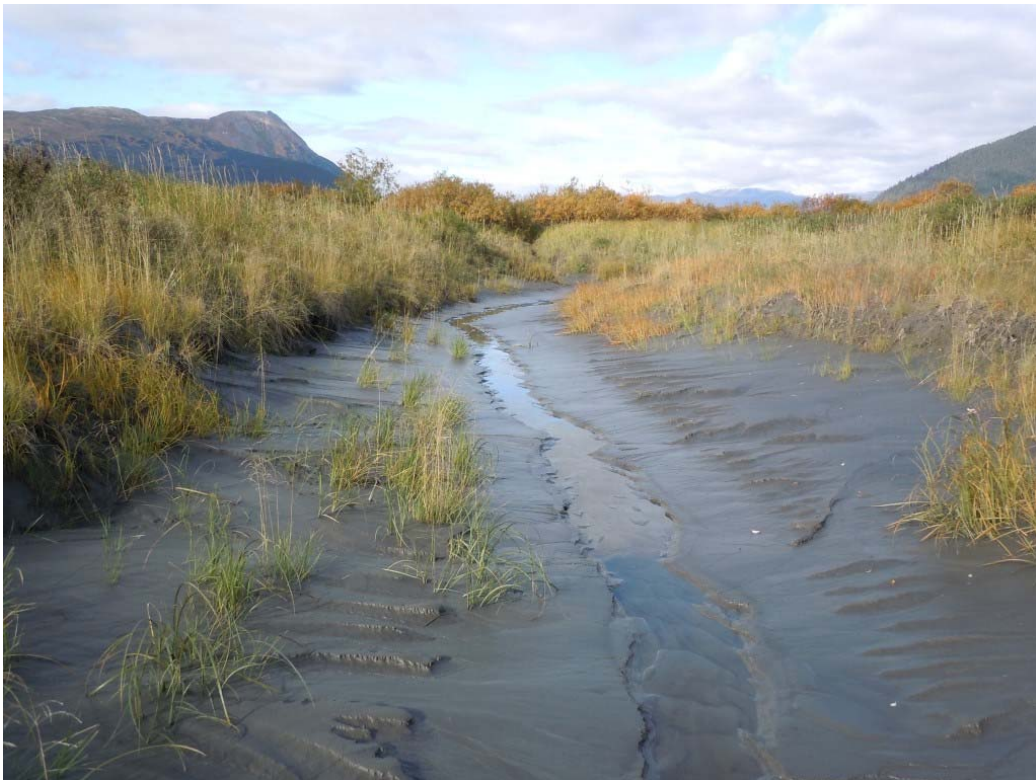
**The tidal guts, though mostly outside of the property boundary, provide a direct link to the estuarine waters. After the high tide subsides, water slowly drains out of the wetlands (201309329).**

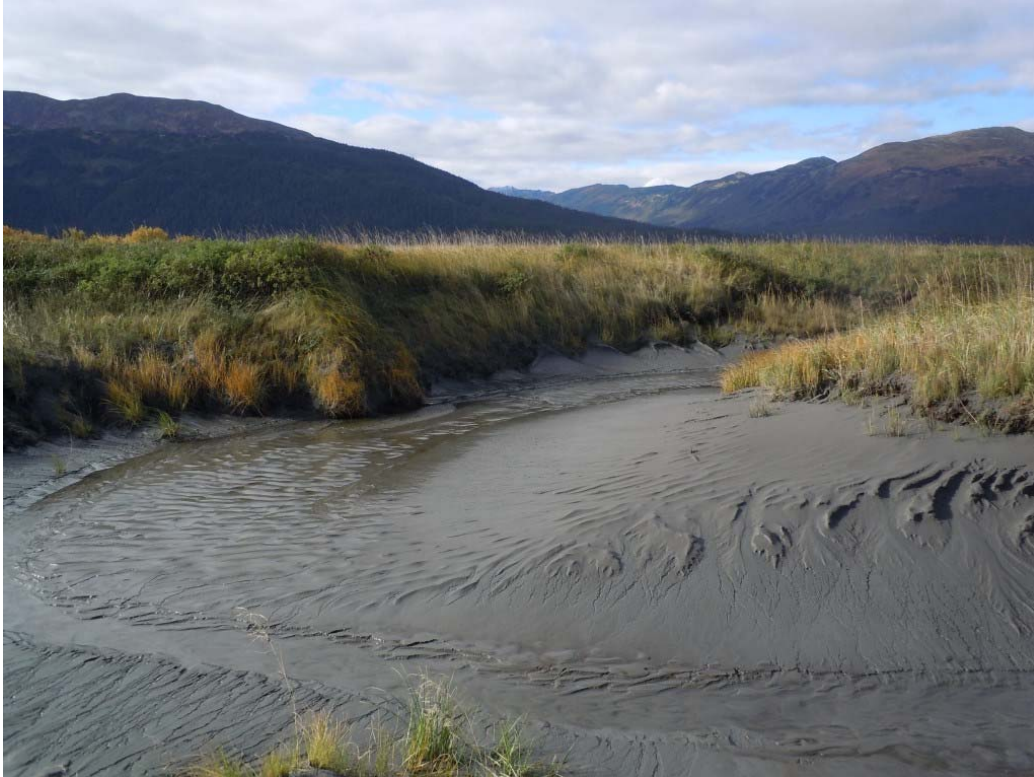
**Near the north end of the Bank property, the tidal guts become deeper and wider, with steep sides turfed with a mixture of grasses and herbs (201309329).**

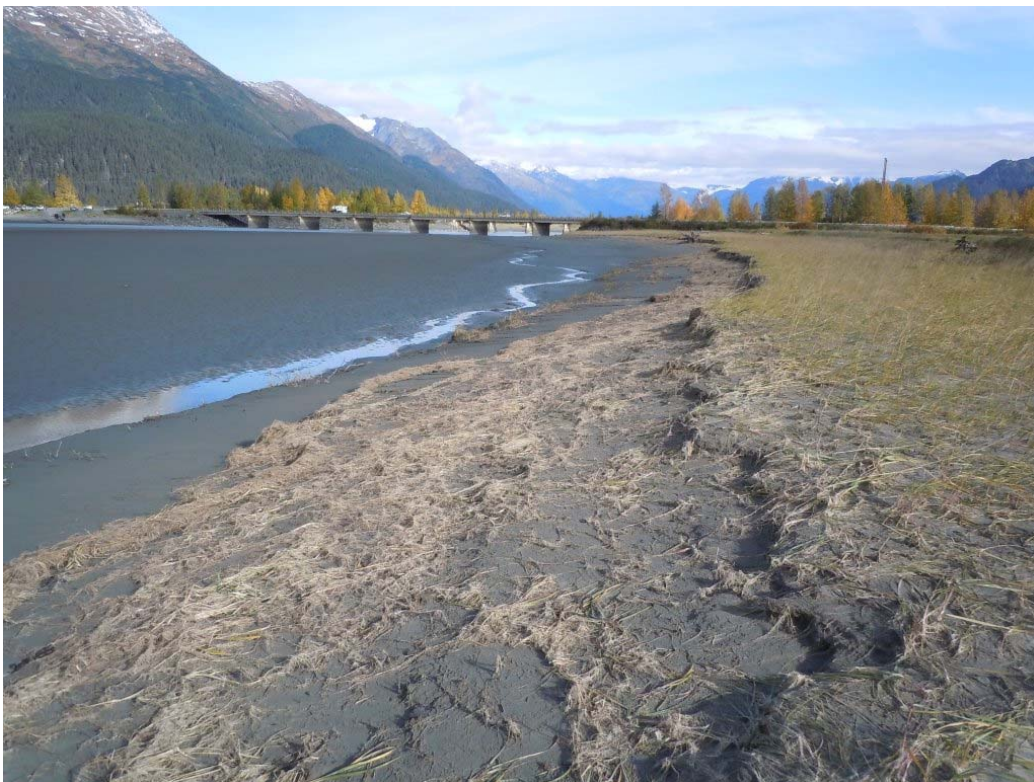
**The intertidal area of the north boundary of the Bank property, view toward the east and Twentymile River bridge of Seward Highway (201309329).**

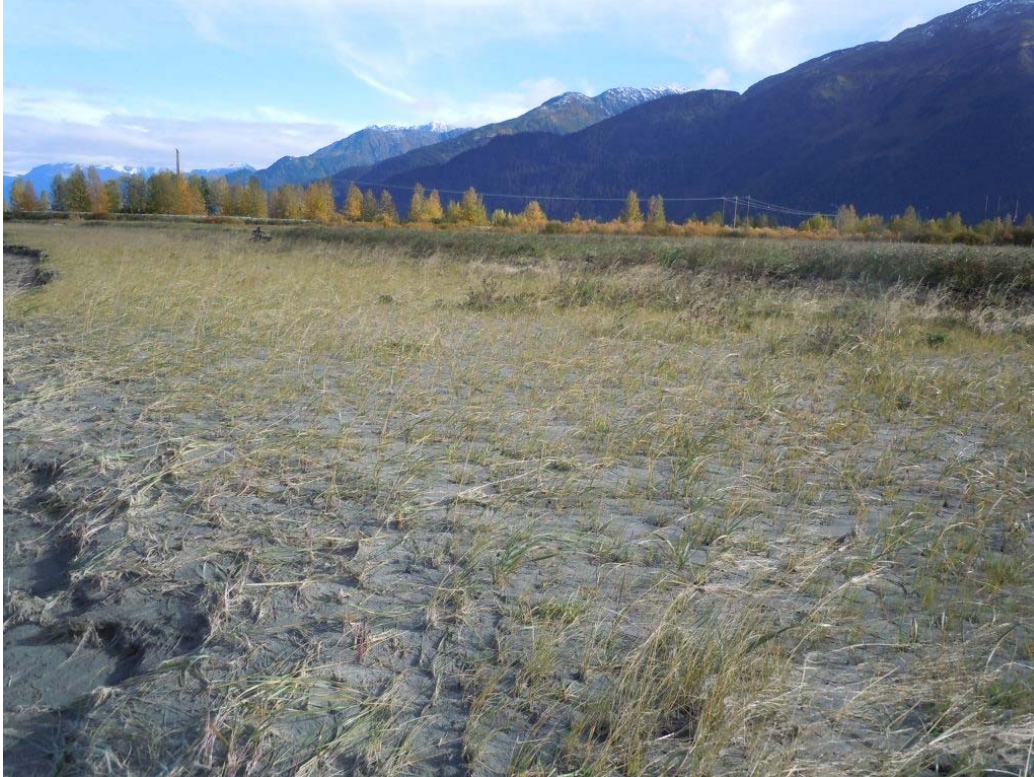
**Intertidal zones defined by the topography, with the foreground of a sand-dominated substrate with grass cover. The rise in the background is accentuated by a dense colony of sedges (201309329).**

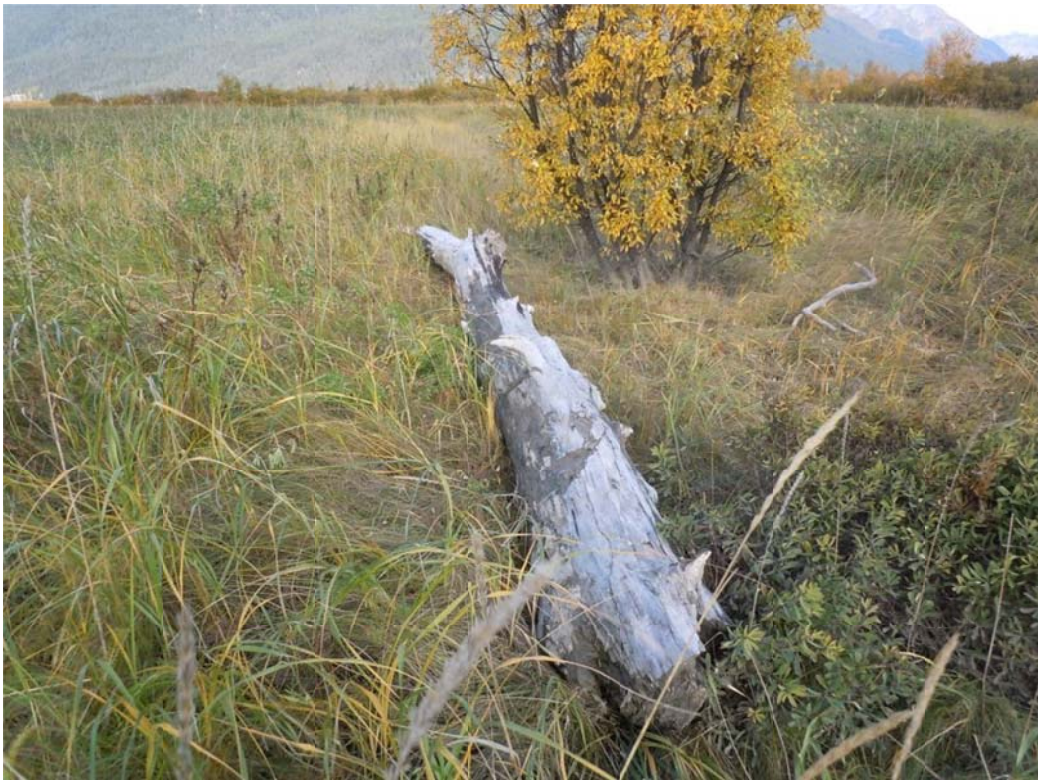
**Drift deposits of logs and other coarse woody debris floated into the Bank property enhance the ecological linkages between the marine and freshwater environments (201309329).**

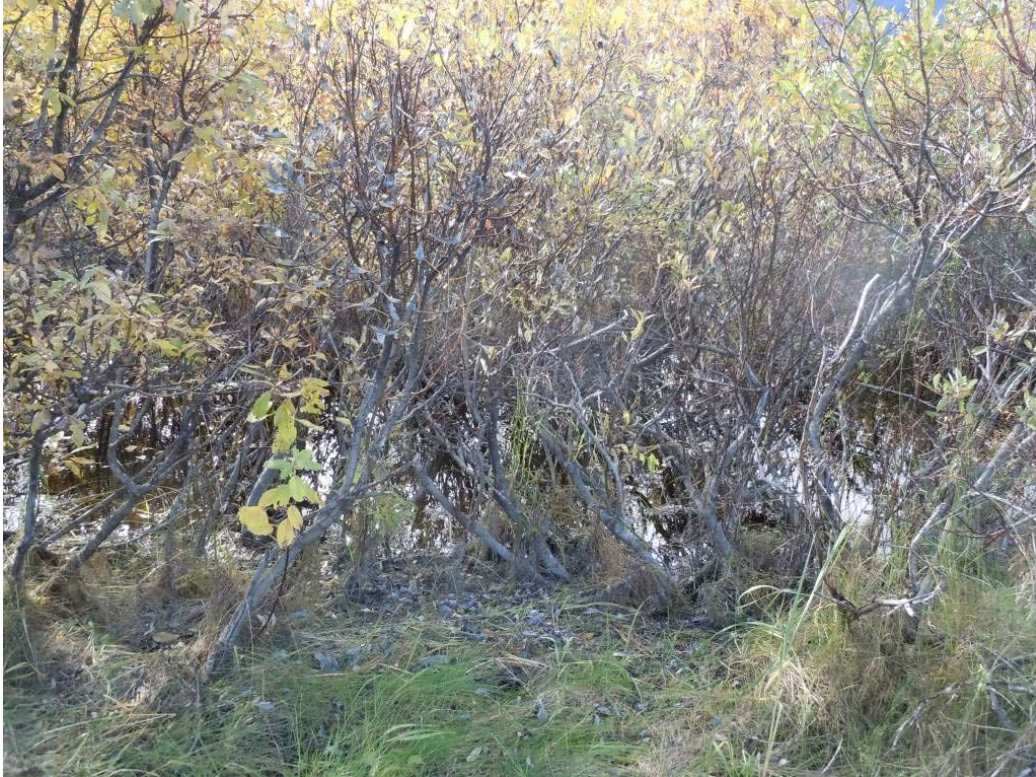
**Tidal floodwaters remain in the upper channels of the tidal guts that are choked with vegetation (201309329).**

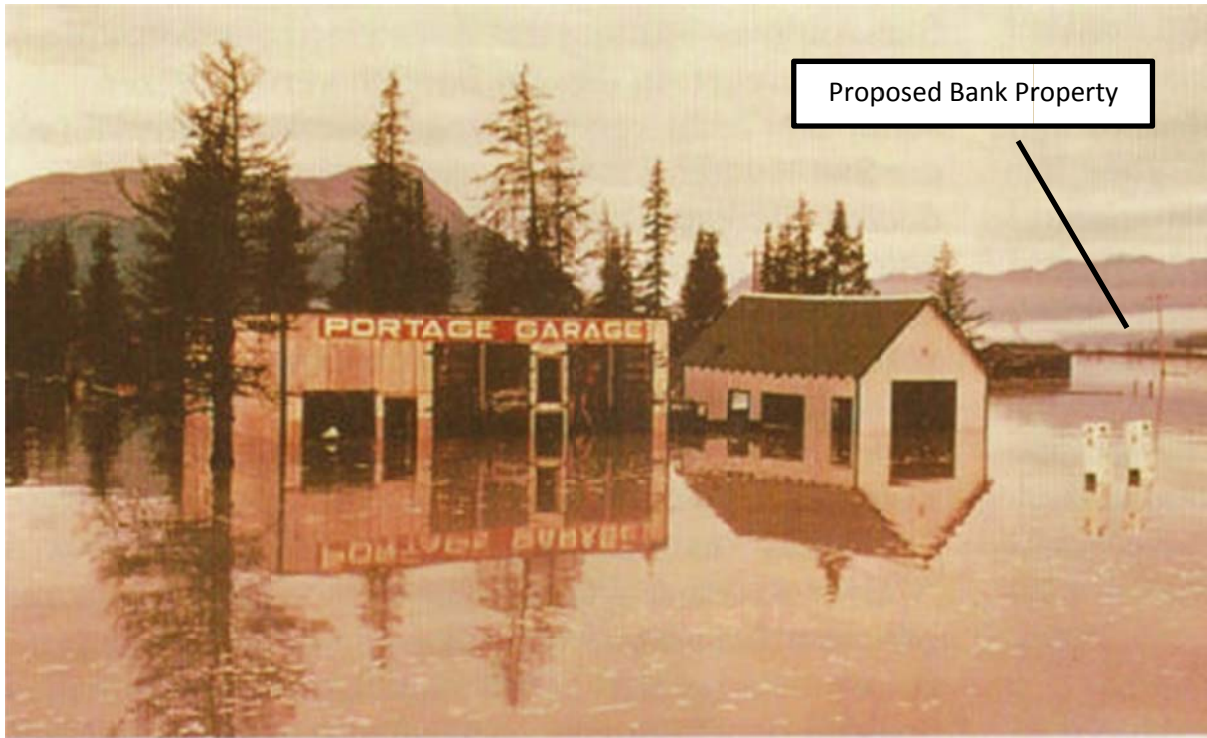
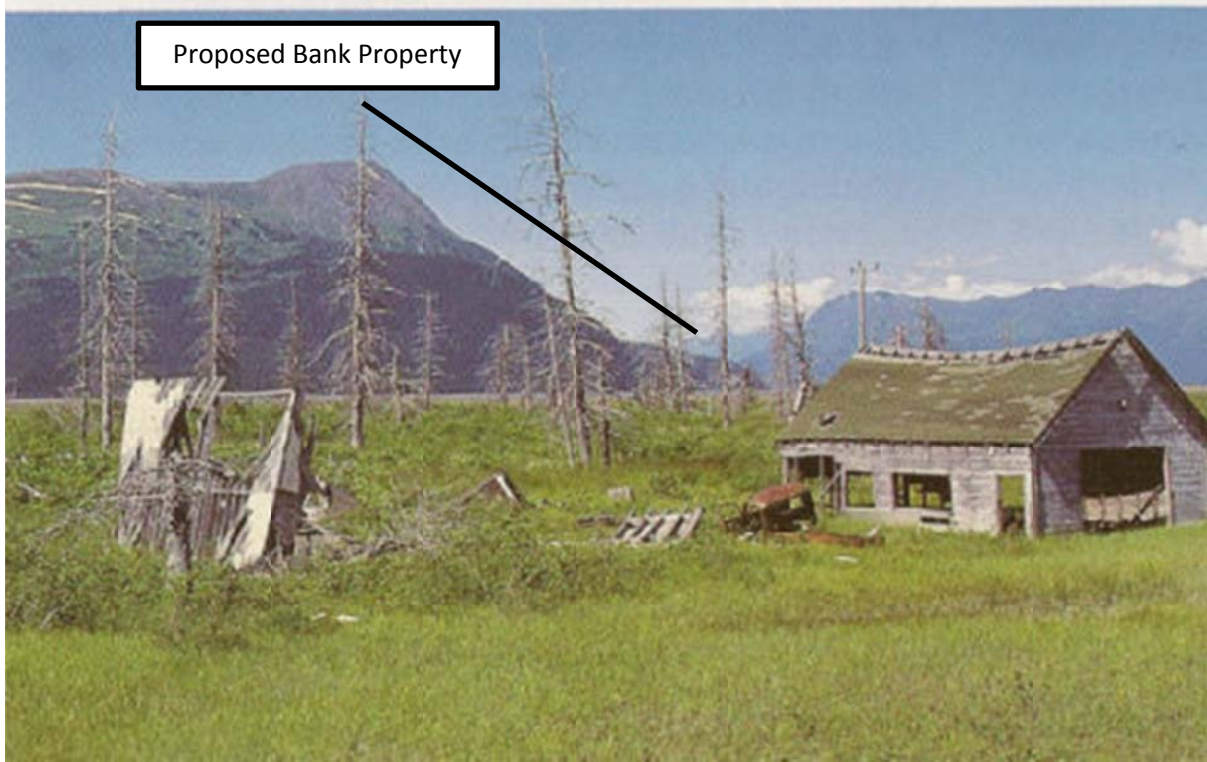
Photos of the property adjacent to the proposed Bank property at Portage, Alaska soon after the subsidence-caused tidal flooding (upper) and the current conditions (lower). From USGS.

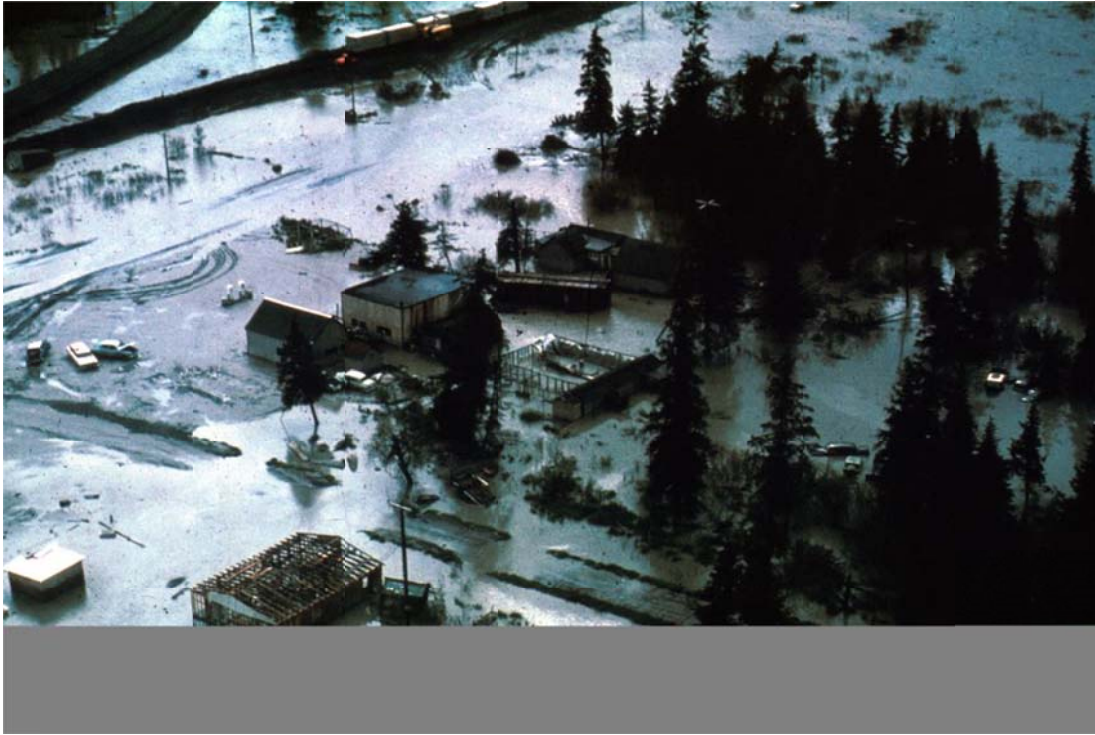
Tidal flooding at Portage soon after the 1964 earthquake and earth subsidence. From USGS.

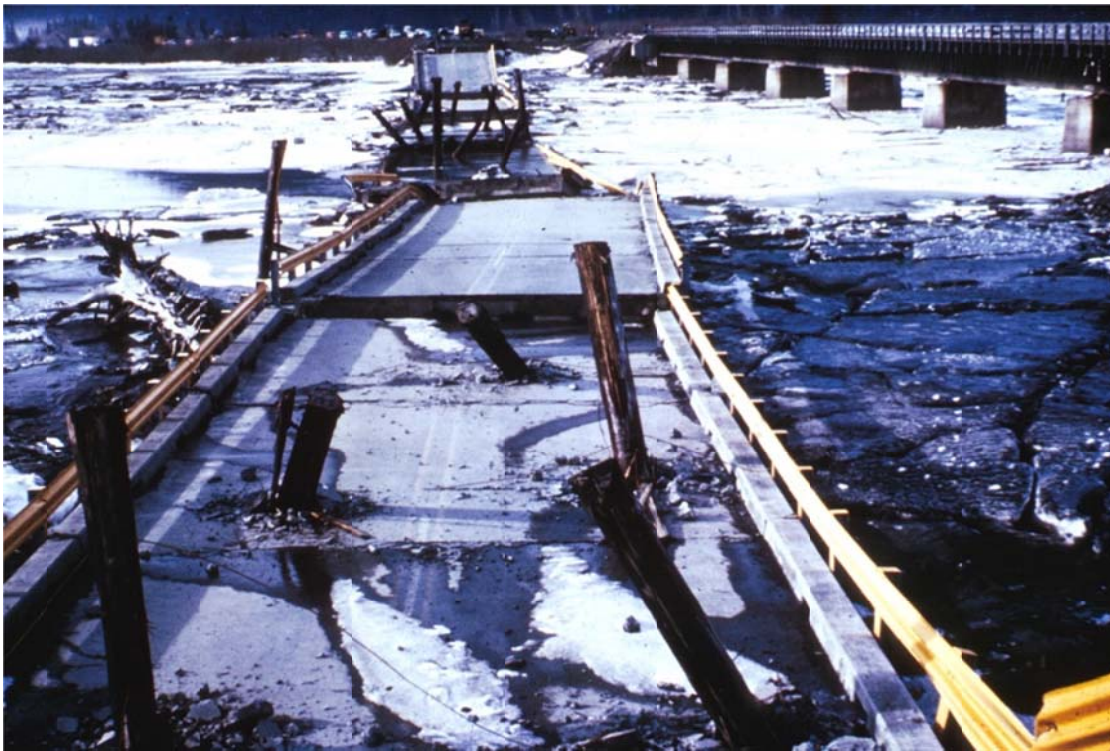
Seward Highway bridge at Twentymile River destroyed by the 1964 earthquake. This on the north side of the proposed Bank property. From USGS.

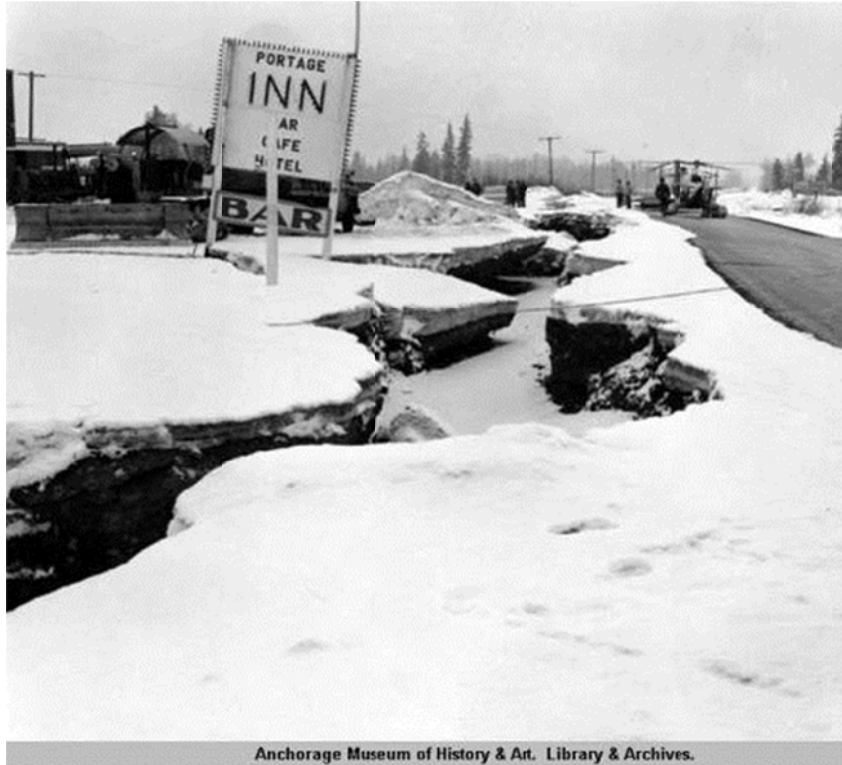
Cracked earth at the Portage Inn along the Seward Highway. From USGS.

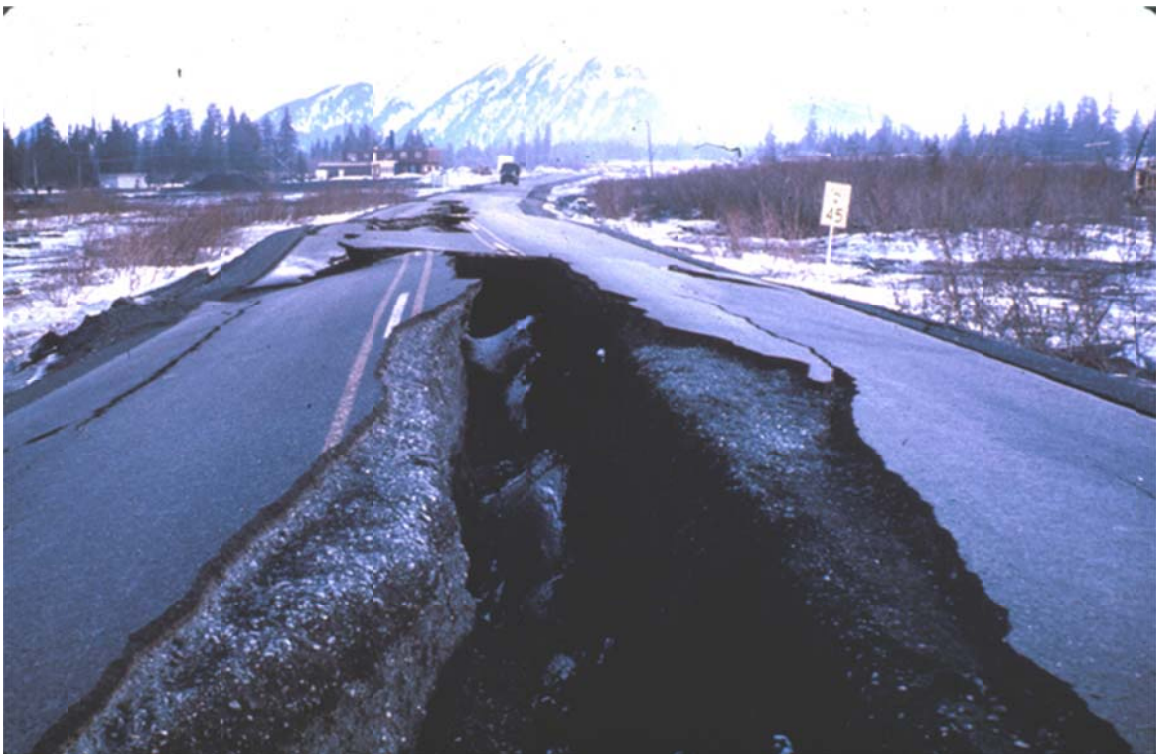
Cracked earth along the Seward Highway. From USGS.

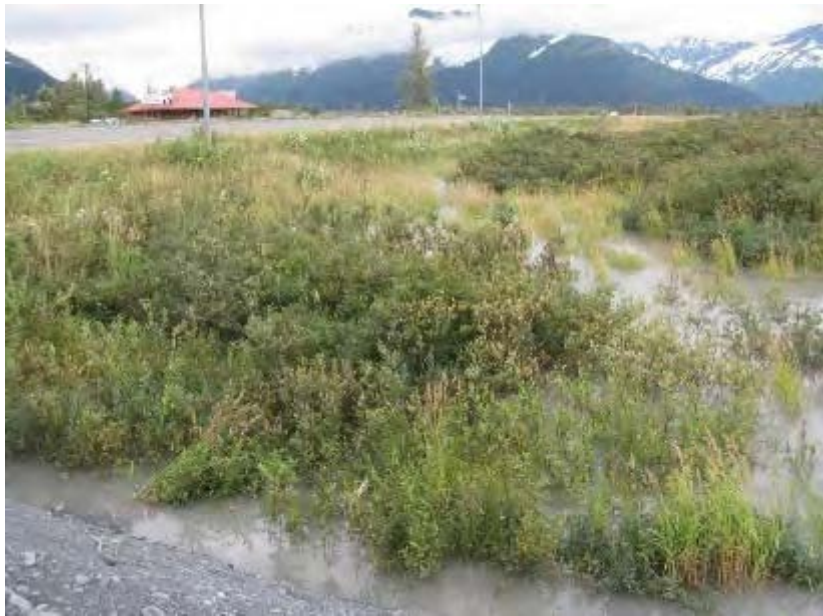
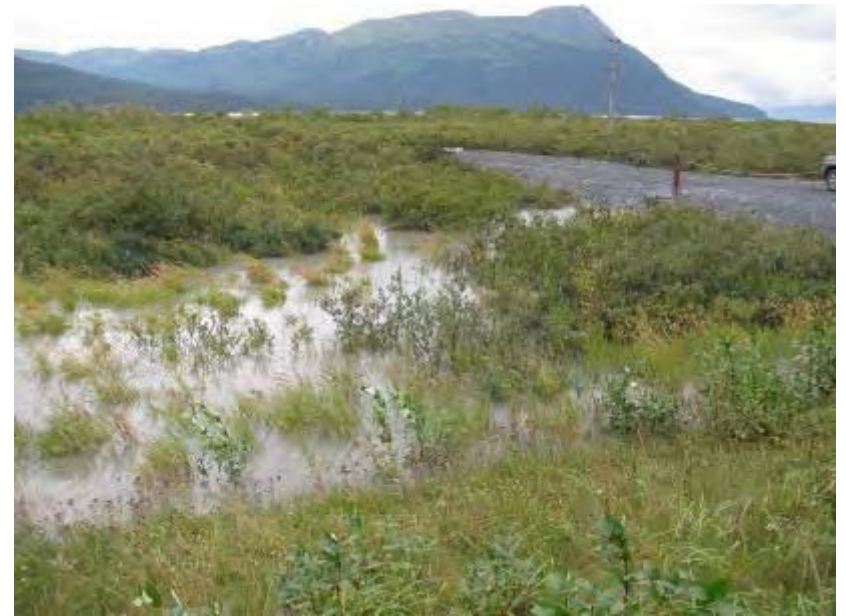
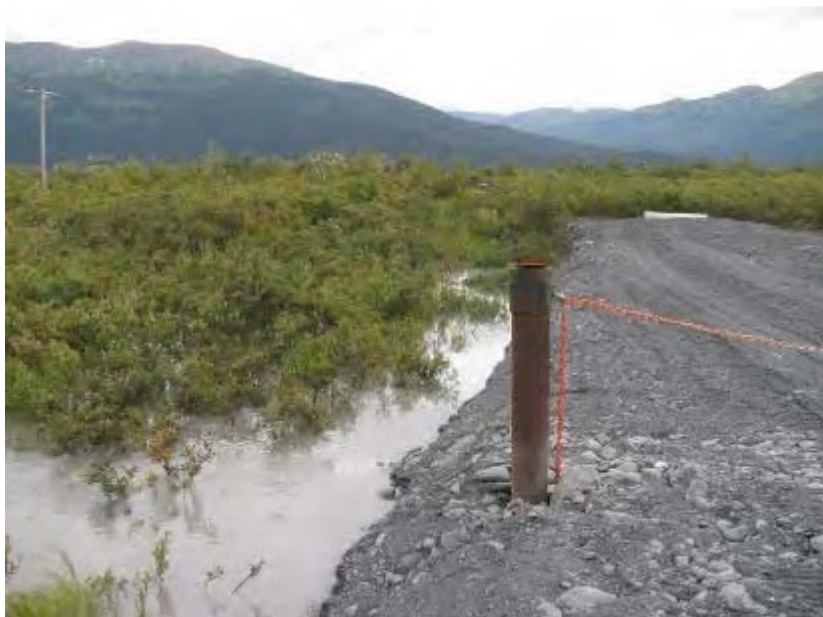
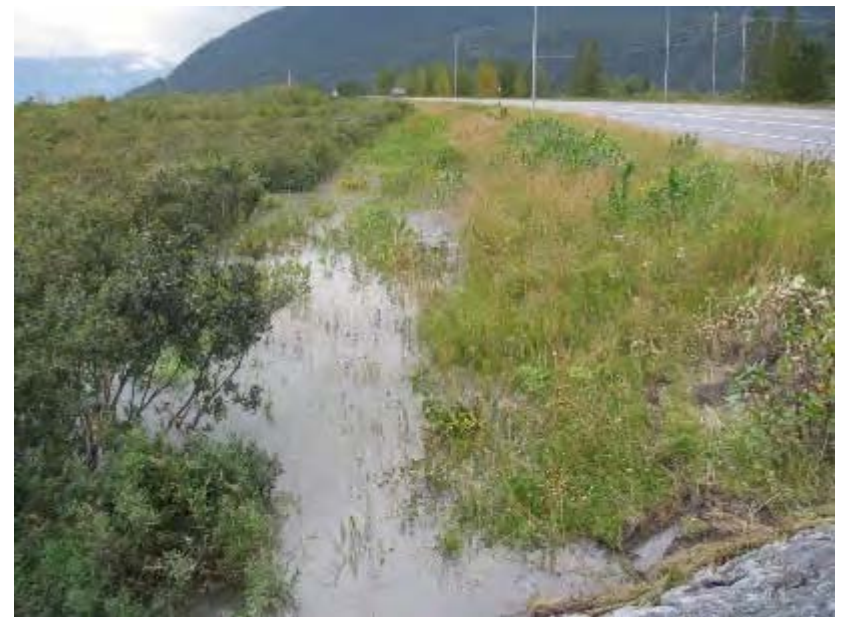
**DP-1 - Tidal flooding September 9, 2010 09:38AM ADST**

**DP-1 - Tidal flooding September 9, 2010 09:39AM ADST**

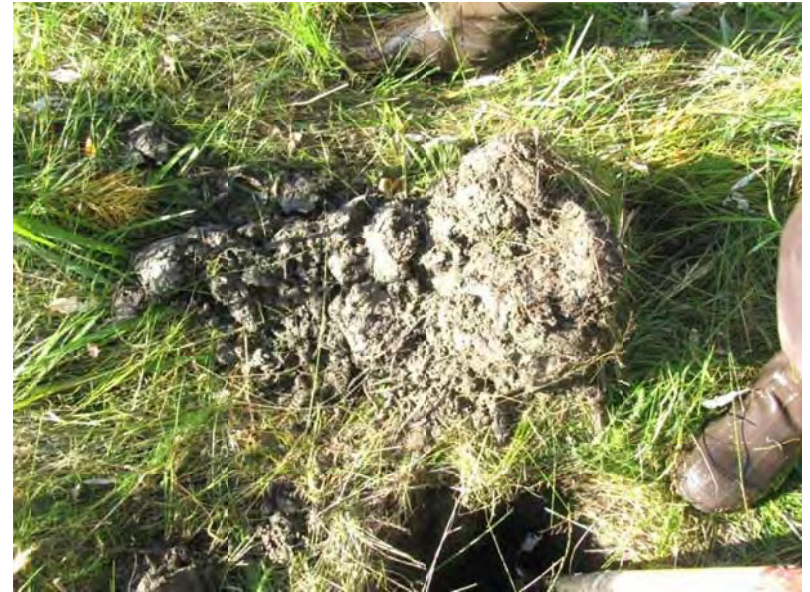
**DP-8 – Soil Profile September 13, 2010.**

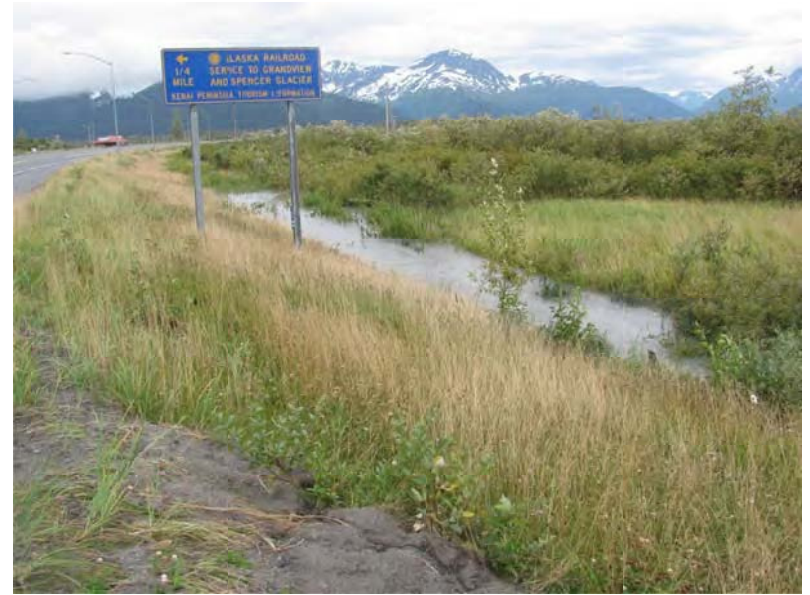
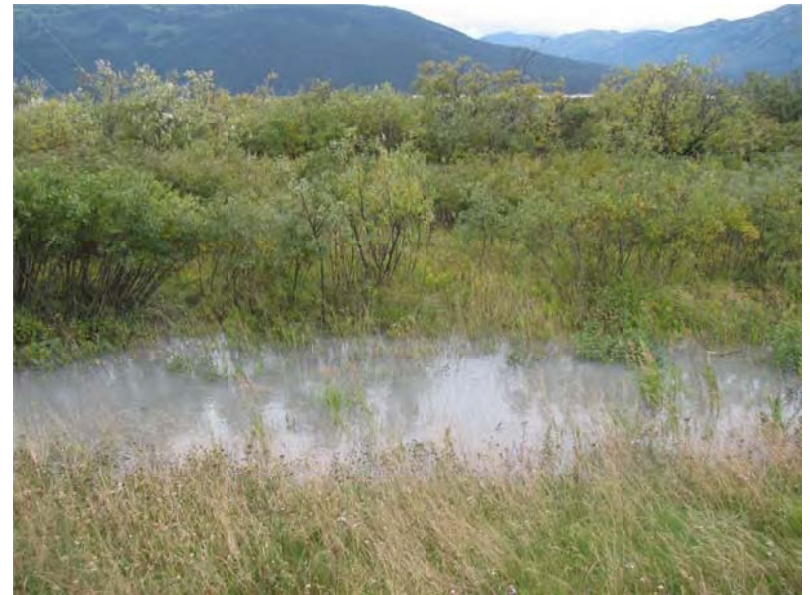
Northeast Side of Parcel - Tidal flooding September 9, 2010 10:05 AM ADST.
