APPENDIX B

**HYDRAULICS AND HYDROLOGY
KENAI BLUFF EROSION
TECHNICAL REPORT
KENAI, ALASKA**

1.0 KENAI RIVER BLUFFS PROJECT

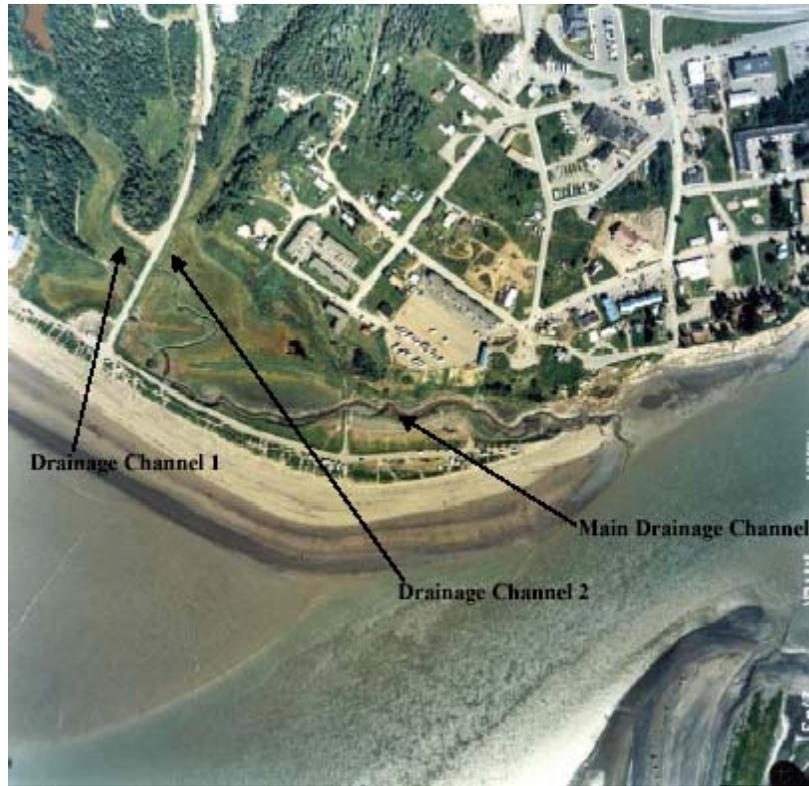
Figure 4. Drainage Channels.

The topography in the area of the Kenai River mouth consists of a bluff approximately 70 feet high opposite a low-lying wetland and tide flat area with a dendritic drainage pattern (figure 2). The topography indicates that the river valley historically has experienced much higher flows (figure 3). Two drainage channels west of the city of Kenai which extend from the south and southwest end of the airport to their confluence behind the dunes at the mouth of the river, could be remnant drainage channels associated with the historical higher flows. These drainage channels appear to play a major part in the local bank stability (figure 4).

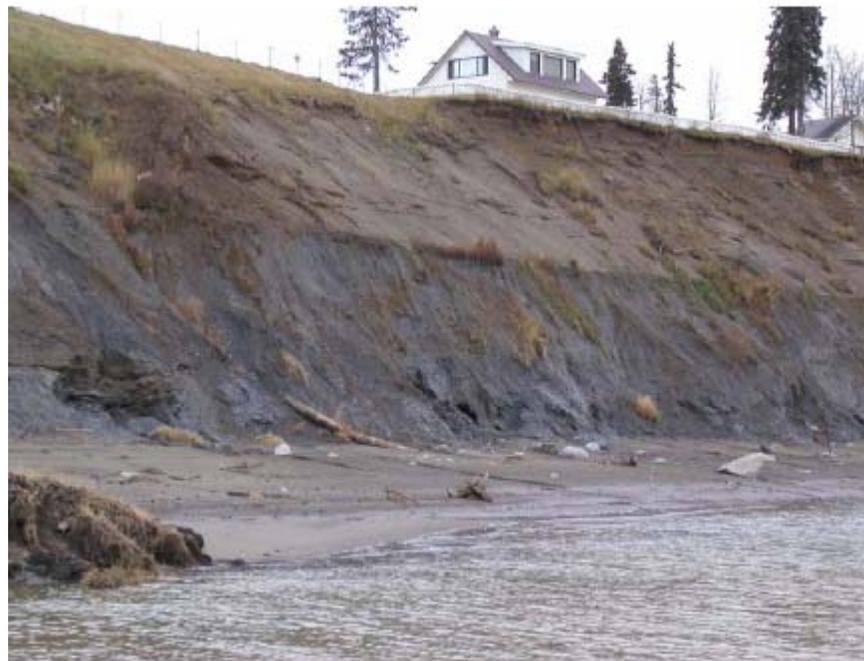
Figure 5. Bluff face with three distinct material types: Marine deposit, sand, and organic mat.

The bluff at the mouth of the river is composed of three distinct material types (figure 5). An organic mat top layer that is approximately 2 feet thick, a fine sand layer that is approximately 37 feet thick, and a lower marine deposit layer that can vary from 35 to 45 feet thick. According to Dick Reger, retired geologist with the Alaska Division of Geological and Geophysical Surveys, the lower material is composed of marine deposits that were compacted by a tidewater glacier. Sand and gravel were deposited above the compacted marine deposits through sediment charged efflux jets coming from beneath the approaching glacier. Dropstones from melting icebergs and fine material rained onto the sandy bottom from turbid plumes in front of the glacier (figures 6 and 7).

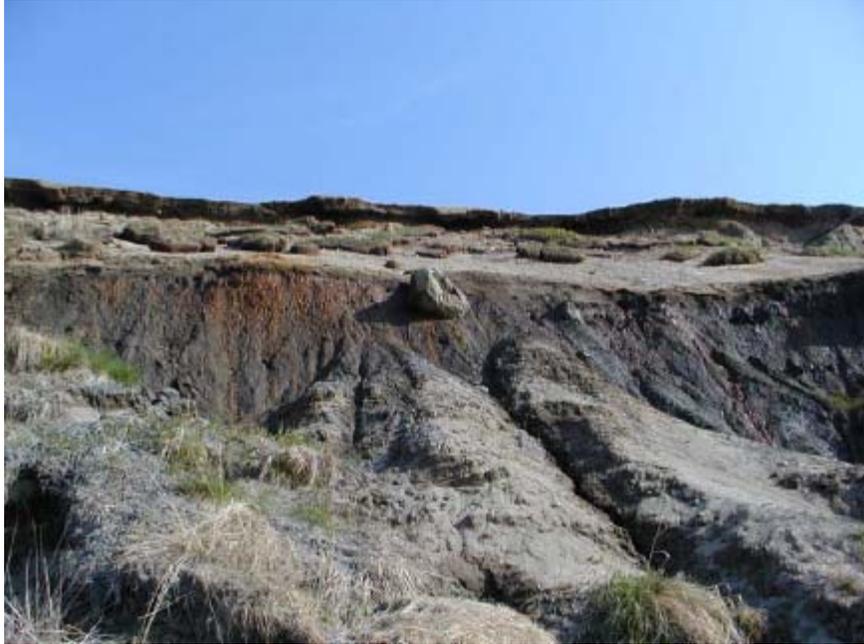
Figure 6. Dropstone embedded in bluff face.

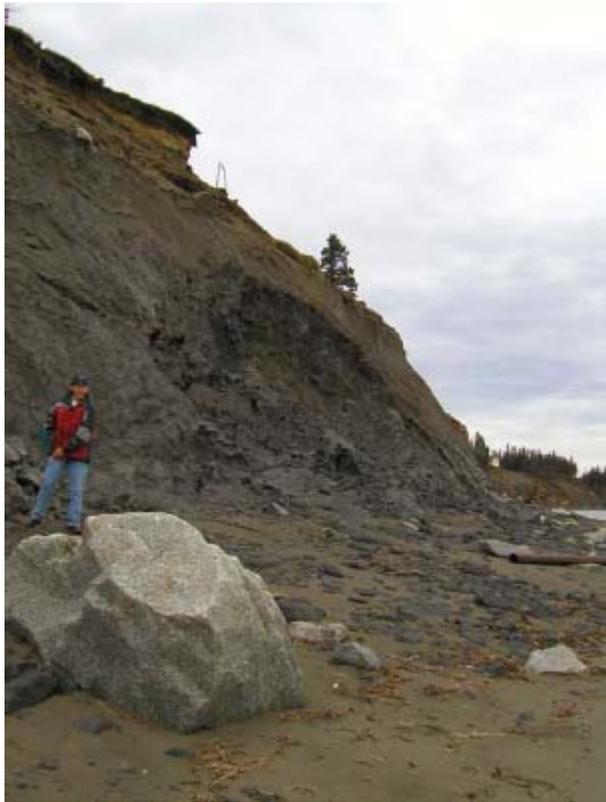
Figure 7. Dropstone.

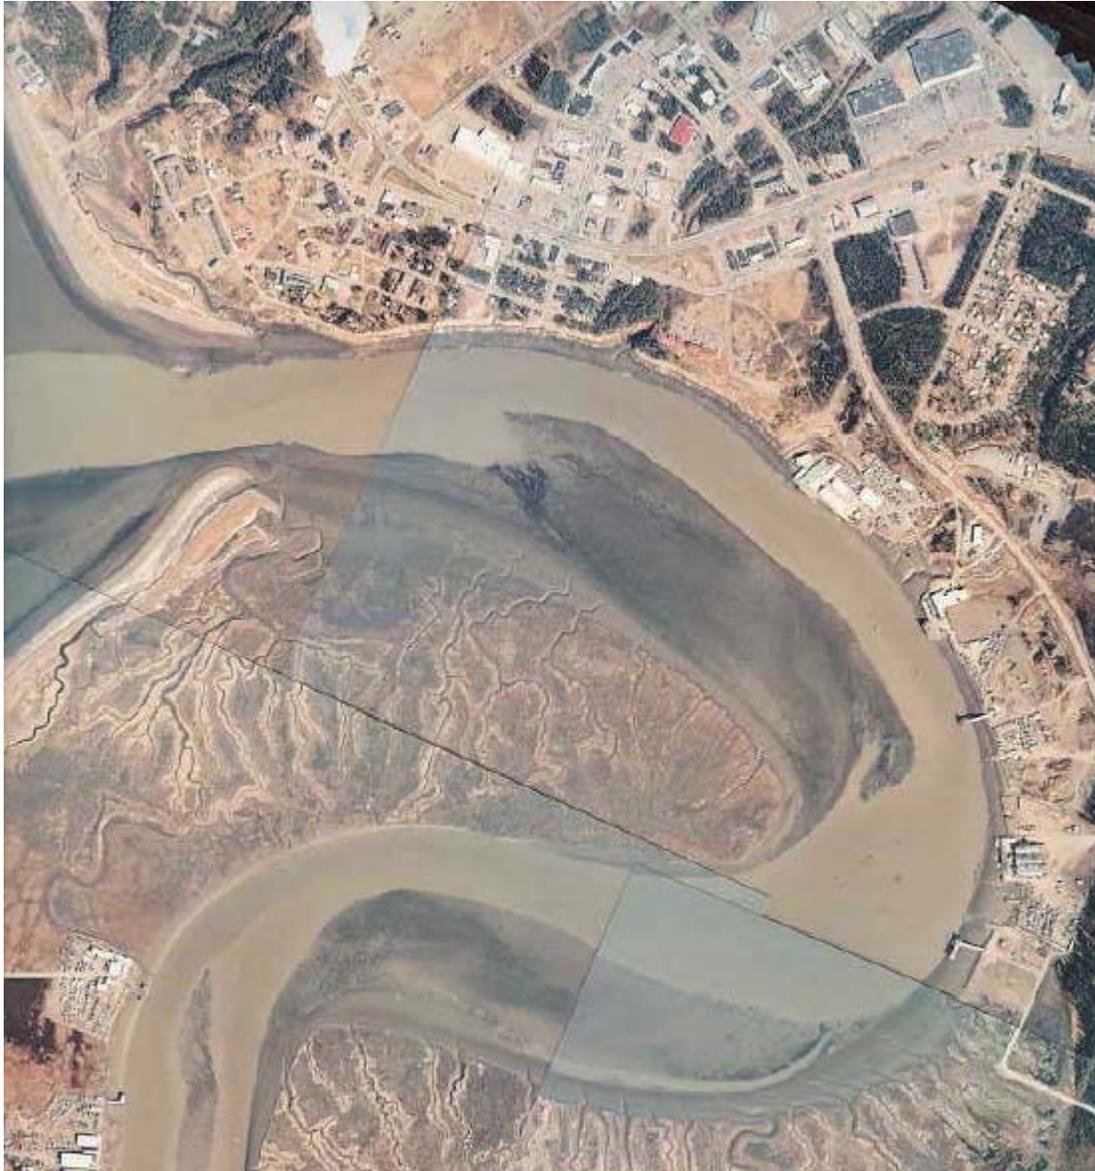
Figure 10. Topography affecting wave behavior at the mouth and along the bluffs.

Wave action at the bluff section upstream of Mission Avenue is an infrequent occurrence. There must be a combination of storm surge and high tide for the bluff to be impacted by wave action since the wetland and shoal at the mouth of the river create a natural barrier to waves by limiting the wave heights.

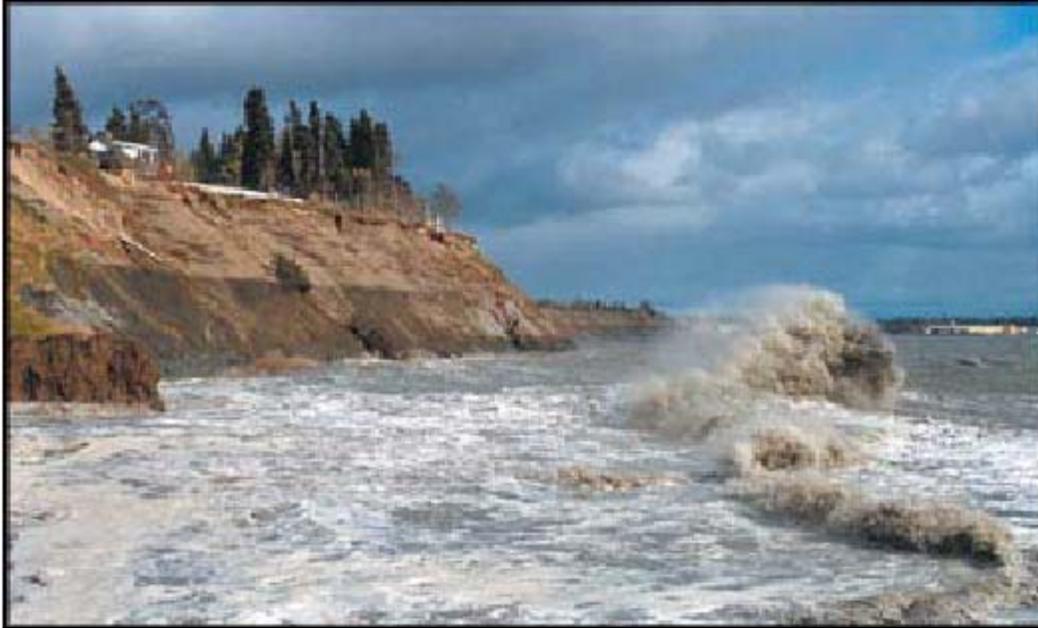
Figure 11. Breaking wave in front of the bluffs.

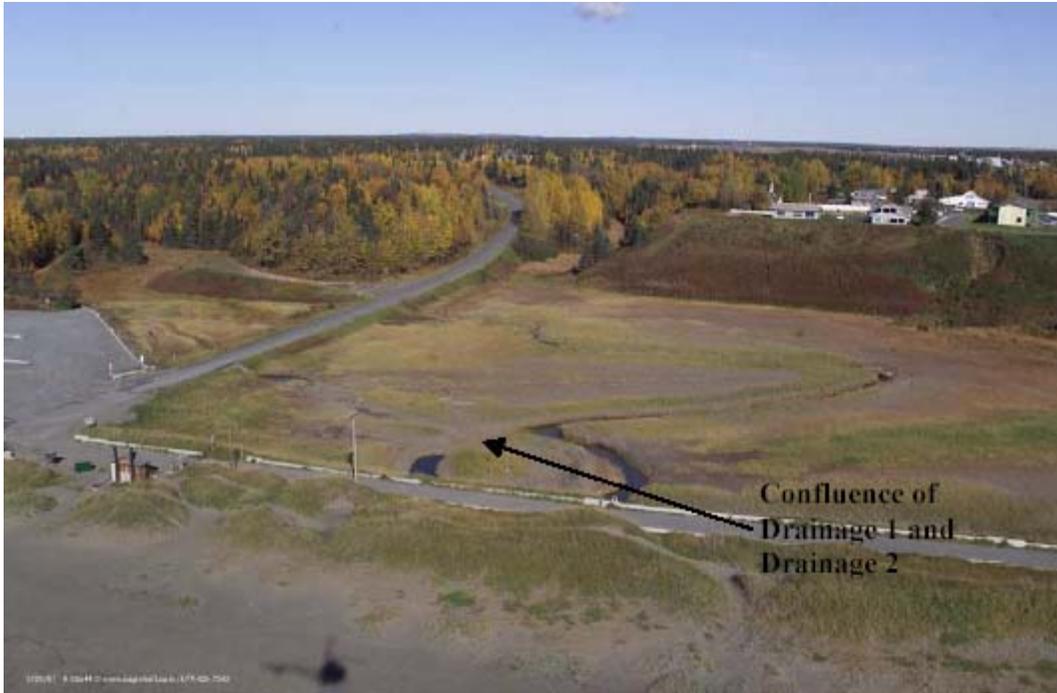
Confluence of
Drainage 1 and
Drainage 2

Figure 12. View of the two drainages behind the dunes

Two areas east of the proposed project site appear to interrupt the groundwater flow with a natural channel (figure 12). These areas appear to provide a gradient away from the bluff face and towards two channels that meet behind the dunes at the mouth of the river. In this local drainage the bluffs are more stable and seepage out the bluff face is not observed (figure 13). Figure 14 shows a transition area between the bluff where the groundwater is channelized away from the bluff face and where seepage is observed out of the bluff face.

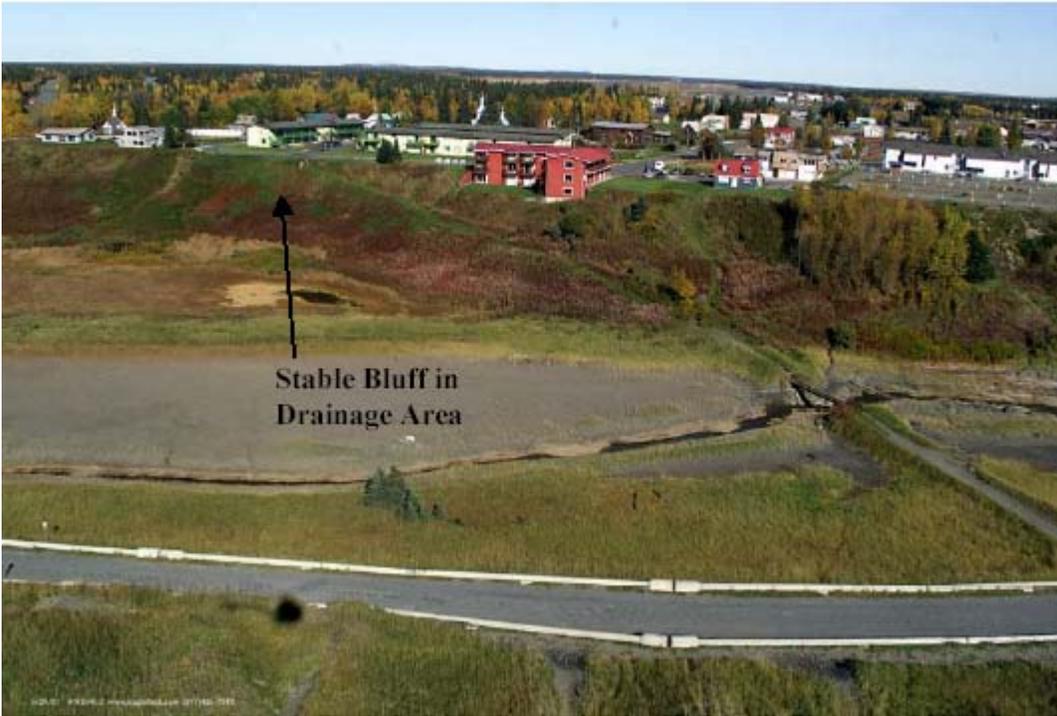
Stable Bluff in
Drainage Area

Figure 13. Stable bluff in the area behind the drainage.

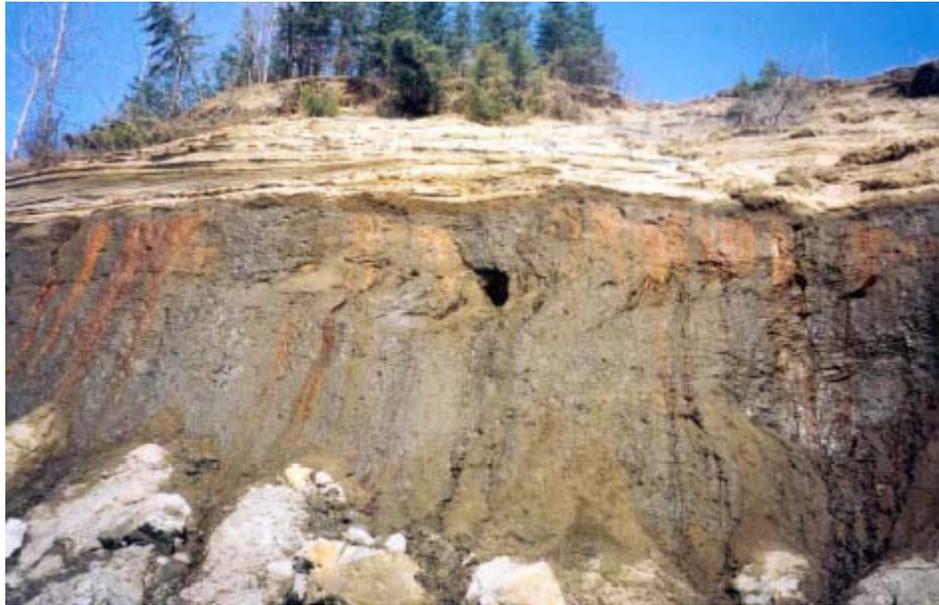
Figure 15. Piping hole in the bluff face.

Bluff damage due to seepage is evident by the piping holes along the face of the bluff. At the interface between the sand layer and the marine deposit, piping holes are visible along the entire length of the proposed project area (figures 15 and 16). This indicates that the water is seeping along preferential flow paths and removing material from the sand layer. As the material is removed, the support for the material above weakens until it collapses and localized failure is experienced on the upper bluff (figure 17). The failed material covers the lower bluff and then is washed away by high tides, storms, and rain. The cycle of piping out the lower material and subsequent failure then begins again.

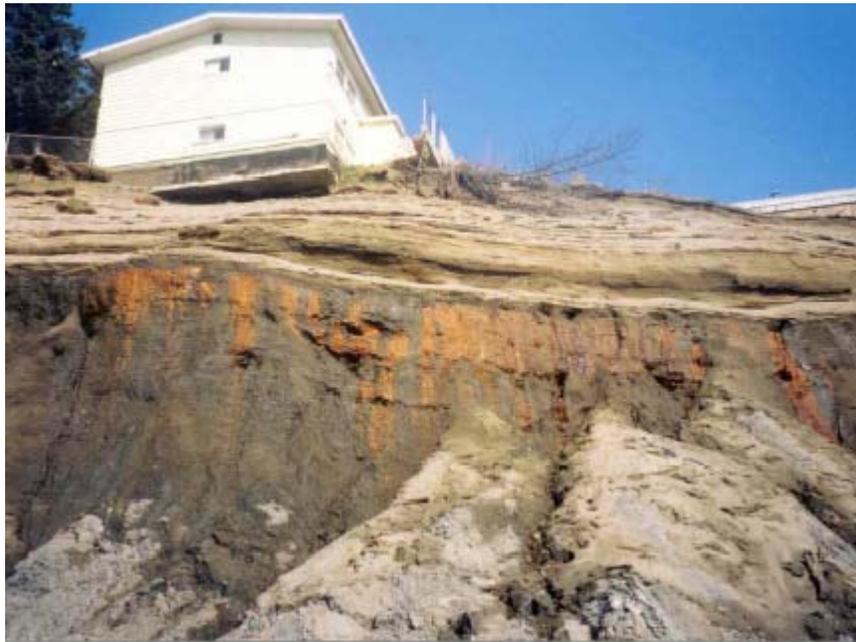
Figure 16. Series of piping holes in bluff face.

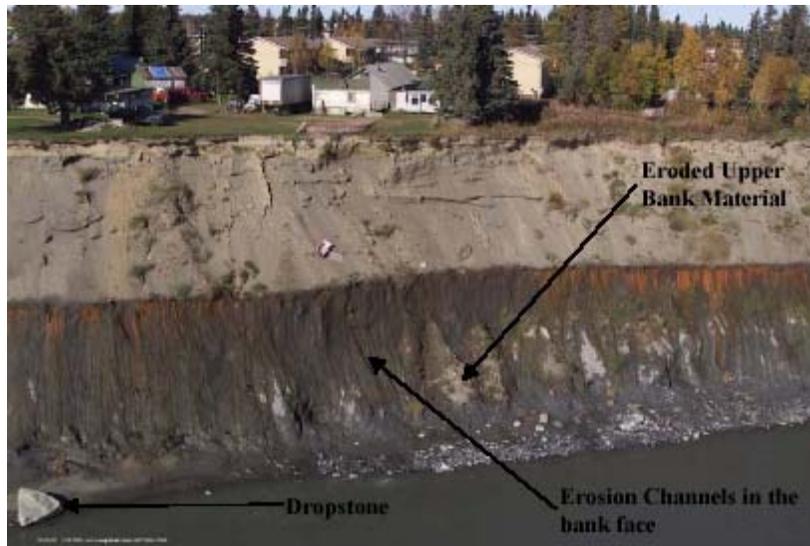
Figure 17. Eroded upper bank material at the base of the bluff and channels cut in more impermeable marine deposit.

The bluff damage from the groundwater seepage is not limited to impacts seen on the upper bluff sand layer. The water seeping out of the bluff face travels over and sometimes through fractures in the marine deposit. The water traveling over the marine deposit eventually erodes channels into the deposits. In areas where the water travels through the marine deposit, the water pressure appears to build up and pipes out of the bluff base (figure 18). This was observed along the bluff after the heavy rainfall events in the fall of 2002 where blocks of marine deposit material had piped out and left large voids in the bluff base. The failed material was gone the following year having been washed away or scoured away by ice over the winter.

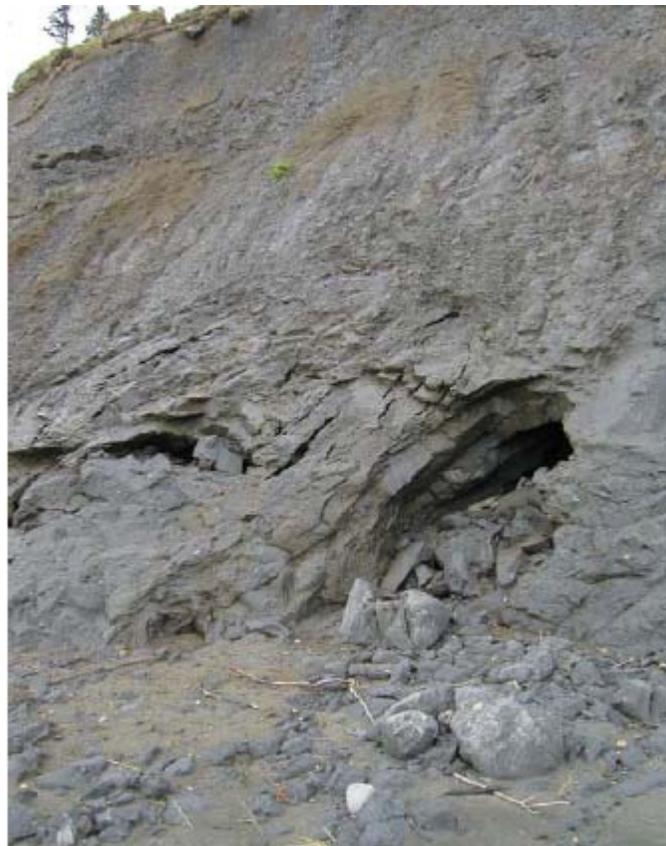
Figure 18. Piping at the bluff base.

In other areas the water seeps to the base of the bluff resulting in areas of high pore pressure making a traverse of the bluff base very soupy. The seepage pathway through the marine deposit is also susceptible to deterioration from freeze thaw effects. The water freezing in the fractures in the bluff will expand to increase the fracture and weaken and or fail the bluff material. High tides, waves, or high flows at the base of the bluff remove the failed material that accumulates and the erosion process starts over. The groundwater seepage from the bluff face is a major contributor of erosion of the bluff face.

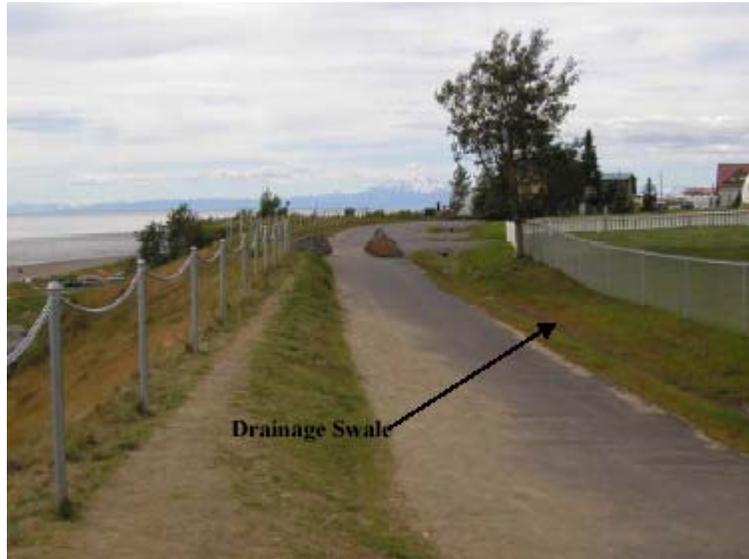
Figure 19. Drainage swale for overland flow.

Uncontrolled flow over the top of the bluff would erode the sand in the upper bluff. It appears that in some areas along the bluff an effort has been made to control overland flow. A drainage swale has been put in place along Mission Avenue (figure 19). This has helped to control the overland flow in this area, but the bluff is still affected by the action of the other erosional forces previously discussed.

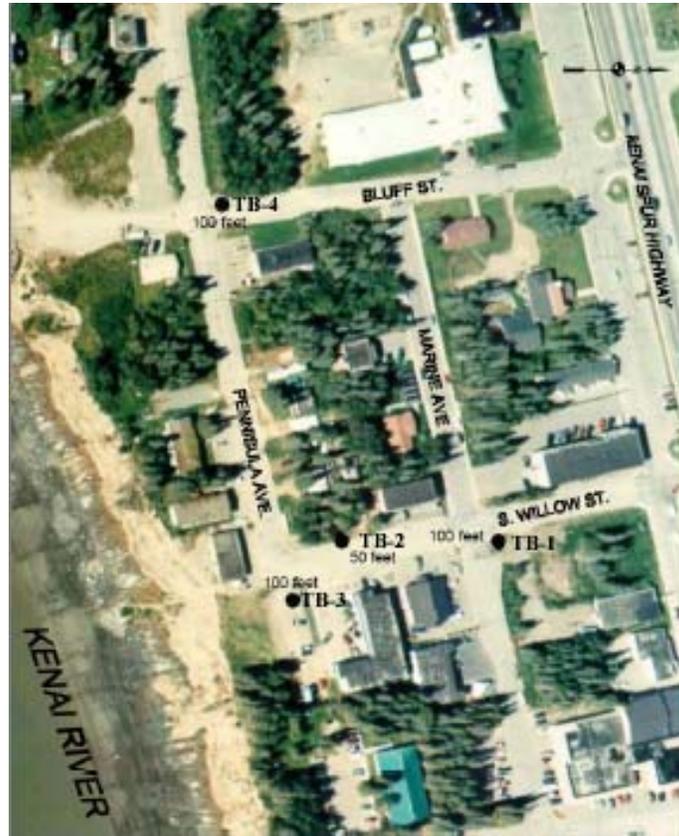
Figure 20. Location of soil borings

Soil borings were advanced at four locations (figure 20) in support of a slope stability and groundwater flow analysis. Soil samples collected during the drilling effort indicated that the sand layer was approximately 37 feet and was underlain by a clay layer that was 36 to 45 feet thick. Piezometers were installed in each of the borings to allow groundwater elevation measurements to be taken periodically. Groundwater measurements taken in October 2003 and April 2004 did not indicate much variation in the water level elevation.

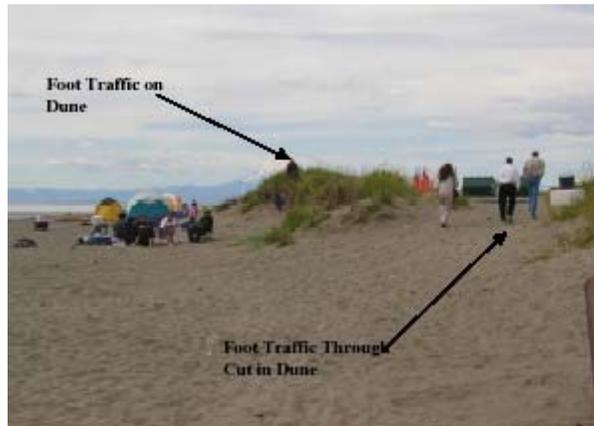
Figure 22. Dune during heavy use before storm event

The dune appears to be nourished by wind blown sand, which is trapped in the beach grass, allowing the dune to grow until a storm event. The wind blown sand is sacrificed during storm events and the grass remains to capture more sand and renourish the dunes. The key to dune preservation is the preservation of the dune grasses. Figures 22 and 23 show the dune before and after a storm event.

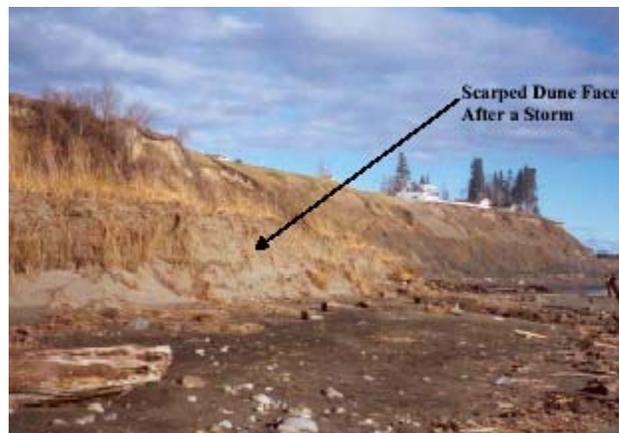
Figure 23. Scarped face of dune after a storm

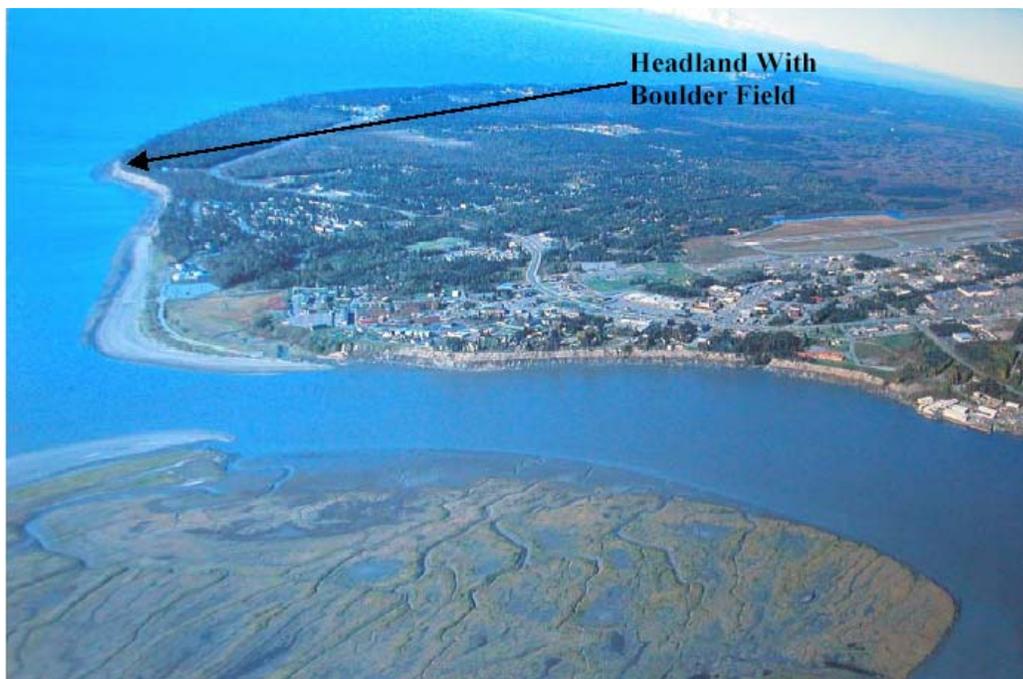
Figure 24. View of the Kenai River and indicator of sediment transport direction

The shoreline exposure and orientation to Cook Inlet indicate a dominant northwest to southeast littoral transport system for the north river bank. Evidence for this transport is found northwest of the mouth of the river in a headland area with numerous boulders lying on the tide flat. The headland and boulder field act like a large groin. The oblique aerial photograph at the Kenai Airport offers an excellent view of the groin effect of the headland (figure 24 and 25). The headland is indented in its lea and fine sand is evident at this site

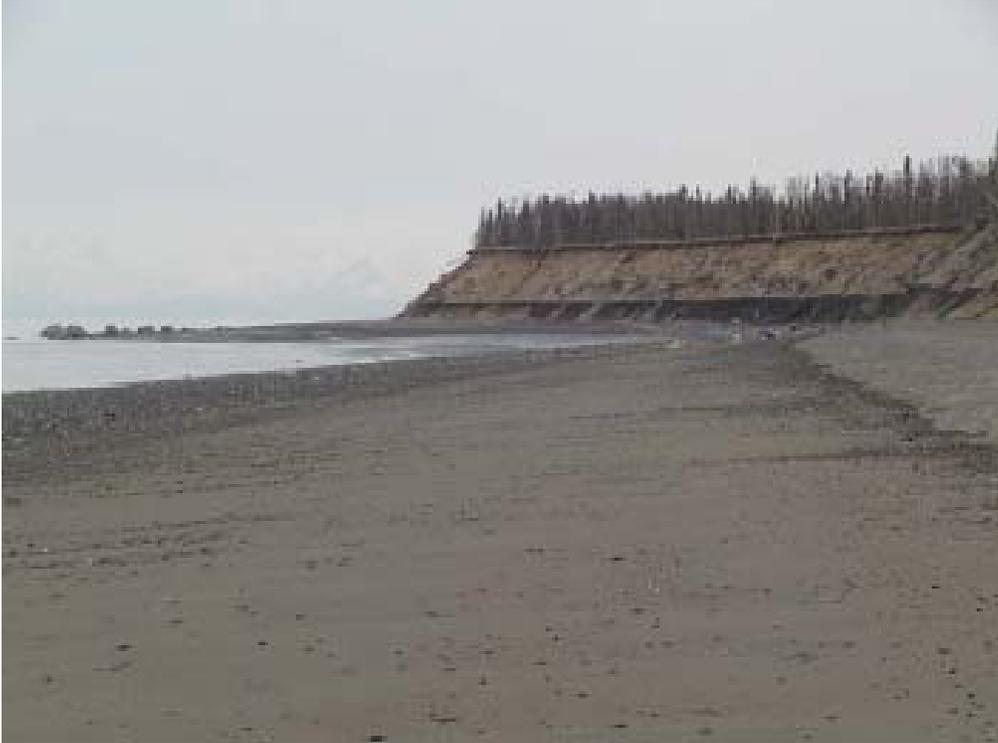
Figure 25. Ground view of the headland acting as a groin

where the “groin” starves the beach of coarser sediment and allows fine material to deposit in the eddy formed behind the groin. Further to the southeast in the direction of the dune the coarser material rejoins the beach and is carried along the base of the bluff. The material is continuous from where it rejoins the shoreline to the dune zone.
