Appendix H. Water Resource Report

***WATER SOURCE AND QUALITY INVESTIGATIONS
FOR
POTENTIAL RELOCATION SITES
KIVALINA, ALASKA***

**CONTRACT NO. DACW85-03-D-006
DELIVERY ORDER NO. 07 MOD 05**

Tryck Nyman Hayes, Inc.
911 W. 8th Avenue
Anchorage, Alaska 99501

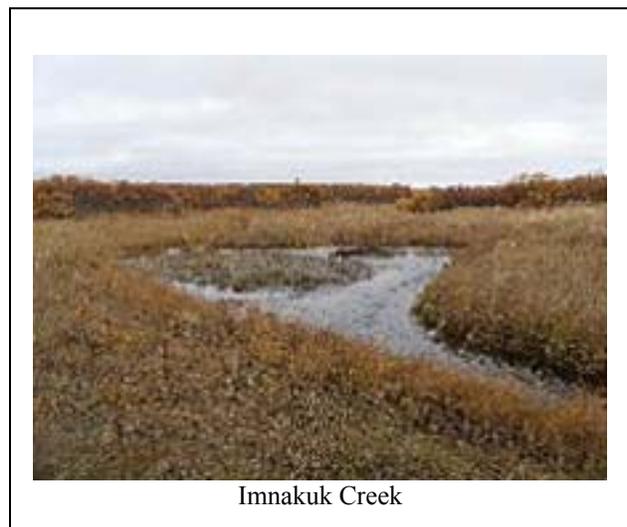
Two visual estimates and simple flow test measurements were conducted at the mouth and approximately ¼ mile upstream of the mouth. On September 19th, 2005, Engineers performed a flow test and estimated the river to flow between 1,800 and 2,700 gpm. The

drainage channel appeared to be low, with evidence of flooding higher on the bank.

Imnakuk Creek: Analysis of the Imnakuk Creek indicates the estimated size of the drainage basin is 4012 acres. Mean annual flow is estimated to be 4,027 gpm. Average flows for April and June are 70 gpm and 12,870 gpm, respectively. Sheet 6, located in Appendix A, shows the drainage basin and monthly flow estimates.

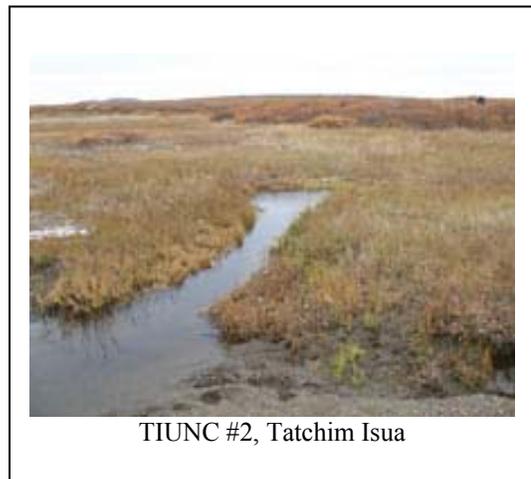
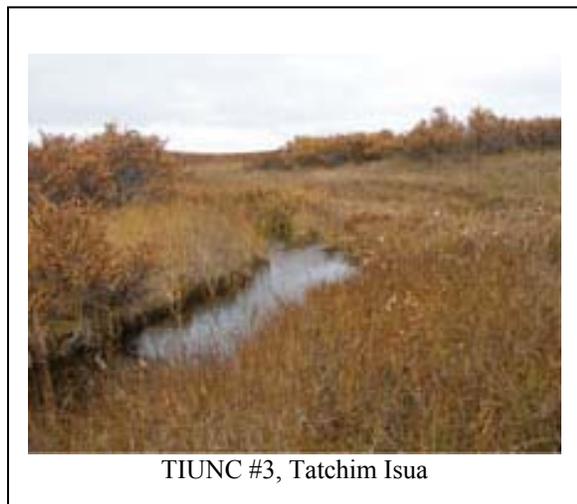
Visual estimates and a simple flow test measurement were conducted near the creek mouth. An estimate for flow on September 19th was 400 gpm. Village elders report that the creek appears to go dry in the winter months. However, with snow cover, there are commonly small flows present under the snow pack or in the gravel bed of streams. Verification of winter flows should be conducted.

TIUNC #2: Analysis of the TIUNC #2 indicates the estimated size of the drainage basin is 830 acres. Mean annual flow is estimated to be 834 gpm. Average flows for April and June are 15 gpm and 2,664 gpm, respectively. Sheet 8, located in Appendix A shows the drainage basin and monthly flow estimates.

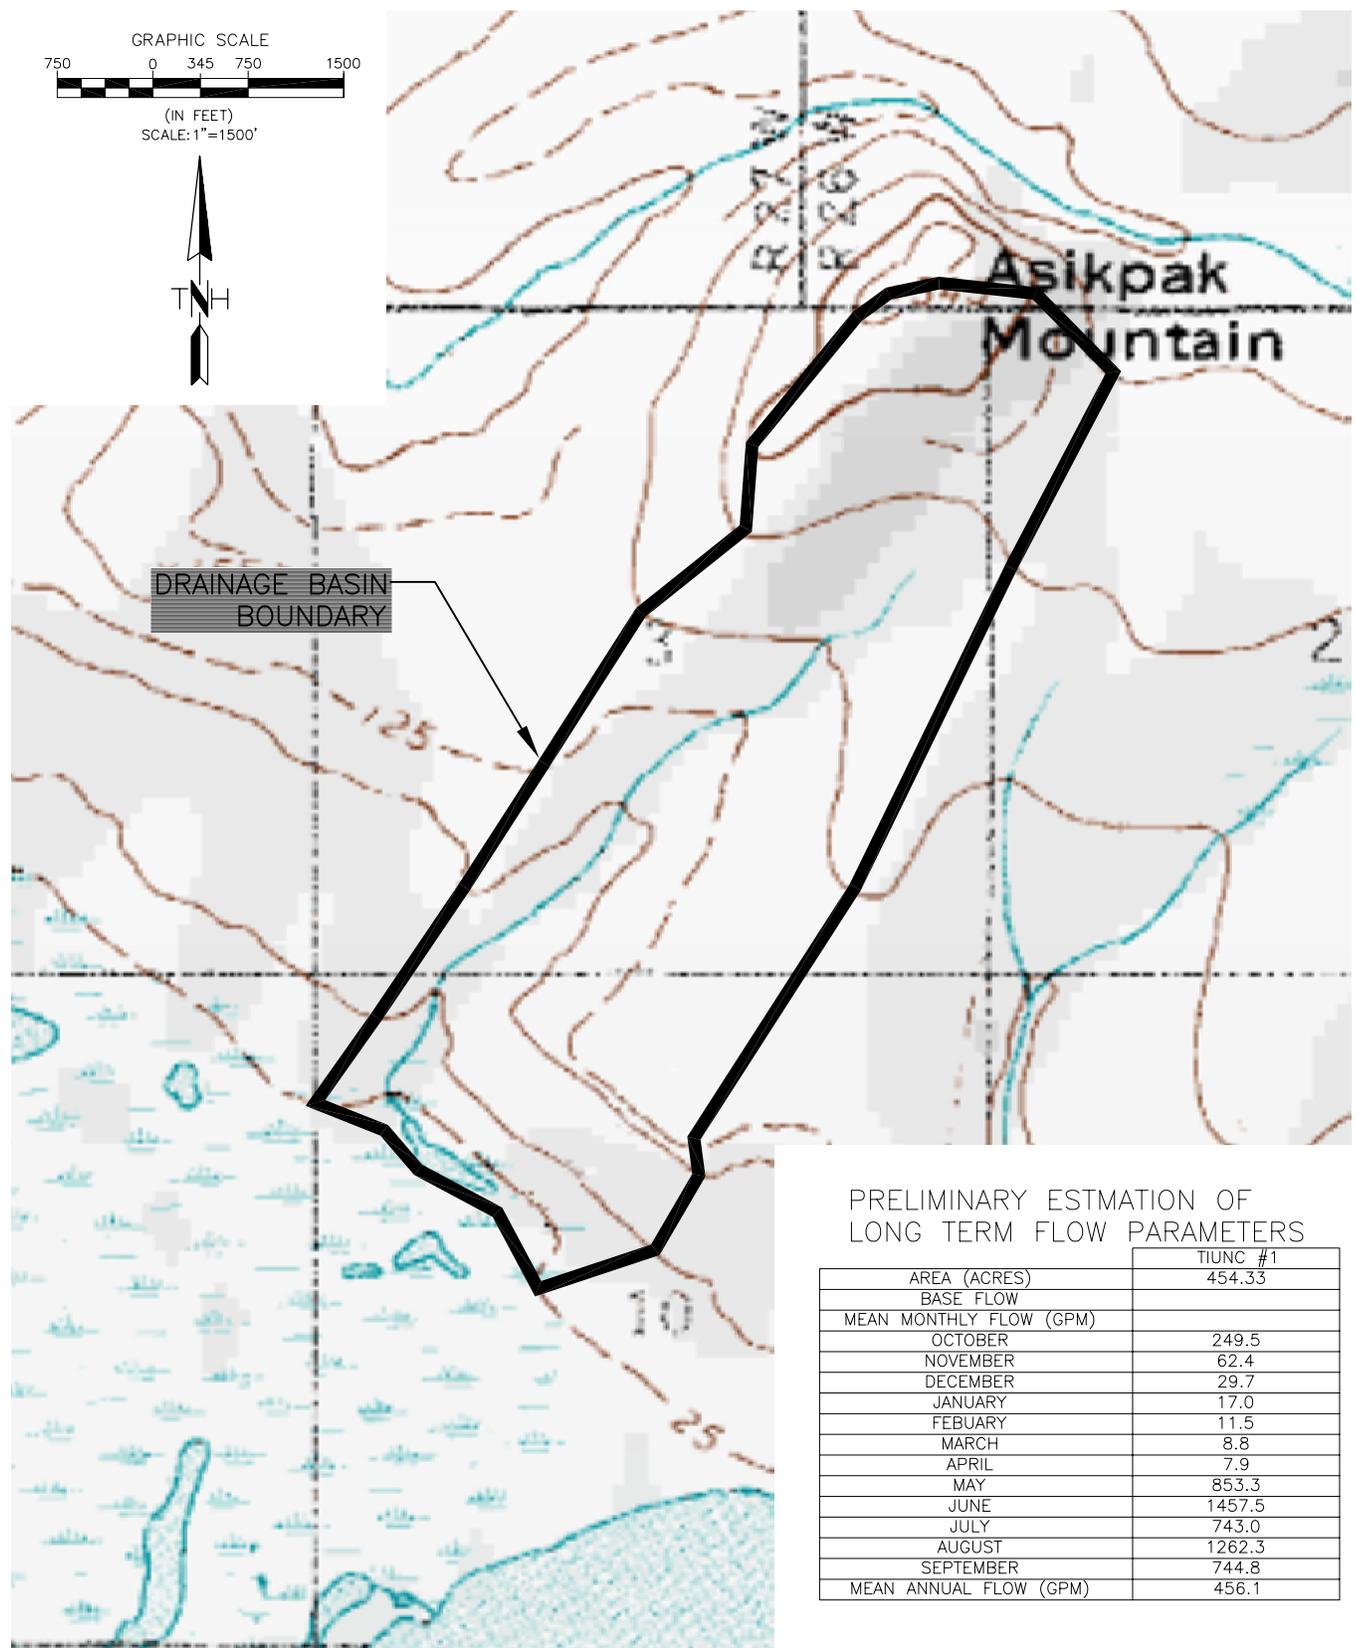
PRELIMINARY ESTIMATION OF
LONG TERM FLOW PARAMETERS

TIUNC #1
AREA (ACRES)	454.33
BASE FLOW	
MEAN MONTHLY FLOW (GPM)	
OCTOBER	249.5
NOVEMBER	62.4
DECEMBER	29.7
JANUARY	17.0
FEBRUARY	11.5
MARCH	8.8
APRIL	7.9
MAY	853.3
JUNE	1457.5
JULY	743.0
AUGUST	1262.3
SEPTEMBER	744.8
MEAN ANNUAL FLOW (GPM)	456.1

Village elders report that the unnamed creeks near Tatchim Isua go dry during winter months. Calculations show that TIUNC #1 has flow rates that could average as low as 8 gpm in April. TIUNC #2 and #3 were computed to have higher April flows of 14.5 gpm for TIUNC #2, and 19 gpm for TIUNC #3. To confirm winter flow rates, daily flow tests should be measured for TIUNC #2 and TIUNC #3. Quarterly water quality tests should be performed from TIUNC #2 and TIUNC #3. Quarterly tests should also be performed for Asikpak River. TIUNC #1 is not recommended for further study due to the small drainage basin of 454 acres.

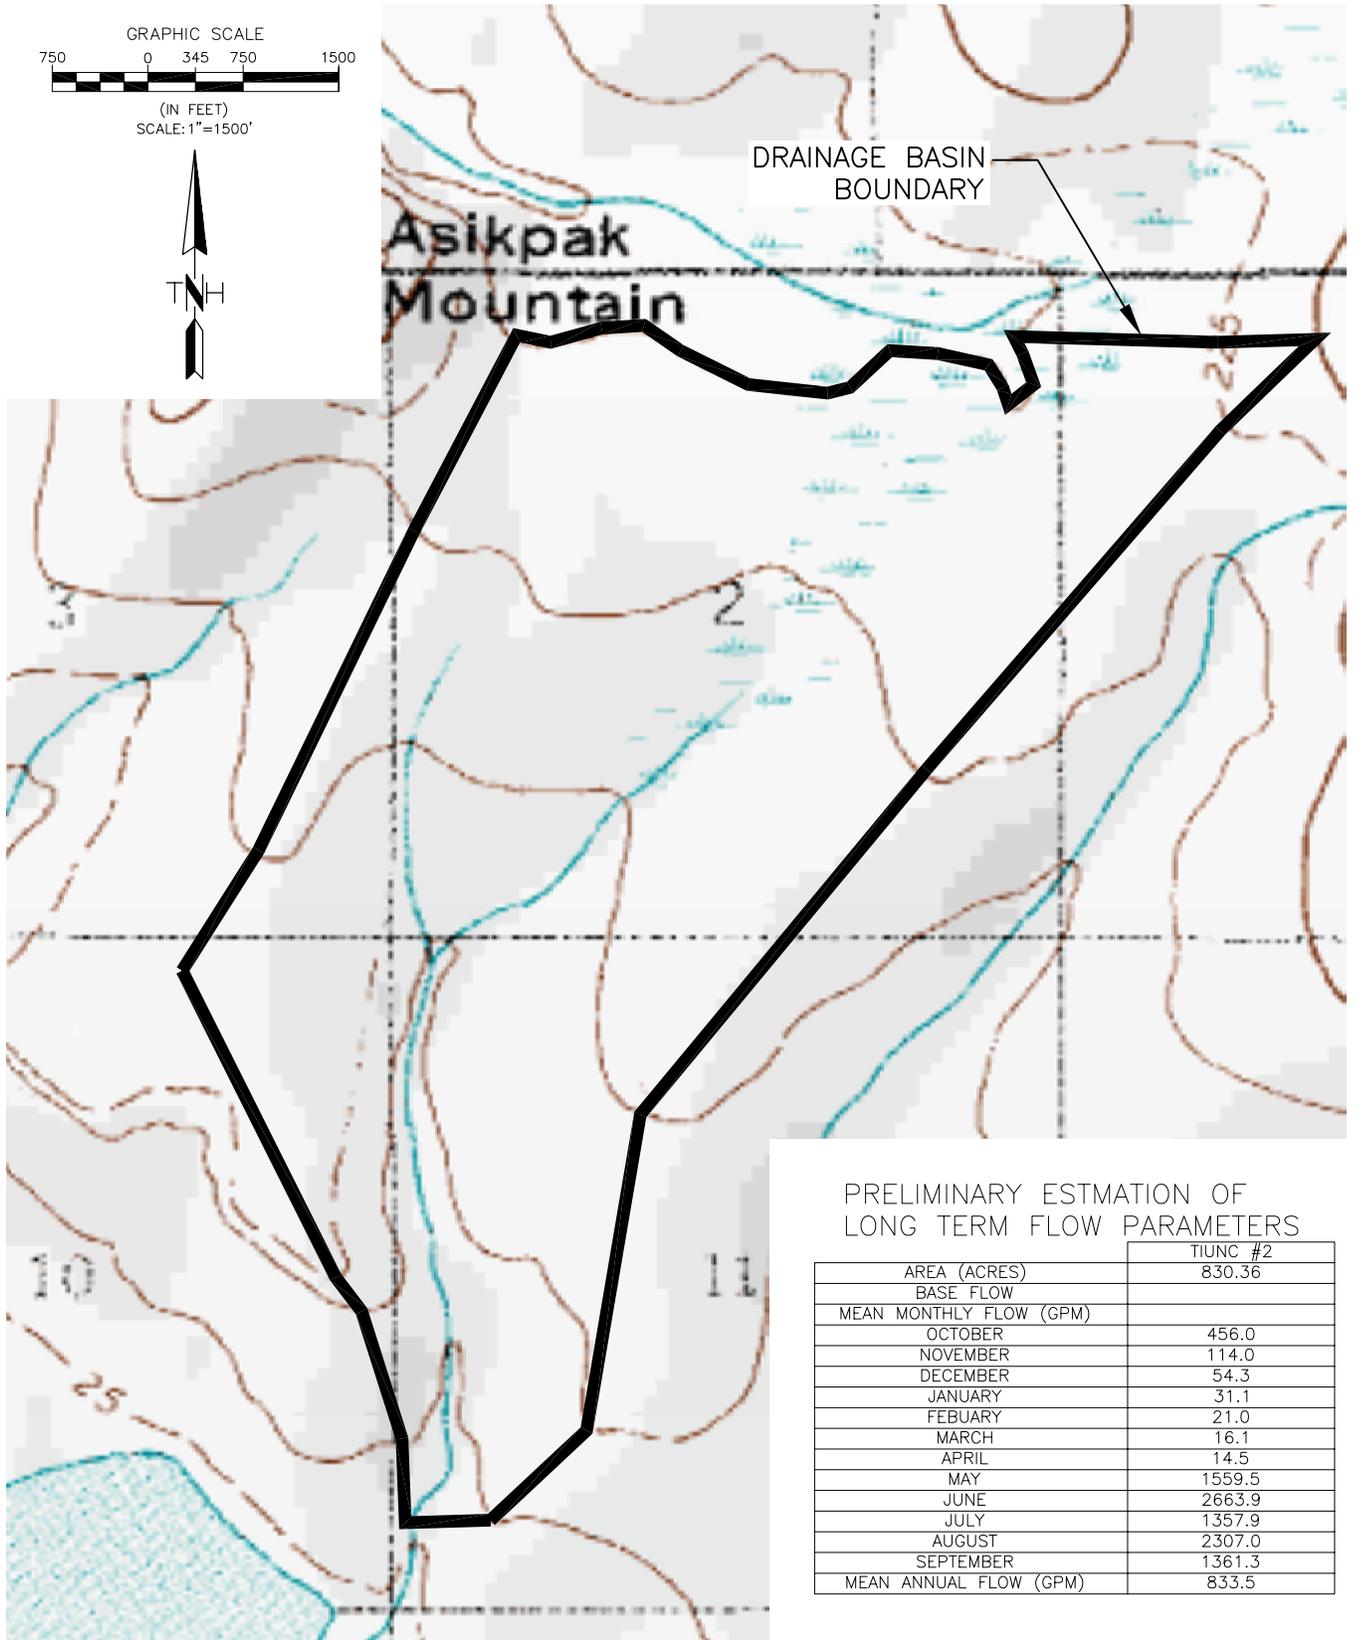
PRELIMINARY ESTIMATION OF
LONG TERM FLOW PARAMETERS

TIUNC #2
AREA (ACRES)	830.36
BASE FLOW	
MEAN MONTHLY FLOW (GPM)	
OCTOBER	456.0
NOVEMBER	114.0
DECEMBER	54.3
JANUARY	31.1
FEBRUARY	21.0
MARCH	16.1
APRIL	14.5
MAY	1559.5
JUNE	2663.9
JULY	1357.9
AUGUST	2307.0
SEPTEMBER	1361.3
MEAN ANNUAL FLOW (GPM)	833.5

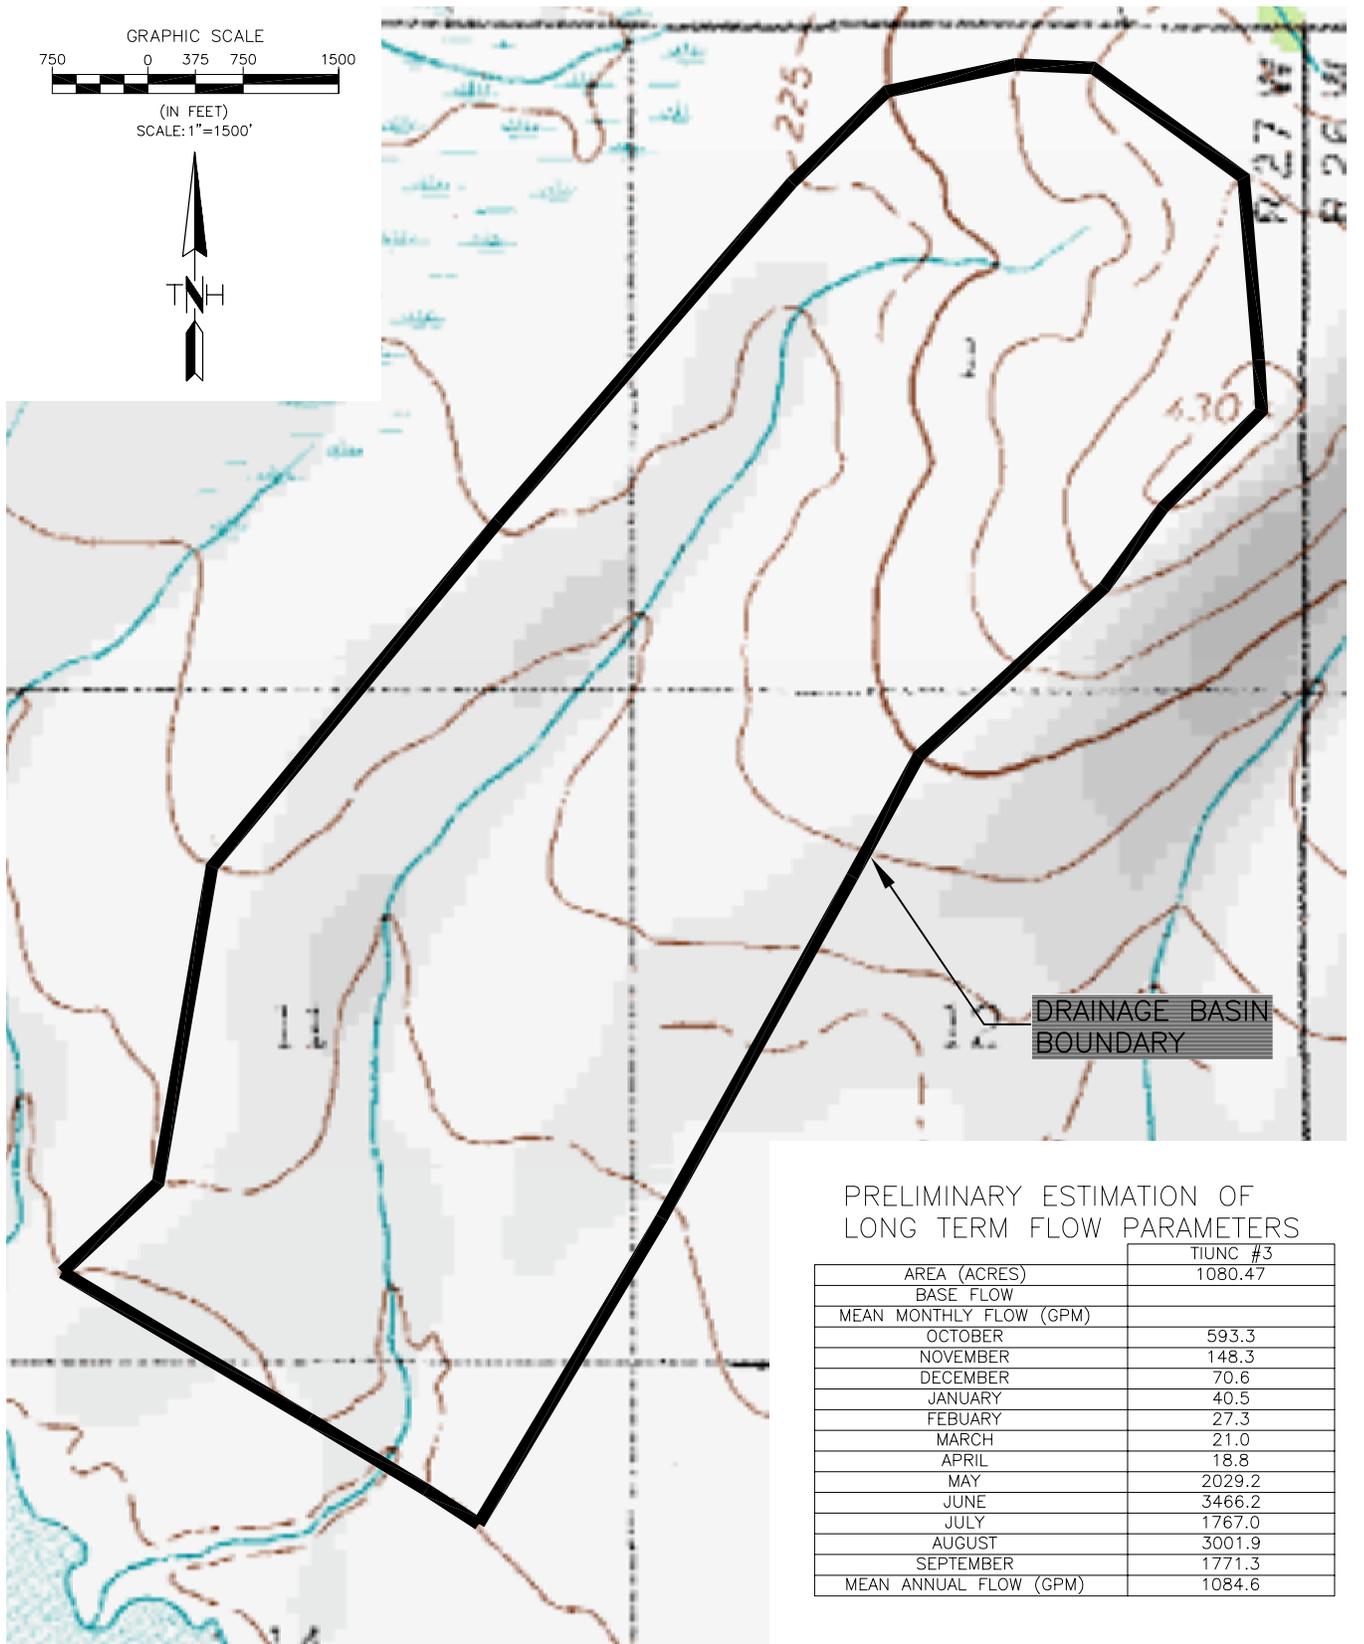
PRELIMINARY ESTIMATION OF
LONG TERM FLOW PARAMETERS

TIUNC #3
AREA (ACRES)	1080.47
BASE FLOW	
MEAN MONTHLY FLOW (GPM)	
OCTOBER	593.3
NOVEMBER	148.3
DECEMBER	70.6
JANUARY	40.5
FEBUARY	27.3
MARCH	21.0
APRIL	18.8
MAY	2029.2
JUNE	3466.2
JULY	1767.0
AUGUST	3001.9
SEPTEMBER	1771.3
MEAN ANNUAL FLOW (GPM)	1084.6

TIUNC #3: Analysis of the TIUNC #3 indicates the estimated size of the drainage basin is 1,080 acres. Mean annual flow is estimated to be 1,085 gpm. Average flows for April and June are 19 gpm and 3,466 gpm, respectively. Sheet 9, located in Appendix A, shows the drainage basin and monthly flow estimates.

Visual estimates and simple flow test measurements were conducted near the mouth. An estimate for flow on September 19th was 670 gpm. Village elders report that the creek appears to go dry in the winter months. However, with

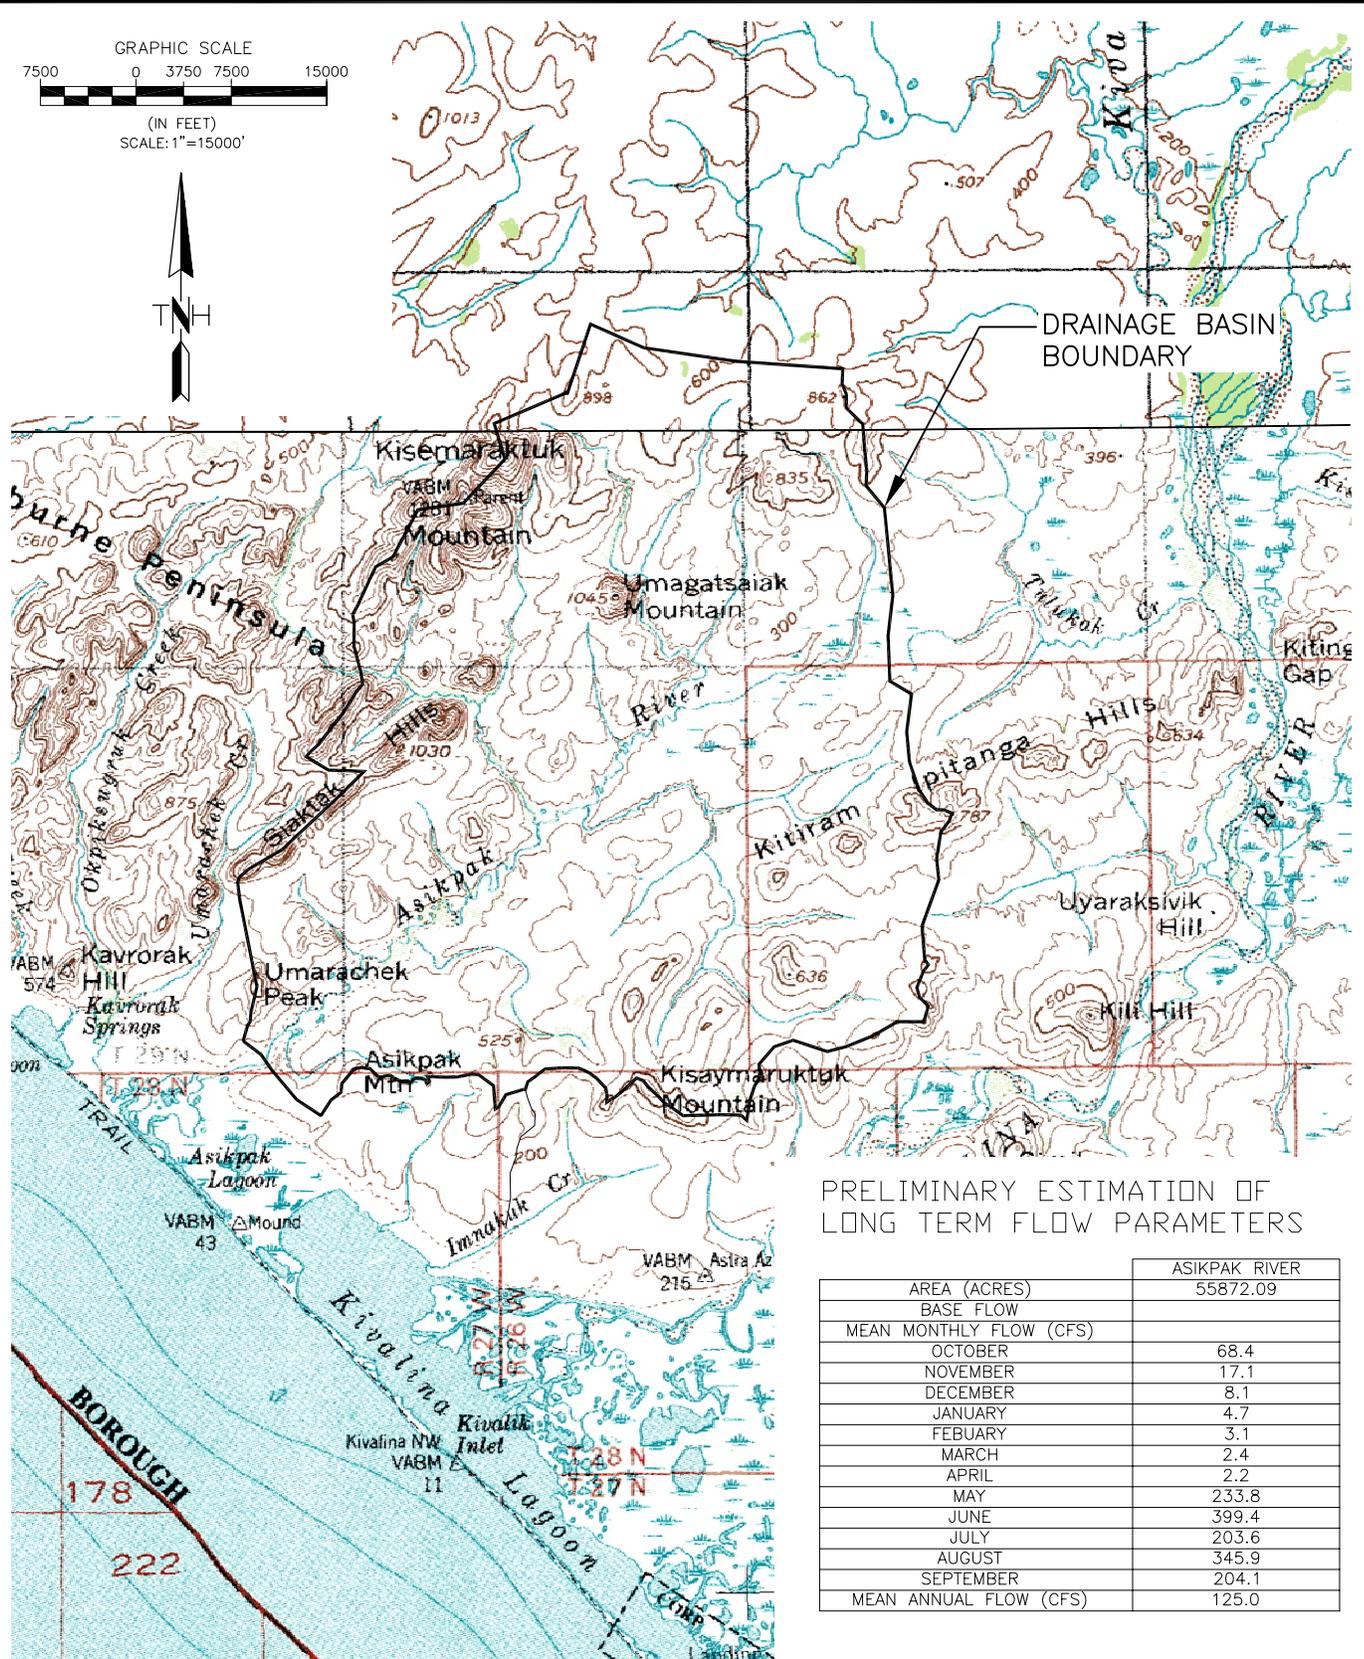
PRELIMINARY ESTIMATION OF LONG TERM FLOW PARAMETERS

ASIKPAK RIVER
AREA (ACRES)	55872.09
BASE FLOW	
MEAN MONTHLY FLOW (CFS)	
OCTOBER	68.4
NOVEMBER	17.1
DECEMBER	8.1
JANUARY	4.7
FEBRUARY	3.1
MARCH	2.4
APRIL	2.2
MAY	233.8
JUNE	399.4
JULY	203.6
AUGUST	345.9
SEPTEMBER	204.1
MEAN ANNUAL FLOW (CFS)	125.0
