WETLAND DETERMINATION DATA FORM - Alaska Region

Project/Site: GMT2 Borough/City: North Slope Borough Sampling Date: 21-Jul-15
Applicant/Owner: Conoco Phillips Alaska, Inc. (CPAI) Sampling Point: GMT2-08
Investigator(s): WAD, EKJ Landform (hillside, terrace, hummocks etc.): Flat plateau
Local relief (concave, convex, none): flat Slope: 0.0 % / 0.0 ° Elevation: 76
Subregion: Northern Alaska Lat.: 70.2377566666667 Long.: -151.547598333333 Datum: _____
Soil Map Unit Name: _____ NWI classification: pem1/ss1e

APPENDIX C
HDL 2016 PROJECT ANALYSIS REPORT

**Nuiqsut Repair
Bridge Crossings**

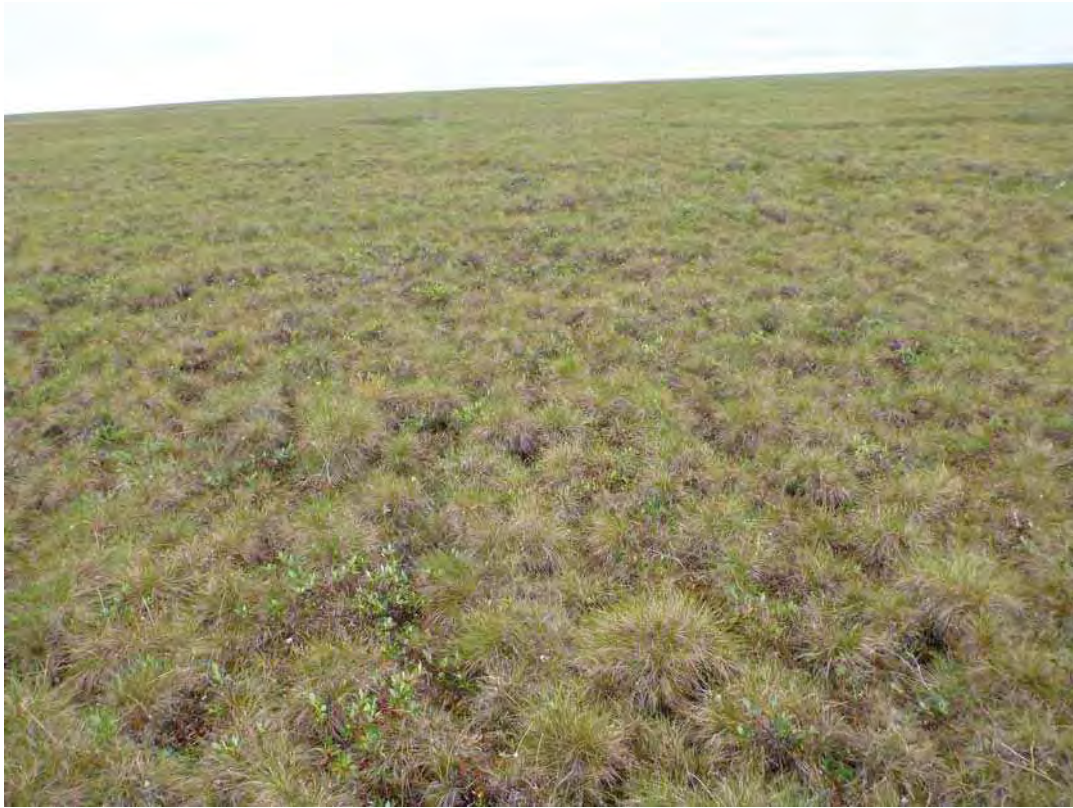
GMT2-07

Wetland Functional Class: Saturated Graminoid/Shrub Meadow

Wildlife Habitat: Moist Tussock Tundra

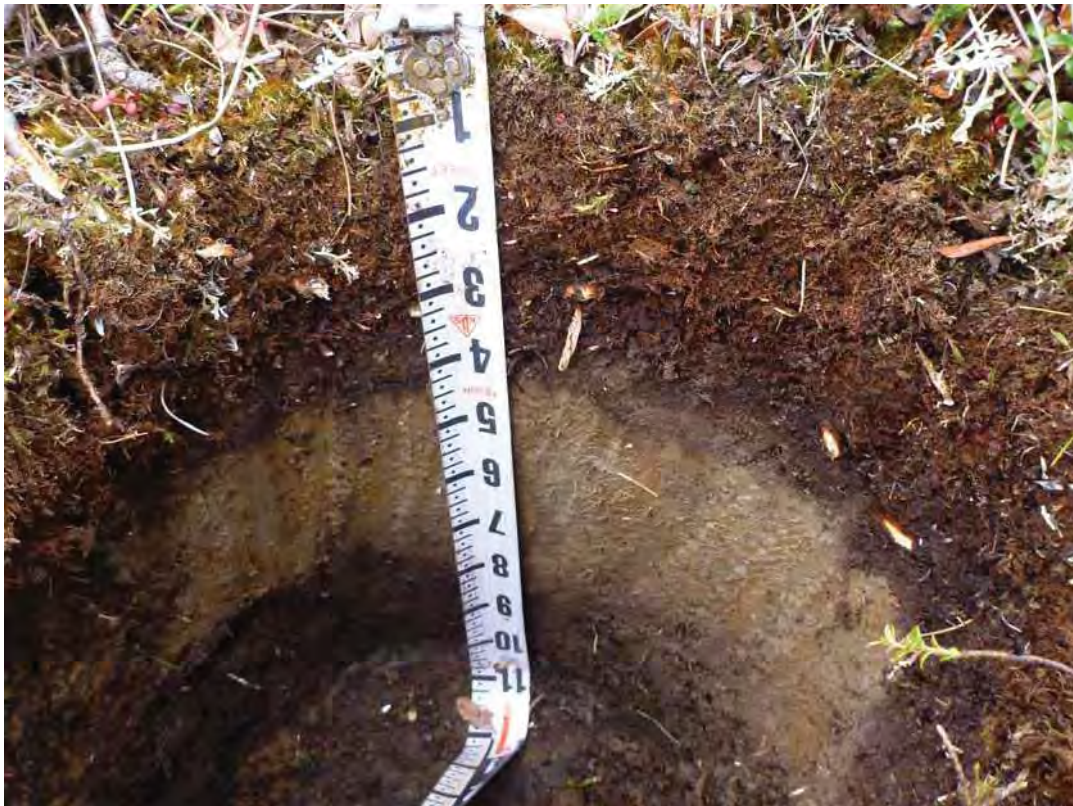
Hydric Soil Indicators: Alaska Redox with 2.5Y Hue

Wetland Hydrology Indicators: Surface water in depressions and secondary hydrology indicators

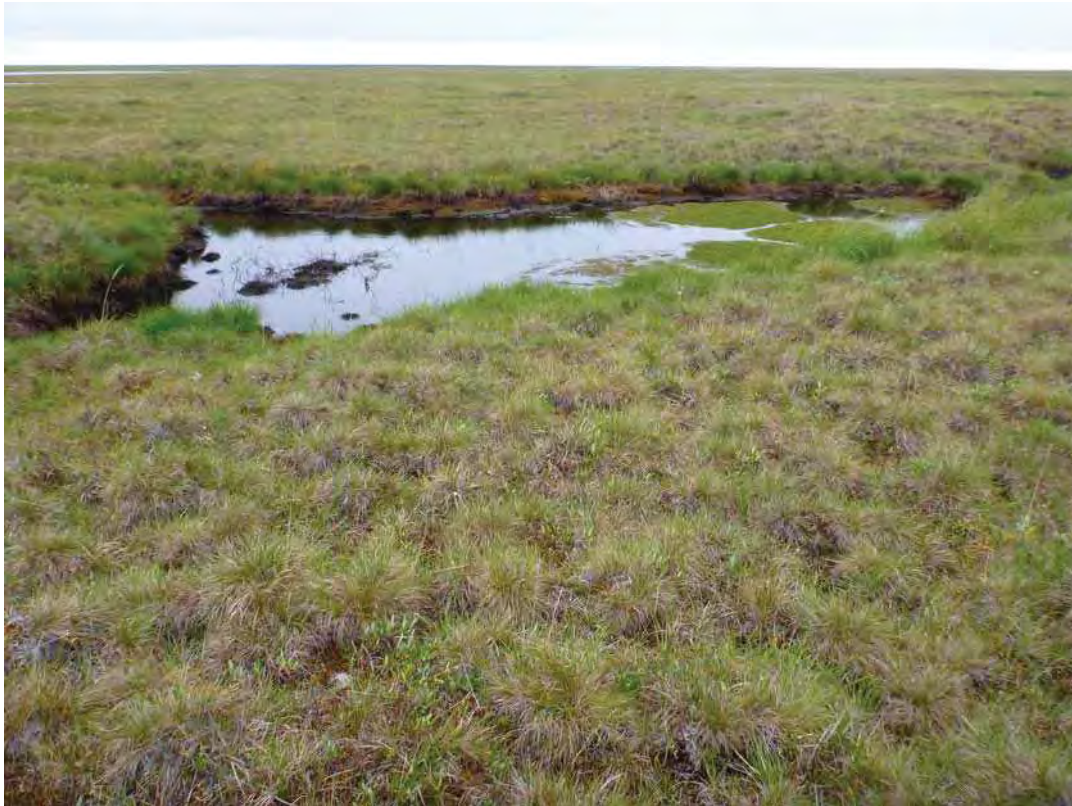
GMT2-08

pem1/ss1e

Wetland Functional Class: Seasonally Flooded Saturated Graminoid/Shrub Meadow

Wildlife Habitat: Moist Sedge Shrub Tundra

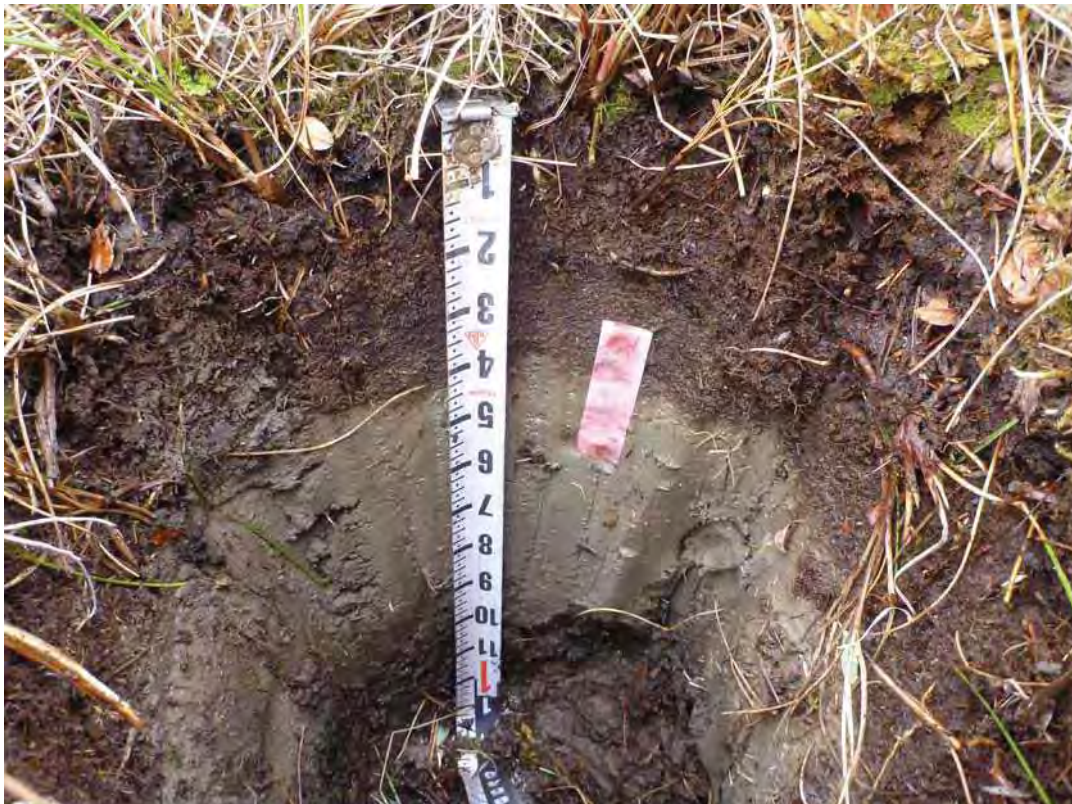
Hydric Soil Indicators: Positive for alpha alpha dipyrdil

Wetland Hydrology Indicators: Surface water in low depressions, saturation

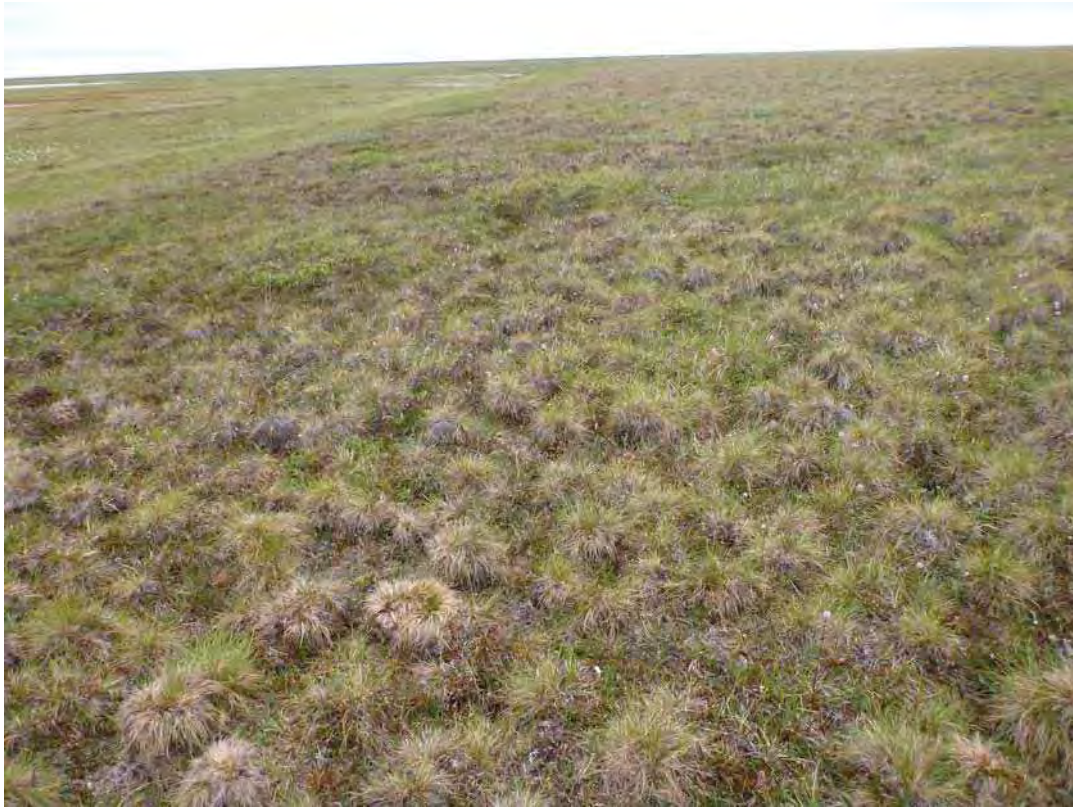
GMT2-09

Upland

Wetland Functional Class: Upland

Wildlife Habitat: Moist Tussock Tundra

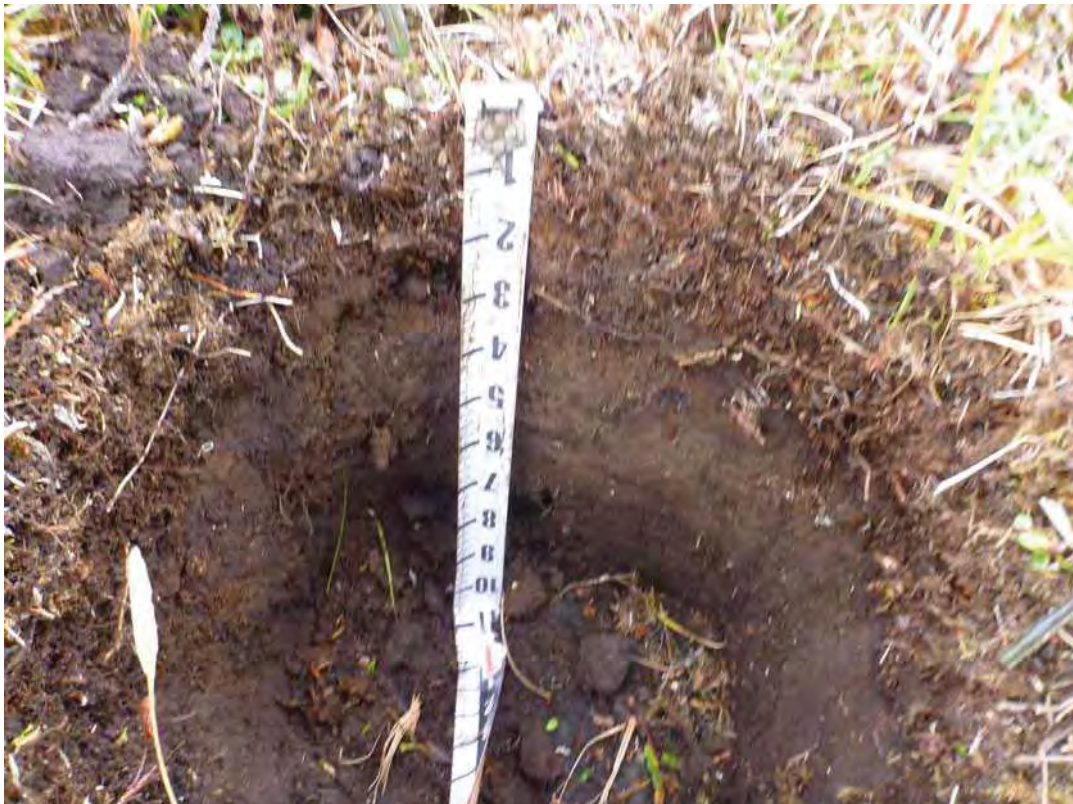
Hydric Soil Indicators: No hydric soil indicators

Wetland Hydrology Indicators: One secondary indicator (shallow aquitard)
