***DRAFT***  
**GREATER MOOSES TOOTH TWO (GMT2)  
DEVELOPMENT PROJECT PERMITTEE  
RESPONSIBLE WETLANDS MITIGATION PLAN  
NATIONAL PETROLEUM RESERVE-ALASKA**

*Prepared for:*  
ConocoPhillips Alaska, Inc.  
Anchorage, AK

**March 2018**

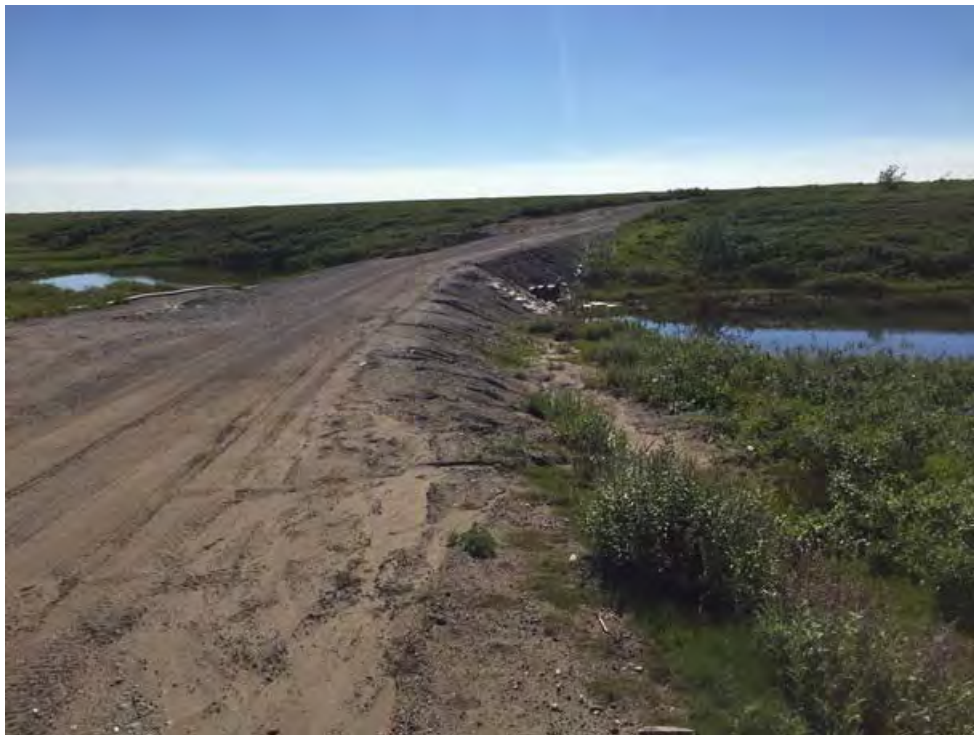
**Photo 1.** View along roadway and crossing, looking south.

**Photo 2.** View along roadway and crossing, looking north.

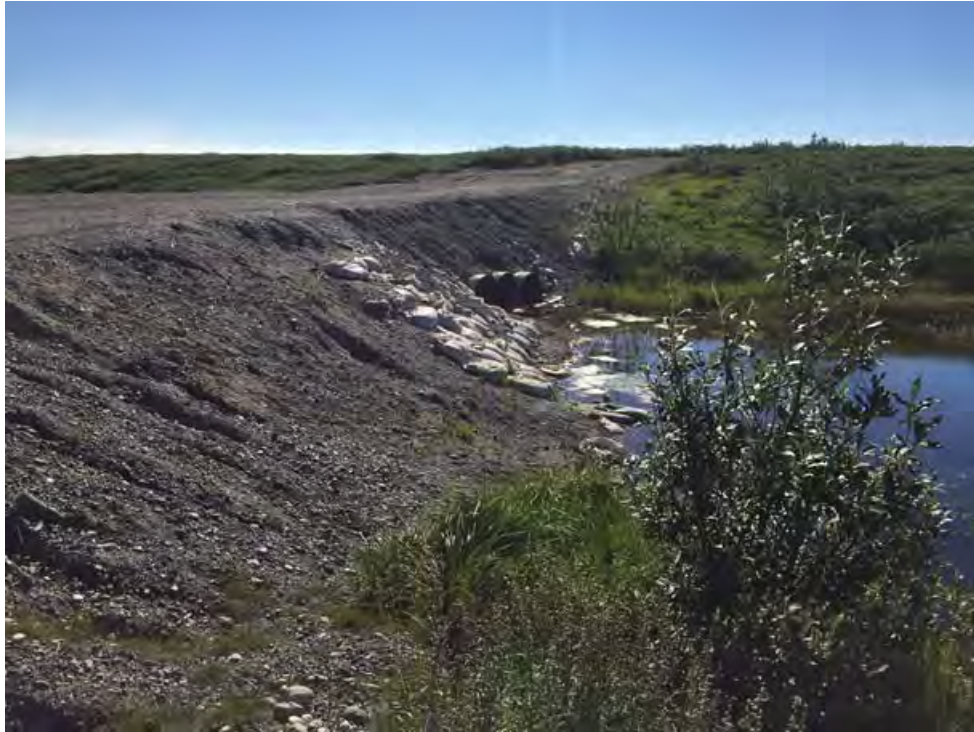
**Photo 3.** View looking south at upstream side of culverts.

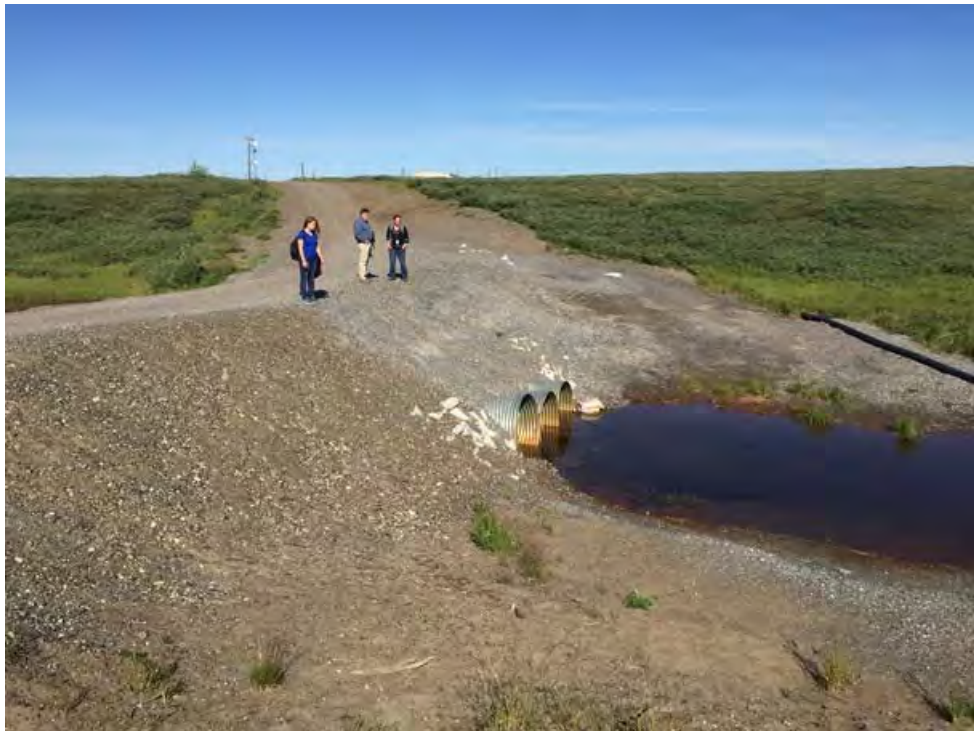
**Photo 4.** Looking north at downstream side of culverts. The gravel in the stream is from road washouts.

This flooding has contributed to road damage which results in excess gravel and sediment deposition downstream of the crossing. This deposition has resulted in channel constriction downstream of the culverts and removal of shoreline vegetation and wetlands habitat. Additional impacts resulting from repeated inundation may be experienced upstream to the limit of reported flood elevations. The upstream portion also discharges from Nuiqsut airport; therefore, flooding could jeopardize the runaway during spring break up.

The excess gravel deposited downstream because of the recent flood events will be removed as part of this effort. The gravel, depending on the quality, could be reused in road grade improvements. Vegetation along the shoreline will be allowed to develop naturally where gravel is removed.

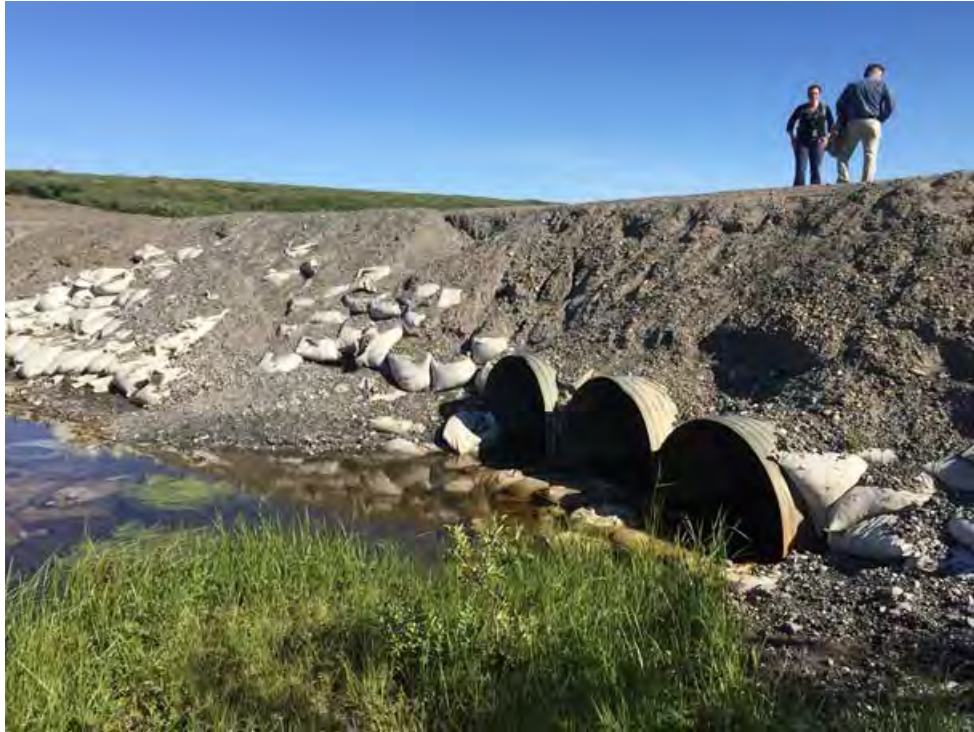
**Photo 5.** View of upstream side of culverts and sand bag armoring in creek and road embankment.

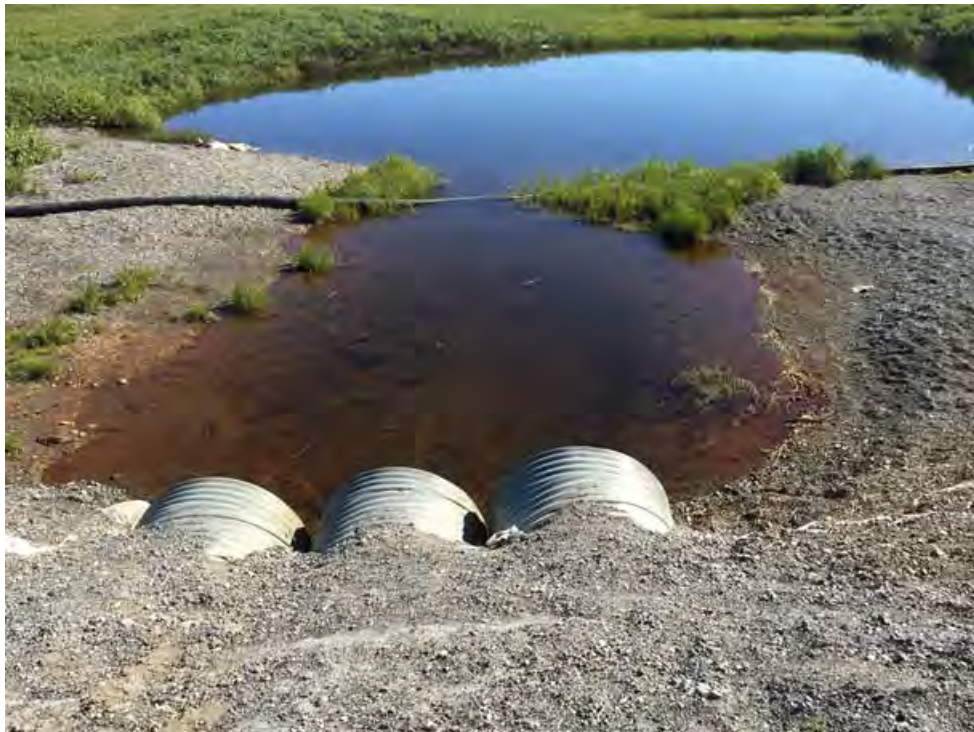
**Photo 6.** View downstream from road surface with gravel in stream.
