Barrow Alaska Coastal Erosion Feasibility Study

Appendix I: Barrow, AK Coastal Storm Damage Reduction Technical Report

Coastal Storm Damage Reduction Technical Report

July 2010

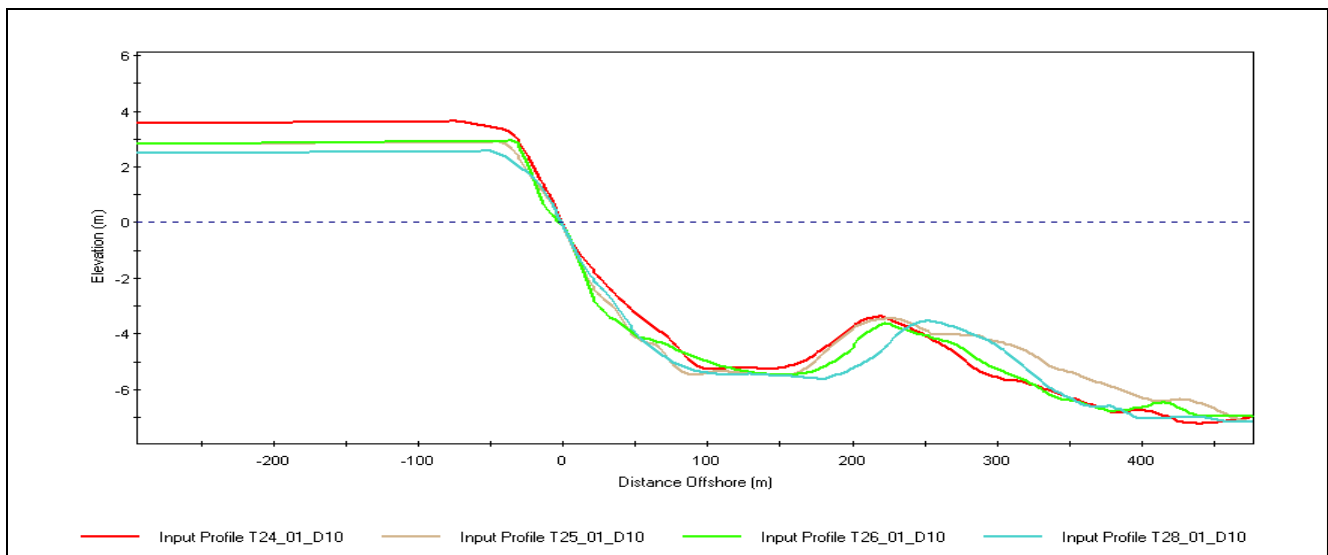
Figure 11. Example Beach profiles for Reaches 24, 25, 26, and 28 at Barrow.

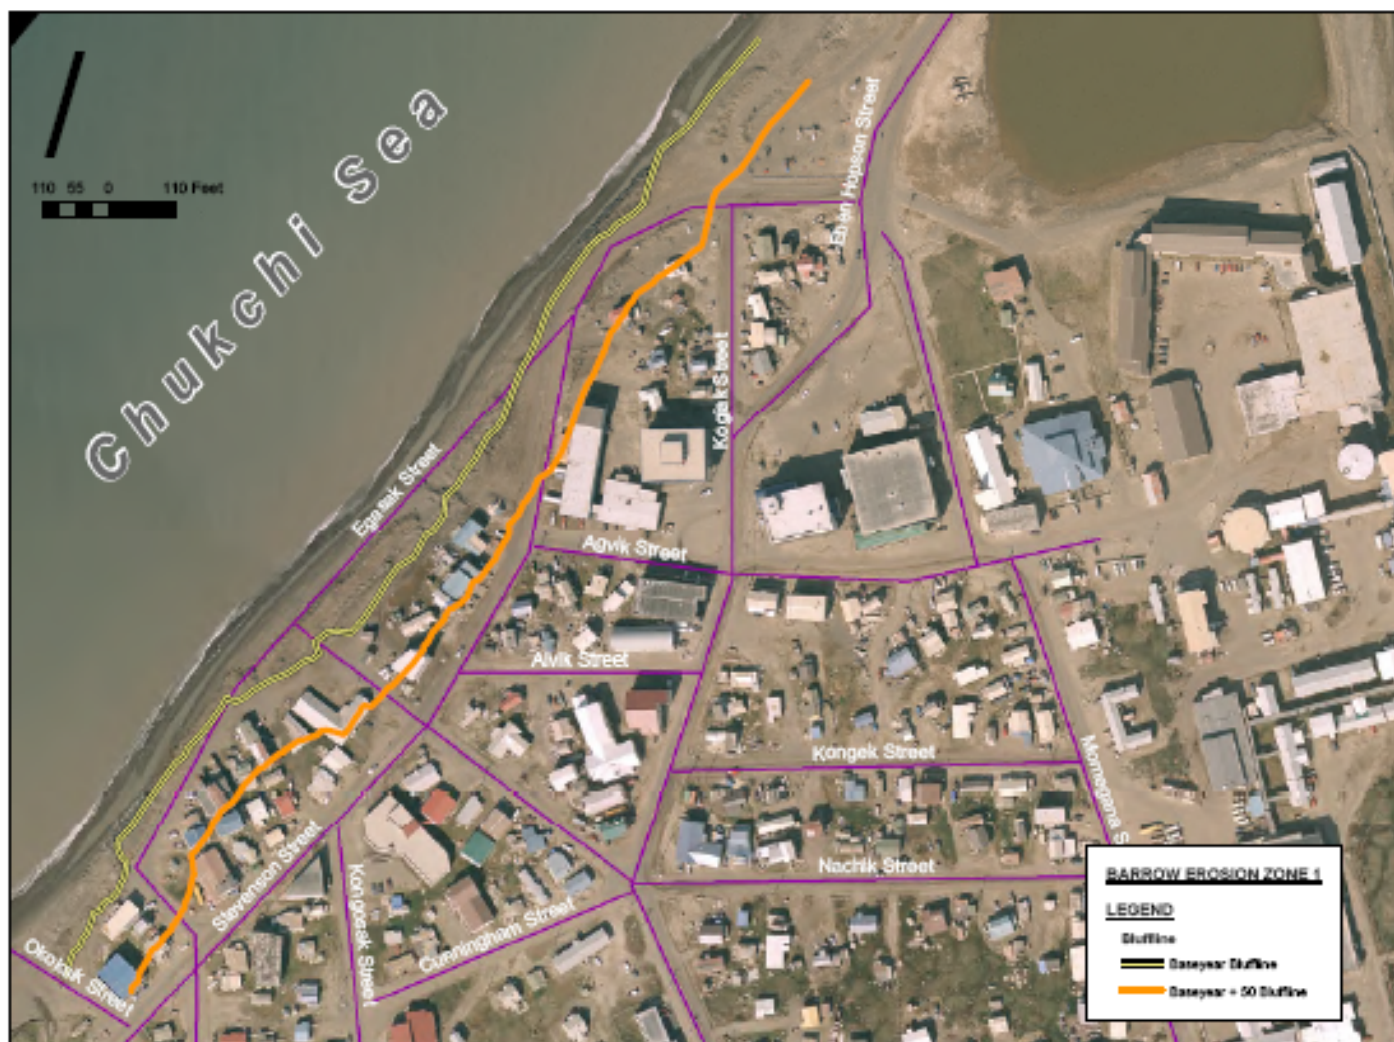
Figure 19. Expected 50-year erosion in the vicinity of Barrow.

Historic erosion along the bluff in Barrow can be divided into two zones (figure 19). Erosion Zone 1, extending southwestward from the beach in front of the western end of Tasigrook Lagoon to Okoksik Street, was estimated to have a future erosion rate of 2.2 feet per year, resulting in inland movement of the bluff line by 110 feet over the 50-year period of analysis. Erosion Zone 2, extending southwestward from Okoksik Street to the bluff in front of the northeastern end of the airport runway, was estimated to have a future without project landward erosion rate of 1.0 feet per year, resulting in moving the bluff line inland by 50 feet over the 50-year period of analysis. The result of the erosion in both zones would be damages associated with the loss of land, structures, and cultural and historic resources. Figures 19 and 20 show the expected zone of bluff retreat (erosion) over the 50-year period of analysis. The extent of lost land over the 50-year period of analysis is estimated at 7.4 acres. Estimated land damages from erosion over the 50-year period of analysis, based upon a value of \$100,000 per acre, have a total present value of \$283,000 (equivalent average annual damage is \$15,000). As a result of continued bluff erosion, it is estimated 31 structures in the Barrow Neighborhood would be condemned or otherwise removed. Valuation of erosion damages to structures was based upon the estimated depreciated replacement cost of each structure, assuming all contents of value would be removed and no future development would occur in the identified erosion zone. Estimated structural damages from erosion over the 50-year period of analysis have a total present value of \$4,735,000 (equivalent average annual damage is \$254,000).

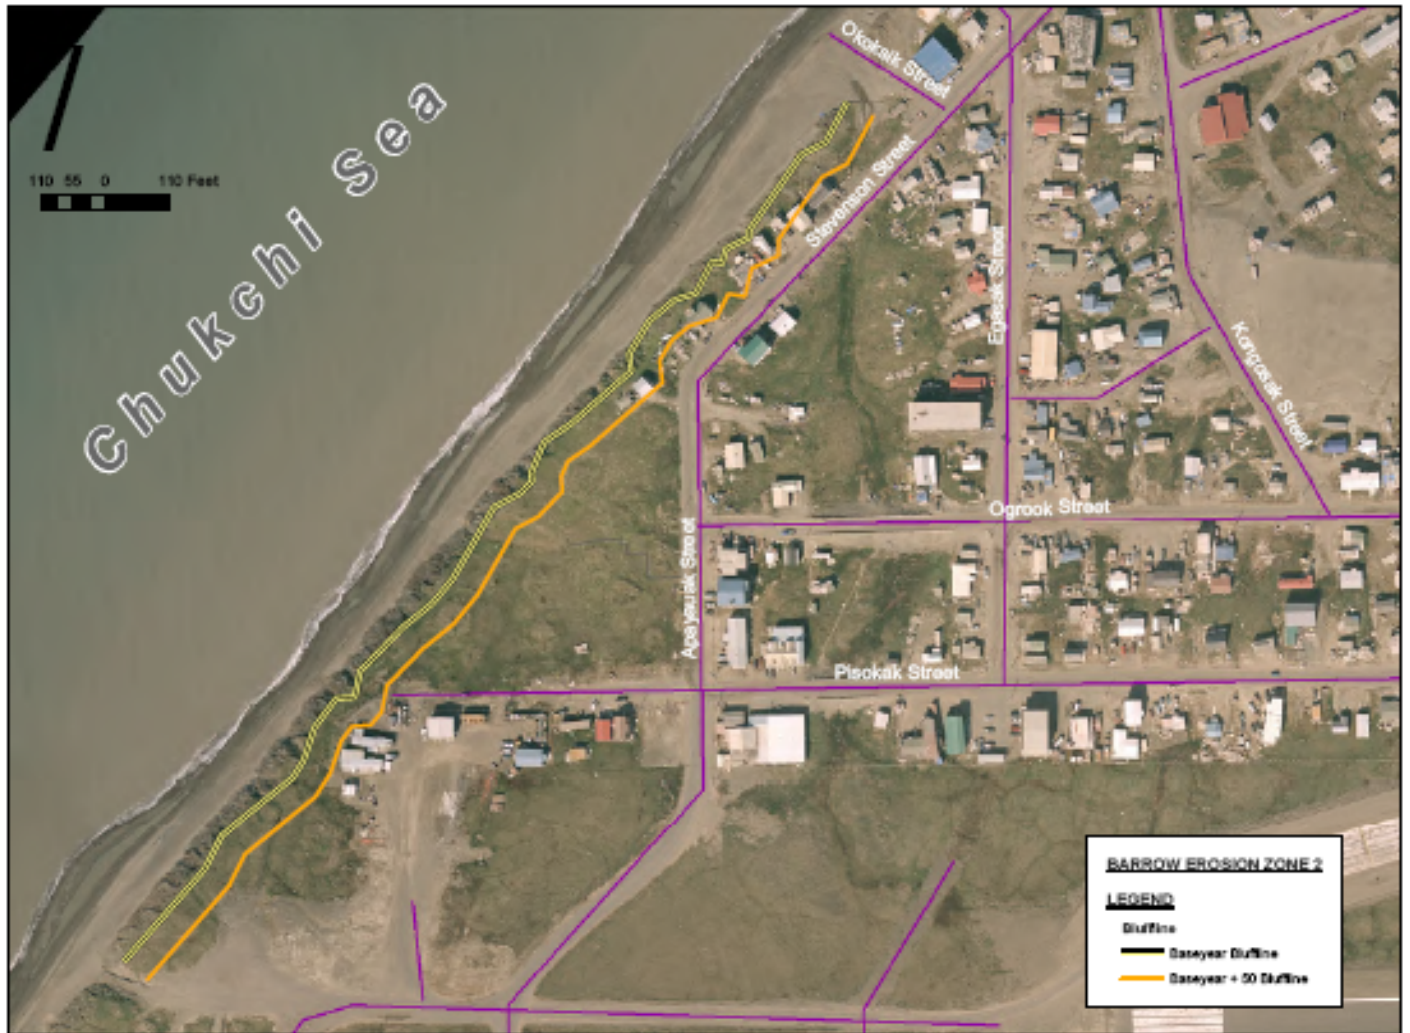
Figure 20. Expected 50-year erosion in the vicinity of Barrow.

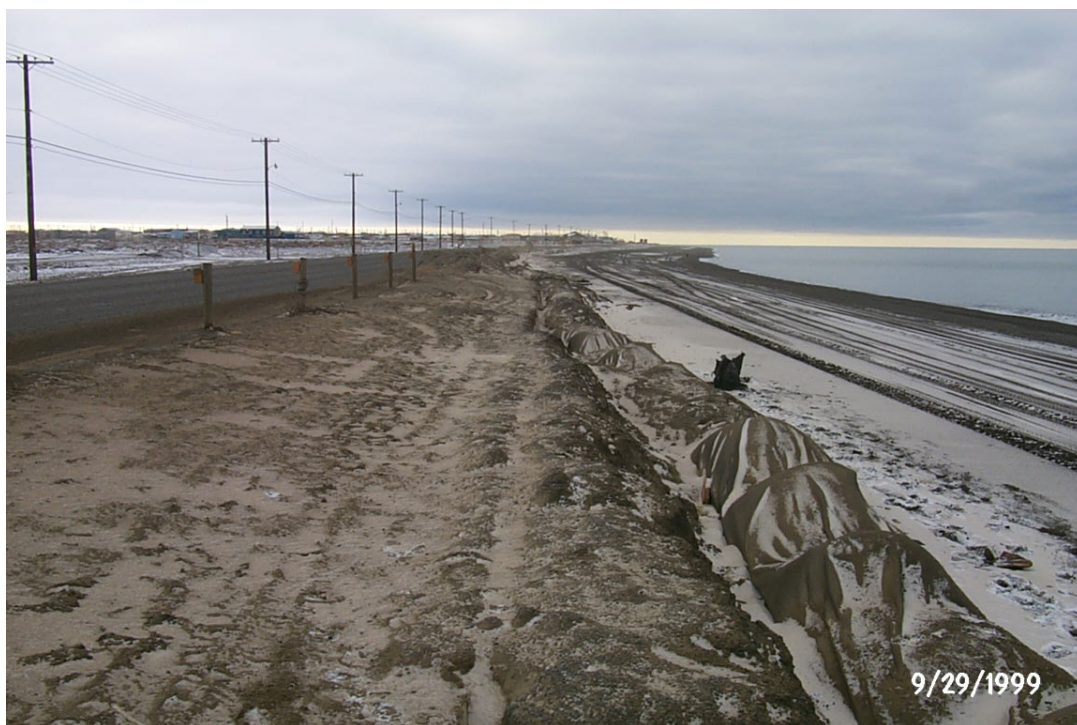
Figure 21. Geotextile tube protection.

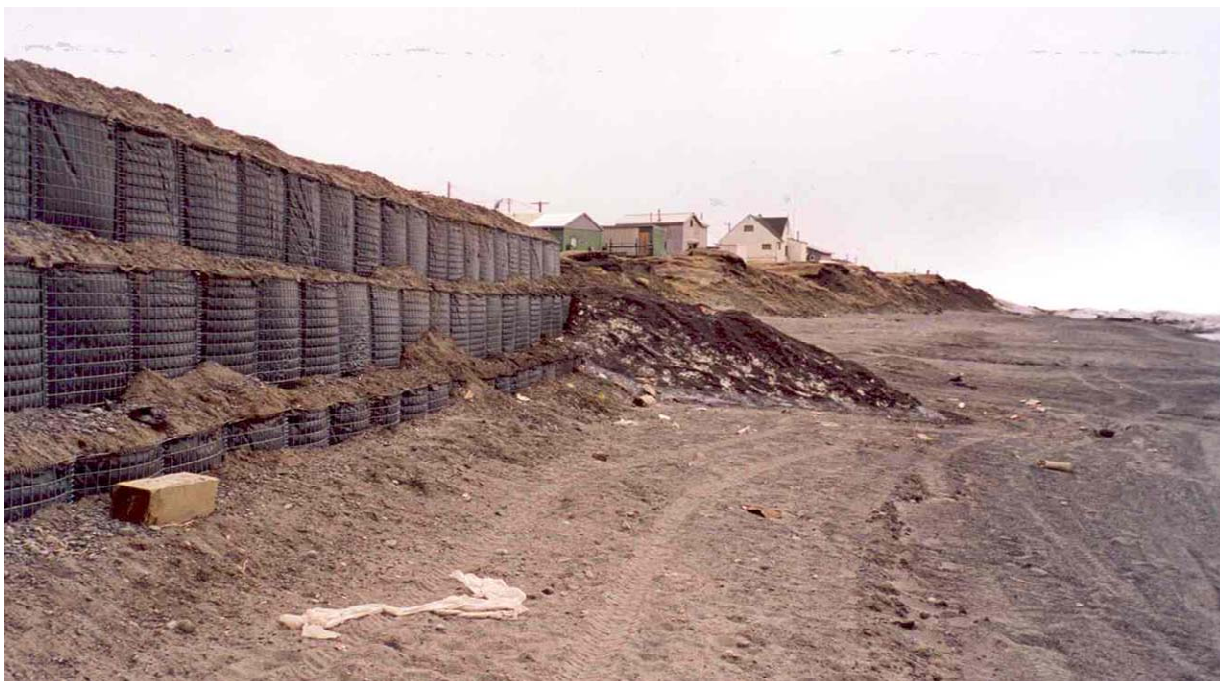
Figure 22. Geotextile fabric encased in a wire basket.

The most current storm damage reduction measure was the installation of a seawall type structure using geotextile fabric encased in a wire basket (figure 22). This was installed in the summer of 2004. To date it has held up well in Barrow, but has failed at three other coastal applications in Alaska. The cause of the system failure at the other locations in the State is not certain, but factors that would increase the system's survivability at Barrow include the fact that the system was not exposed to a storm event during or immediately after construction, which gave it time to saturate with water and freeze during the winter. Once frozen, the system would act more as a solid block rather than loose granular material that could be washed out by wave action. The system at Barrow was also put in place to stem road and bluff erosion so it is set back from the shoreline typically out of the zone of wave impact.

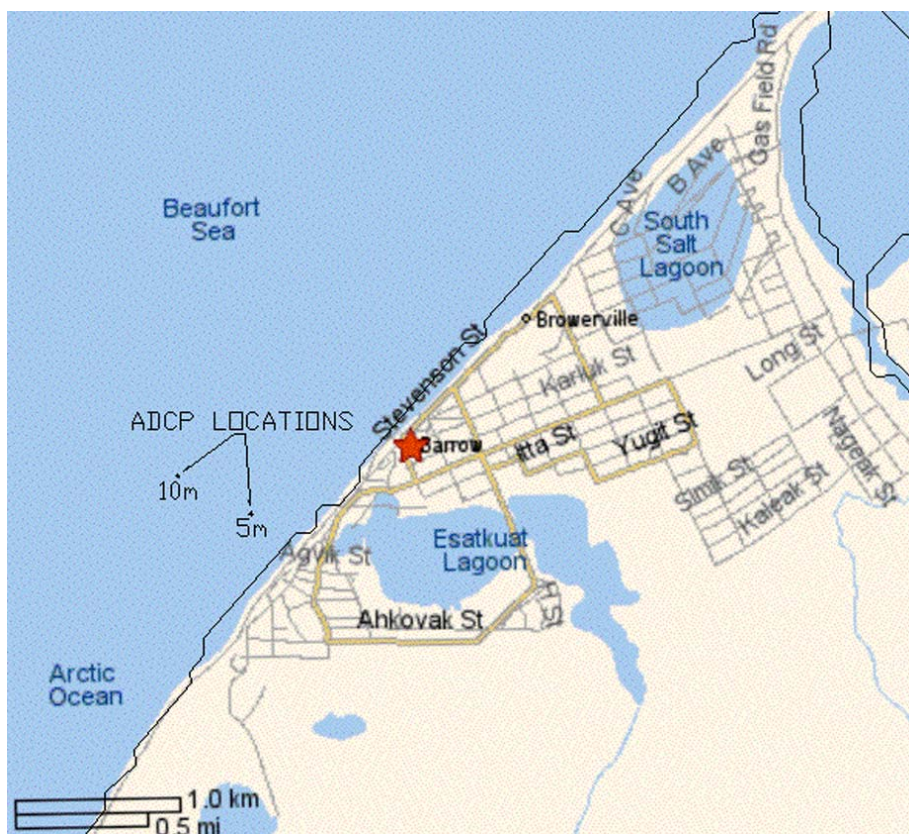
Figure 50. Location of ADCP Instruments

An attempt to collect a second season of data was unsuccessful as one gauge was damaged by an ice keel, and ice formation made the collection of the second gauge impossible at the end of the season. Attempts to retrieve the second gauge the following season were unsuccessful.

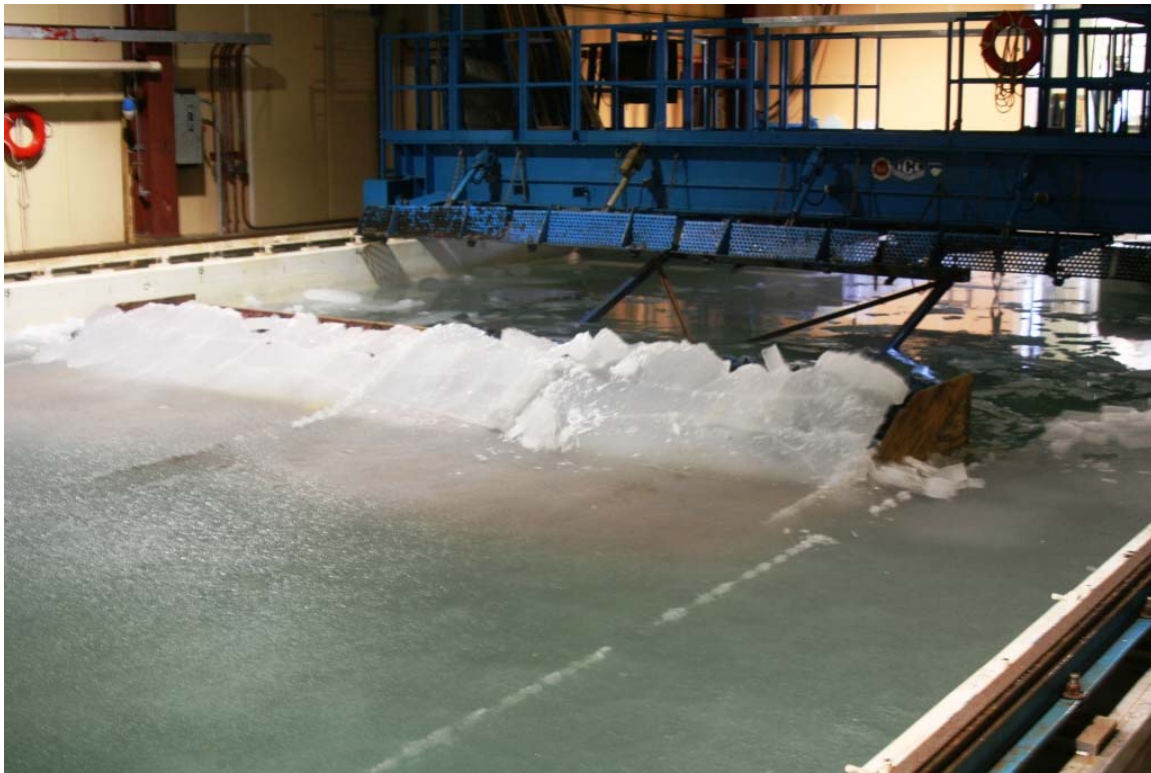
Figure 103. Revetment test section being pushed by carriage.

template extended out from the center of the structure to ensure that each half of the ice sheet was separate before impacting the structure. The stone placement method: random or selective, the size of the stones, and the toe configuration were varied between tests. Selective placement of the stones to interlock and support each other provided a much greater degree of stability during ice shoves than random placement. The size and placement of the stones at the toe of the revetment was also found to be important in the survivability of the revetment.

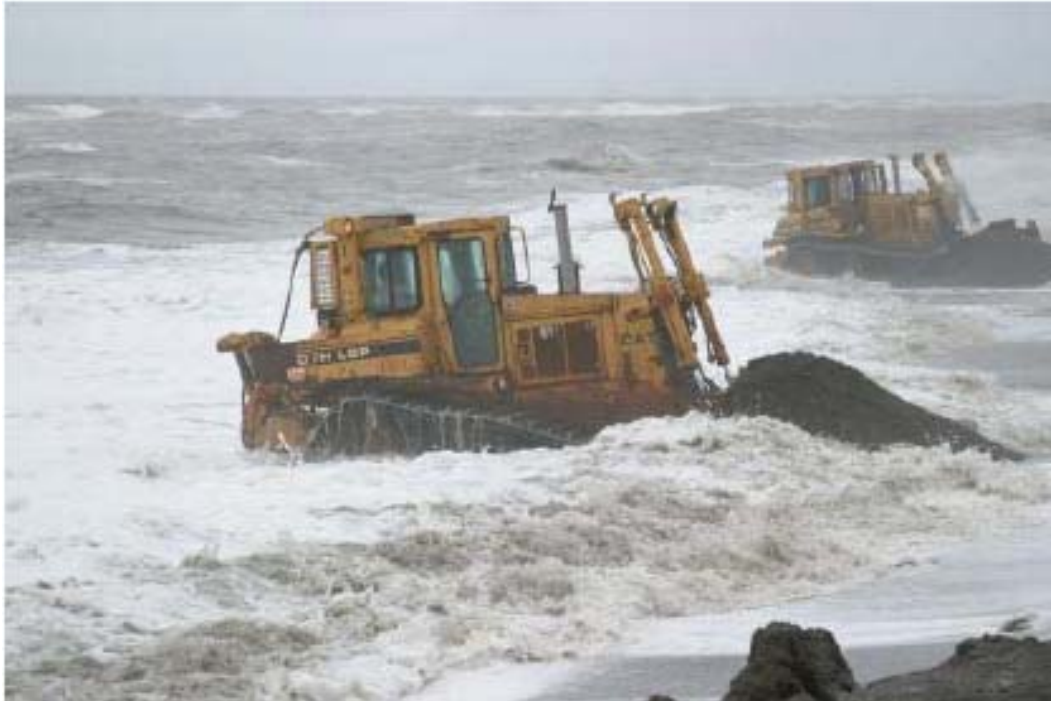
Figure 8: Dozers Rebuilding Beach Berm during Storm

The storms that hit the community generally range in length from 3-5 days. When the storms are larger, the berms do not last very long, often gone after 8-10 large waves. When the berms are reinforced and/or rebuilt during storm conditions, D7/D8 dozers are operated in the salt water (figure 8). The NSB has stated that although the berms provide limited flooding and erosion protection during larger storms, they would continue doing what they could to keep the berms in place, even if that means continued operation of the dozers in the water. When the dozers are operated this way additional maintenance is required to keep this equipment in order. Due to the corrosive nature of the salt the electrical systems are the hardest to keep in working order. The dozers must routinely be steam cleaned to keep salt off, while the electrical connections are shrink-wrapped to prevent salt from entering the connections.

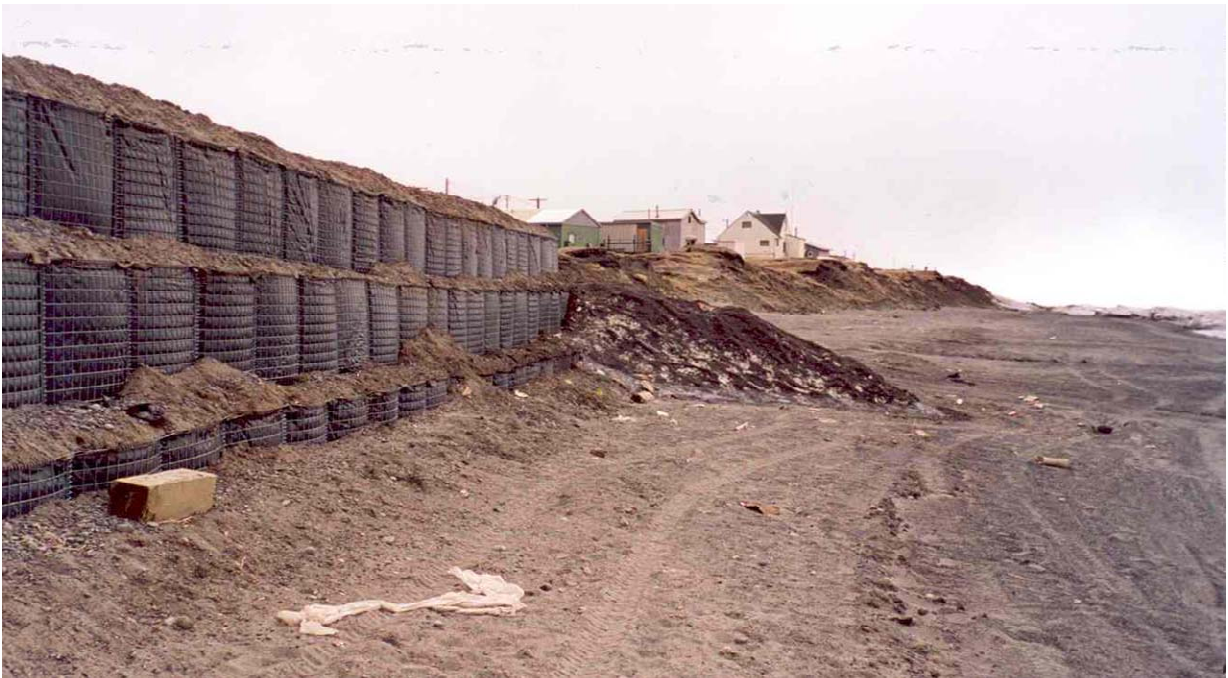
Figure 11. HESCO Concertainers near Okoksik Street.

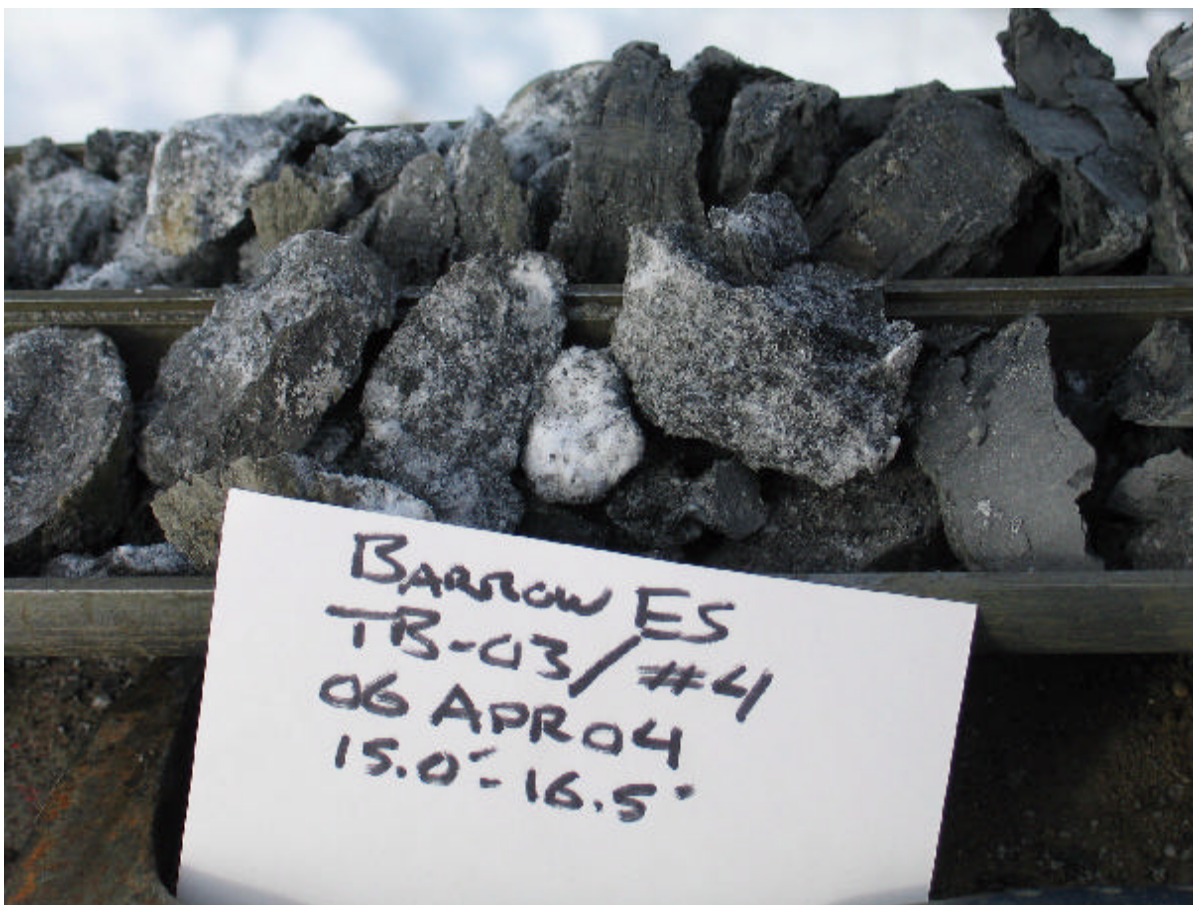
Photo 7. Example of the silt with high ice content encountered at the BIA Prospect.

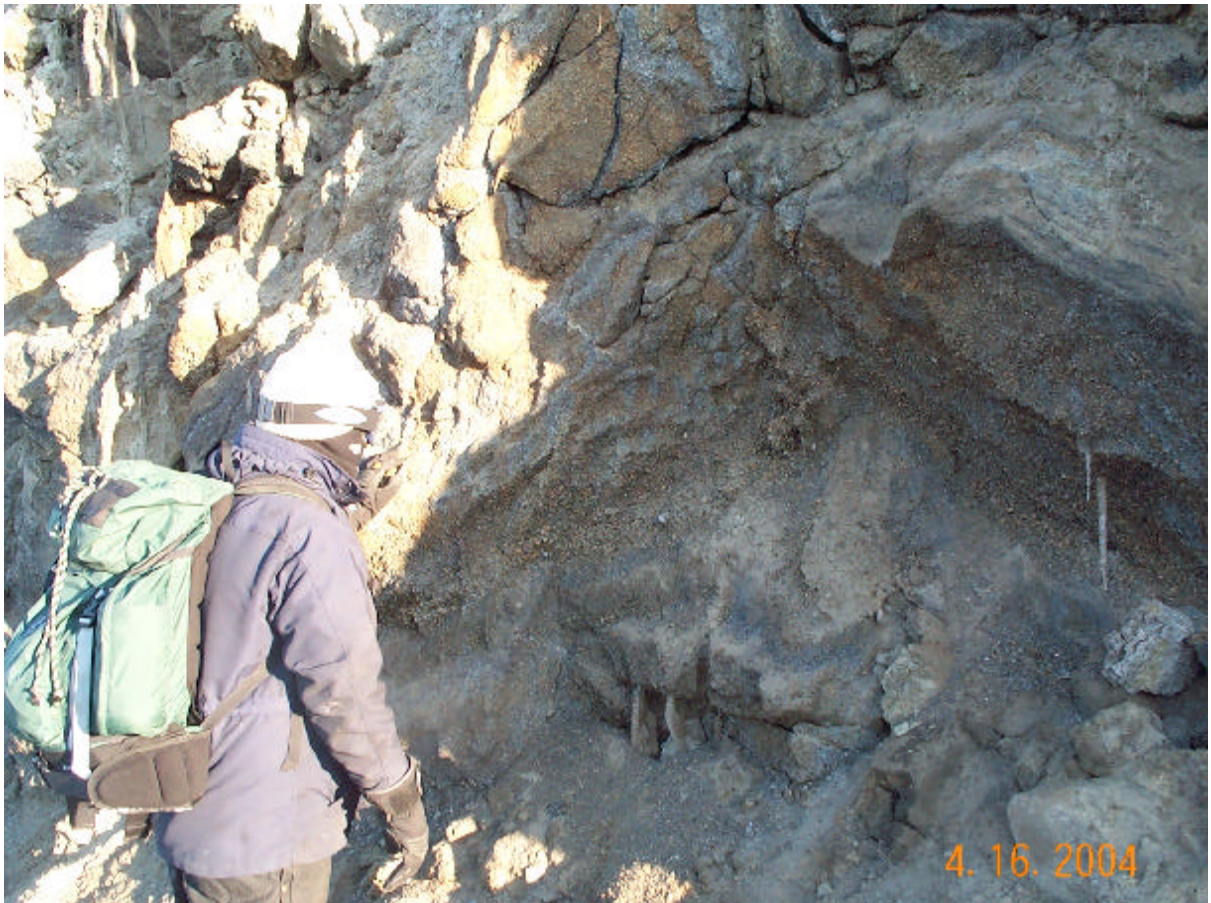
Photo 8. Typical "gravel" deposit in sidewall of existing borrow area.

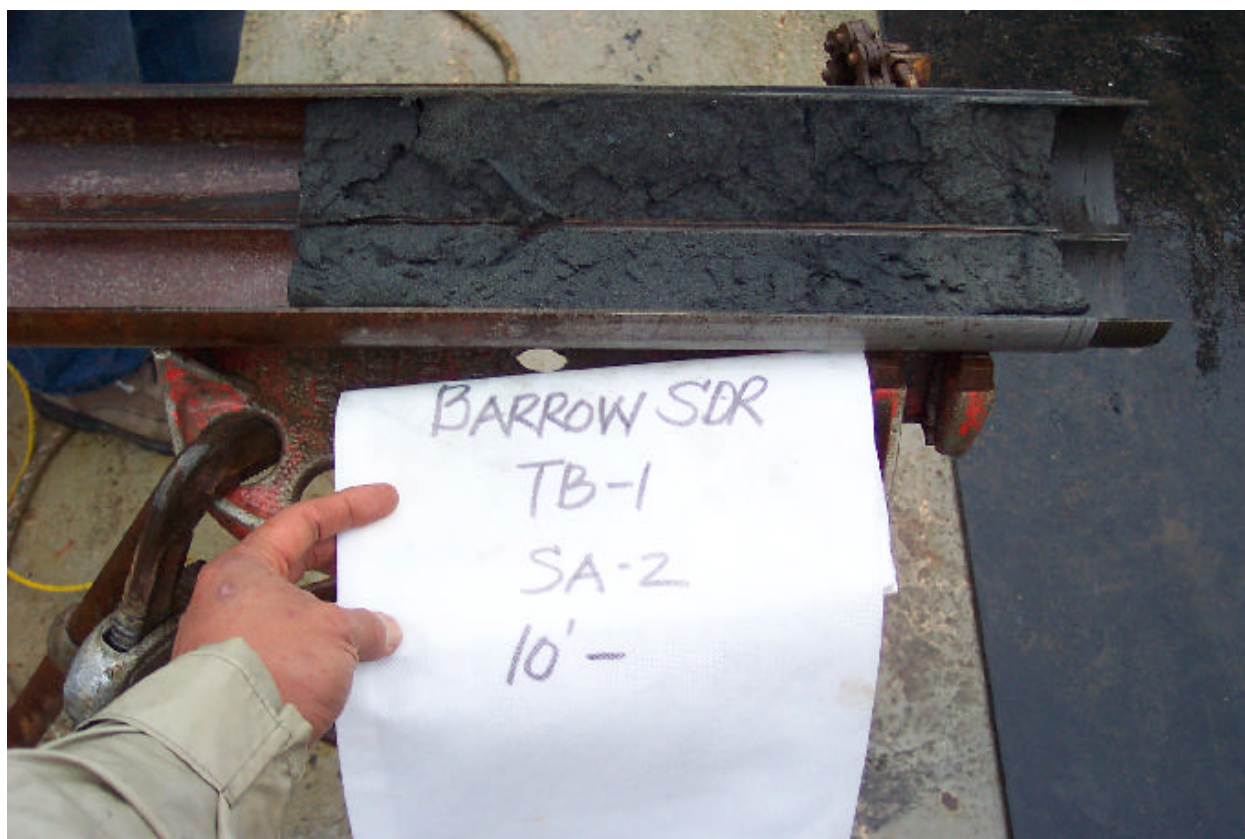
Photo 10. Typical sand encountered during the drilling operation.
