Planning Assistance to
States Technical Report

Site Conditions in the Vicinity of Cape Blossom Kotzebue, Alaska

September 2021

U.S. Army Corps of Engineers
Alaska District

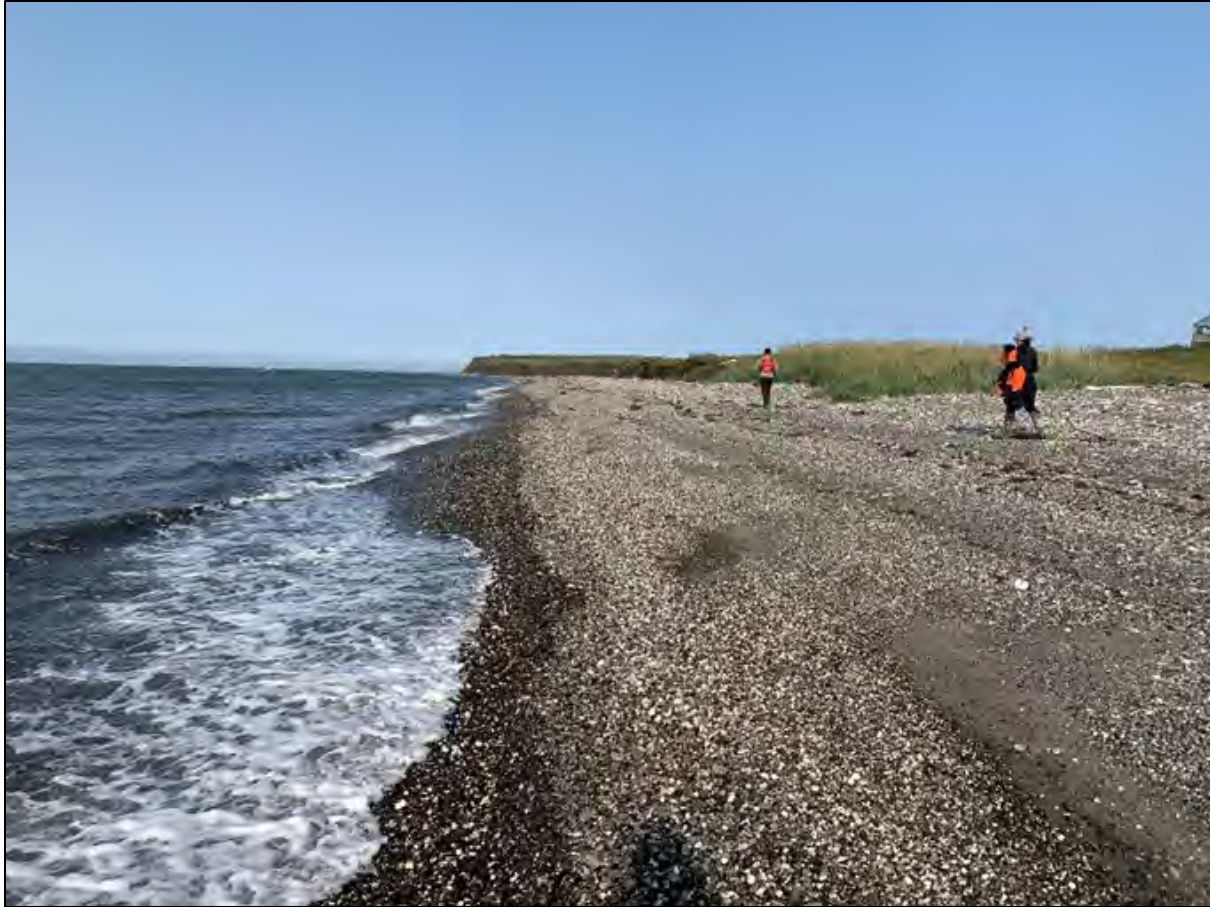
Figure 30. Looking west toward Cape Blossom along beach of ECA1

Site observations indicate that coastal erosion of the shoreline bluff and uplands is less active in this section as indicated by the erosion rates discussed above in Section 3.1. An example of the beach and bluff is shown in Figure 30. The bluffs were approximately 10'-20' feet in height along the coast of this area. Standing water existed in the uplands while polygonal topography was visible there was less indication of thawing ice wedges and polygons than when compared to the Original Study Area. Surficial soils were wet and poorly drained with standing water throughout the uplands.

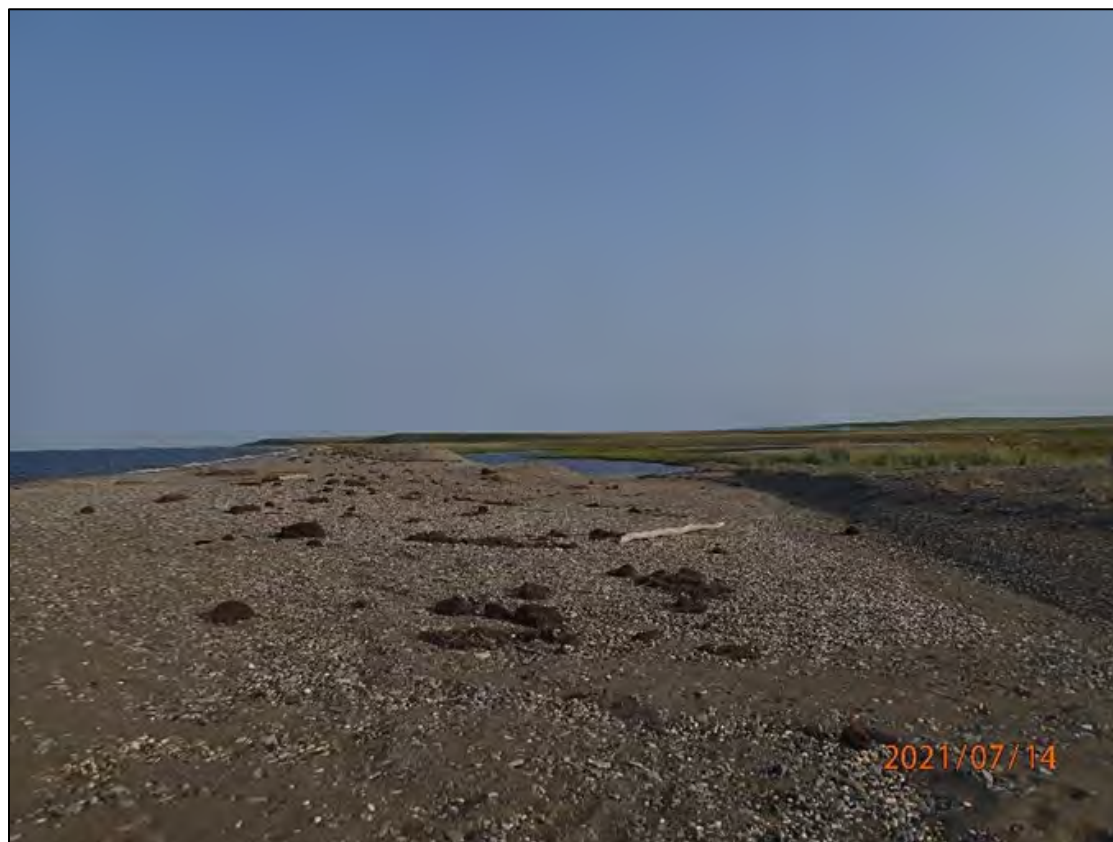
Figure 33. Looking North West along the coastline from ECA2

This area is the most eastern location in study area (Figure 29). Little to no shoreline bluff was observed in this coastal reach area. The erosion analysis presented in Section 3.1 above indicated there was no noticeable erosion in this area, and the team observed no visible signs of active erosion caused by direct wave action or thawing permafrost along the beach. There were even signs of accumulation of coastal sediments (accretion) in this coastal reach area. Slopes transitioning from the beach inland were currently maintaining established vegetation and they ranged from 14 to 26 degrees from horizontal, indicating they are stable in their current configuration. Areas with elevations higher than the adjacent lagoon were well drained and there was very little indication observed from the surficial deposits indicating large ice wedges and ice rich soils were present at the site.

Road construction to this location may be difficult and expensive due to the additional distance compared the other sites closer to the original study area. A nearby lagoon as seen in Figure 33 may represent high sedimentation rates at the shoreline which could present difficulties with sedimentation within a potential harbor. Maintenance dredging may be required routinely to deal with this issue.

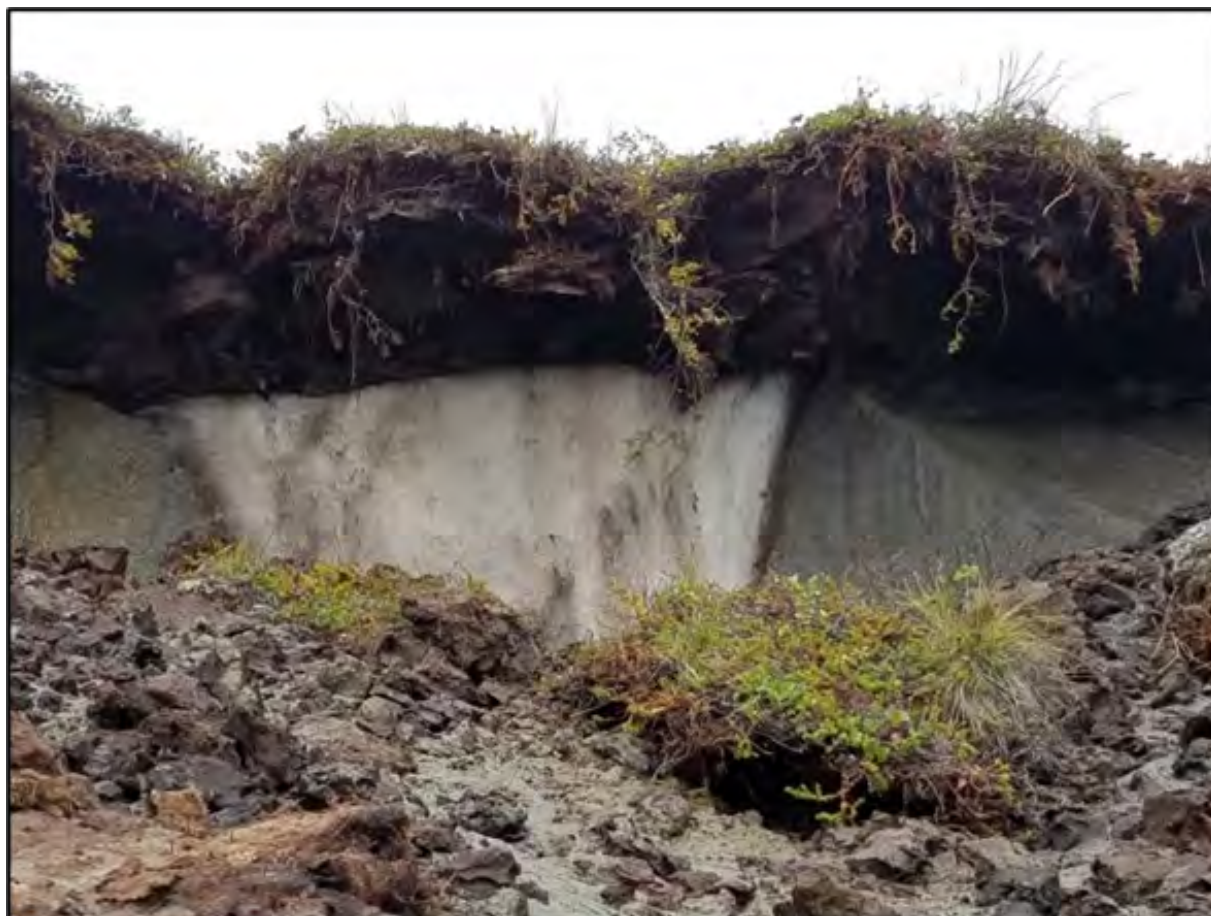
Figure 34. Exposed Ice Lens in bluff face near Cape Blossom

Kotzebue and the rest of the Baldwin Peninsula are in a continuous permafrost zone. The permafrost is typically ice rich as evidenced from aerial photography showing several lakes scattered throughout the Northern Baldwin Peninsula. These lakes could have resulted from the melted ice lenses. The eroding banks of the coastal reaches EC, ED and EE show several exposed ice lenses observed by the field crew that inspected the site in 2016. An example of an exposed ice lens in the eroding bluffs near Cape Blossom is shown in Figure 34.

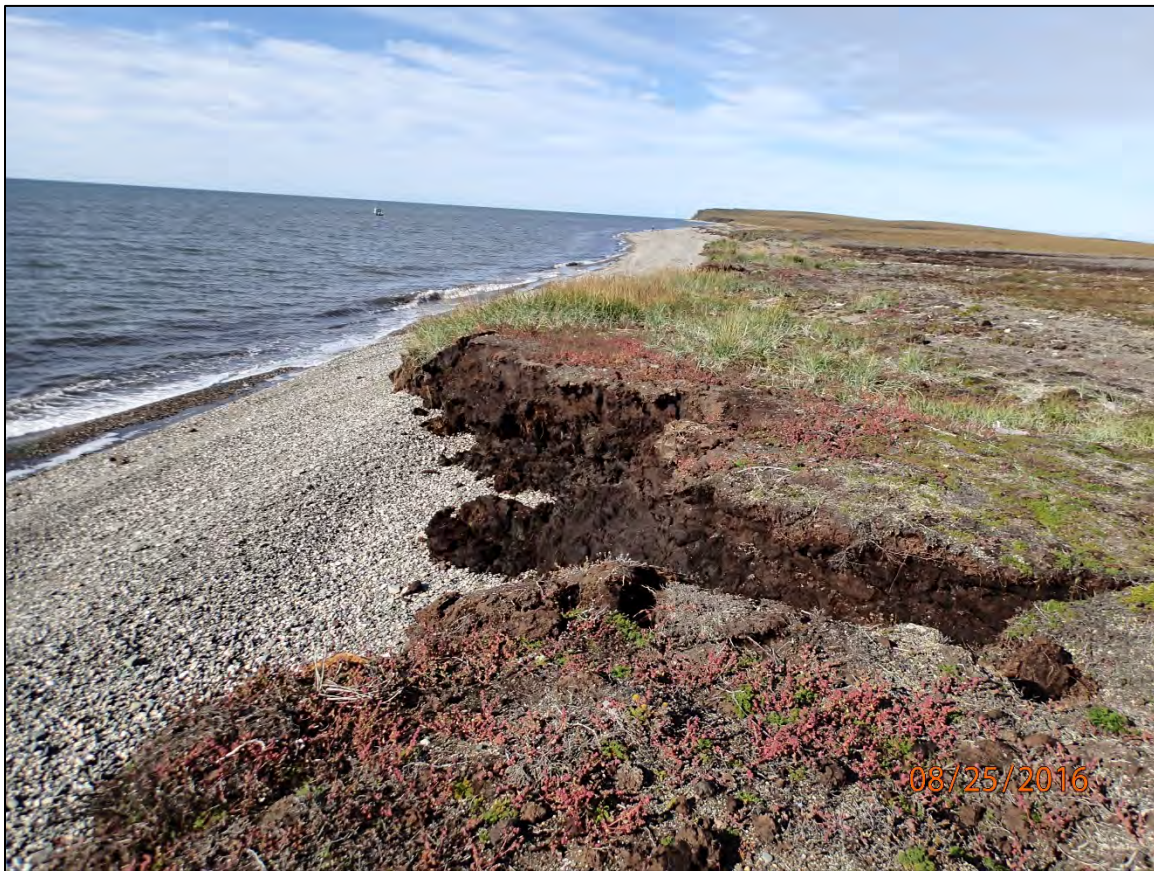
Figure 31. Beach and organic mat in the area of the proposed navigation improvement.

The beach east of Cape Blossom is primarily composed of sand and gravel. Behind the beach is a thick organic mat with exposed melting permafrost (Figure 31 and Figure 32).
