ENVIRONMENTAL ASSESSMENT

Tanana River Recreation Access Improvements Project

AK FNSB TANANA(1) Tanana River Recreation Access Improvements
June 2021

Prepared by
U.S. Department of Transportation
Federal Highway Administration
Western Federal Lands Highway Division

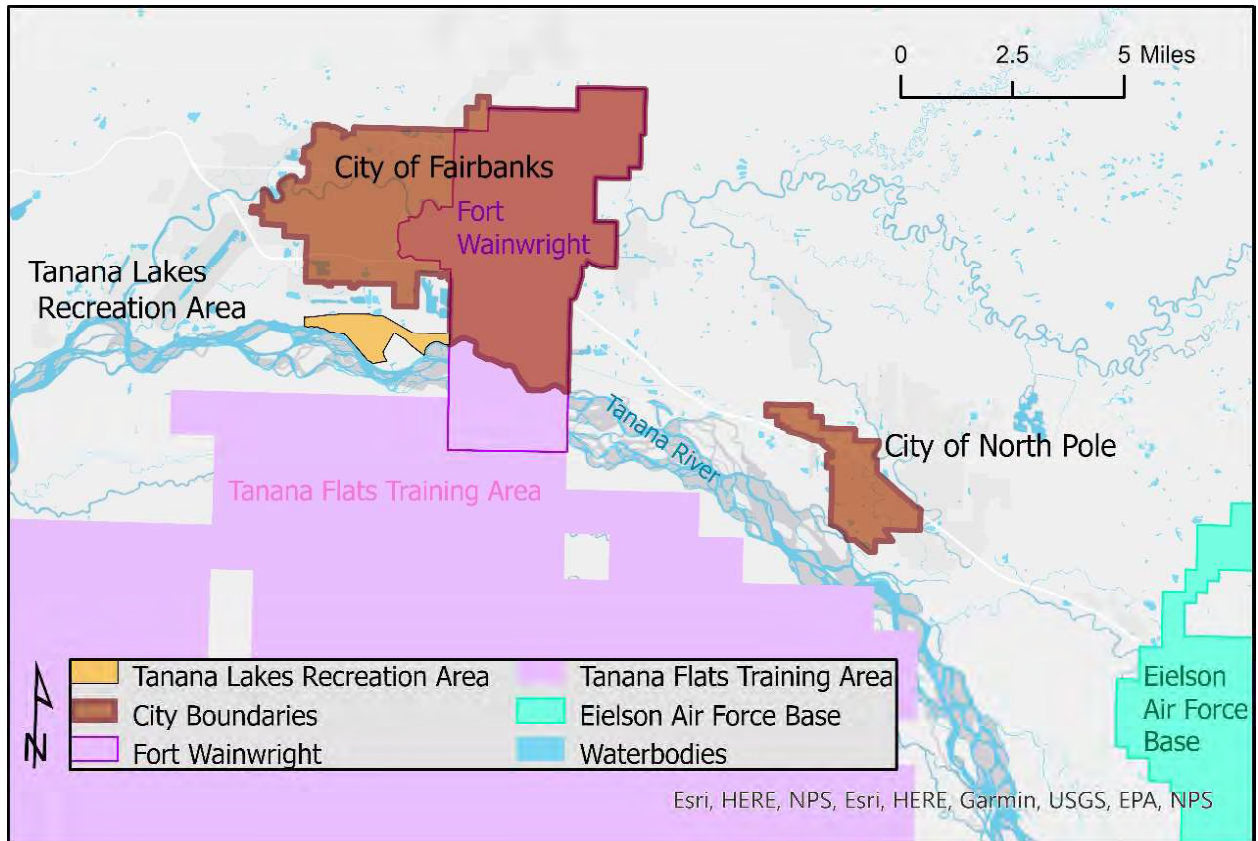
Figure ES-1 – Overview of TRRA Improvements Project region and federal lands

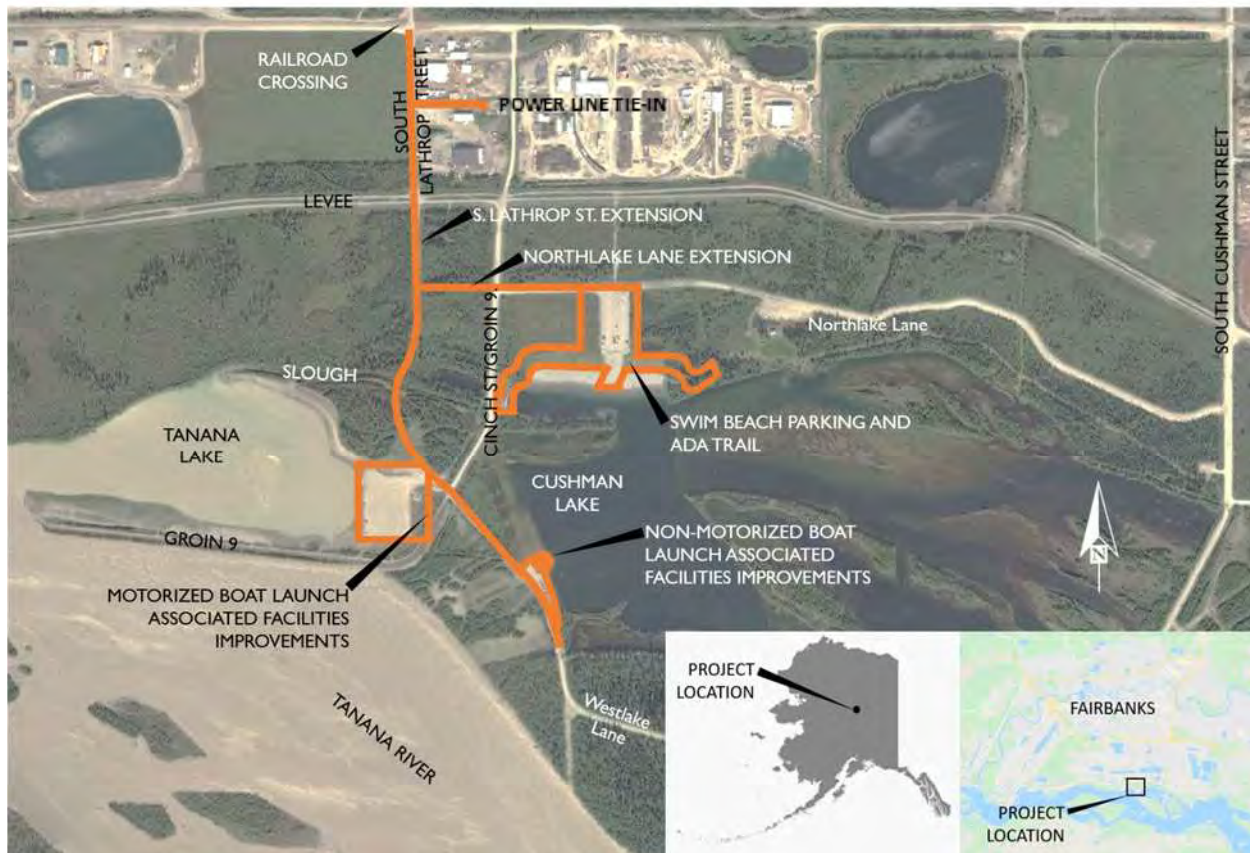
Figure 1-1 – Overview of the TRRA Improvements Project region

The TLRA is located on the south (river) side of the Tanana Flood Control Levee (TFCL) in south Fairbanks (Figure 1-1). The recreation area has been established around Cushman Lake, which was formed by the impounded waters of an active slough of the Tanana River. The Goose Island Causeway (a groin extension of South Cushman Street (St.)) and Groin 9 (an extension of Cinch St.) were constructed to create the freshwater Cushman Lake, which is suitable for recreation activities and habitat conservation. Groin 9 also protects the motorized boat launch area. The area was cleaned up and developed after 2012 to include a swimming beach on Cushman Lake, hiking trails, the motorized boat launch that connects with the active channel of the Tanana River, and the non-motorized boat launch on the shore of Cushman Lake (FNSB 2007). Much of the area to the south of the TLRA and outside of the City of Fairbanks and other cities remains intact habitat.

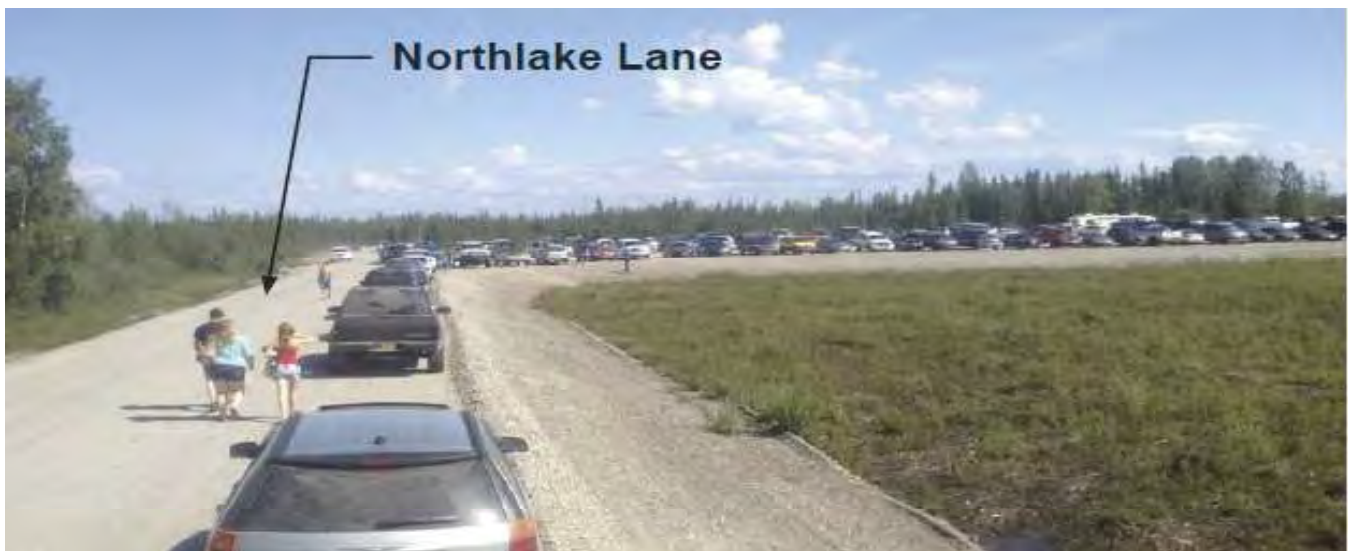
Figure 3-1 – Overflow parking on Northlake Lane looking east toward Swim Beach Parking Area (2019 AFLAP)

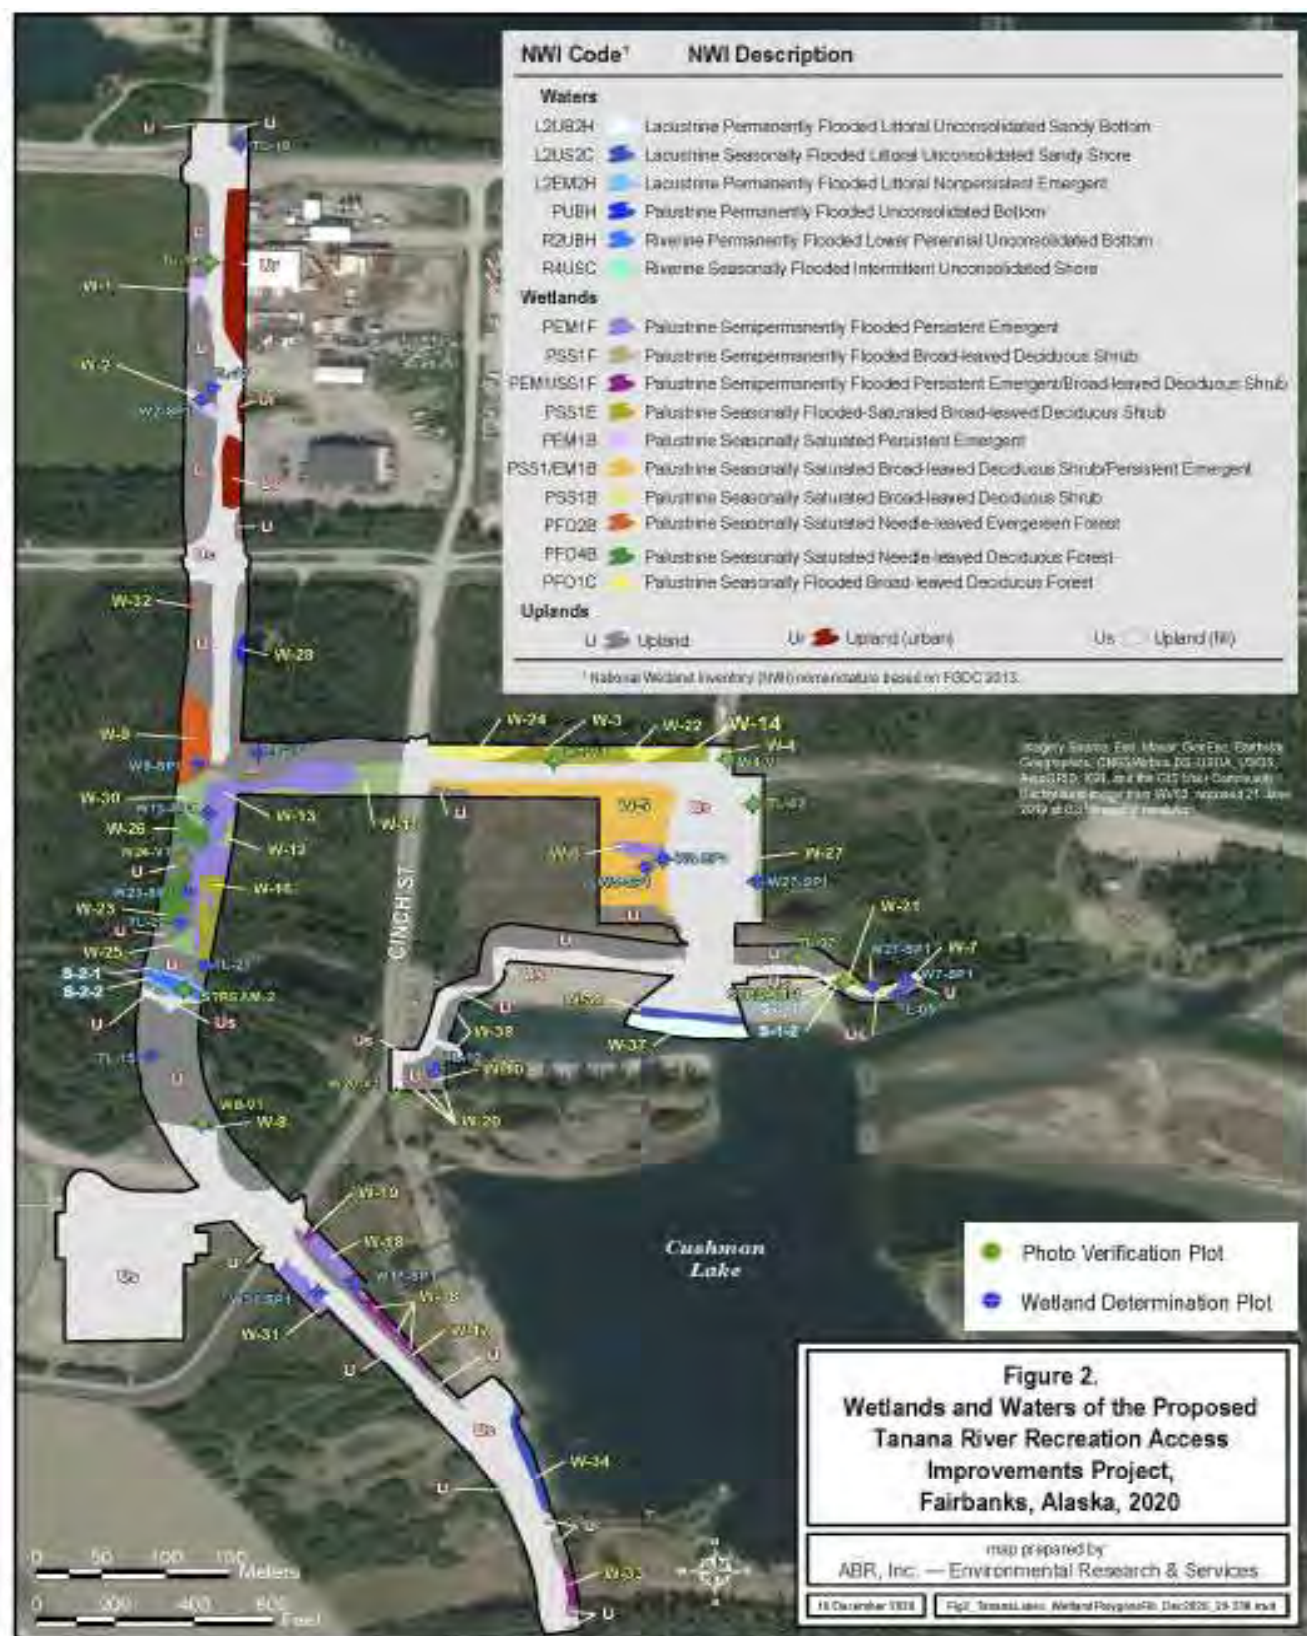
Figure 3-3 – Wetlands and Waters in the study area of the TRRA Improvements Project (ABR 2020a)

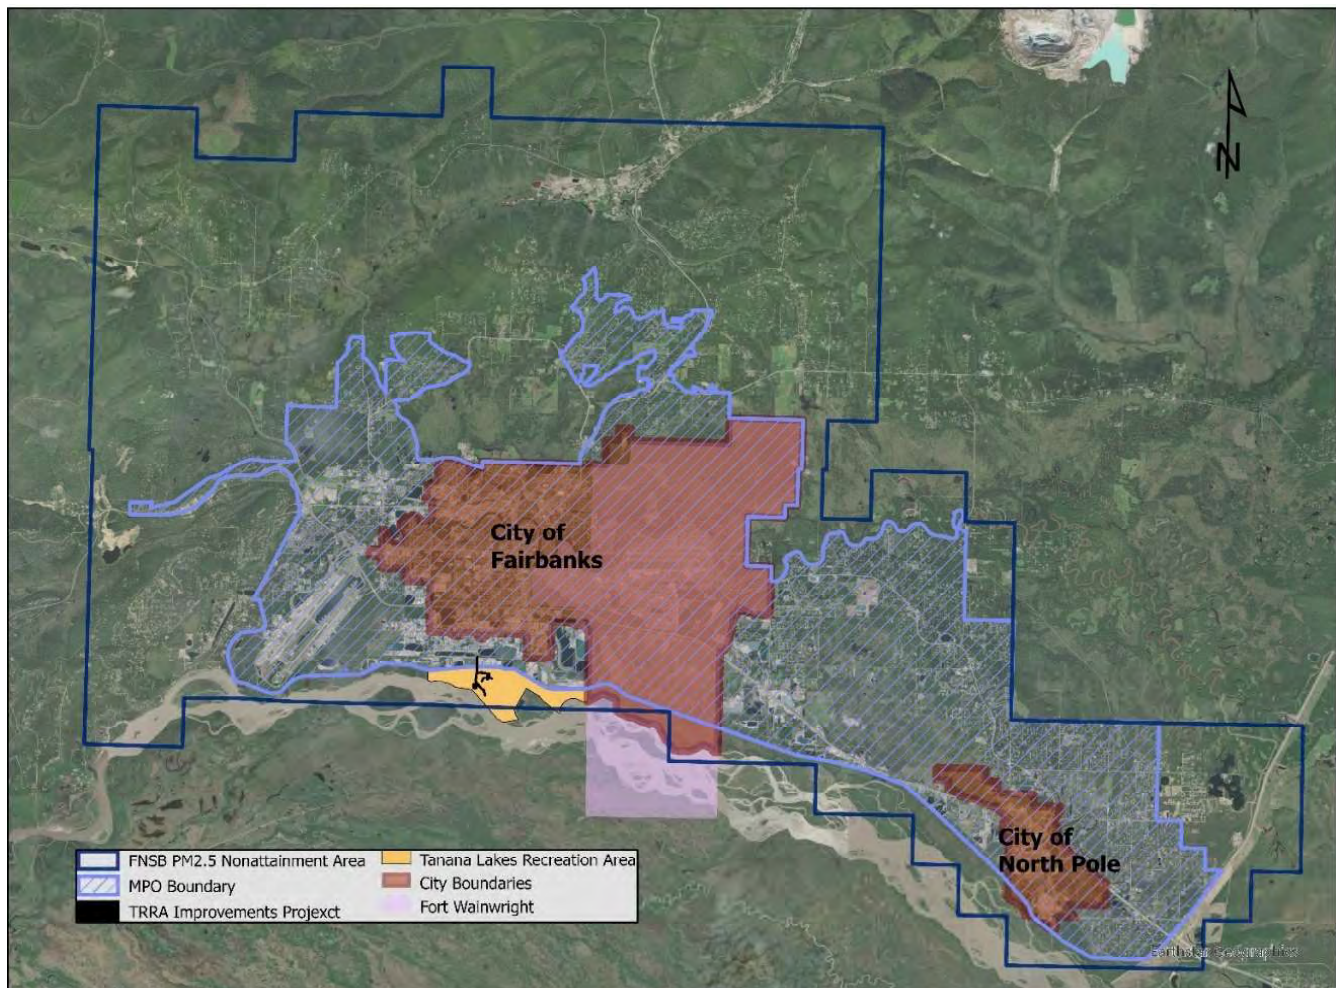
Figure 3-4 – The figure shows the boundaries of the MPO, PM2.5 Nonattainment Area, and project location.

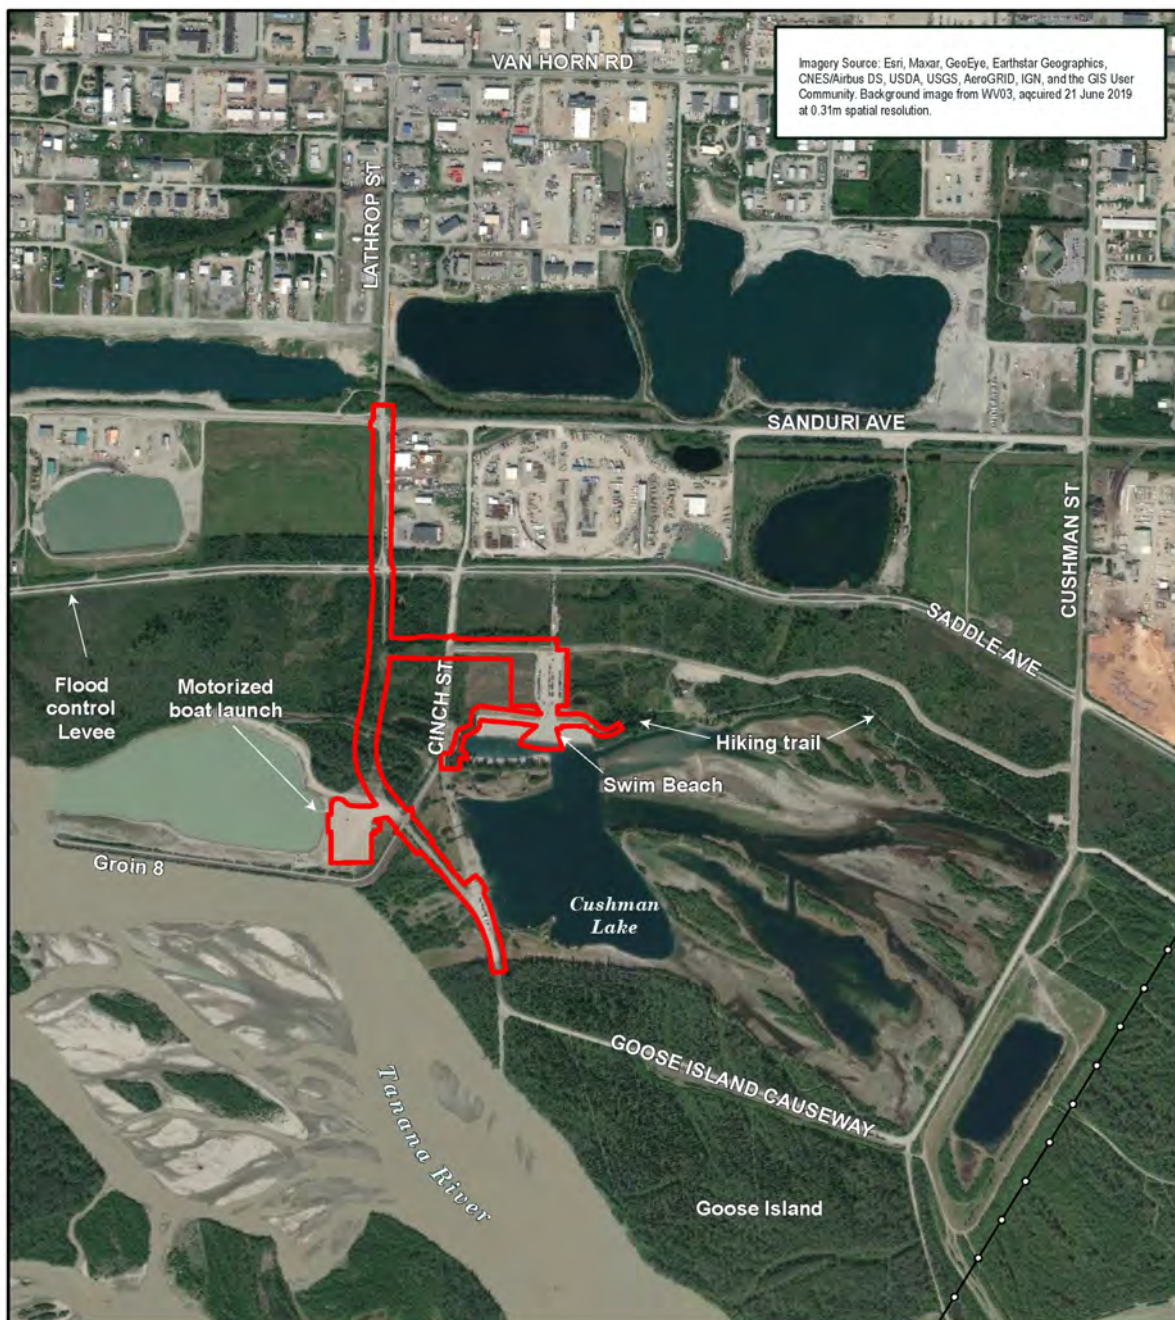
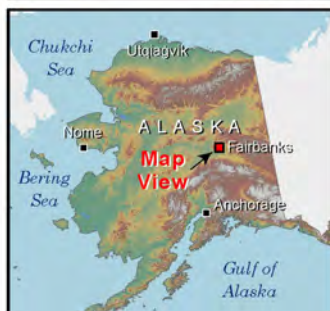
Figure 1.
Wetland Mapping Study Area for the
Proposed Tanana River Recreation
Access Improvements Project,
Fairbanks, Alaska, 2020

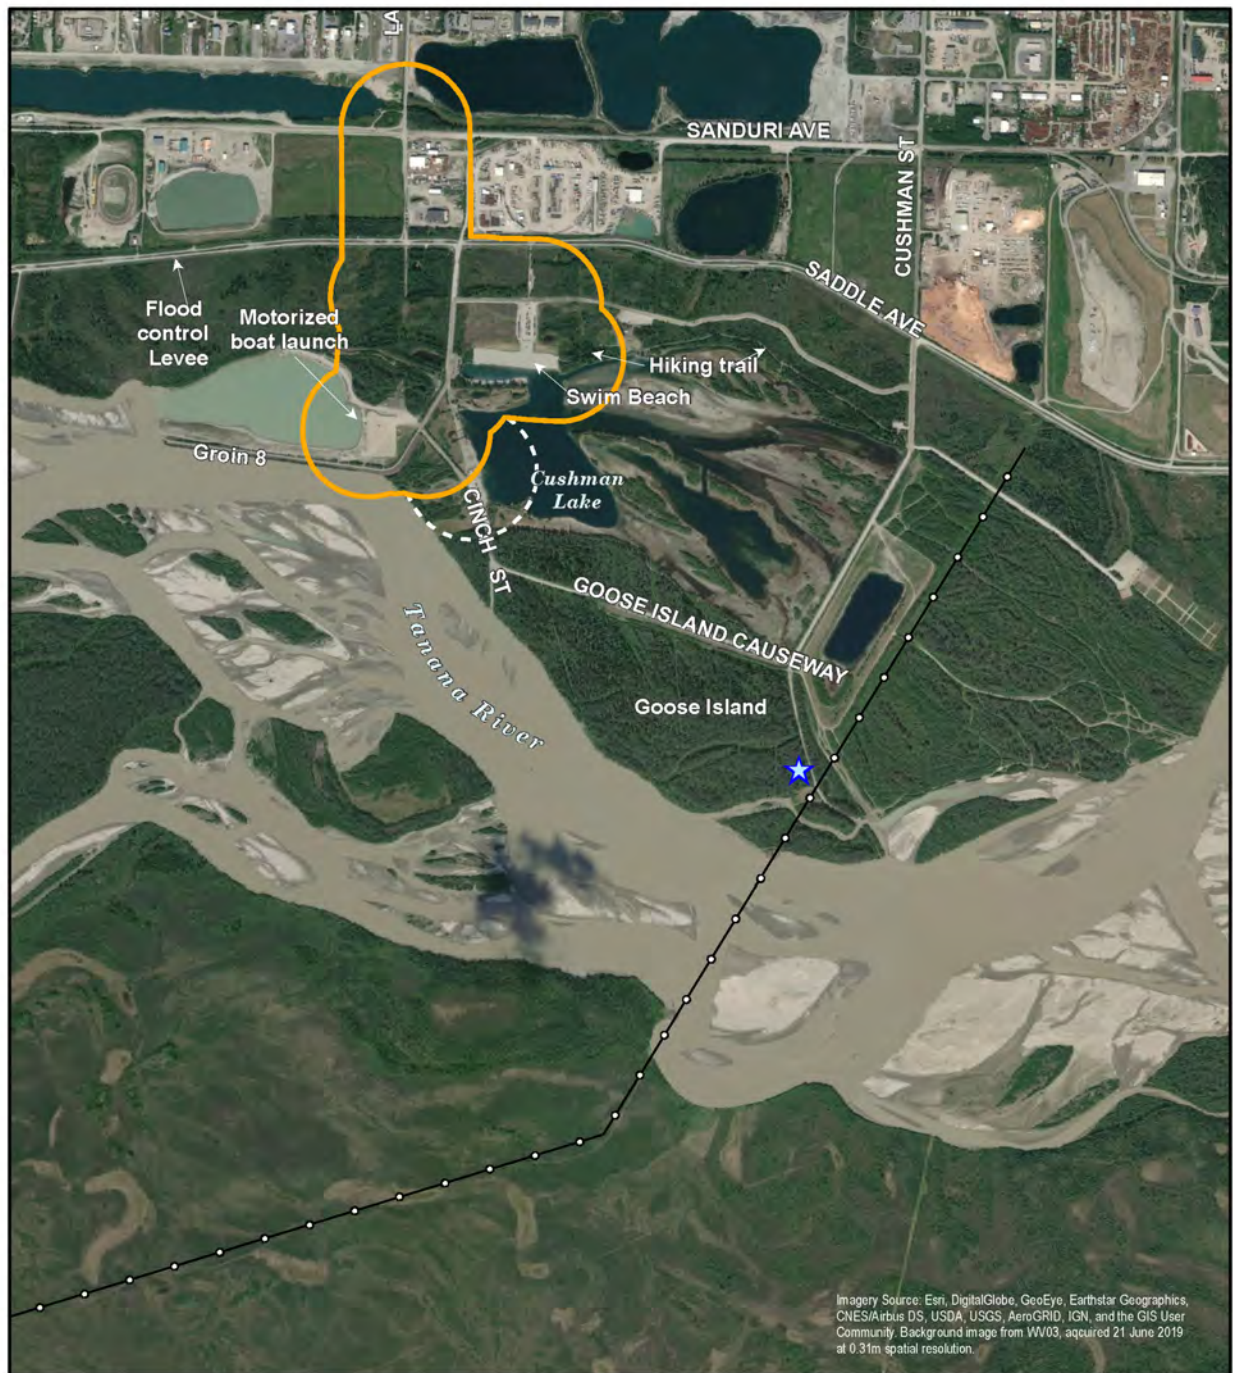
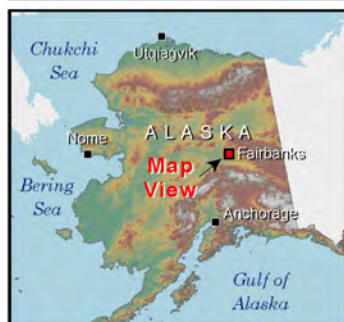
Figure 3.
Eagle Nests in the
Proposed Improvement Areas,
Tanana Lakes Recreation Area.

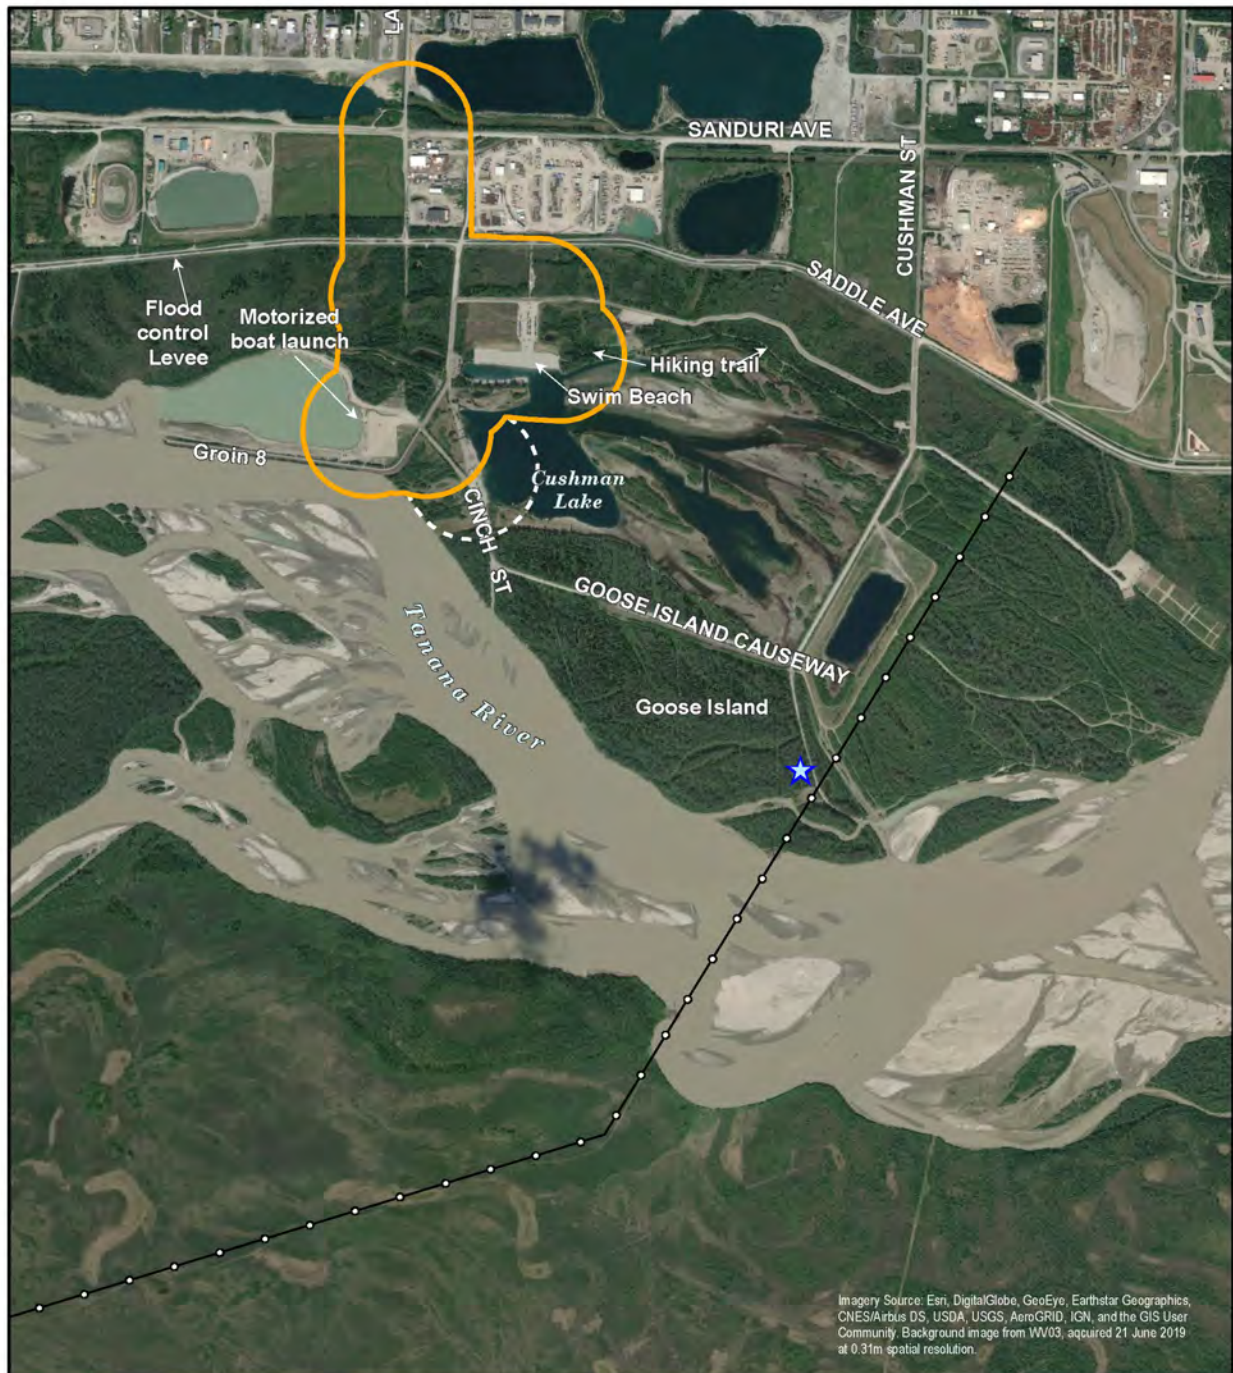
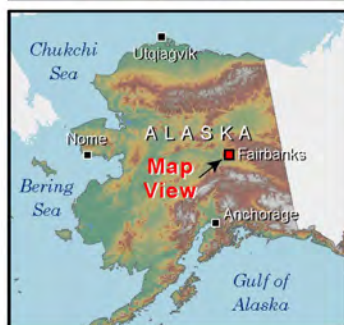
Figure 3.
Eagle Nests in the Vicinity of the
Proposed Tanana River Recreation
Access Improvements Project.
