## **ALASKA BASELINE EROSION ASSESSMENT**

### **Erosion Information Paper - Akiachak, Alaska**

Current as of April 9, 2008

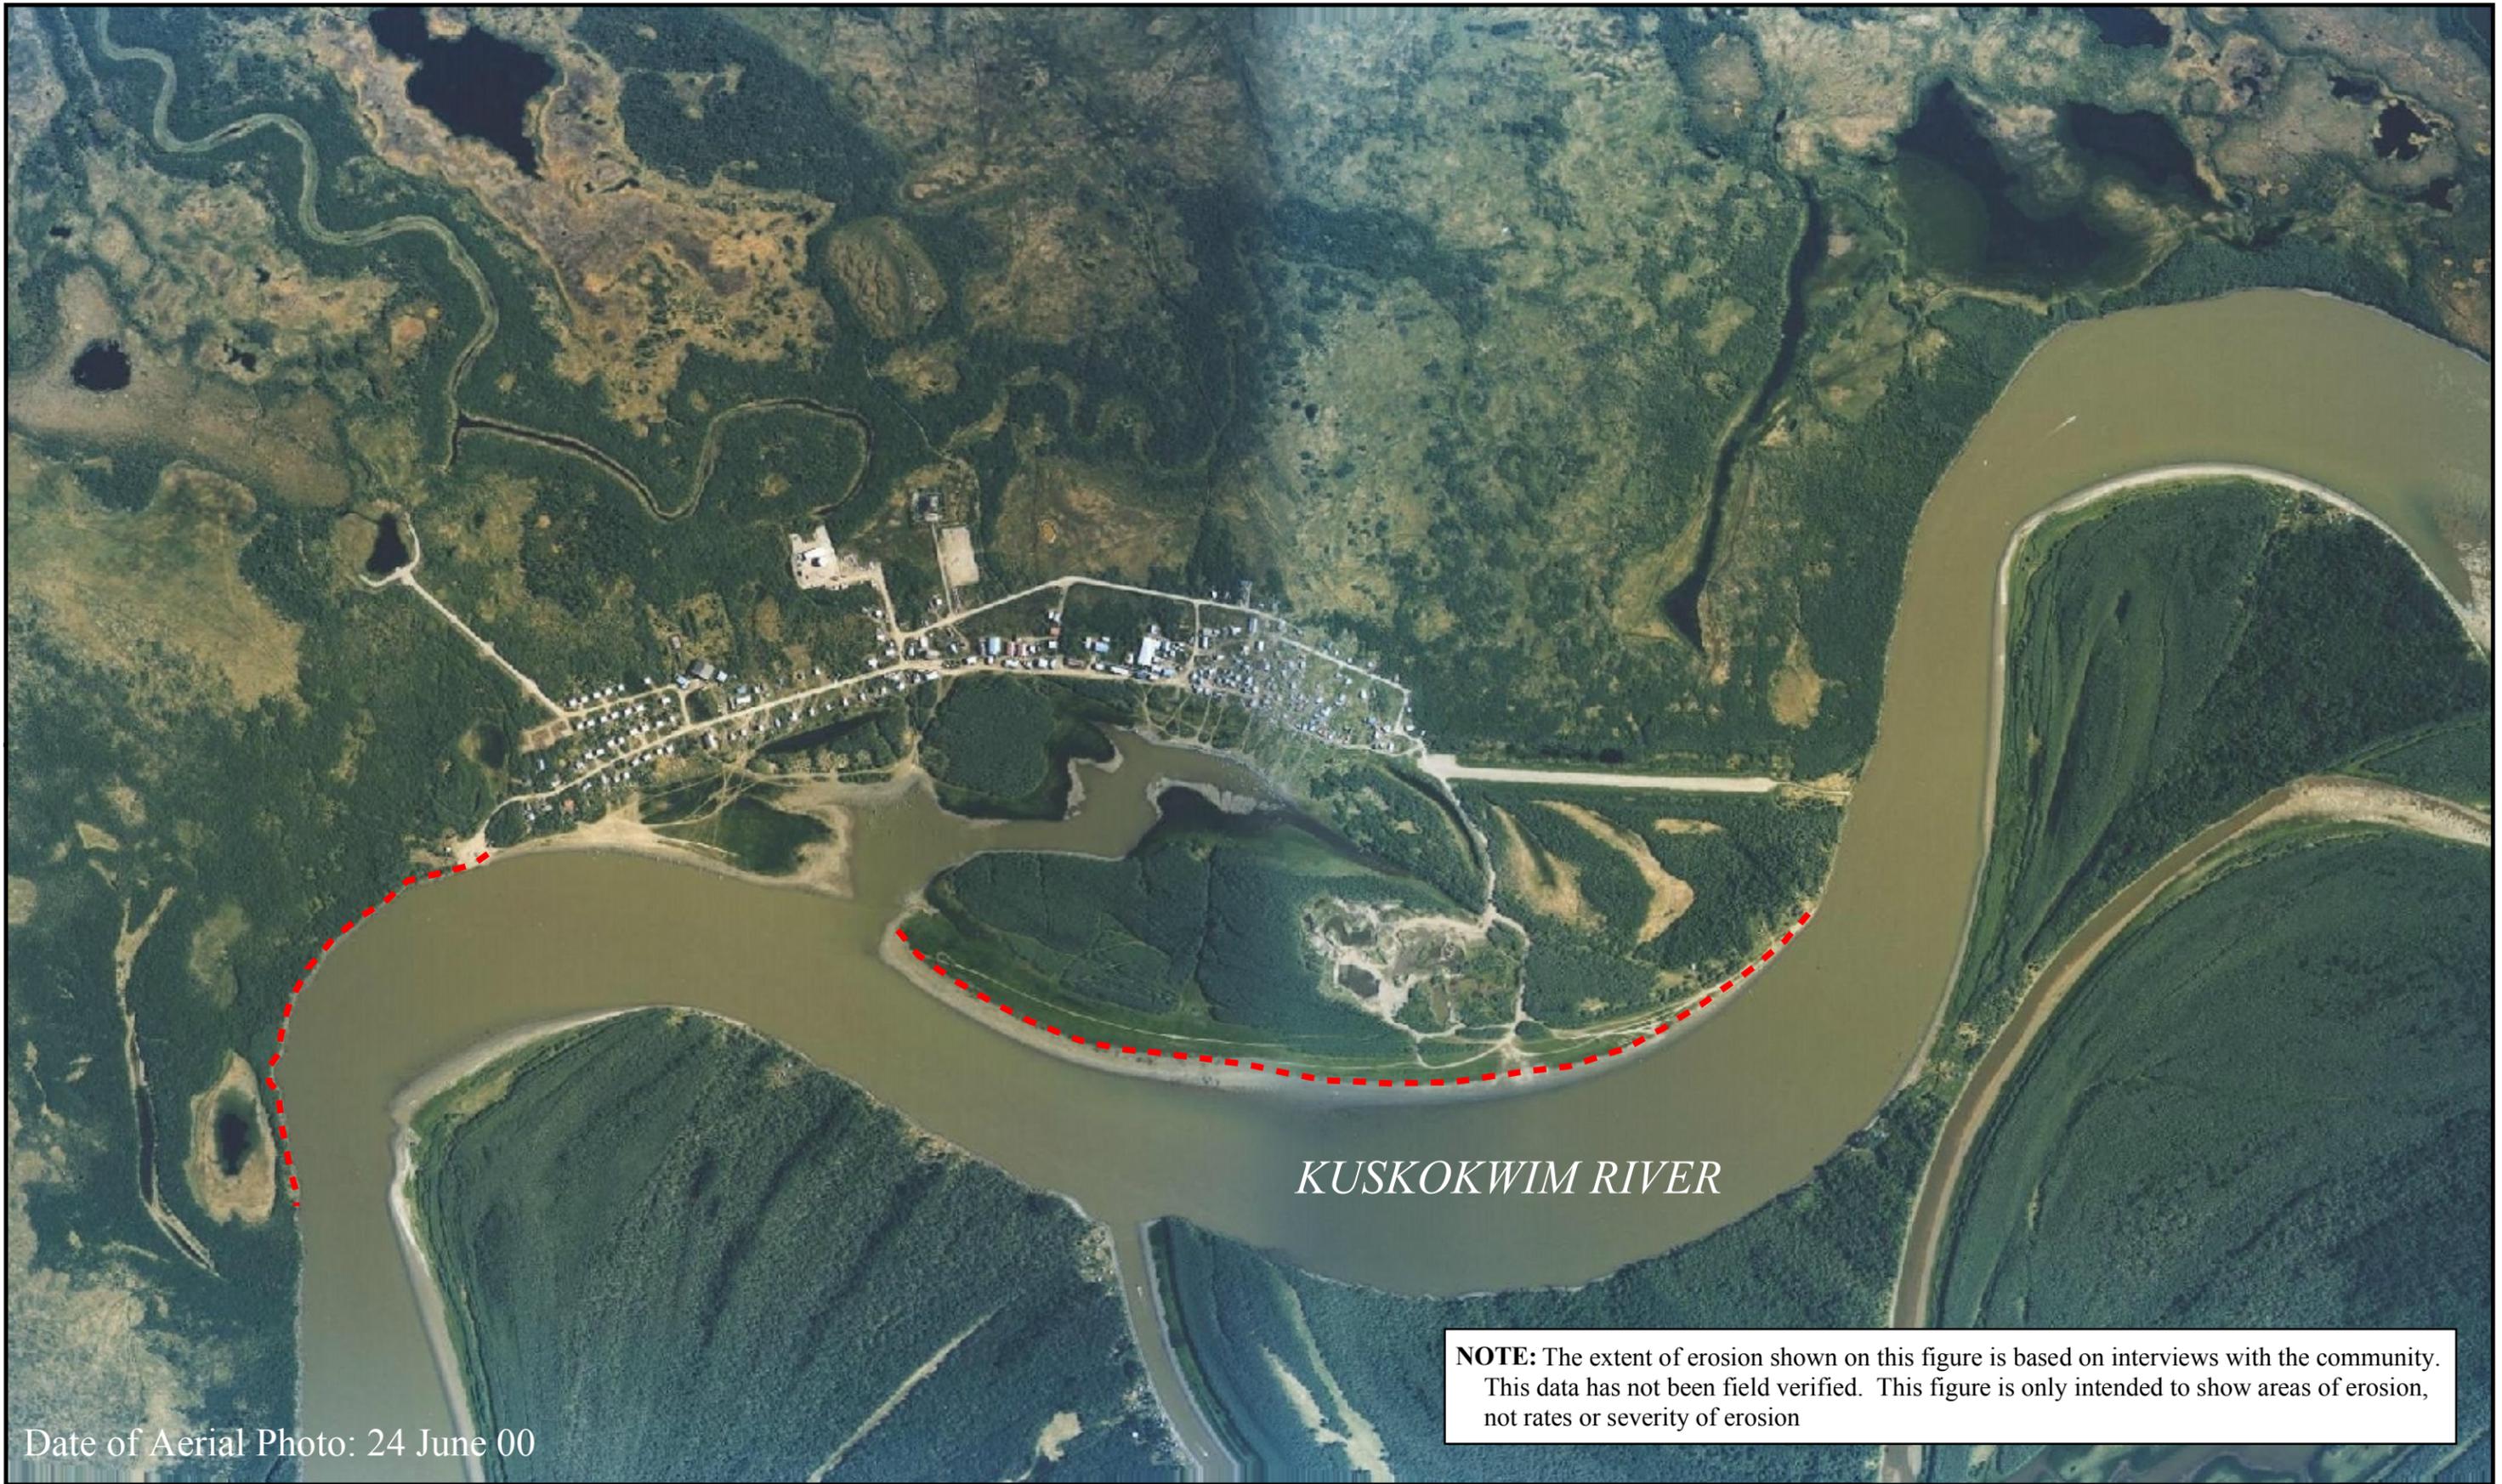
Alaska Baseline Erosion  
Akiachak, Alaska

No photos were provided by the community or other sources. A diagram depicting the linear extent of erosion in the community is attached and the erosion areas that are shown have been taken from the *Akiachak Airport Master Vicinity Map* in the *Akiachak Airport Relocation Final Environmental Assessment* (prepared by HDR Inc.) that depicts the general historic river movement.

**NOTE:** The extent of erosion shown on this figure is based on interviews with the community. This data has not been field verified. This figure is only intended to show areas of erosion, not rates or severity of erosion

--- Linear Extent of Erosion
