U.S. Army Corps
of Engineers
Alaska District

ALASKA BASELINE EROSION ASSESSMENT

Erosion Information Paper - Alatna, Alaska

Current as of January 5, 2008

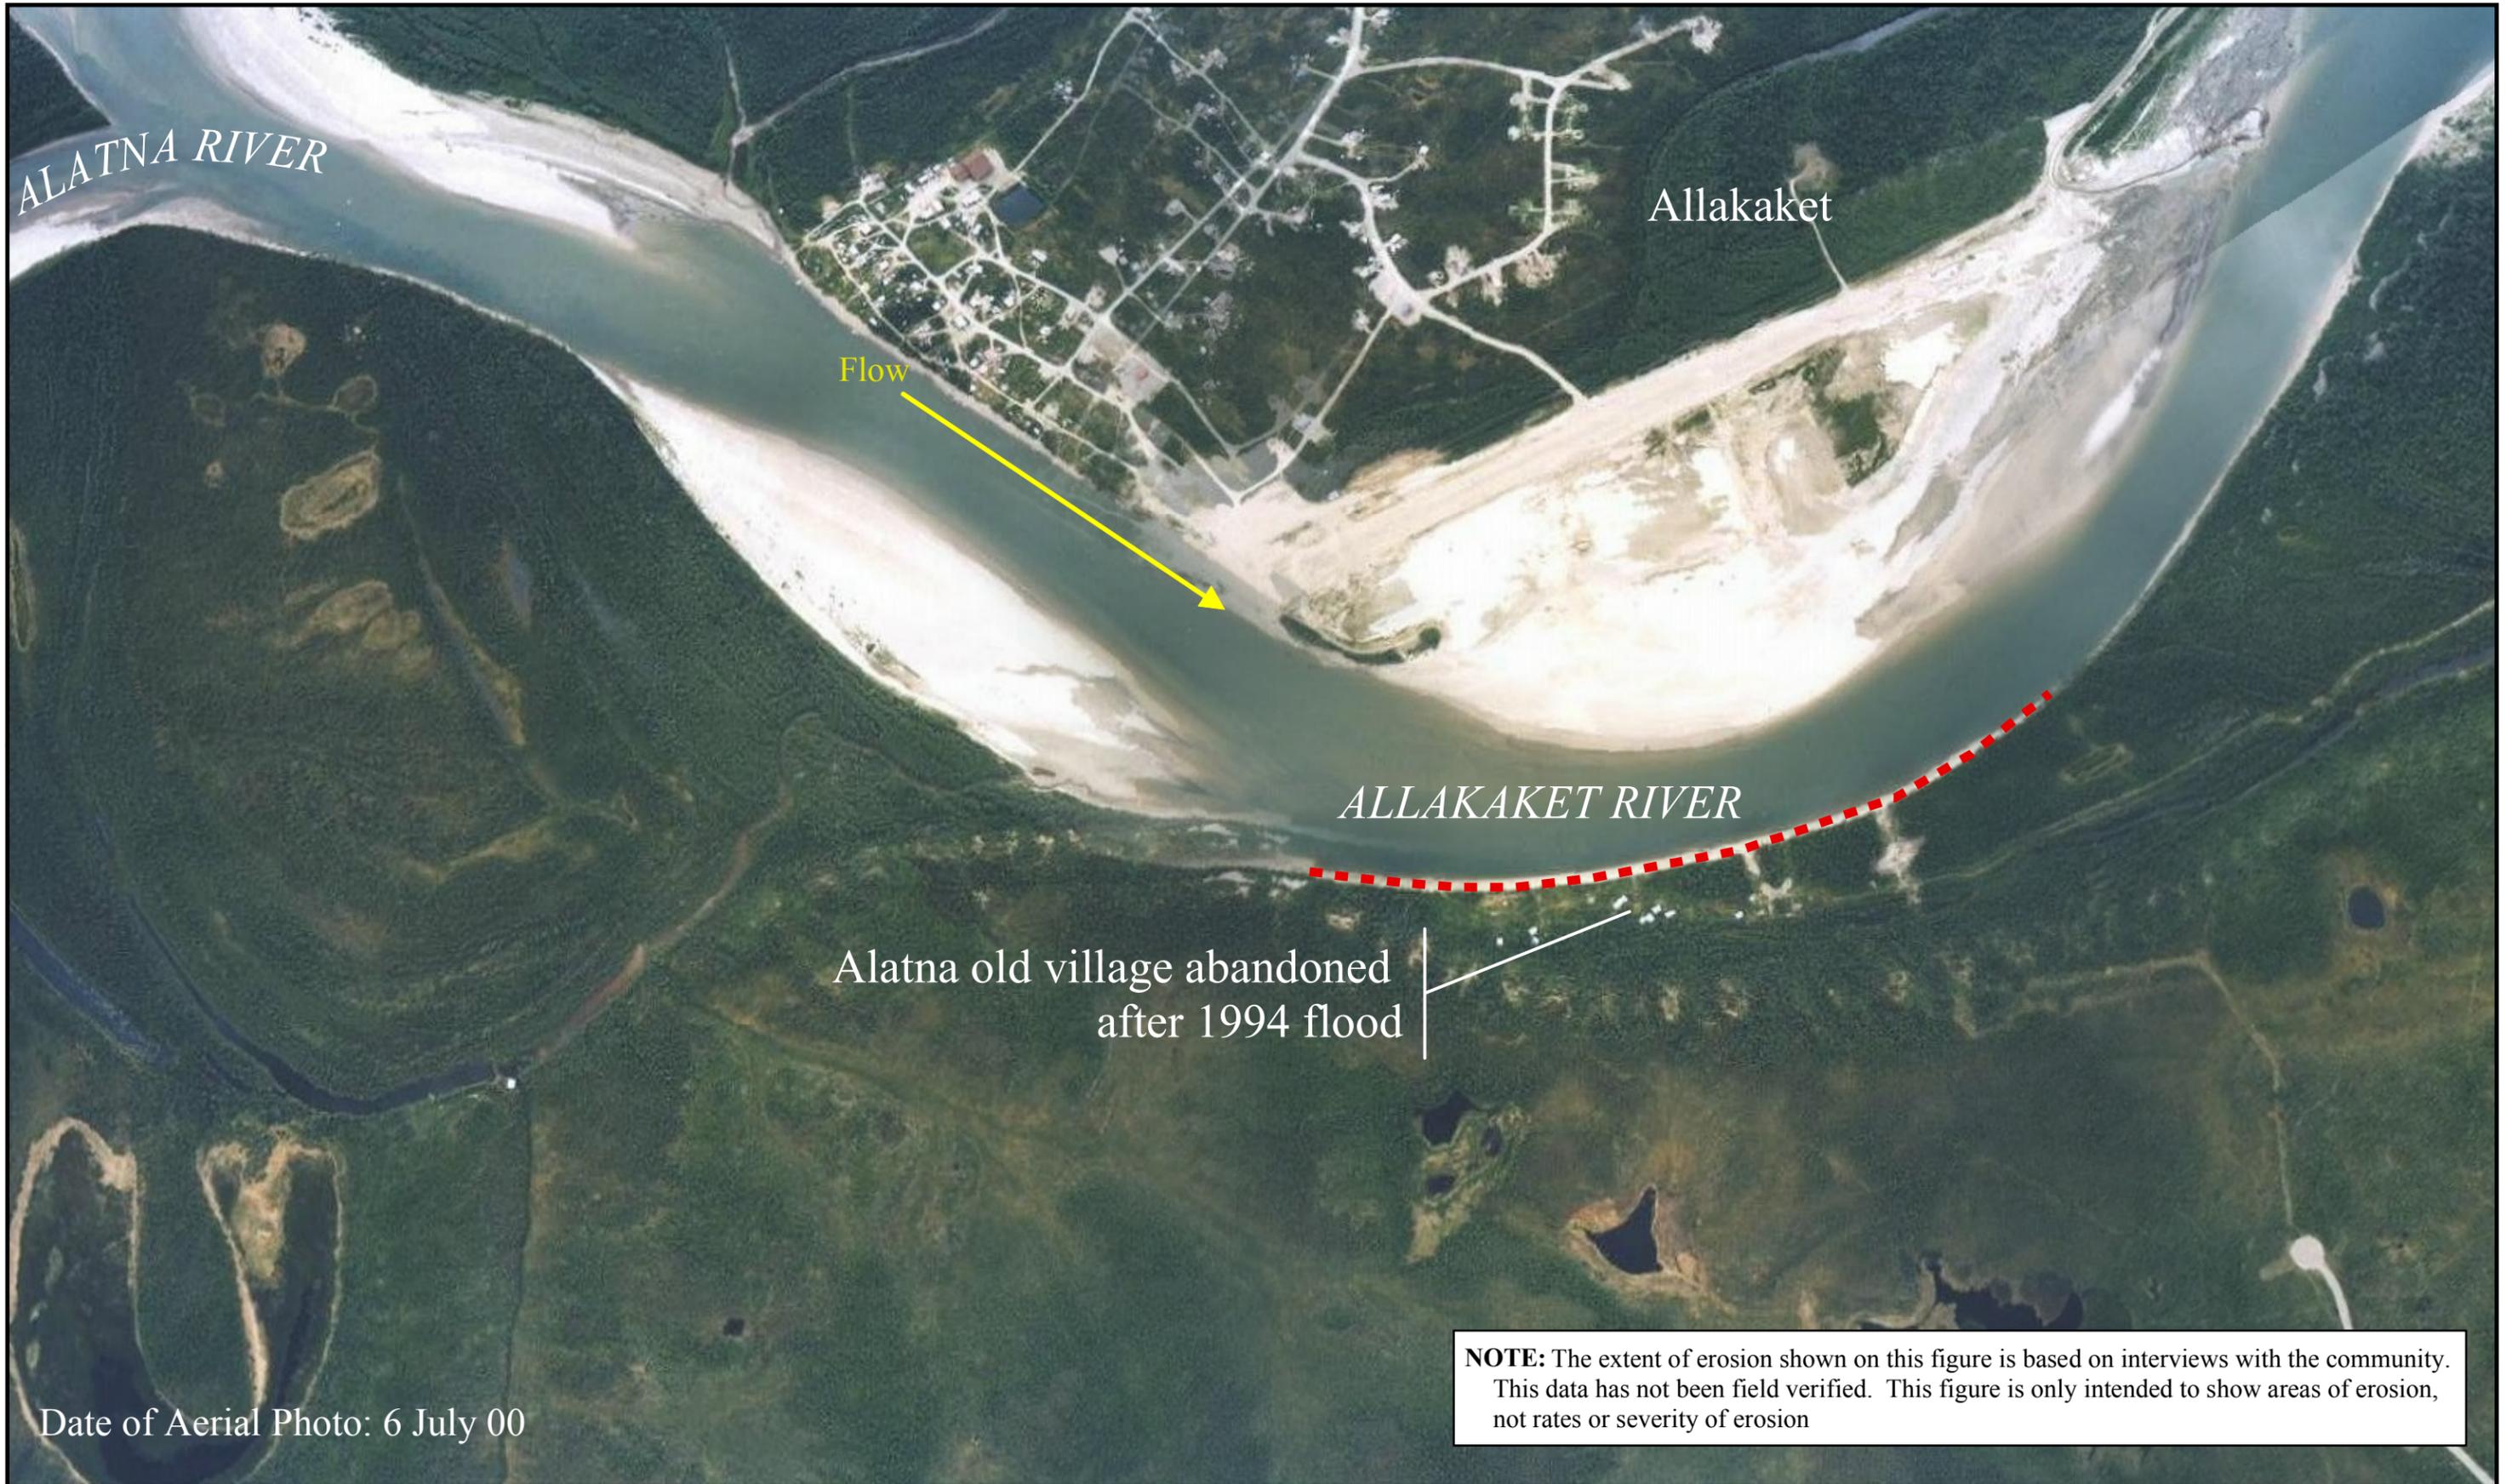
<p>Alaska District Corps of Engineers Civil Works Branch</p>	<p>--- Linear Extent of Erosion Part 1</p>			<p>Alaska Baseline Erosion Alatna, Alaska</p>
--	--	--	--	--	---

Date of Aerial Photo: 6 July 00

NOTE: The extent of erosion shown on this figure is based on interviews with the community. This data has not been field verified. This figure is only intended to show areas of erosion, not rates or severity of erosion

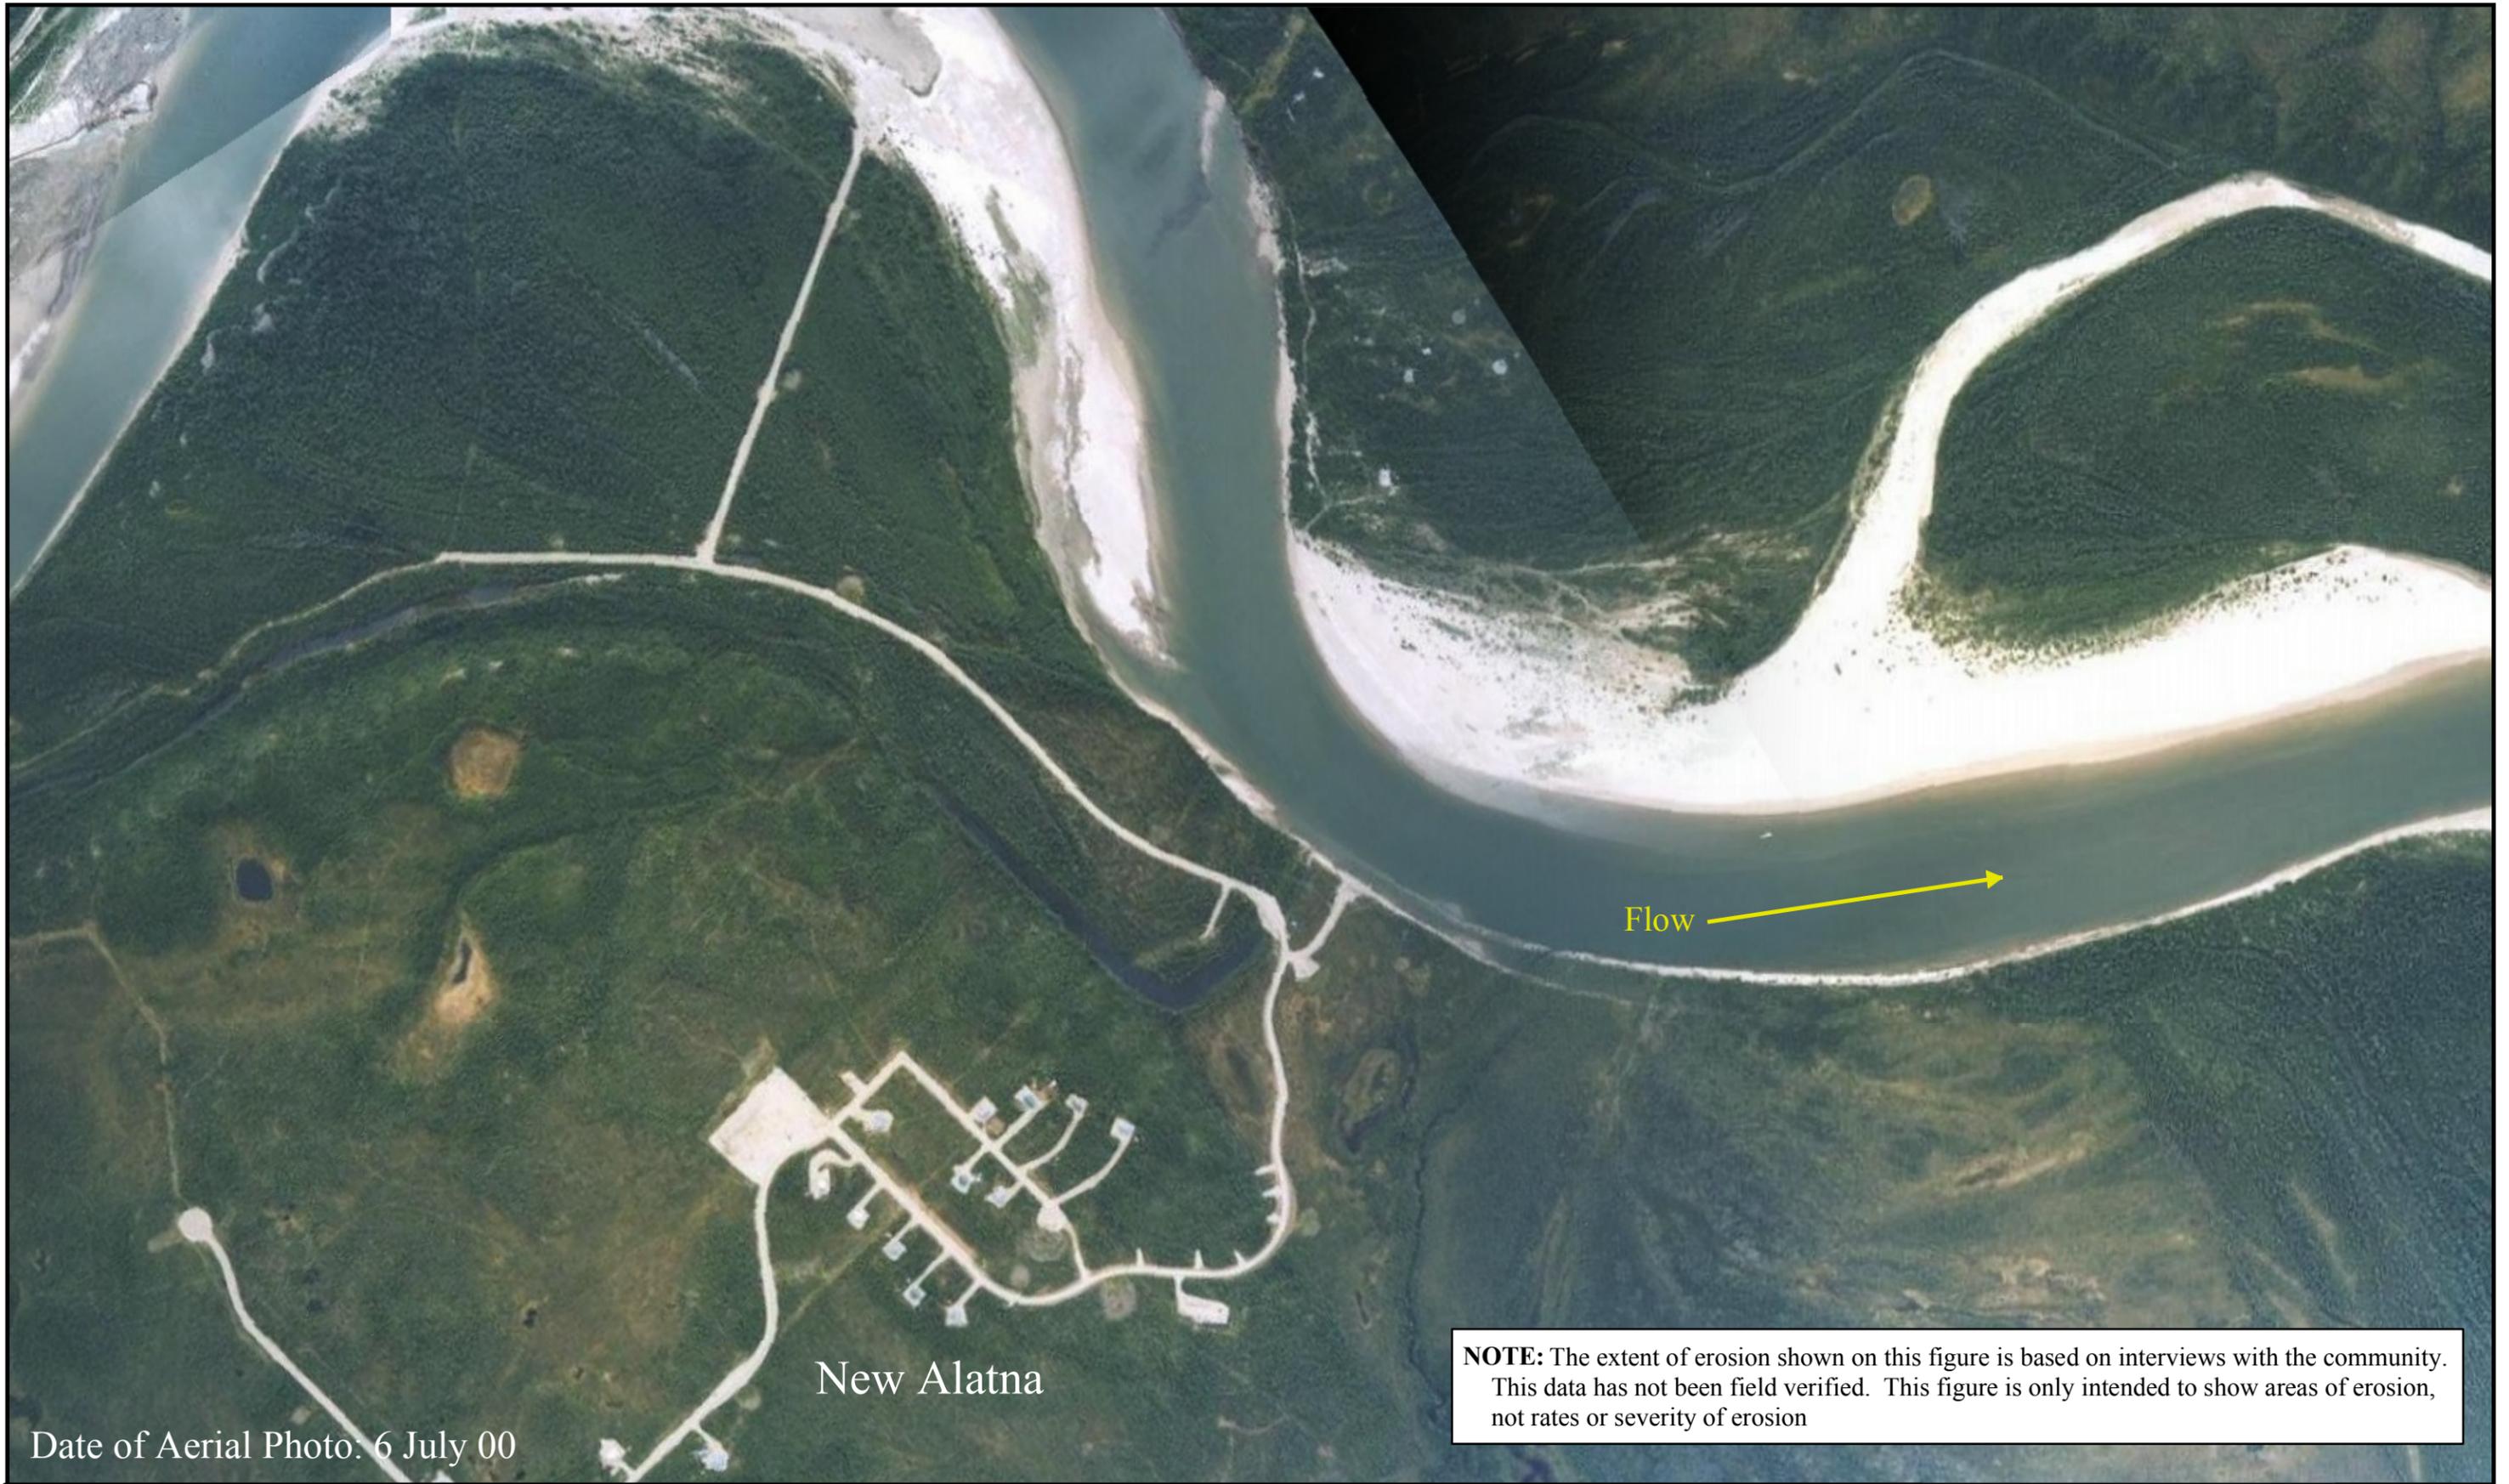
--- Linear Extent of Erosion
Part 2

Date of Aerial Photo: 6 July 00

New Alatna

NOTE: The extent of erosion shown on this figure is based on interviews with the community. This data has not been field verified. This figure is only intended to show areas of erosion, not rates or severity of erosion
