U.S. Army Corps
of Engineers
Alaska District

ALASKA BASELINE EROSION ASSESSMENT

Erosion Information Paper - Allakaket, Alaska

Current as of December 11, 2007

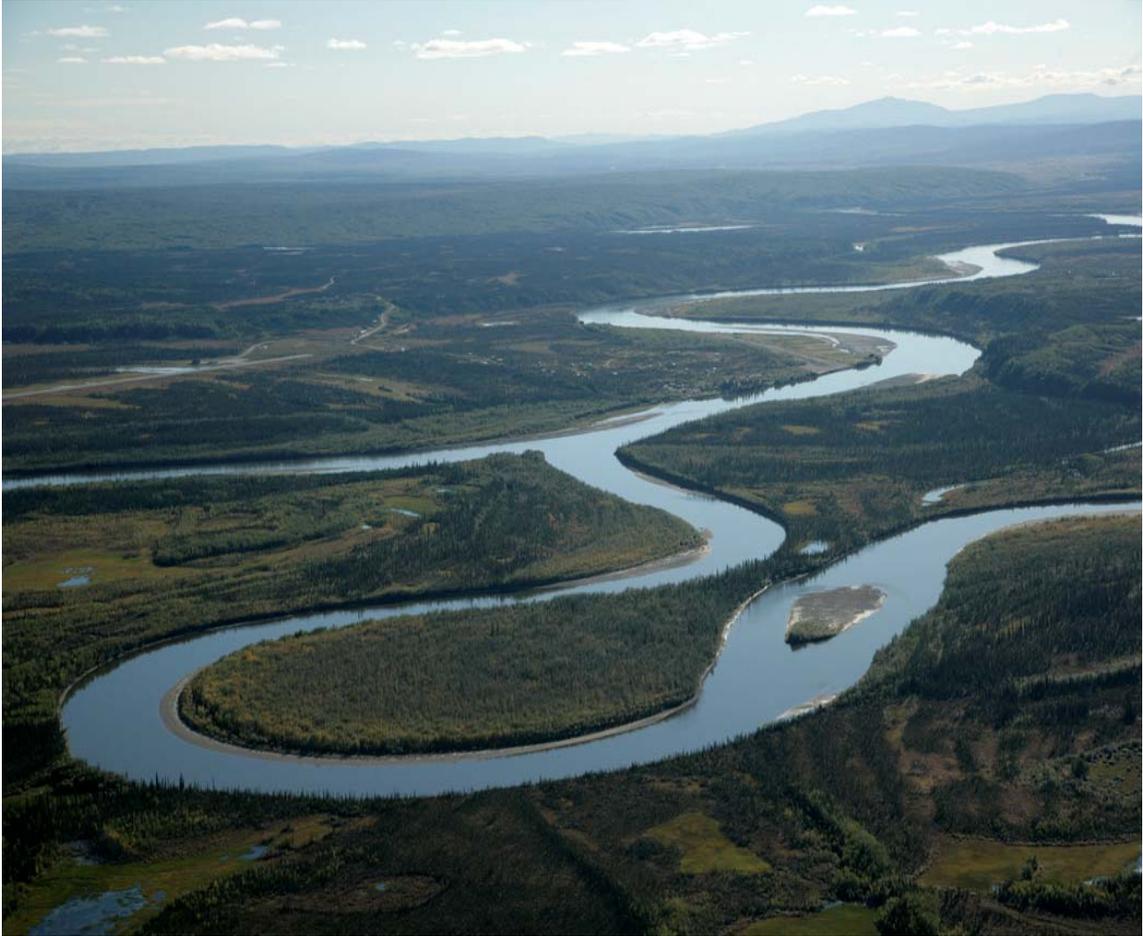
Photo 1: Alatna River, center, and Koyukuk River confluence near Allakaket. Photo by Steve Hillebrand, USFWS. No photo date.

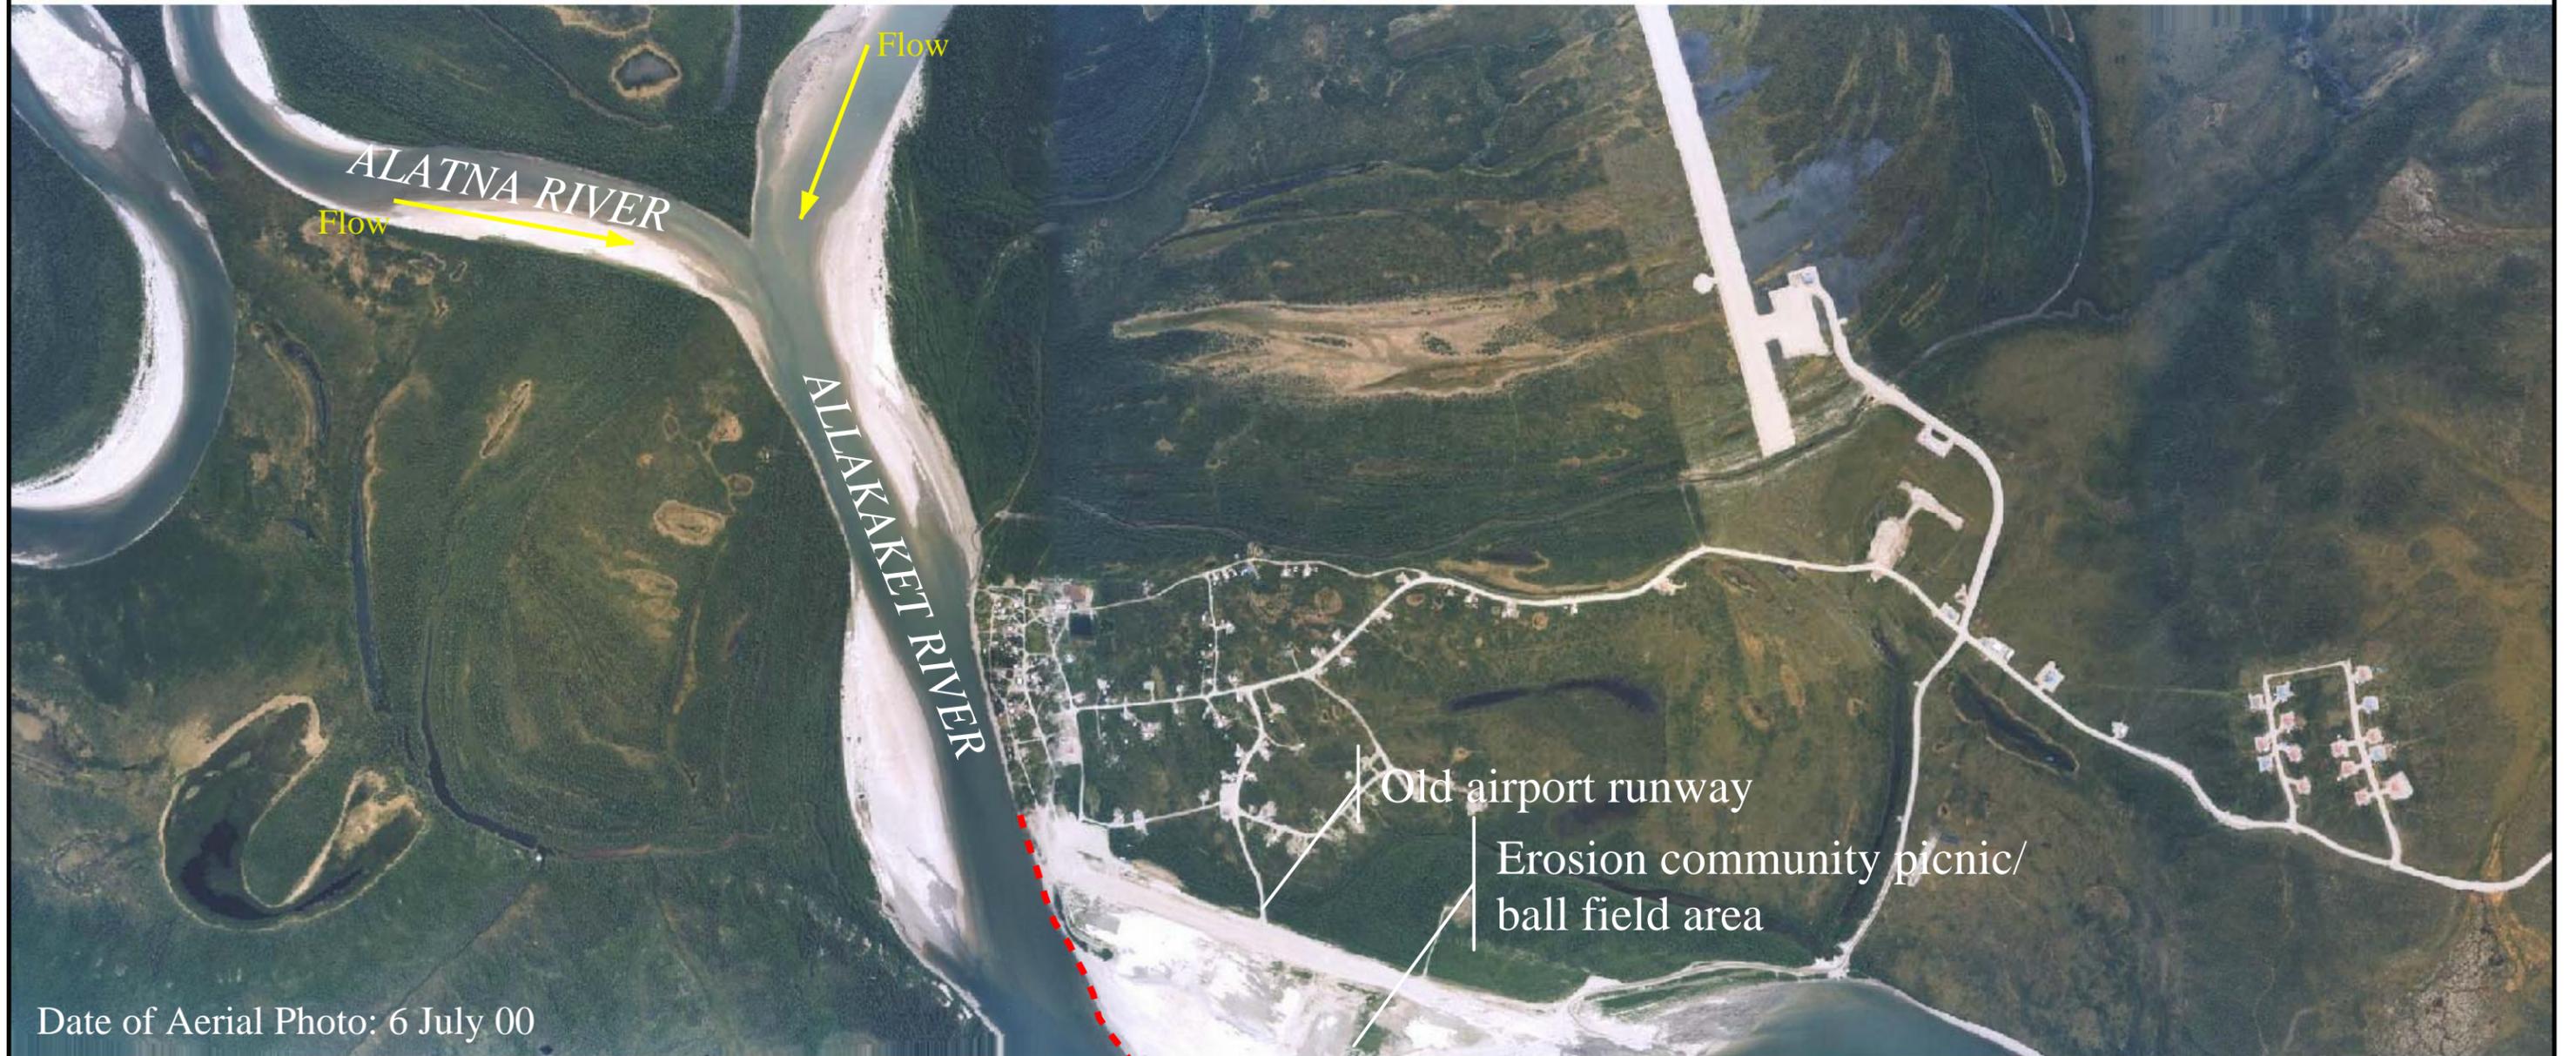
Alaska Baseline Erosion
Allakaket, Alaska

Based on the community survey, seasonal river flow fluctuations, flooding, ice jams, and spring breakup are causes and factors contributing to erosion. Erosion is along the Koyukuk River at the ballpark and picnic area near the old airstrip, where a steep bank drops off to the river. The erosion area is about 200 yards long, with a 12-14 foot vertical bank. It was reported that New Allakaket on higher ground does not have erosion problems.

The community survey reports that the ballpark picnic area along the Koyukuk River near the old airstrip is the primary area of the community threatened by erosion. Some outbuildings, sheds and smokehouses are reported to be threatened.

--- Linear Extent of Erosion
