**Community Erosion Assessment  
Aniak, Alaska  
27 January 2009**

**1. Community: Aniak, Alaska**

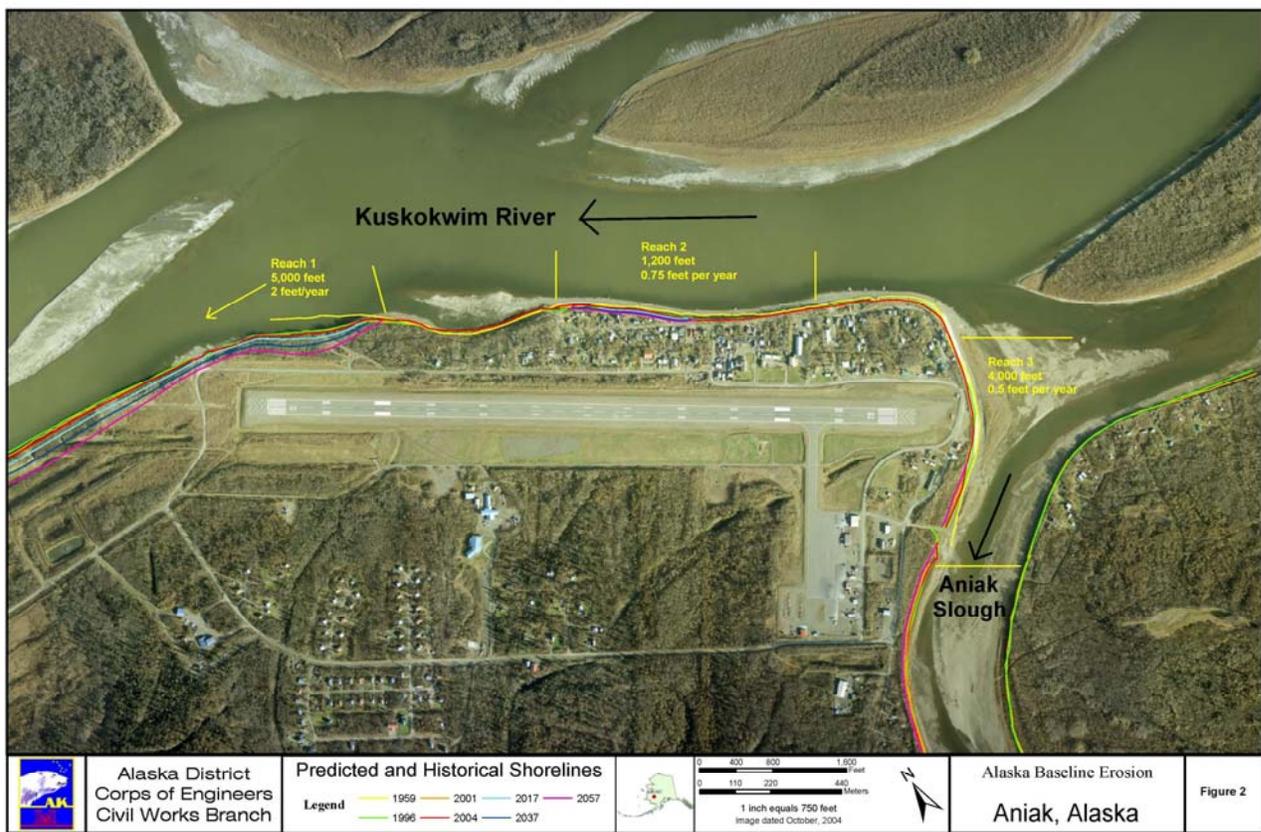
**Figure 2. Aniak Erosion Map**

For this study the riverbank has been divided into three reaches. Reach 1 is a 5,000-foot stretch of land just north and west of the airport and is eroding at an average rate of 4 feet per year. Reach 2 is a 1,200-foot stretch of land in town along the Kuskokwim River, and is eroding at an average rate of 0.75 feet per year. Reach 3 is a 4,000-foot stretch of land along the Aniak Slough and is eroding at an average rate of 0.5 feet per year.

The primary erosion concern for the City of Aniak is erosion of the flood protection levee that borders Aniak along the Kuskokwim River and Aniak slough. This levee was constructed in a piecemeal fashion with the original portions construction in the 1950's. Subsequent phases were constructed in 10-year intervals through the mid-1990's. The levee in its current form consists of a 2,200 foot section constructed in 1996 that is armored with concrete mat that protects the point at the upstream confluence of Aniak slough with the Kuskokwim River. South of the concrete mat the levee has a layer of gravel protecting the riverbank for approximately 1,800 feet. Two earthen levees extend to the west and south from these armored sections along the Kuskokwim River and Aniak slough, respectively. The areas of the levee that have experienced the most erosion are the areas that have been armored either with a concrete mat or with sacrificial gravel.

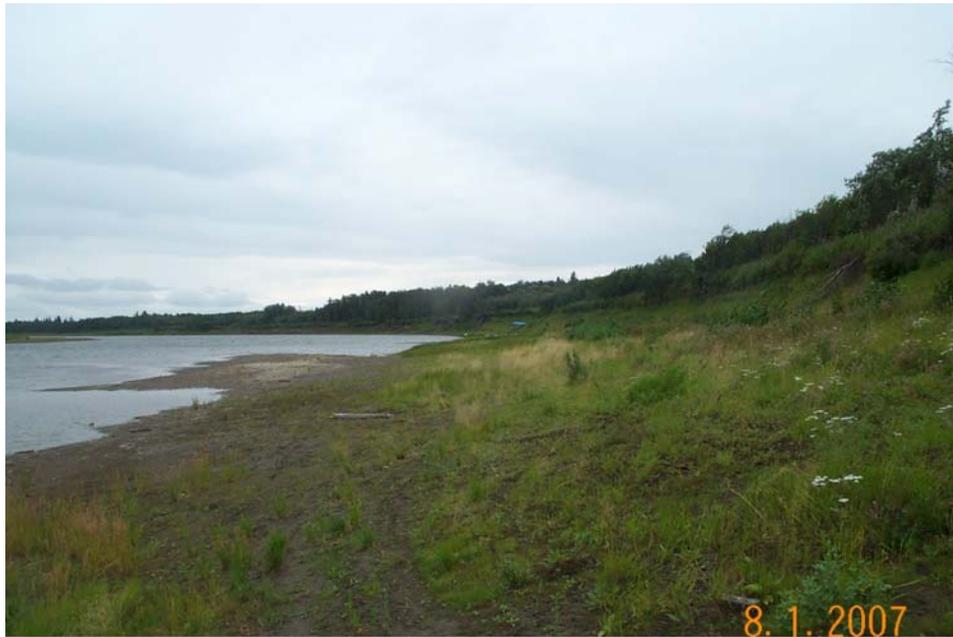
**DCP\_2436**

**N 61° 34.623' W 159° 33.040'      Aniak**  
**Photo 1. Reach 3, Aniak Slough looking downstream.**

The recommended alternative for reach 3 is that approximately 600 feet of the levee be relocated further from the slough. In addition to relocating this portion of the levee the planting of willows should be extended along the Aniak Slough for an additional 1,500 feet downstream. This recommendation is based on the fact that planted willows seem to have been effective in stabilizing the bank upstream of this area.

It is assumed that construction of the relocated levee would be similar to the existing levee along this portion of the slough. The cost for this alternative is roughly \$1,600 per linear foot with an estimated total cost of \$960,000.

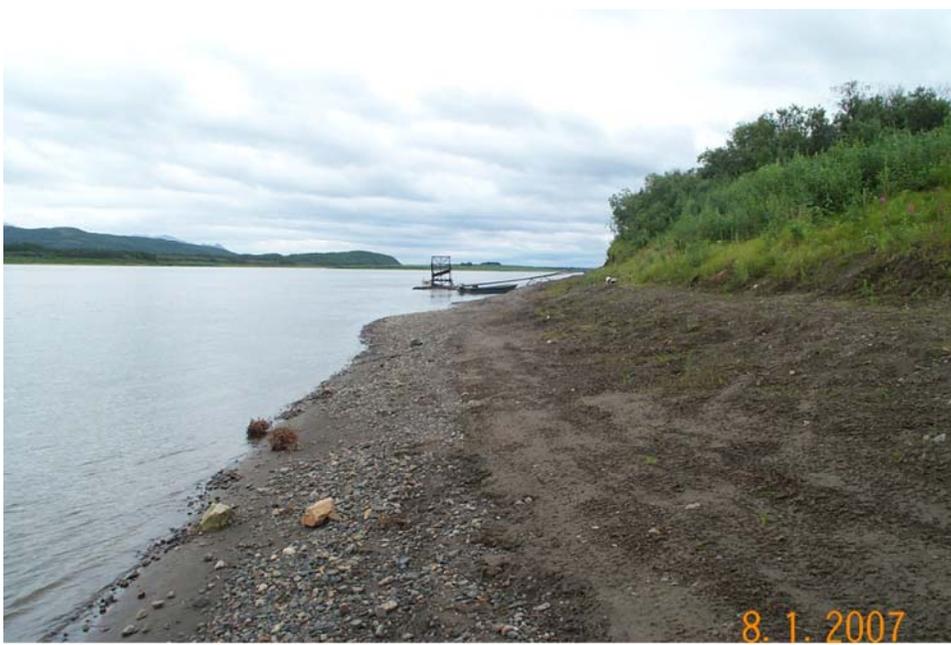
DCP\_2474

Photo 2. Reach 2, West end of the runway looking upstream along the Kuskokwim River.

To effectively reduce erosion in reach 2, it is recommended that the levee be hardened with riprap. The approximate riprap revetment length would be 1,200 feet; 3,000 feet if extended to the end of the existing articulated concrete mat. The revetment would include a thickened section at the toe of the slope to provide some scour protection. The total cost to place a riprap revetment for the approximate 4,200 feet would be approximately \$10.7 million or \$3,600 per linear foot.

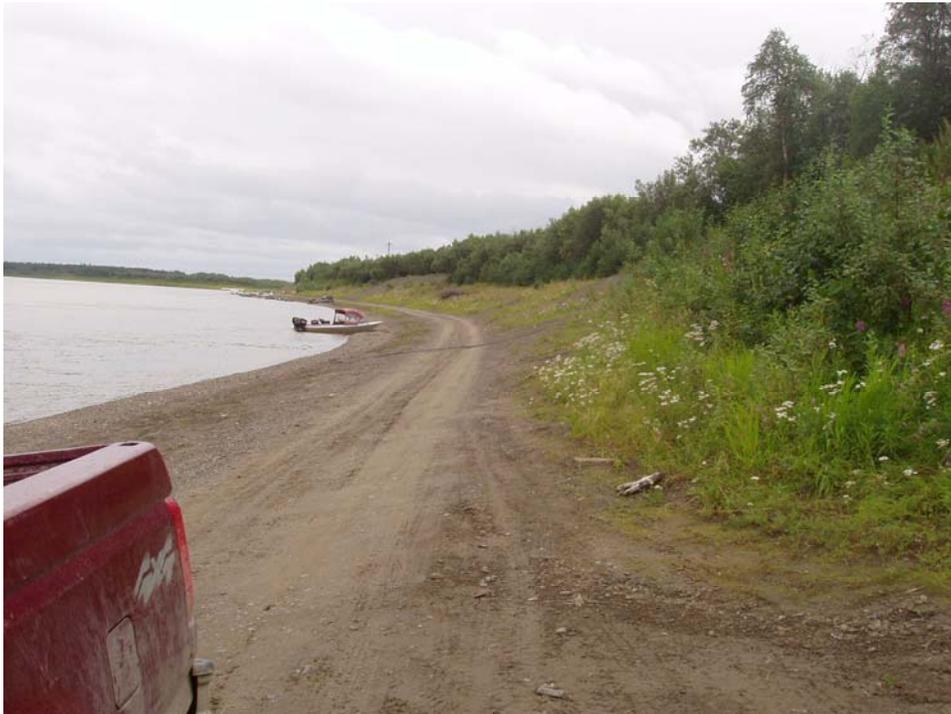
P1011247

Photo 3. Reach 3, Looking upstream along the Kuskokwim River.

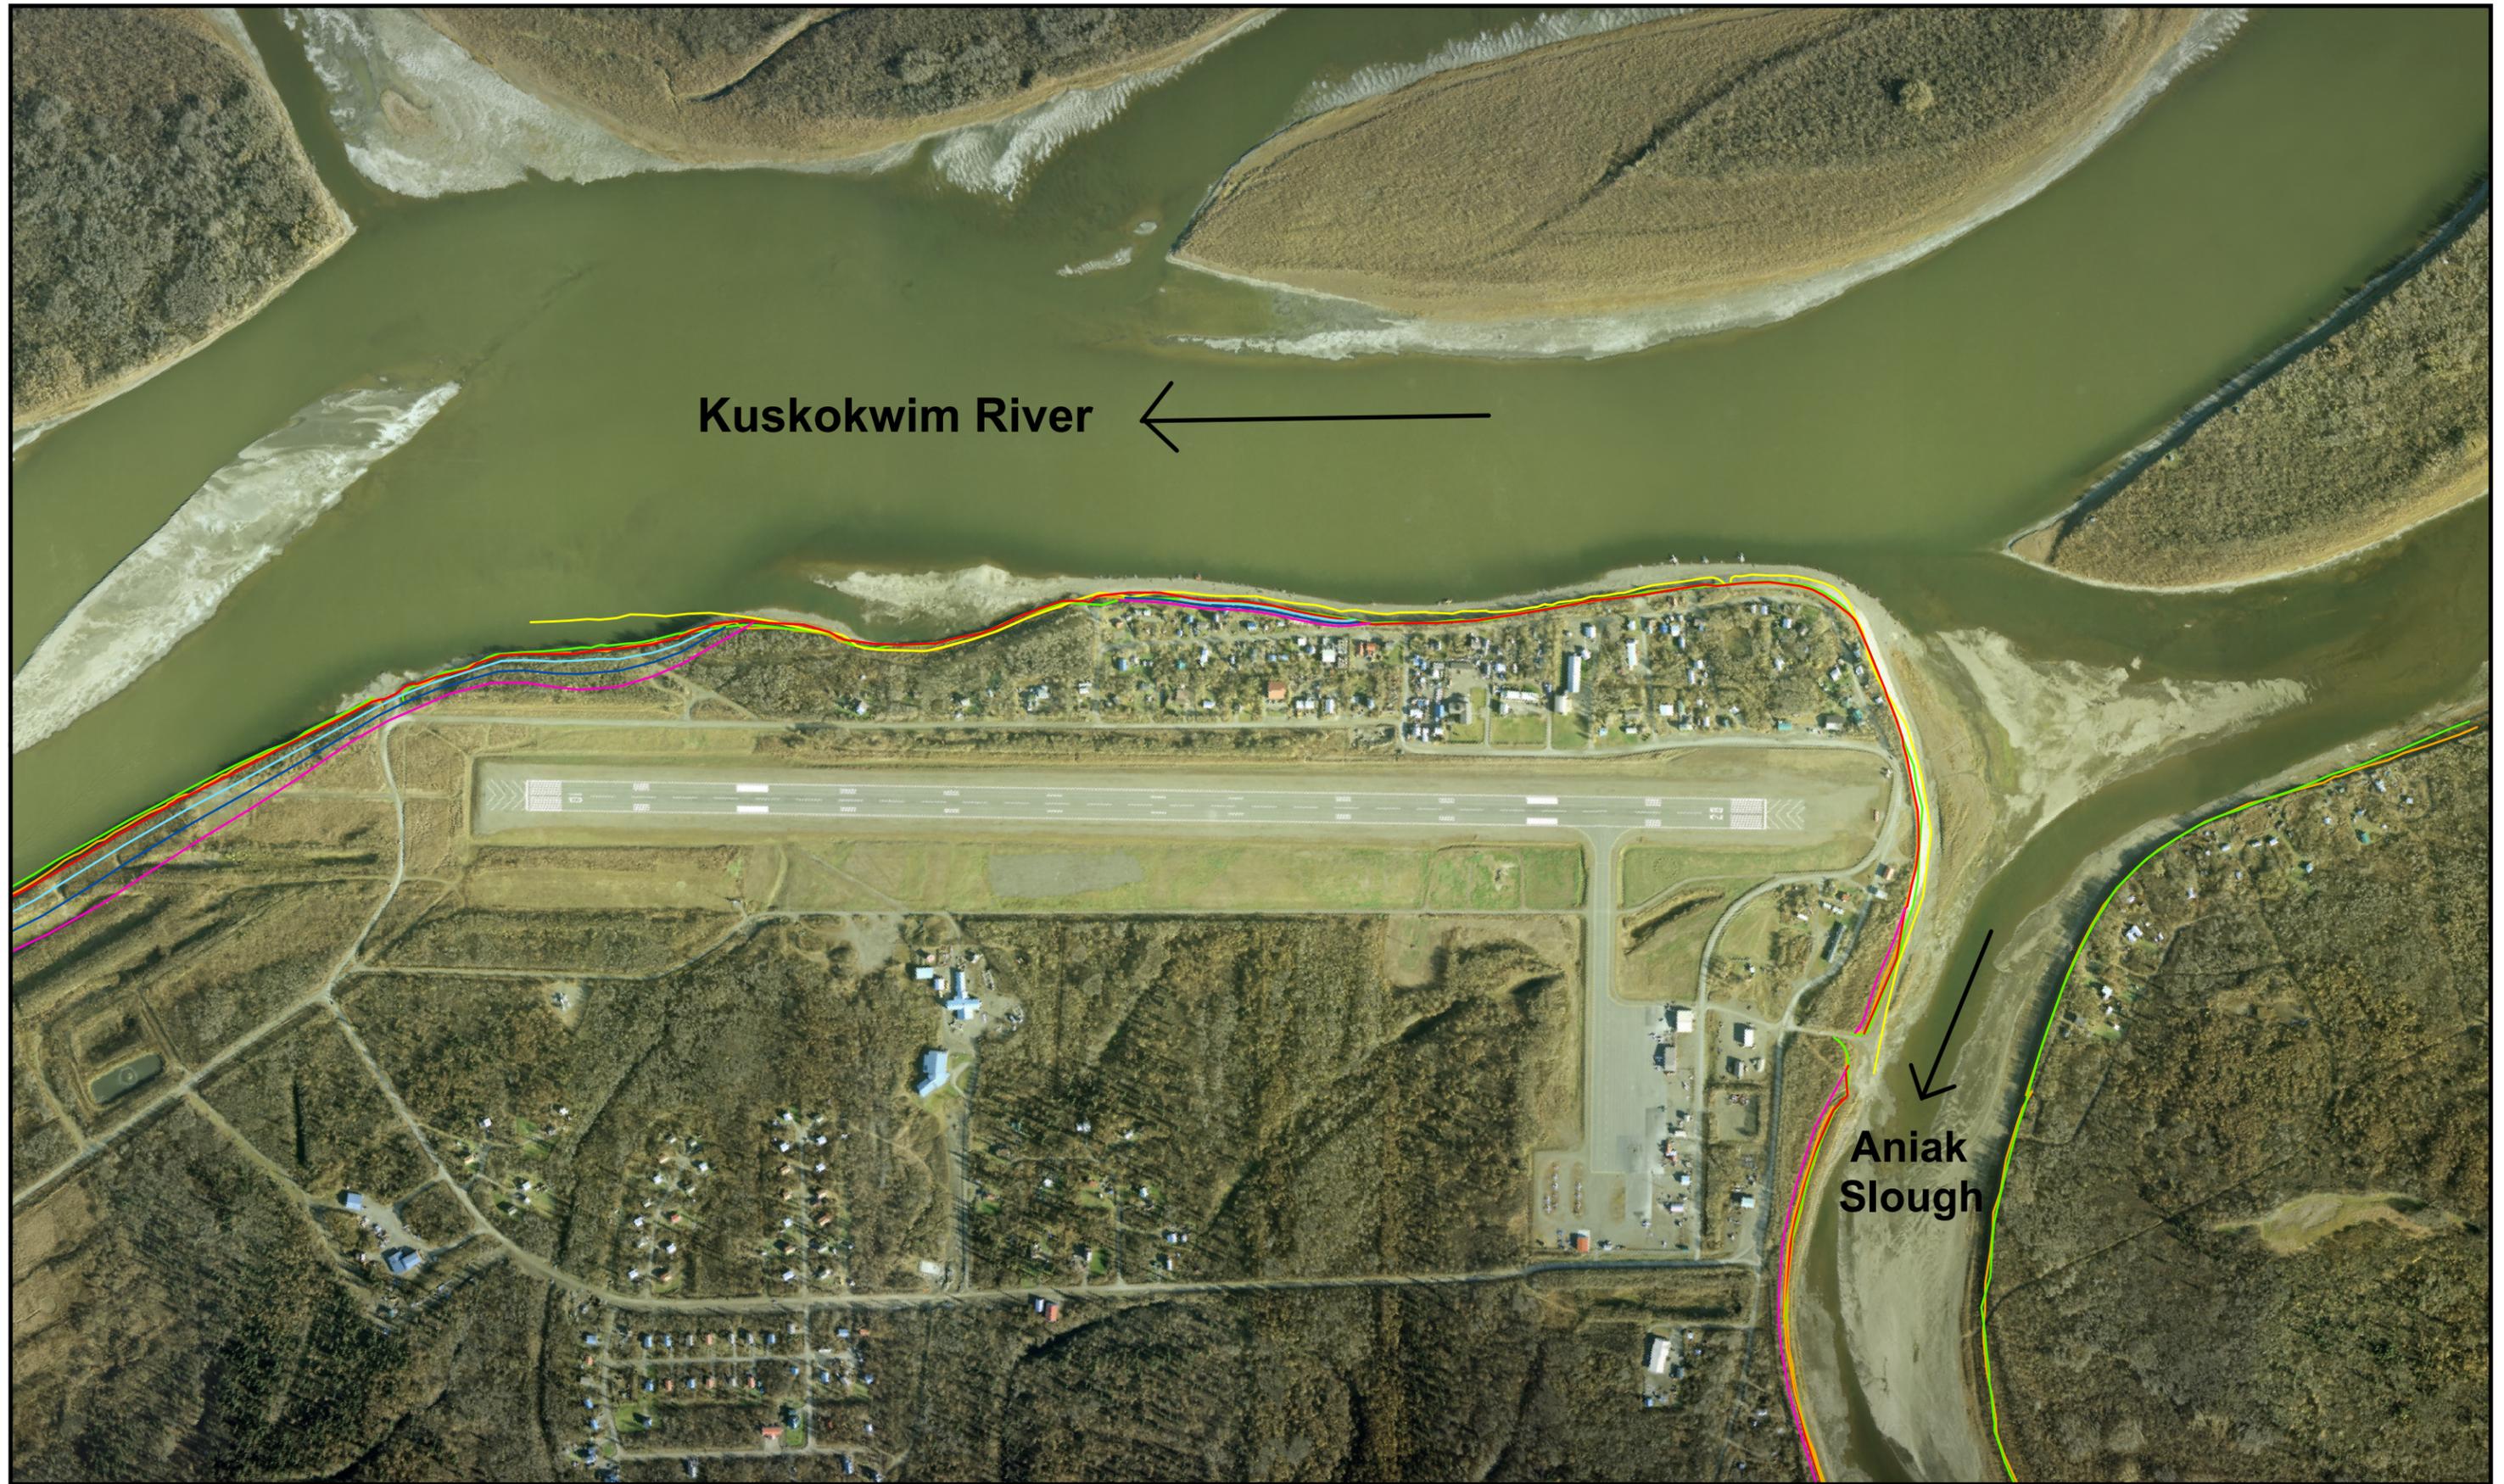
**Predicted and Historical Shorelines**

<b>Legend</b>	1959	2001	2017	2057
	1996	2004	2037
