U.S. Army Corps
of Engineers
Alaska District

ALASKA BASELINE EROSION ASSESSMENT

AVETA Report Summary– Bethel, Alaska

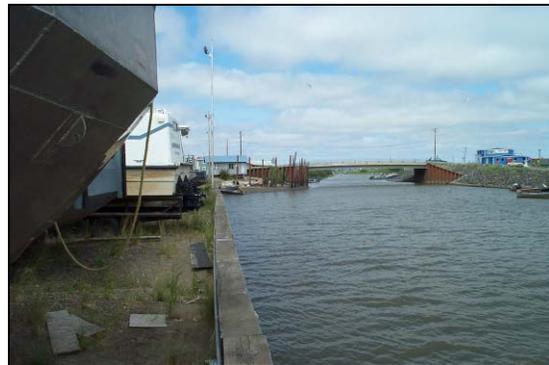
Example of Bethel shoreline

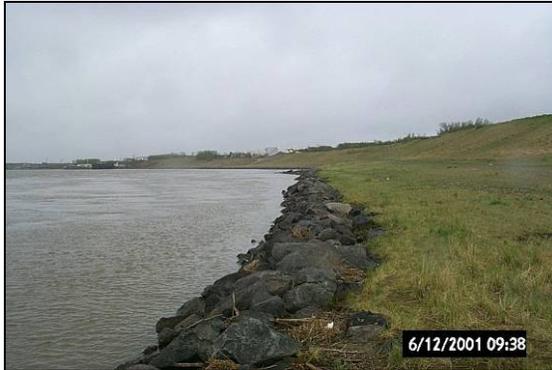
350 feet long and 200 feet inland and endangered several structures. The village's main port is the only one on the western Alaska coast for oceangoing ships and serves as the supply center for villages in the Yukon-Kuskokwim Delta. In response to the 1995 emergency, the Corps placed rock along 600 linear feet of the riverbank and dock.

Riverbank Protection at Bethel

This was the beginning of a Corps 8,000-foot bank stabilization seawall project that cost \$24 million and was completed in 1997. This project included stabilization of the riverbank from the existing petroleum dock at the downstream end to the Bethel city dock at the upstream end.

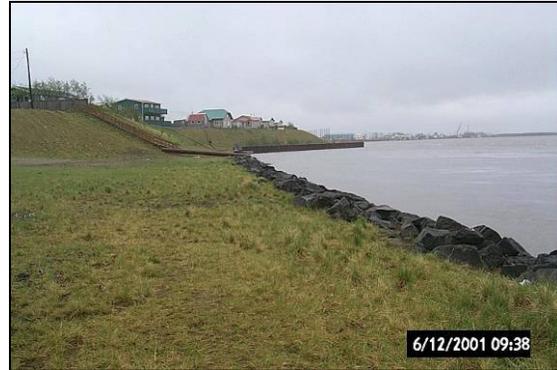
Looking other direction

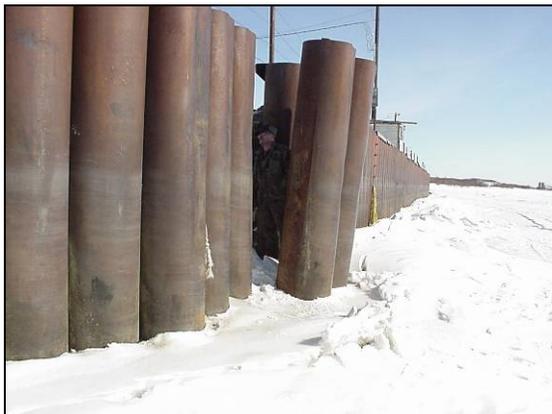
Pile wall of current concern at Bethel.

Although Bethel is not in imminent danger, it has experienced serious erosion and has undertaken various infrastructure-specific activities to resolve this problem. The Corps has a project underway to repair the seawall by placing more rock, by replacing a steel tieback system, and placing steel wale on the inland side of the pipe piles. The project will reinforce the seawall 1,200 feet so that it protects the entrance to Bethel's small boat harbor. The initial cost estimate for this project in 2001 was over \$4.7 million. The project should be completed in 2006. Because of these measures, there are no plans for Bethel to relocate or collocate to another site.

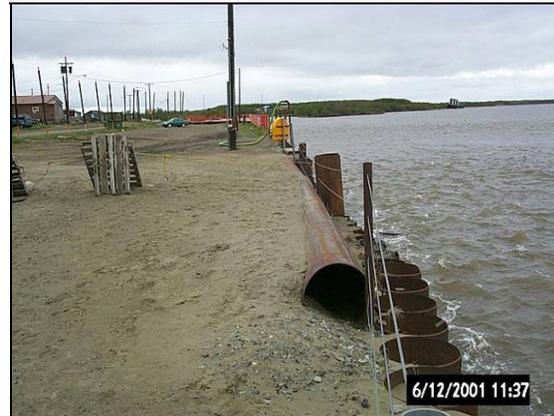
Obvious outward bowing of wall.

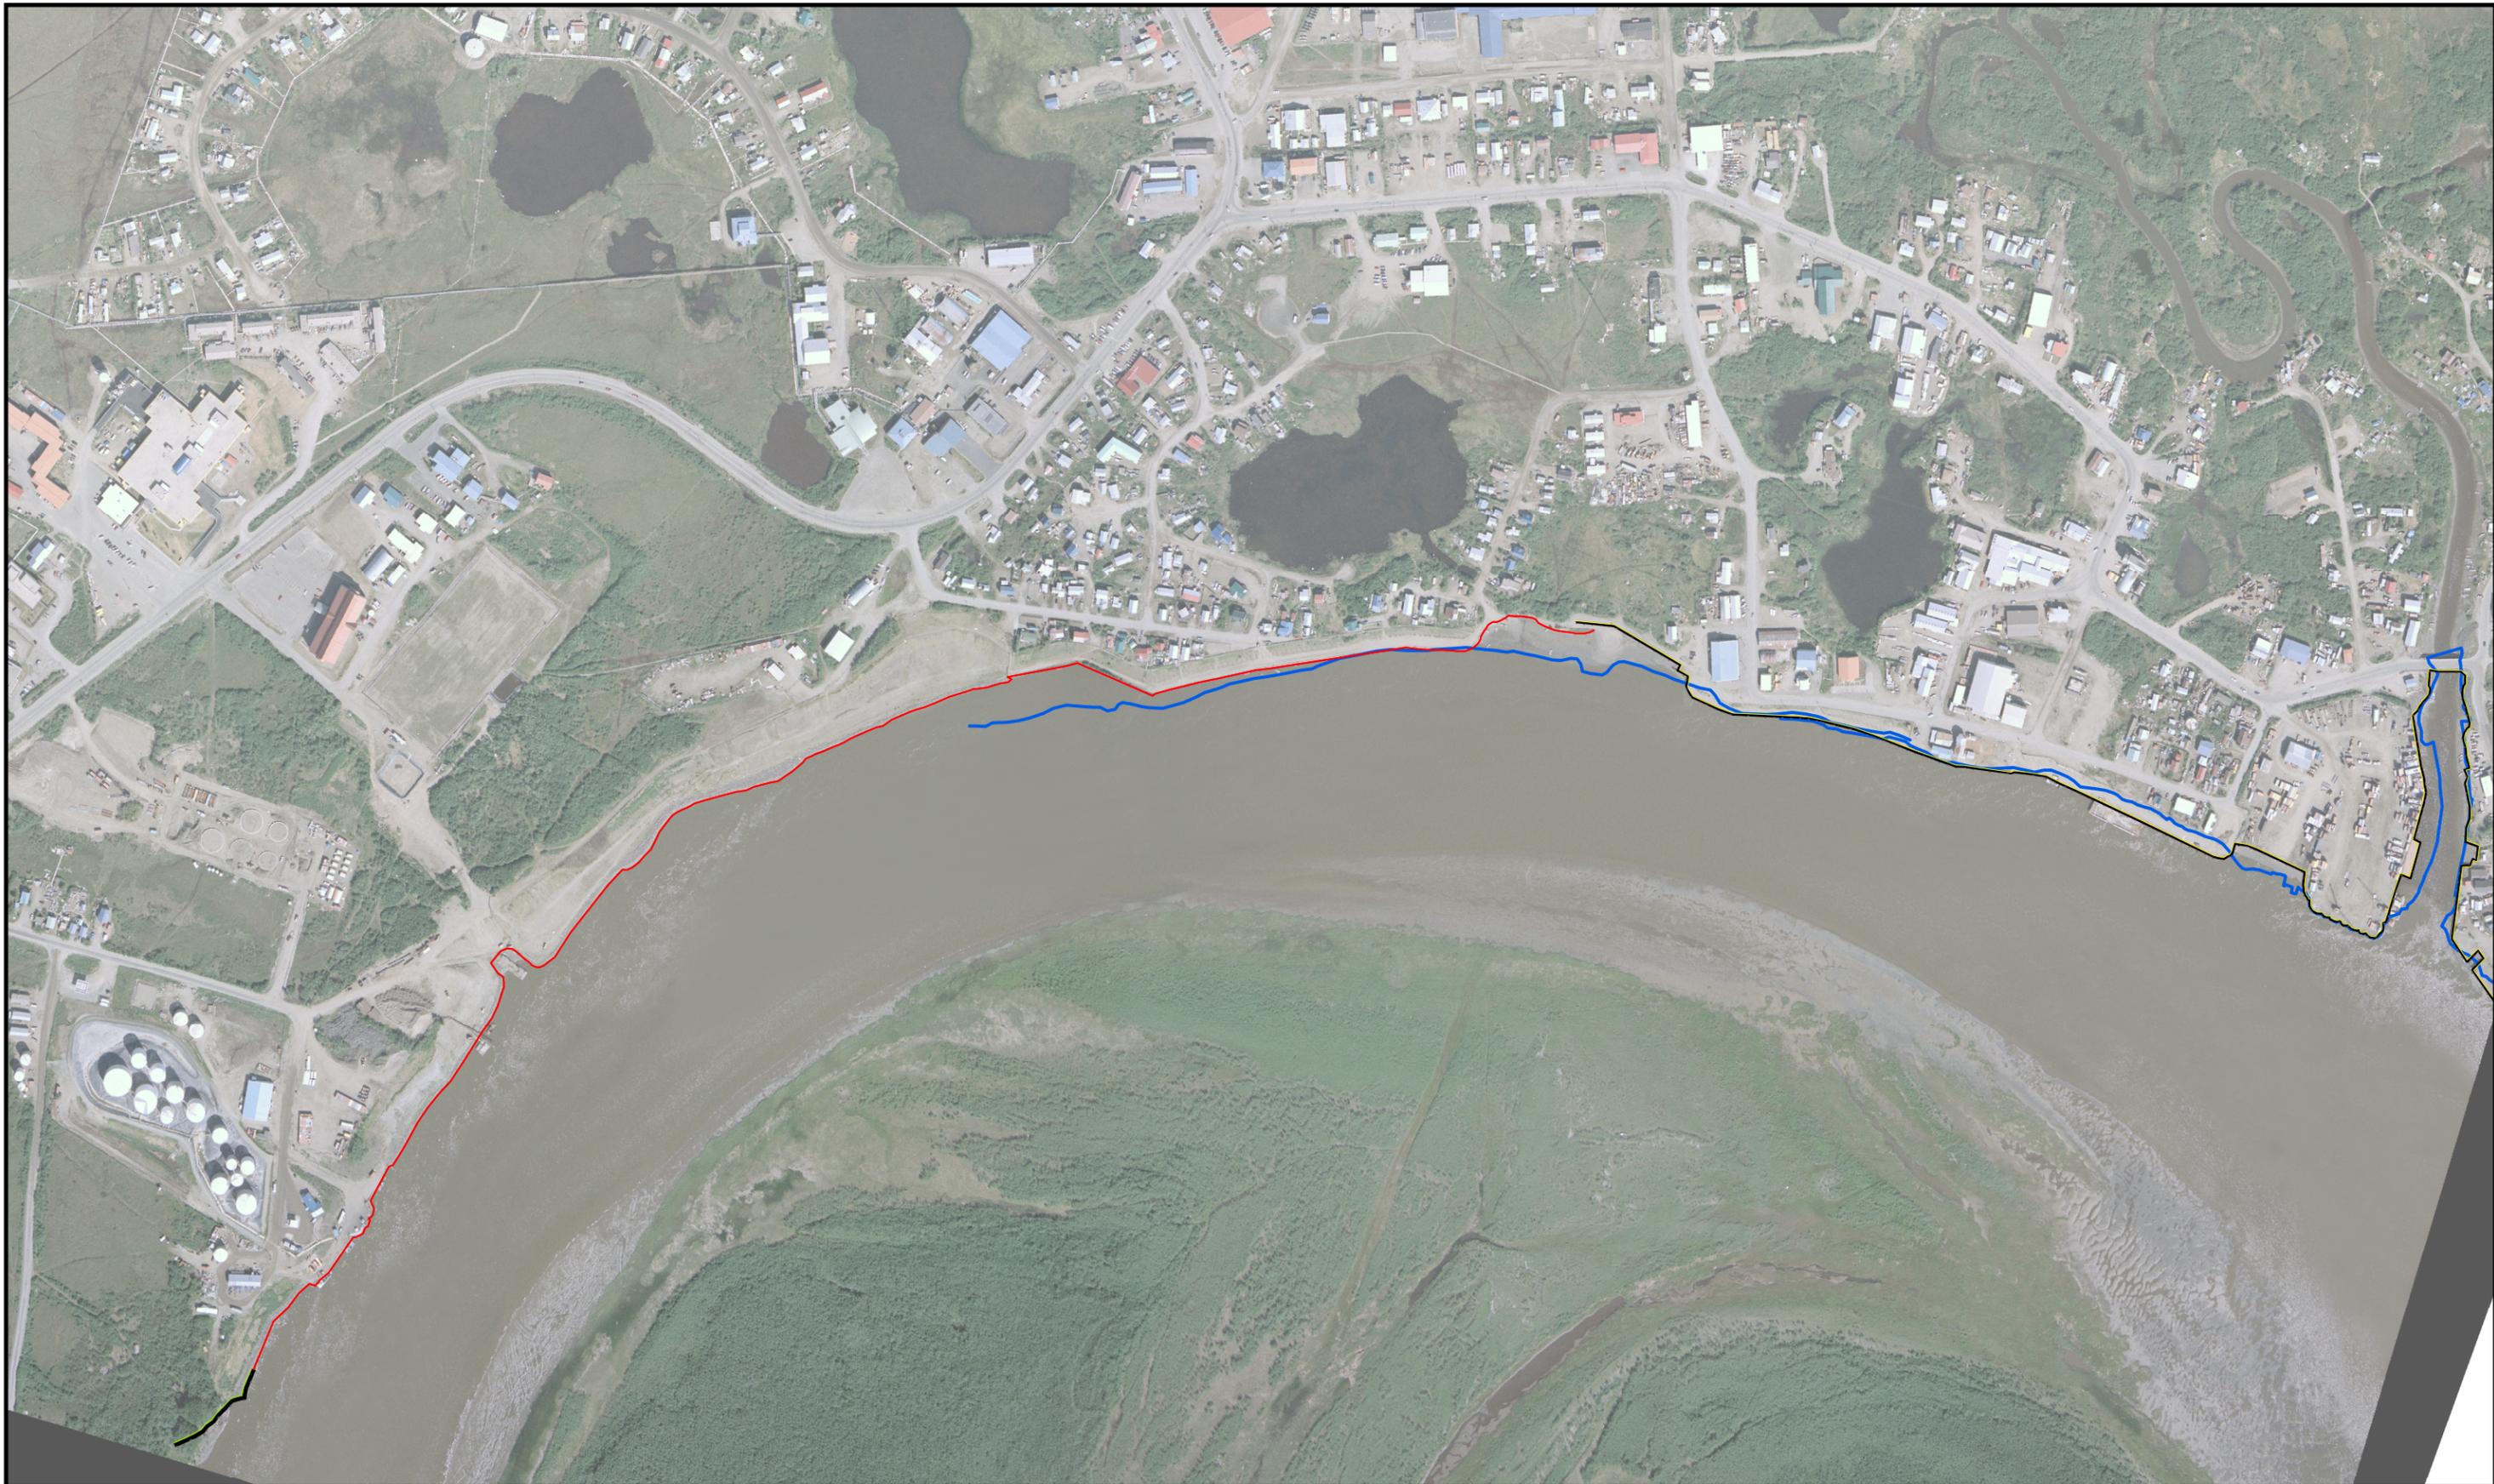
<p>Alaska District Corps of Engineers Civil Works Branch</p>	<p>Historical and Predicted Shorelines</p> <table border="0"> <tr> <td> 1977</td> <td> 2005</td> </tr> <tr> <td> 2003</td> <td> 2020</td> </tr> </table>	1977	2005	2003	2020		<p>Image dated June 2003</p>	<p>Alaska Village Erosion Technical Assistance Program</p> <p>Bethel, Alaska</p>	
1977	2005									
2003	2020
