ALASKA BASELINE EROSION ASSESSMENT

Erosion Information Paper - Birch Creek, Alaska

Current as of January 29, 2008

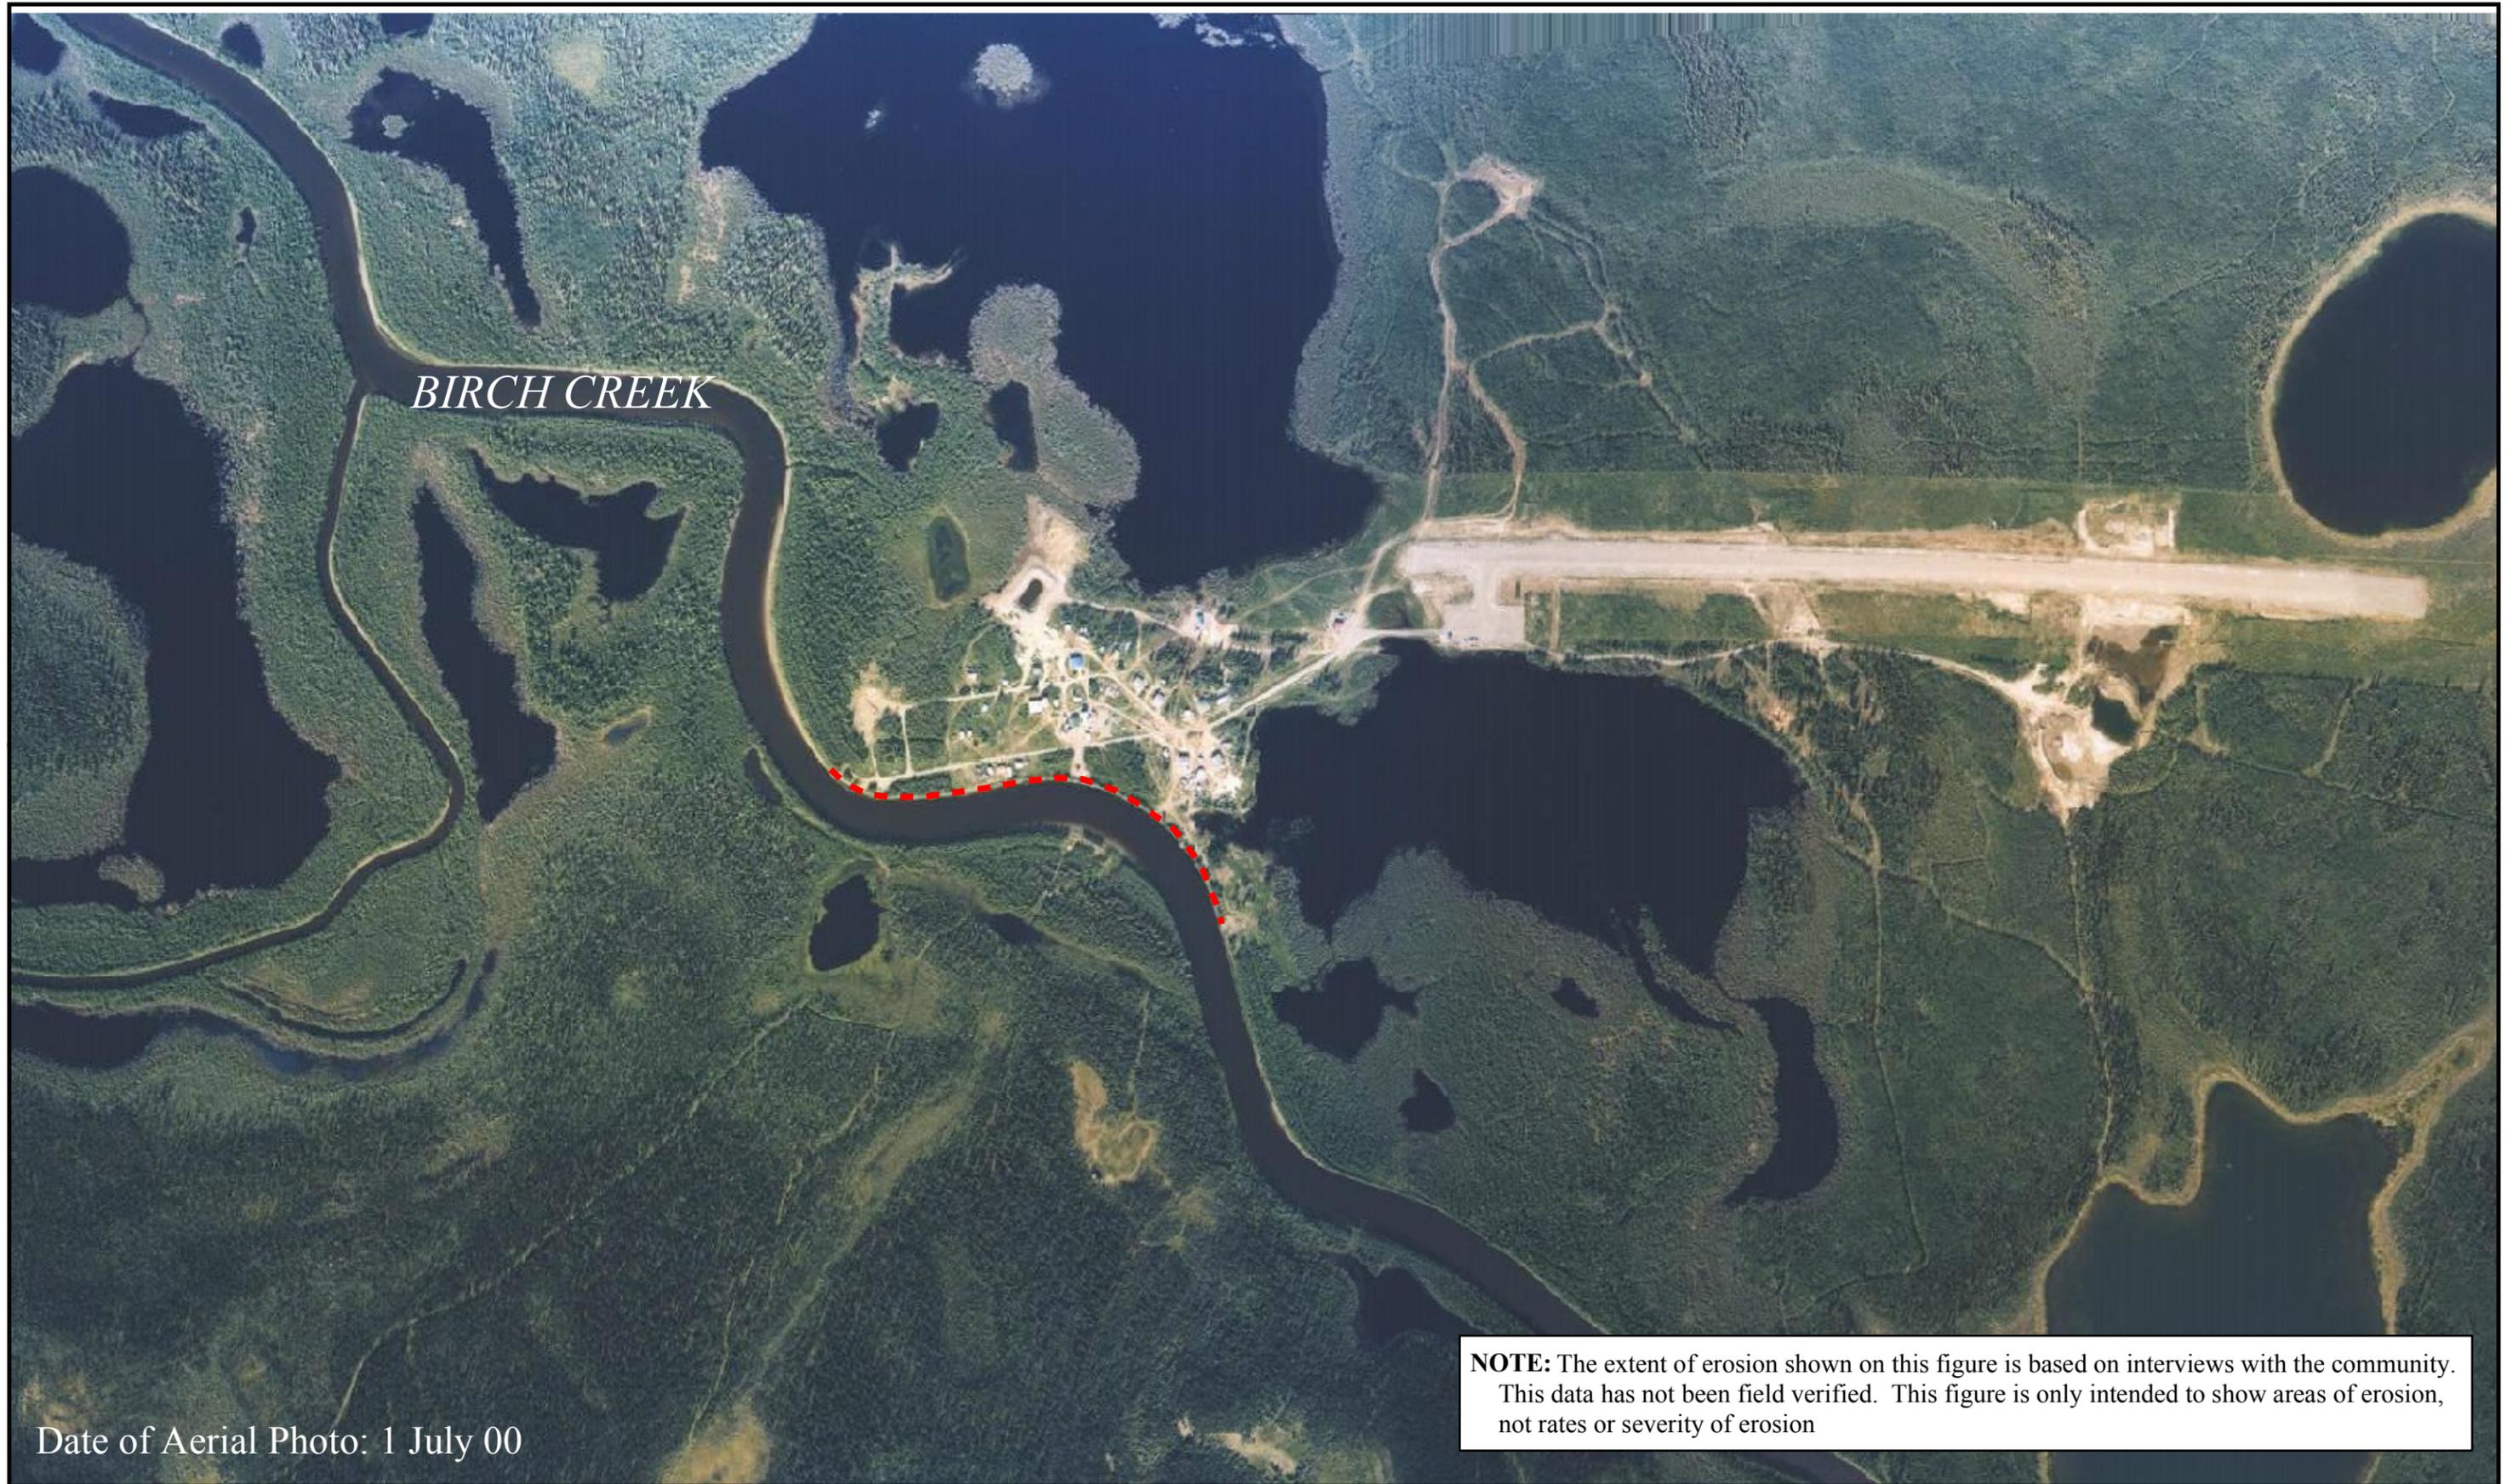
Alaska Baseline Erosion
Birch Creek, Alaska

No photos were provided by community or other sources. The attached diagrams shows the linear extent of erosion.

NOTE: The extent of erosion shown on this figure is based on interviews with the community. This data has not been field verified. This figure is only intended to show areas of erosion, not rates or severity of erosion

- - - Linear Extent of Erosion
