## **ALASKA BASELINE EROSION ASSESSMENT**

### **Erosion Information Paper - Central, Alaska**

Current as of February 11, 2008

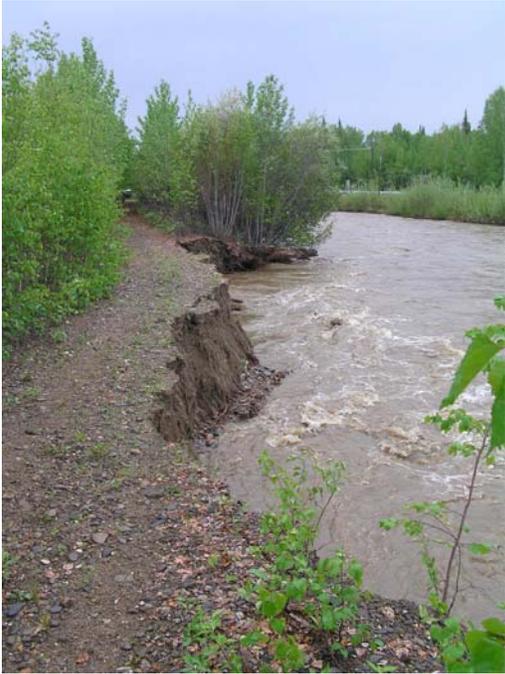
**Photo 1: Crooked Creek dike through Central during high water, June 2006.**

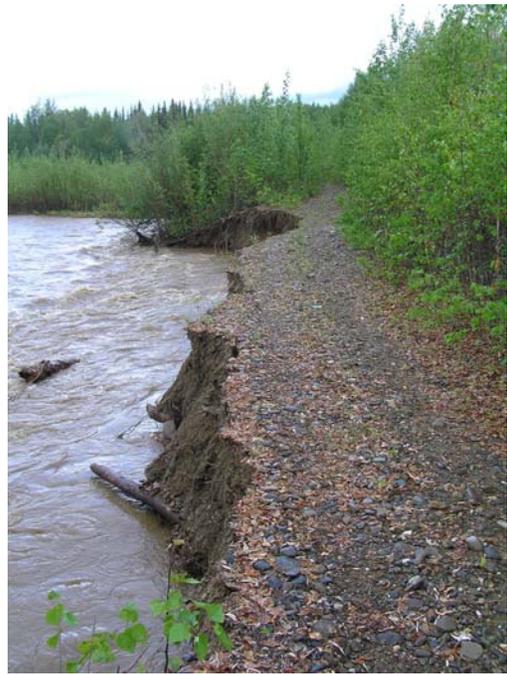
**Photo 2: Central dike during flood, June 2006.**

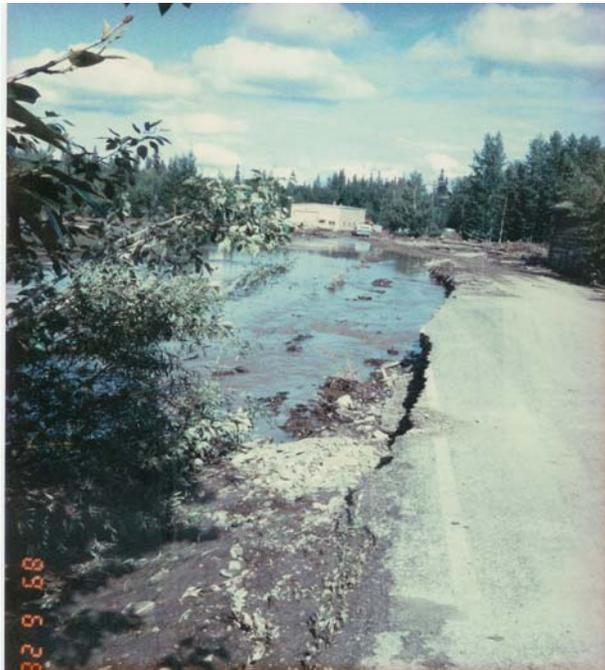
**Photo 3: Central erosion from Crooked Creek at mile 128 past the Steese Highway bridge, with DOT/PF shop in the background, 1989.**
