U.S. Army Corps  
of Engineers  
Alaska District

## ***ALASKA BASELINE EROSION ASSESSMENT***

# **Erosion Information Paper - Chignik Lagoon, Alaska**

Current as of January 5, 2008

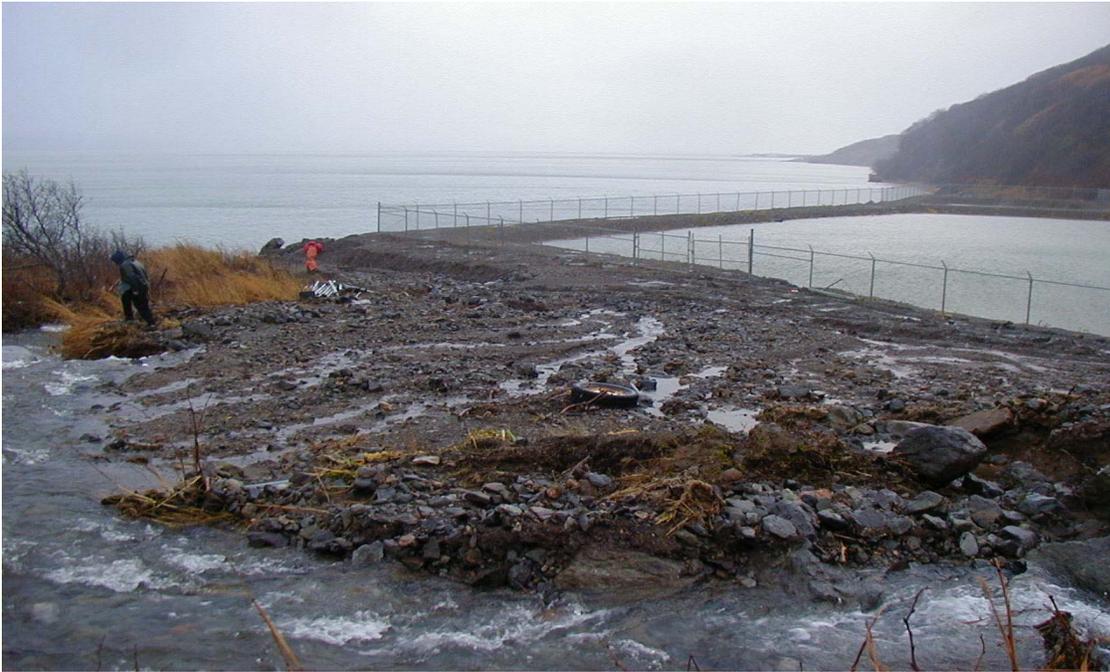
**Photo 1: Erosion around Sewage Lagoon, January 2003.**

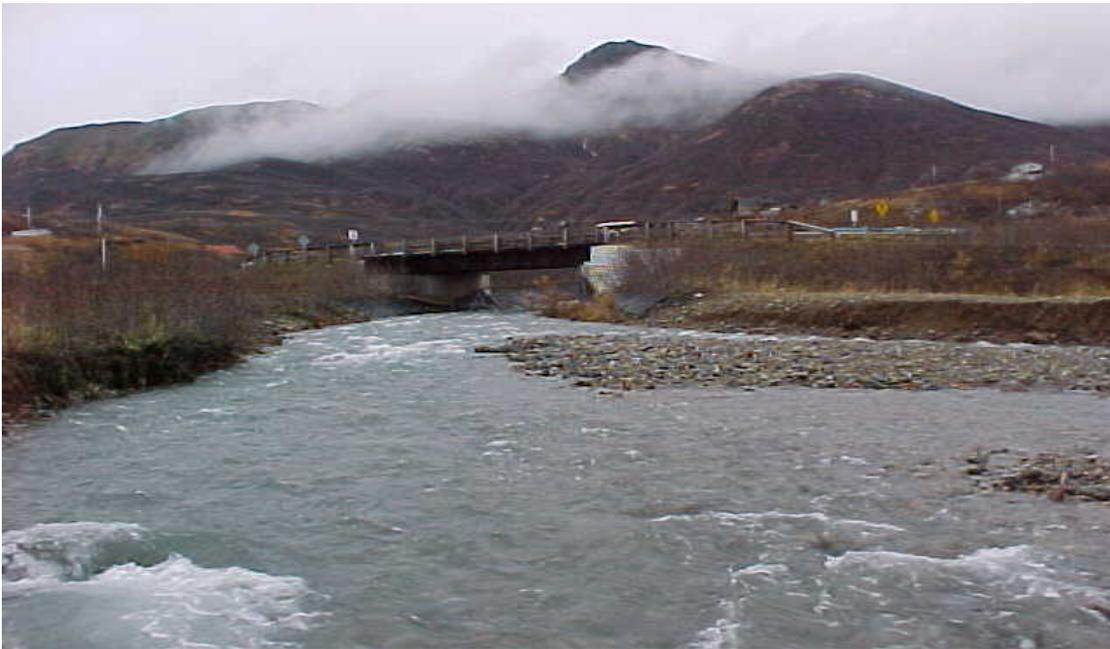
**Photo 2: Erosion along Packer Creek, near Airport, November 2002.**

The community is also subject to periodic stream erosion associated with natural processes (e.g., seasonal flow fluctuations and water level changes) along Packers Creek. Periodic overflow from Chignik Lake, down the Chignik River, and to the lagoon causes flooding and erosion.

The state-maintained 1,600-foot by 60-foot wide gravel airstrip runs through the center of the Chignik Lagoon community. One end of the runway is close to Packers Creek and the other end of the runway stops at the lagoon. The respondent in the survey estimated that up to 100 feet in total has been lost at both ends of the runway in the recent past. There is also substantial erosion at Packers Point, which is an area that juts out into the lagoon.

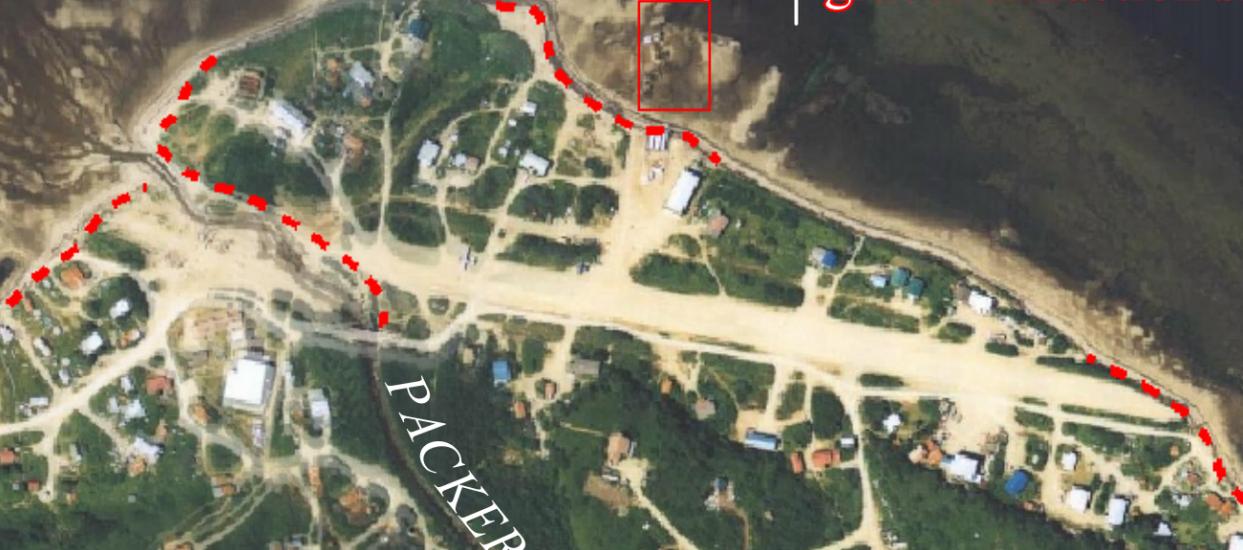
Alaska Baseline Erosion  
Chignik Lagoon, Alaska

Photos of erosion provided by the Lake and Peninsula Borough are attached. Also, attached is a diagram depicting the linear extent of erosion.

Approximate location of ANTHC gravel extraction site

--- Linear Extent of Erosion
