ALASKA BASELINE EROSION ASSESSMENT

Erosion Information Paper – Elim, Alaska

Current as of February 8, 2008

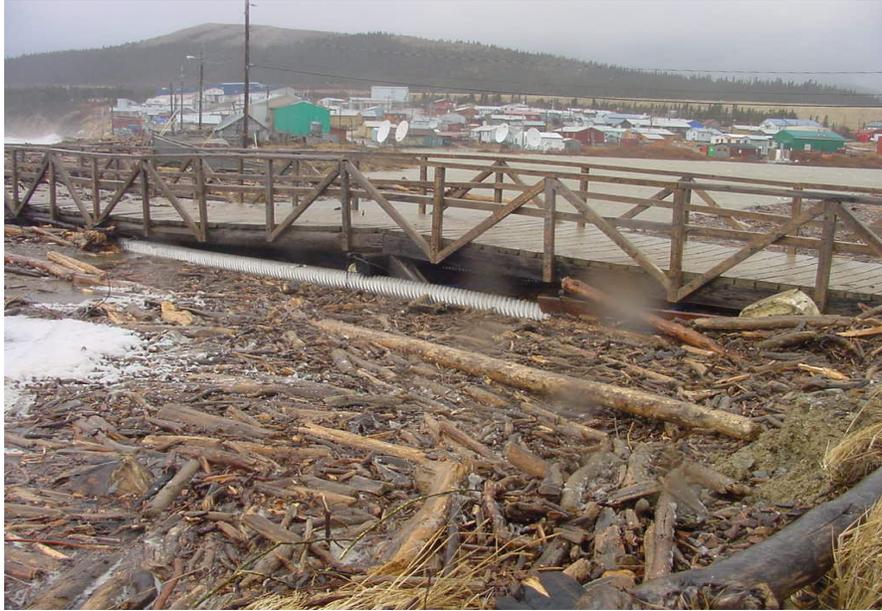
Photo 1: Damaged bridge carrying main water and sewer line, 2004.

Damages associated with the 2004 storm surge totaled \$6,900. The 2005 event damaged the main access bridge and septic lines along the coast, resulting in \$34,000 for repairs which were reimbursed by the Federal Emergency Management Agency (FEMA). The repairs included elevating the structures an estimated 5 feet and protection with rip rap. The city administrator expects these measures will help reduce further erosion damage. Six subsistence use cabins were also destroyed or damaged by the 2005 storm. In addition, the community had to replace fuel headers at the barge landing.

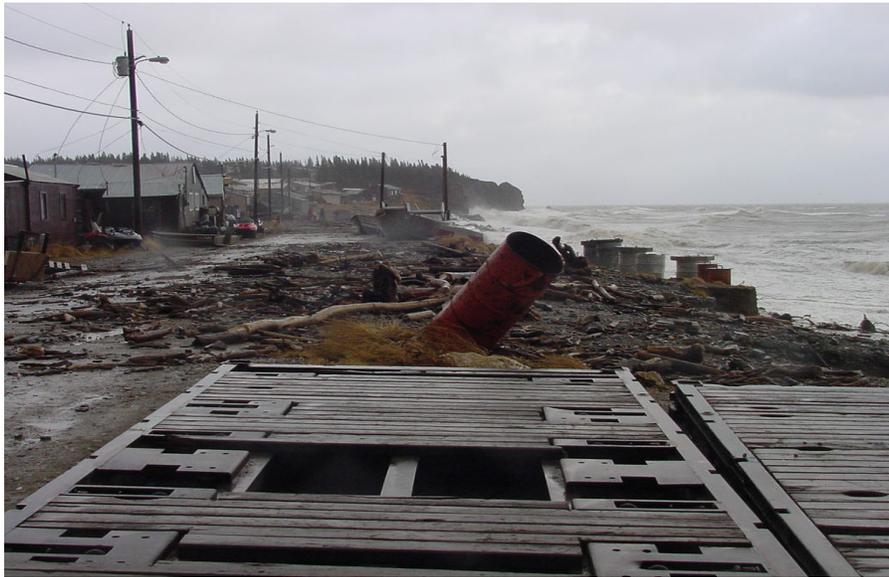
Photo 2: Beach Road looking east during October 2004 storm.
