**Community Erosion Assessment
Lower Kalskag, Alaska
4 March 2009**

1. Community: Lower Kalskag, Alaska

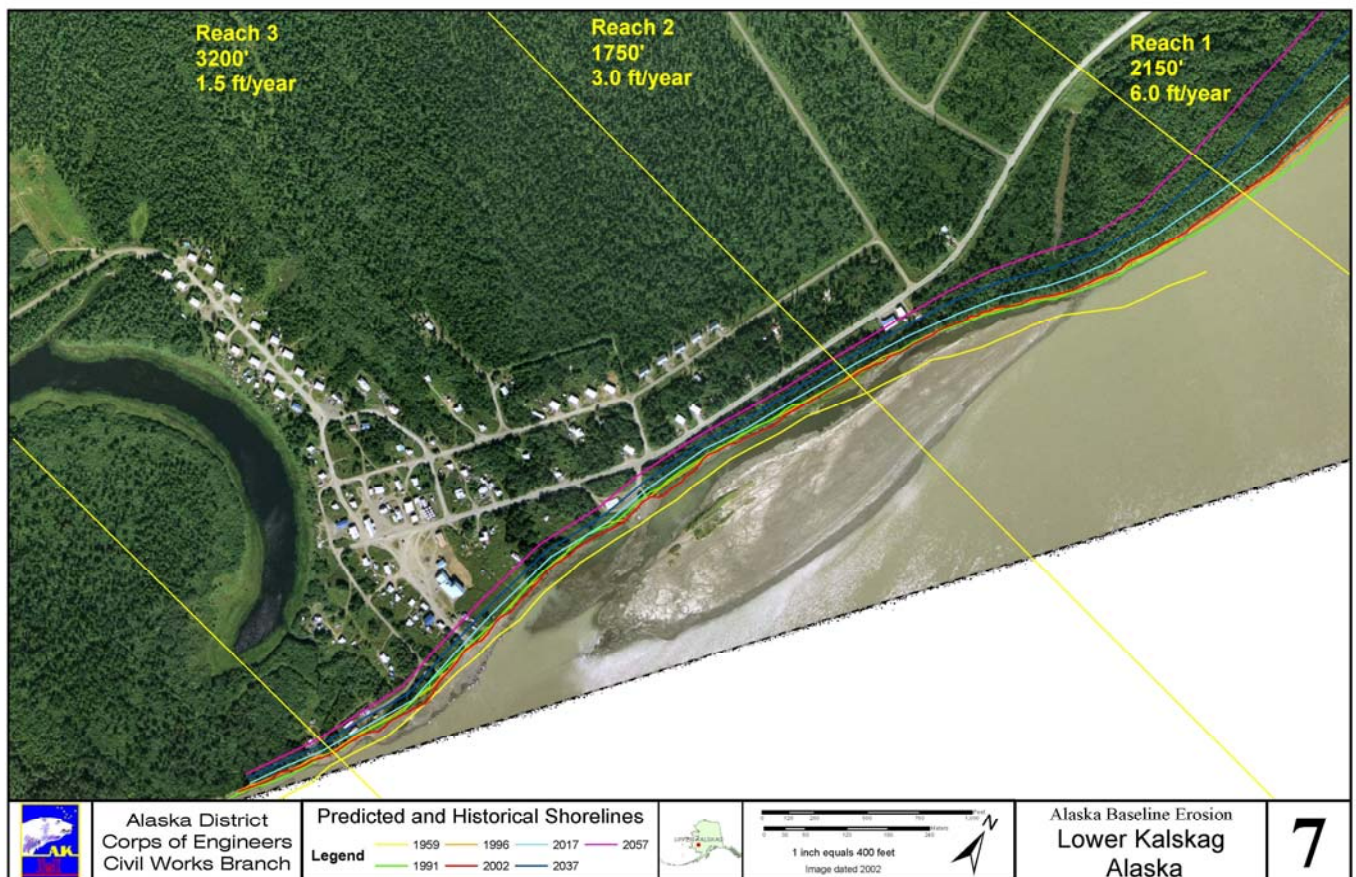
Figure 2: Lower Kalskag Erosion Map

Lower Kalskag is experiencing varying erosion rates along the majority of the community's shoreline. For the purposes of this study, the bank was divided into three river reaches of varying lengths. Reach 1 is defined as the first 2,150 feet of bank at the upstream edge of the community and is eroding at an average of 6 feet per year. Reach 2 is comprised of the next 1,750 feet of bank and stretches in front of the local store and is eroding at an average rate of 3.0 feet per year. Reach 3 is comprised of the 3,200 feet of bank in front of the main community and is eroding at an average rate of 1.5 feet per year.

One of the larger concerns relates to the cemetery in Reach 3. A portion of the grounds have already been lost to erosion. As a result, the community has moved several graves to a new cemetery located next to the church. Based on discussions with the community, it is estimated that between 250 and 300 graves exist in the old cemetery.

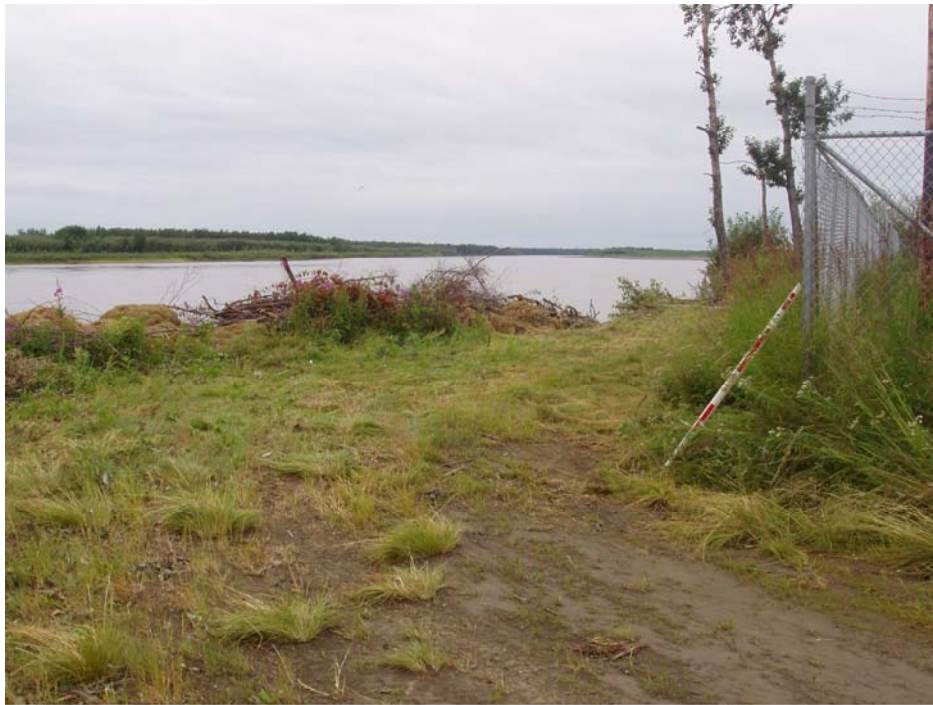
P1011202

The primary environmental concerns in Lower Kalskag are the fuel farms. The surrounding soils are likely contaminated and will pose a threat to the local ecosystem and related fish stocks when they are eroded away. Decommission and closure of the facility is essential to avoid these harmful effects. Based on our above assumptions, this will be necessary within the 11 to 30 year time frame. This process has a cost of \$491,000 million with a net present value of \$217,000 and an average annual cost of \$11,200.

**Photo 1. Perimeter fence around old tank farm, upstream corner 25.0' from top of bank.
Downstream corner <1' from top of bank.**

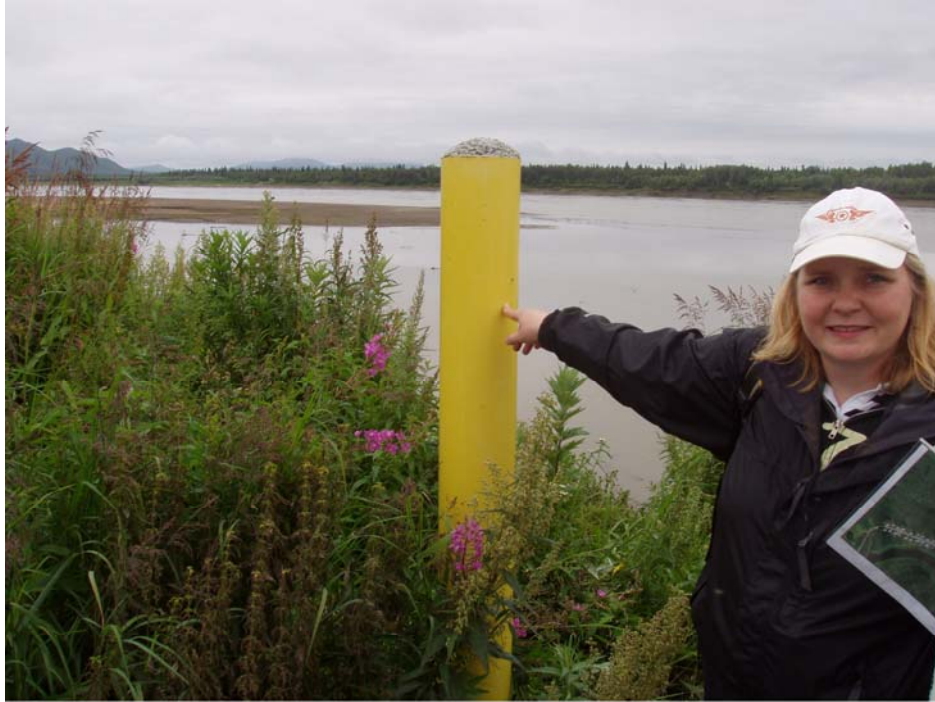
N 61° 30.727' W 160° 21.605' Lower Kalskag P1011212
Photo 2. Bollard protecting school filling point looking towards the river, 7.0' to the top of bank.

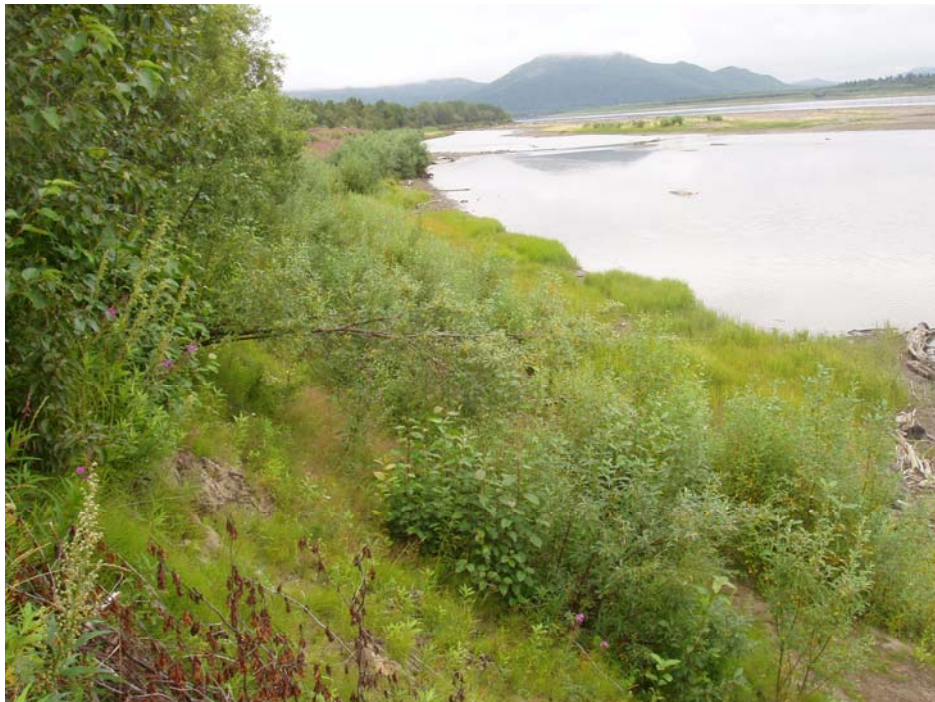
N 61° 30.755' W 160° 21.582' Lower Kalskag P1011215
Photo 3. Looking upstream from the top of bank in front of the cemetery. Planted willows in the background.

1. Relocate the graves from the old cemetery to the newly established cemetery that is located much further from the river bank.
2. Construct a 600-foot riprap revetment to protect the cemetery from further erosion at a cost of \$1.7 million (\$2,333 per linear foot). This revetment will provide protection for the design life of the structure with future protection required as the river erodes upstream and downstream of the revetment.
3. Relocate the school's fuel filling point further back from the top of bank.
4. Long range plans should include relocation of the Kalskag Native Store. (30+ years).
