ALASKA BASELINE EROSION ASSESSMENT

Erosion Information Paper - Mary's Igloo, Alaska

Current as of April 14, 2008

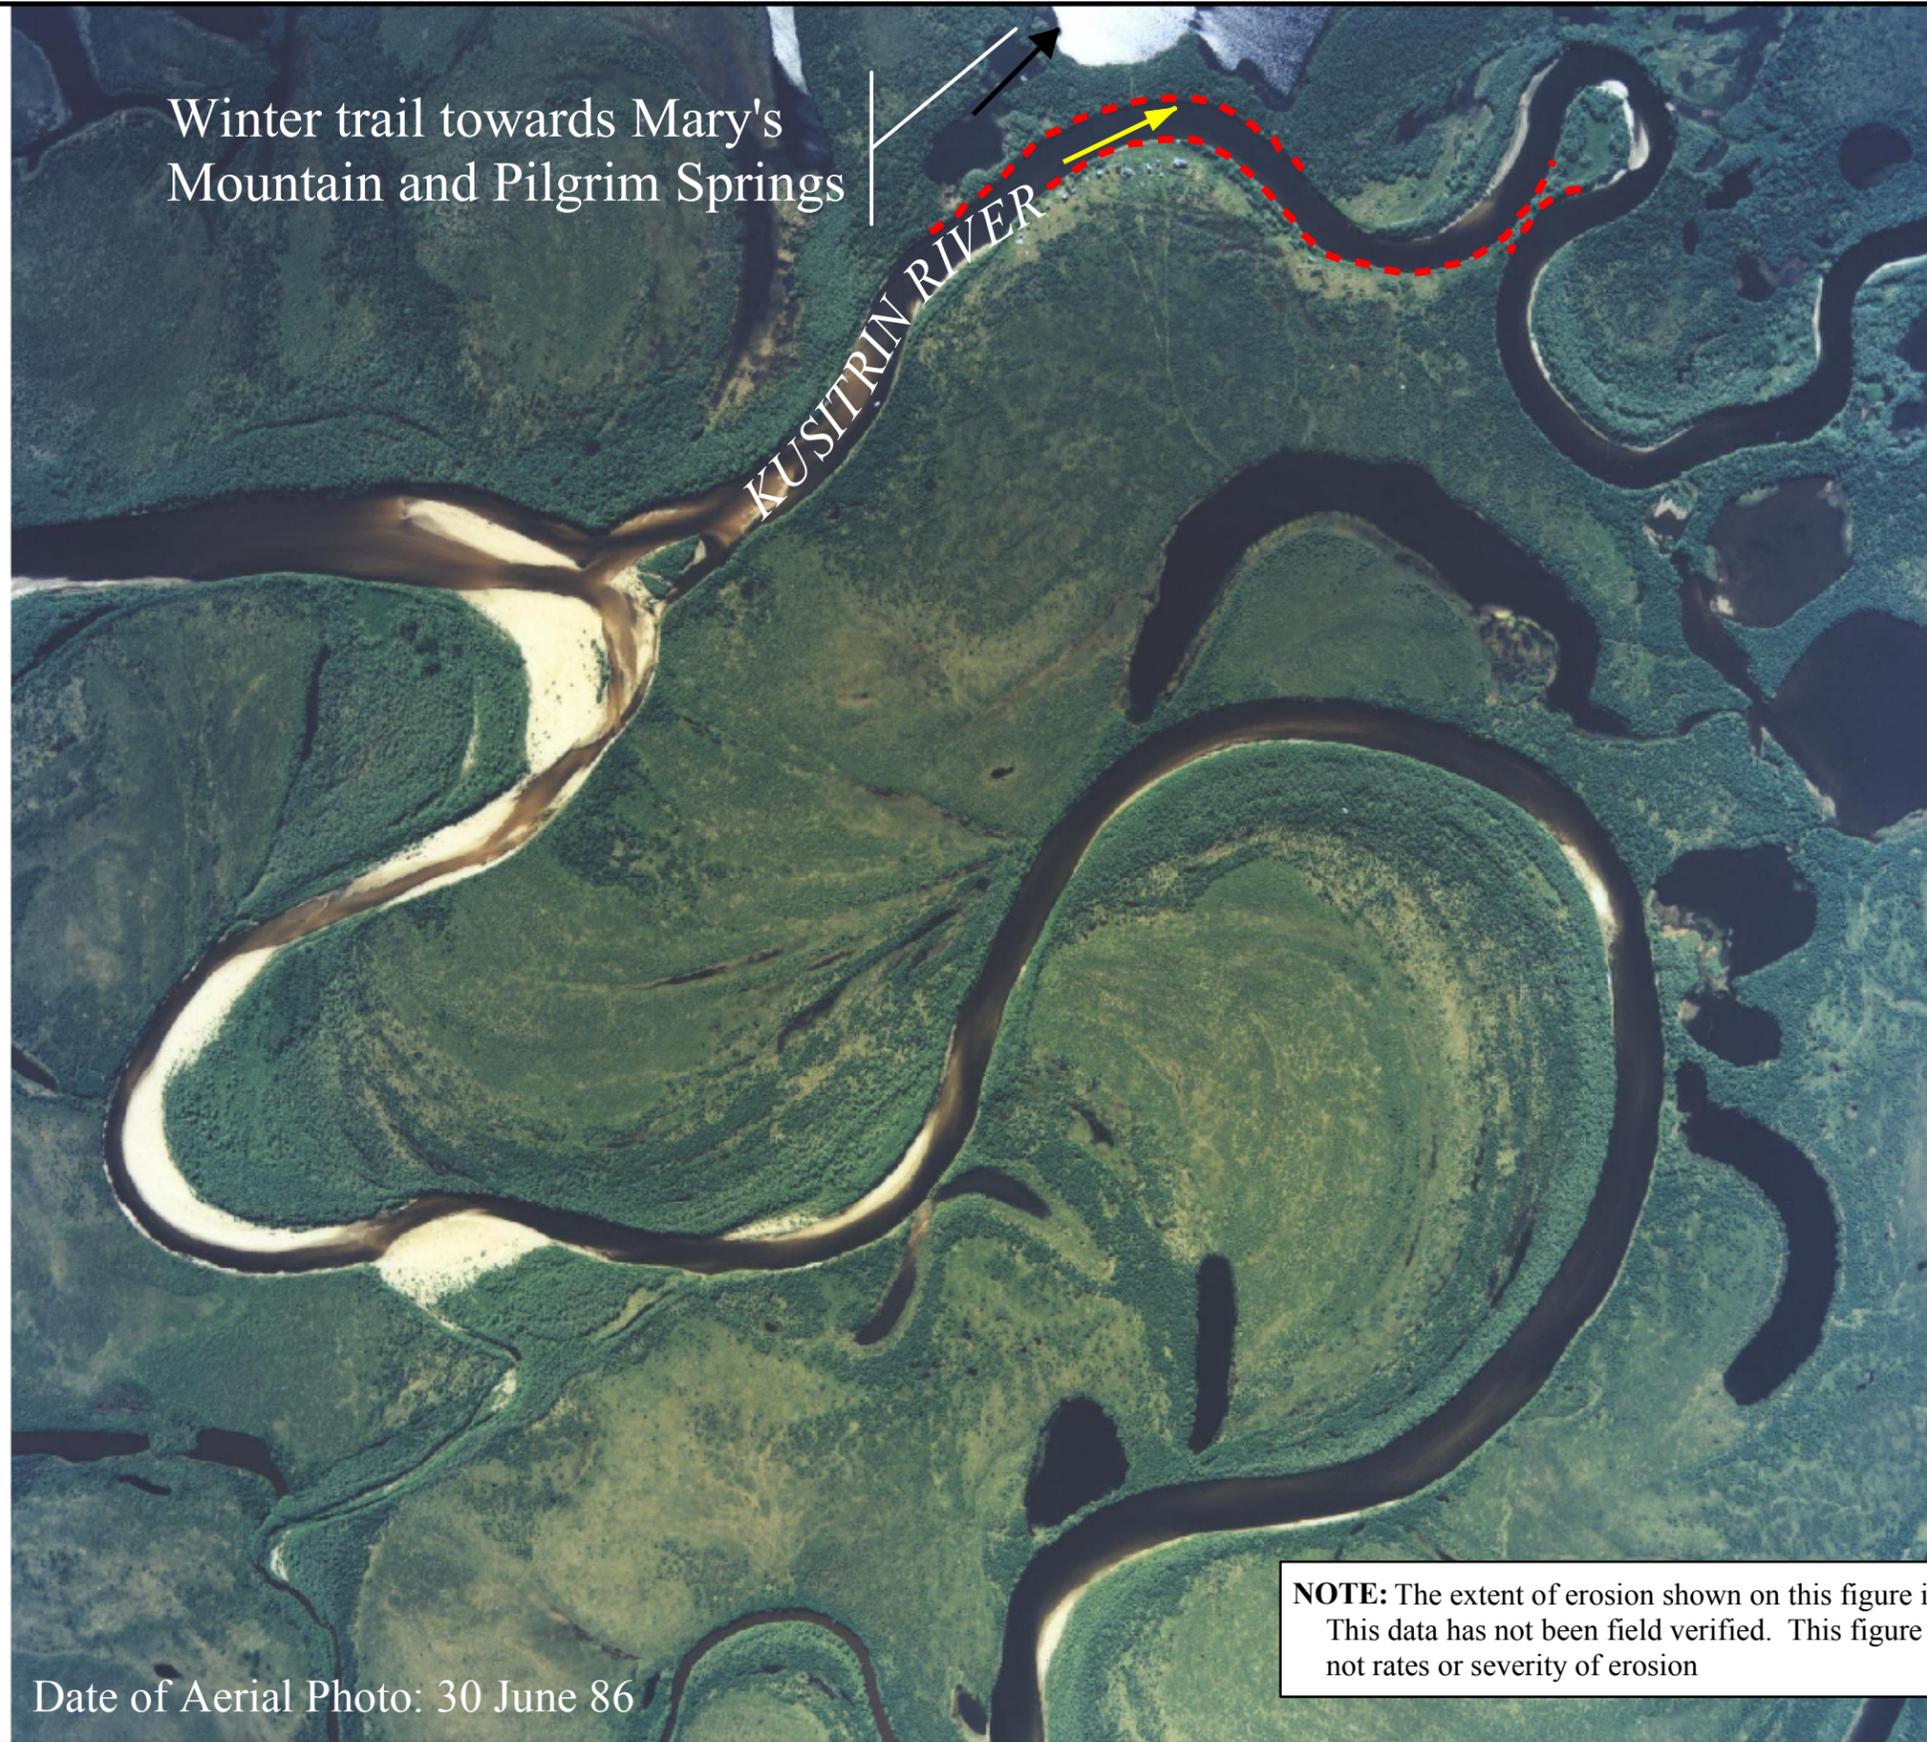
Alaska Baseline Erosion
Mary's Igloo, Alaska

Bank erosion at Mary's Igloo along the Kuzitrin River is caused by periodic fluctuations in river flow and levels, flooding, ice jams, spring break up, melting permafrost, and beaver dams. There have been 5 major erosion events during the past 20 years with the most recent event in 2005. The amount of riverbank lost was not provided. Ongoing annual bank erosion is estimated at 1 to 2 feet per year.

No photos were provided by community or other sources. The attached diagram shows the linear extent of erosion.

NOTE: The extent of erosion shown on this figure is based on interviews with the community. This data has not been field verified. This figure is only intended to show areas of erosion, not rates or severity of erosion

--- Linear Extent of Erosion
