**Community Erosion Assessment
Napaskiak, Alaska
27 January 2009**

1. Community: Napaskiak, Alaska

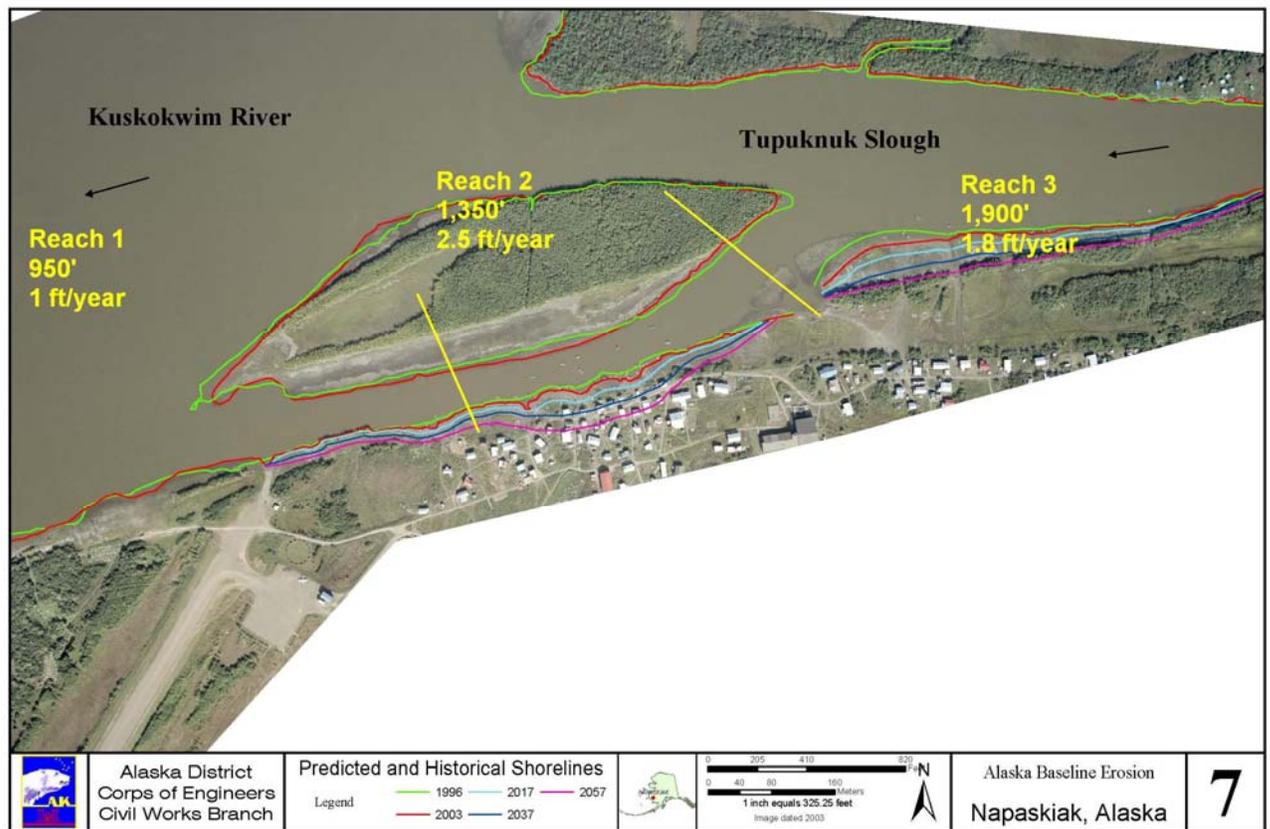
Figure 2. Napaskiak Erosion Map

The community of Napaskiak is oriented along the south bank of Tupuknuk Slough with a large setback from the bank for most of the length of the community. For this study the community was divided into three reaches. Reach 1 is a 950-foot length of bank at the

downstream end of Tupuknuk Slough and is eroding at a rate of 1 foot per year. Reach 2 is a 1,350-foot reach of bank directly fronting the community. Tupuknuk Slough runs between the community and an island at this point. It is the preferred location for boat launchings and landings and is eroding at a rate of 2.5 feet per year. Reach 3 is a 1,900-foot reach of bank at the upstream end of the village prior to the island and is eroding at 1.8 feet per year.

While erosion is not currently a major problem at Napaskiak, the morphology of the sloughs that run past the community suggest that erosion will increase as time progresses. Northeast of Napaskiak is a small slough that feeds into Tupuknuk Slough. From aerial and surface photography, it appears that the thalweg of the Kuskokwim River is beginning to run into this slough which could explain why the depth of the slough is increasing. The initial breach reportedly occurred in 2005 and the Kuskokwim River is moving between 10 and 15 feet a year towards this slough. The Kuskokwim River is approximately 60 feet deep at the bend where the breach occurs. As the thalweg of the Kuskokwim meanders, flow through this small slough will increase causing the channel to widen and deepen.

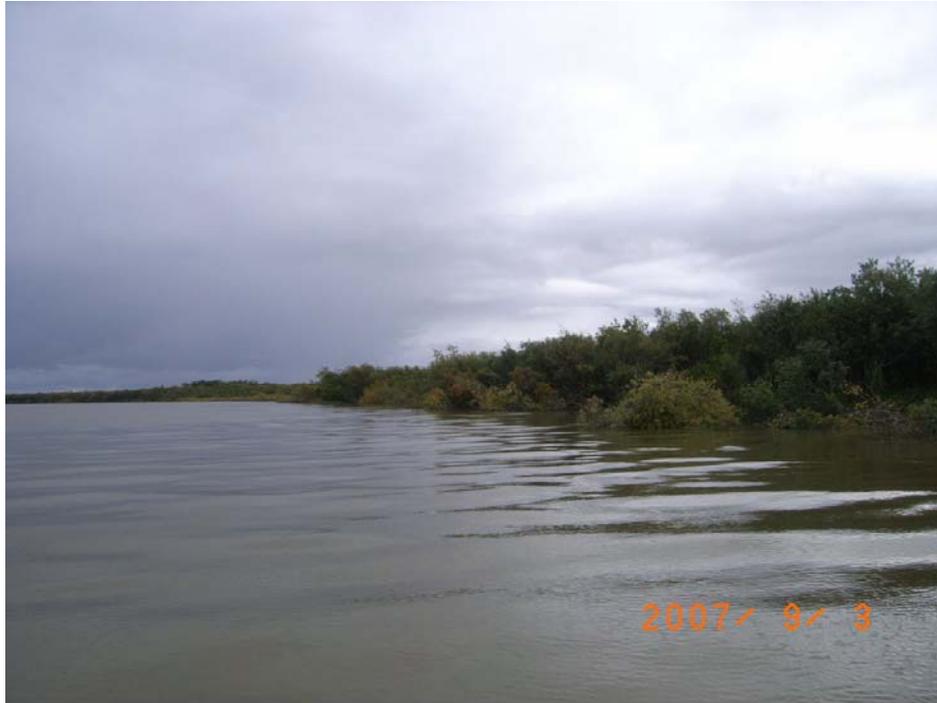
RIMG0072

Photo 1: Reach 3.

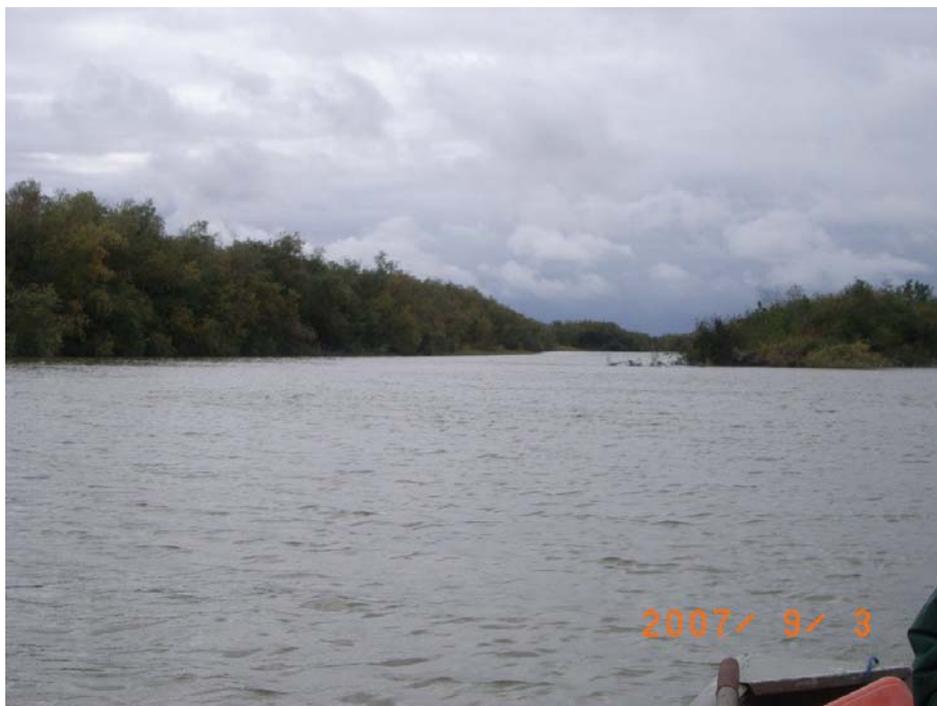
RIMG0091

Photo 2: Looking downstream at the inlet of the slough from the Kuskokwim River. As the Kuskokwim migrates towards this slough, flow past Napaskiak is expected to increase.

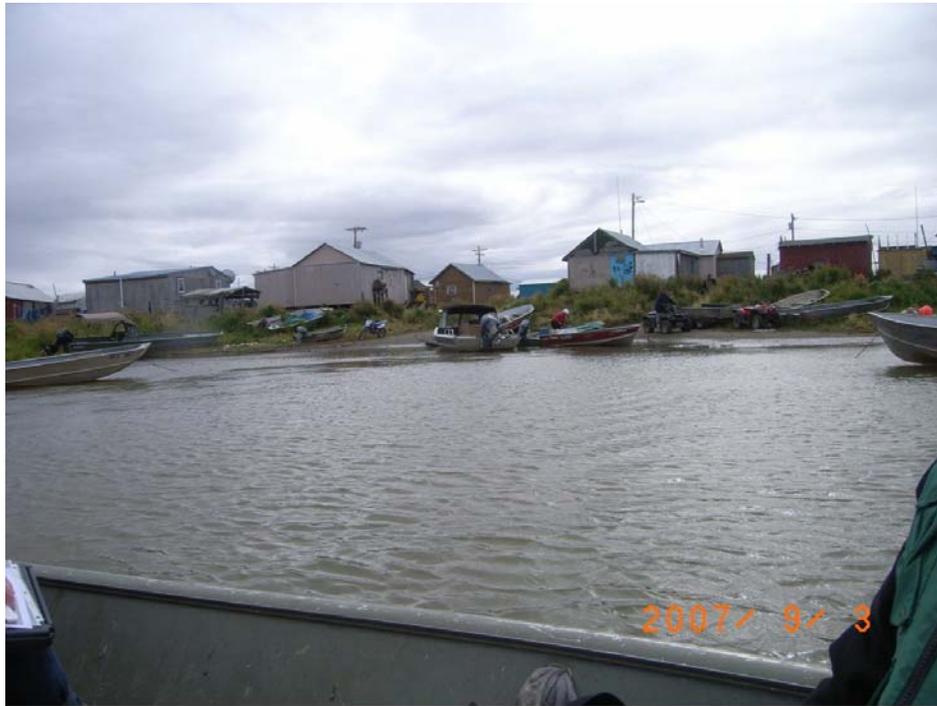
RIMG0058

Photo 3: Looking at the bank from the water in Reach 2.

An articulated concrete revetment could be constructed to protect the mooring area of Napaskiak. The bank would be graded to a uniform surface and a separation geotextile fabric would then be placed over the gravel fill with a nine inch articulated concrete matt placed upon this fabric. The toe of the articulated matt would be placed six feet minimum below the existing channel bed to prevent undercutting of the matt. Gravel would be backfilled over the toe of the matt to provide scour protection. Approximate cost is \$4.0 million which is approximately \$3,300 per linear foot of revetment.
