U.S. Army Corps  
of Engineers  
Alaska District

## **ALASKA BASELINE EROSION ASSESSMENT**

# **Erosion Information Paper – Nelson Lagoon, Alaska**

Current as of September 24, 2007

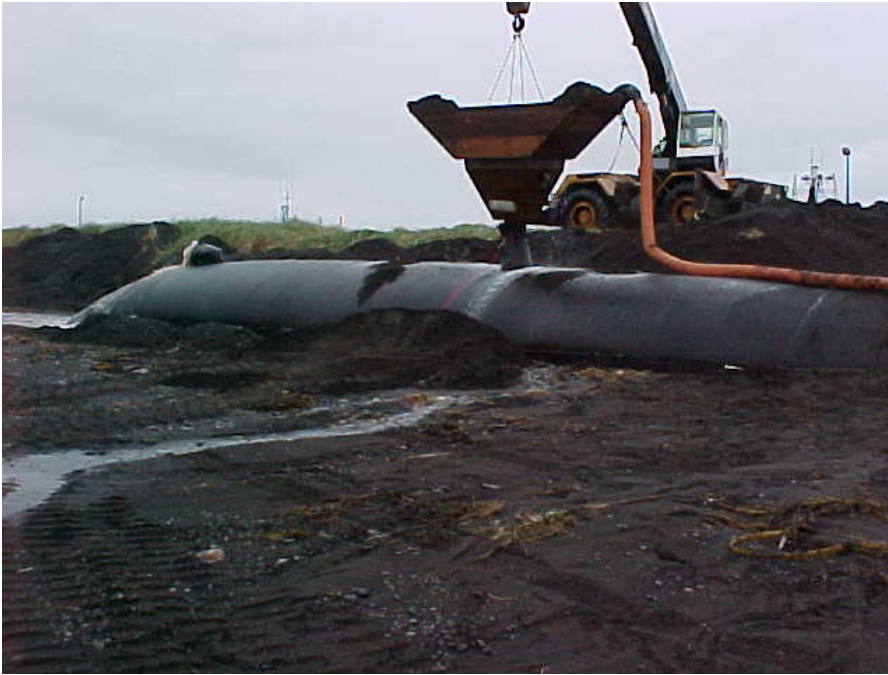
**Photo 1: Demonstration Erosion Control Project; installation of geotubes, September 2005.**

In recent years the community has installed the following major erosion protection measures along the beach: (a) placement of gabions to anchor existing wood in the breakwater; and (b) placement of geotube containment structures, consisting of sediment-filled sleeves of geotextile fabric. The completed structure includes about 300 linear feet of geotube that is 5 feet high, with a 7½-foot attached scour apron on the seaward side to prevent toe scour.

The geotube placement was a demonstration project funded by a \$100,000 Coastal Impact Assistance Program grant to the AEB. The project, completed in September 2005 has been in place for too short a time period for the community to assess its effectiveness.

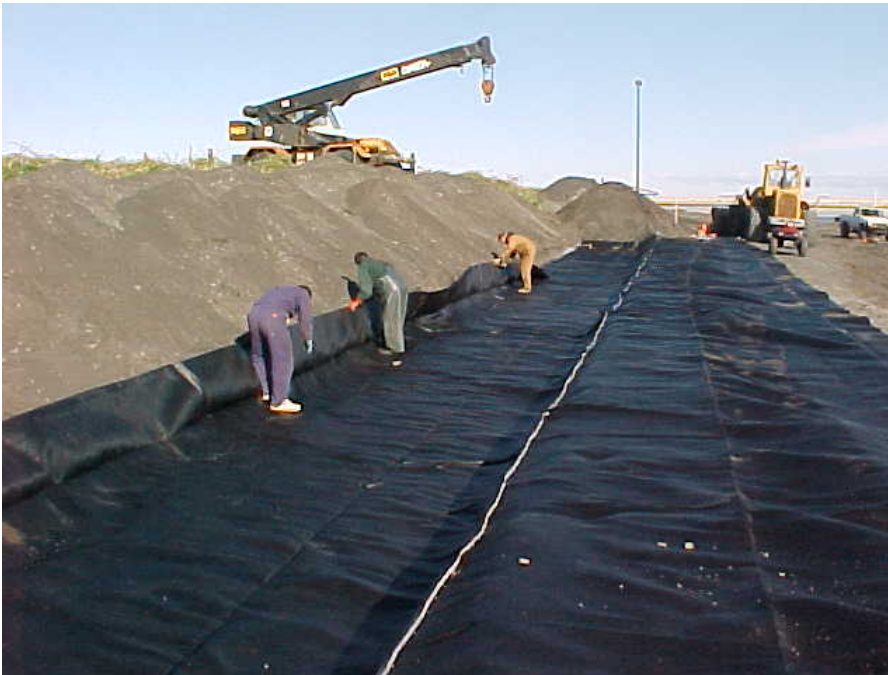
**Photo 2: Community members preparing to install geotube near dock, September 2005.**
