ALASKA BASELINE EROSION ASSESSMENT

Erosion Information Paper - Nome, Alaska

Current as of January 7, 2008.

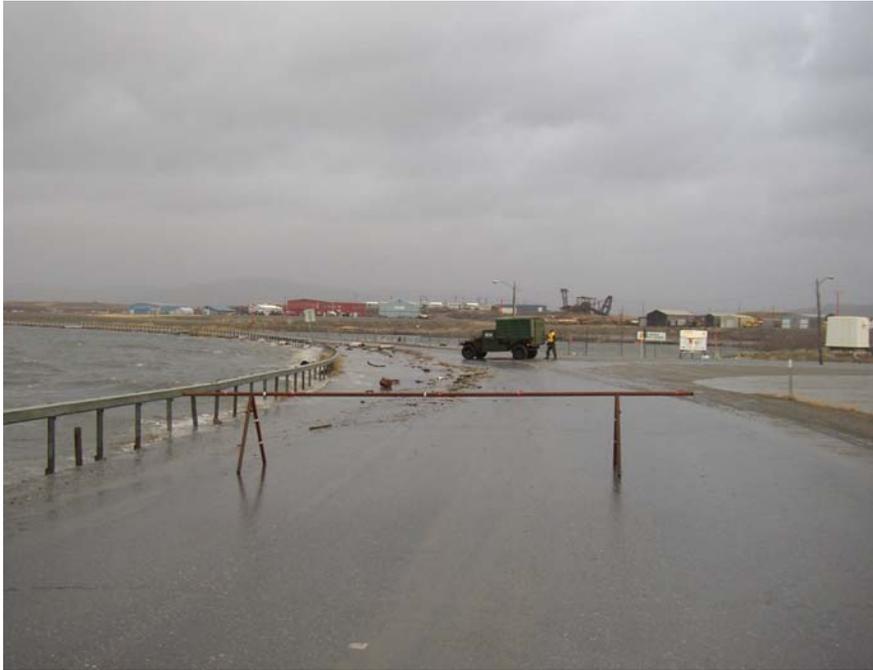
Photo 1: Storm surge on Seppala Drive looking north away from Harbor towards the airport; photo courtesy of City of Nome, October 2004.

The new harbor entrance channel is reportedly causing erosion of the Snake River bank along Seppala Drive, which follows the Snake River to where it empties into the Nome Boat Harbor at Belmont Point. The eroding bank is 10 feet high. Alaska Department of Transportation and Public Facilities (DOT&PF), funded through Federal Emergency Management Agency, was used in the recent past as an erosion protection measure. The present erosion area along Seppala Drive is less than a 100 feet from the roadway; utility poles, telephone and cable lines, the airport runway, and airport facilities. The DOT&PF is planning to repair Seppala Drive in 2008.

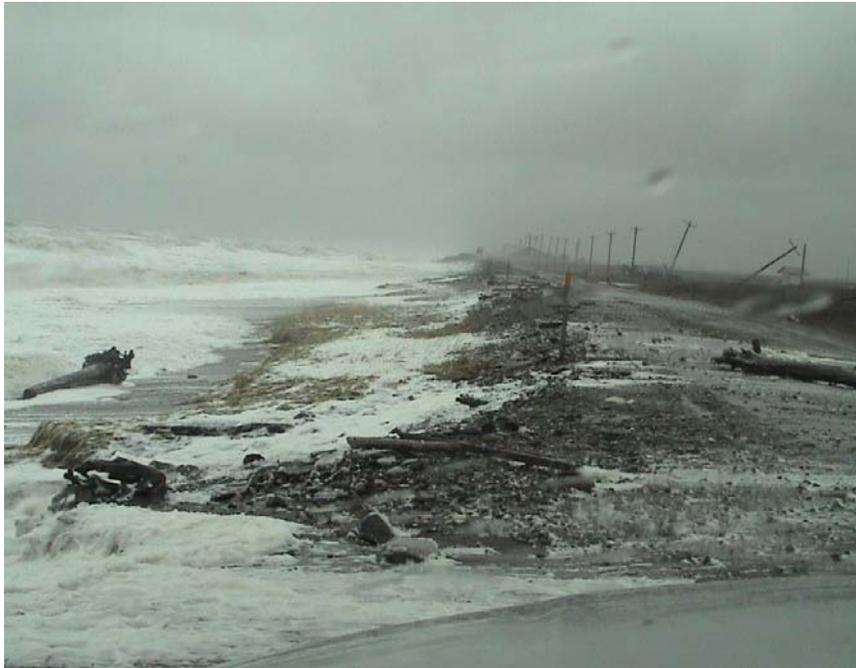
Photo 2: Photo of the October 2004 storm from the cover of the *Nome All-Hazards Plan*; Photo by Megan Hahn.

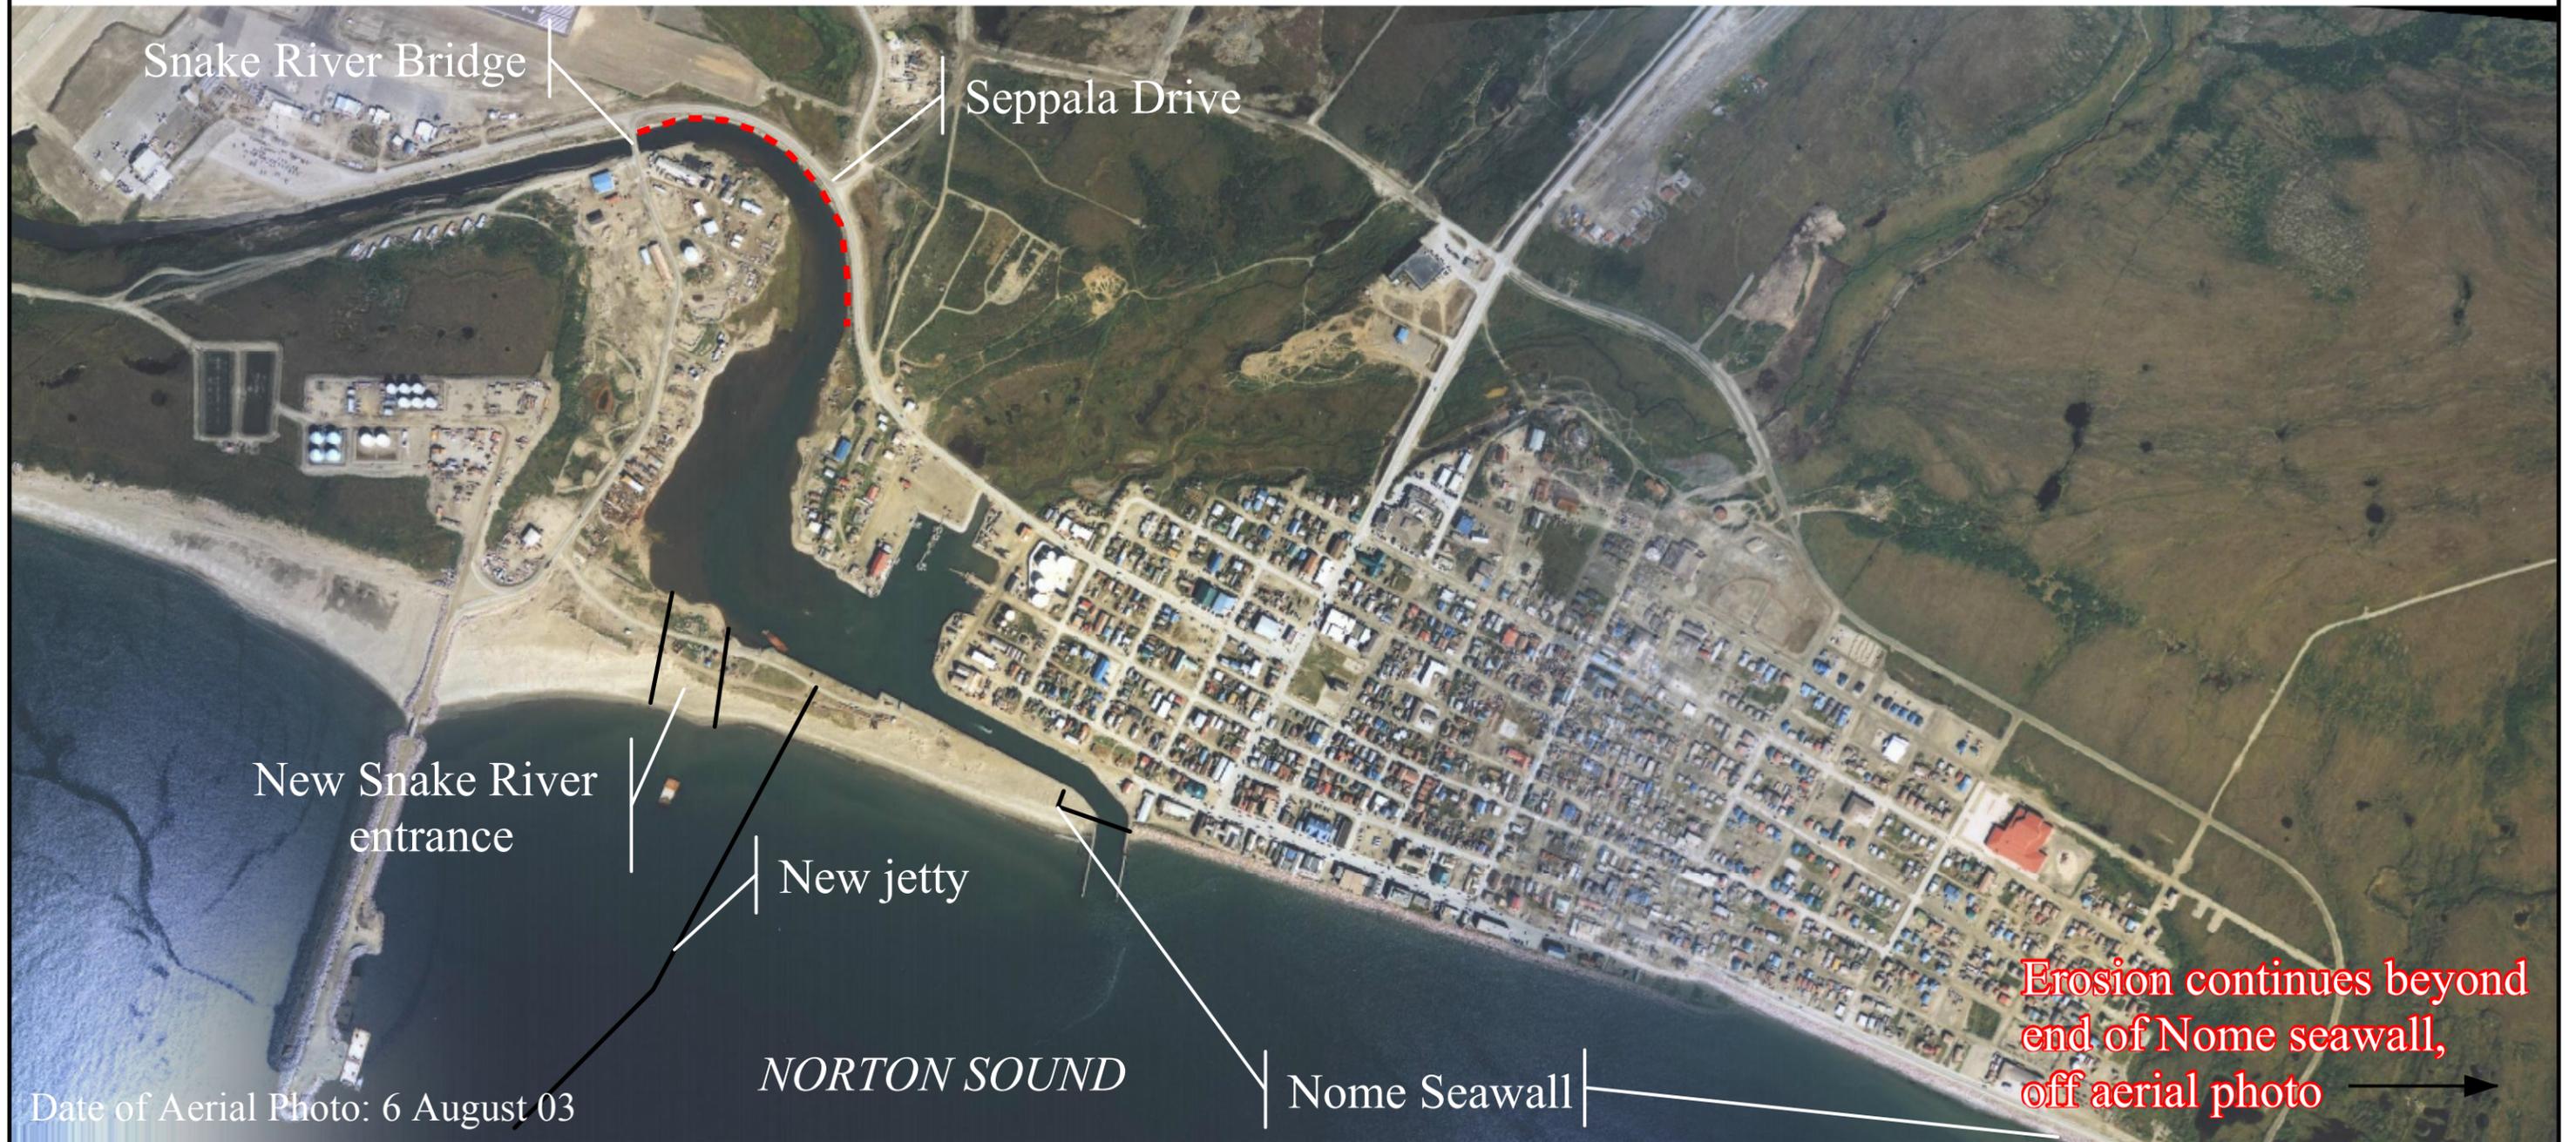
Alaska Baseline Erosion
Nome, Alaska

NOTE: The extent of erosion shown on this figure is based on interviews with the community. This data has not been field verified. This figure is only intended to show areas of erosion, not rates or severity of erosion

--- Linear Extent of Erosion

Photos provided by the community showing storm surge are attached. A diagram depicting the linear extent of is also attached.
