ALASKA BASELINE EROSION ASSESSMENT

Erosion Information Paper - Ouzinkie, Alaska

Current as of November 15, 2007

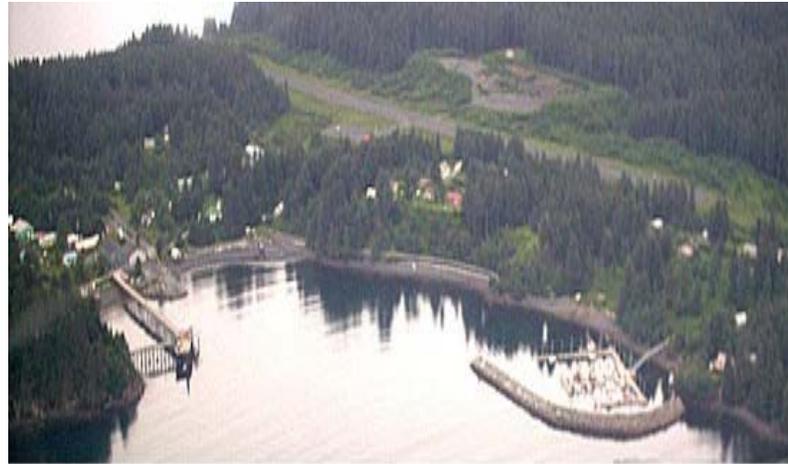
Photo 2: Ouzinkie & small boat harbor, no photo date available.

Picture of Ouzinkie and boat harbor taken from airplane
