## **ALASKA BASELINE EROSION ASSESSMENT**

### **Erosion Information Paper – Saint Michael, Alaska**

Current as of September 21, 2007

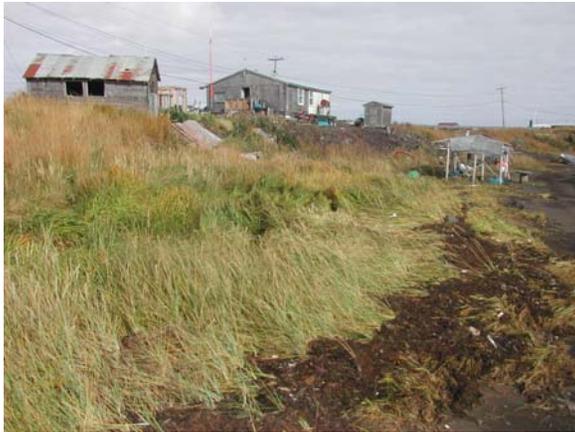
**Photo 1: St. Michael beach erosion in front of Albert Washington's home. Note gravel added for erosion protection in front of home, September 2007.**

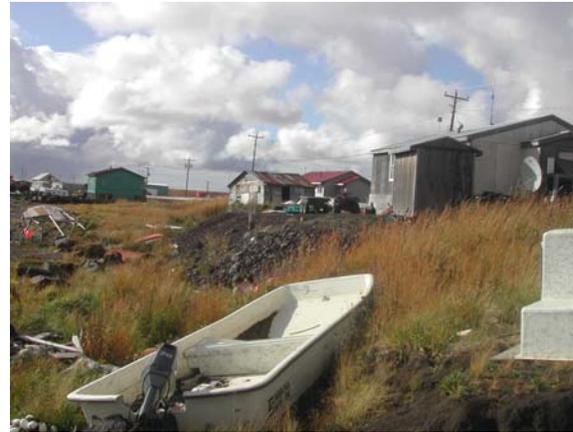
**Photo 2: St. Michael beach erosion in front of Albert Washington's home. The poles in the ground are remnants of a home that was moved to avoid the erosion. Green building in background is the Sewage Treatment Plant. September 2007.**

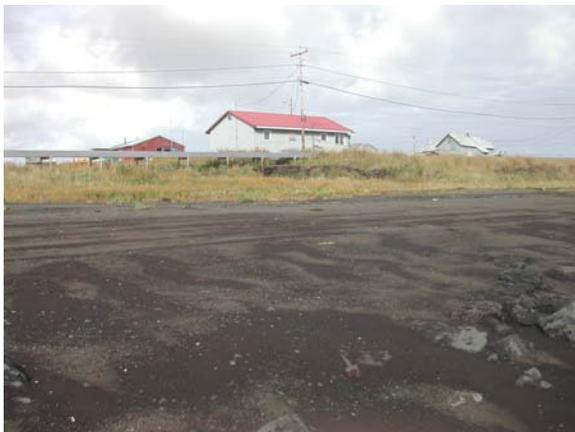
**Photo 3: Saint Michael beach erosion, September 2007.**

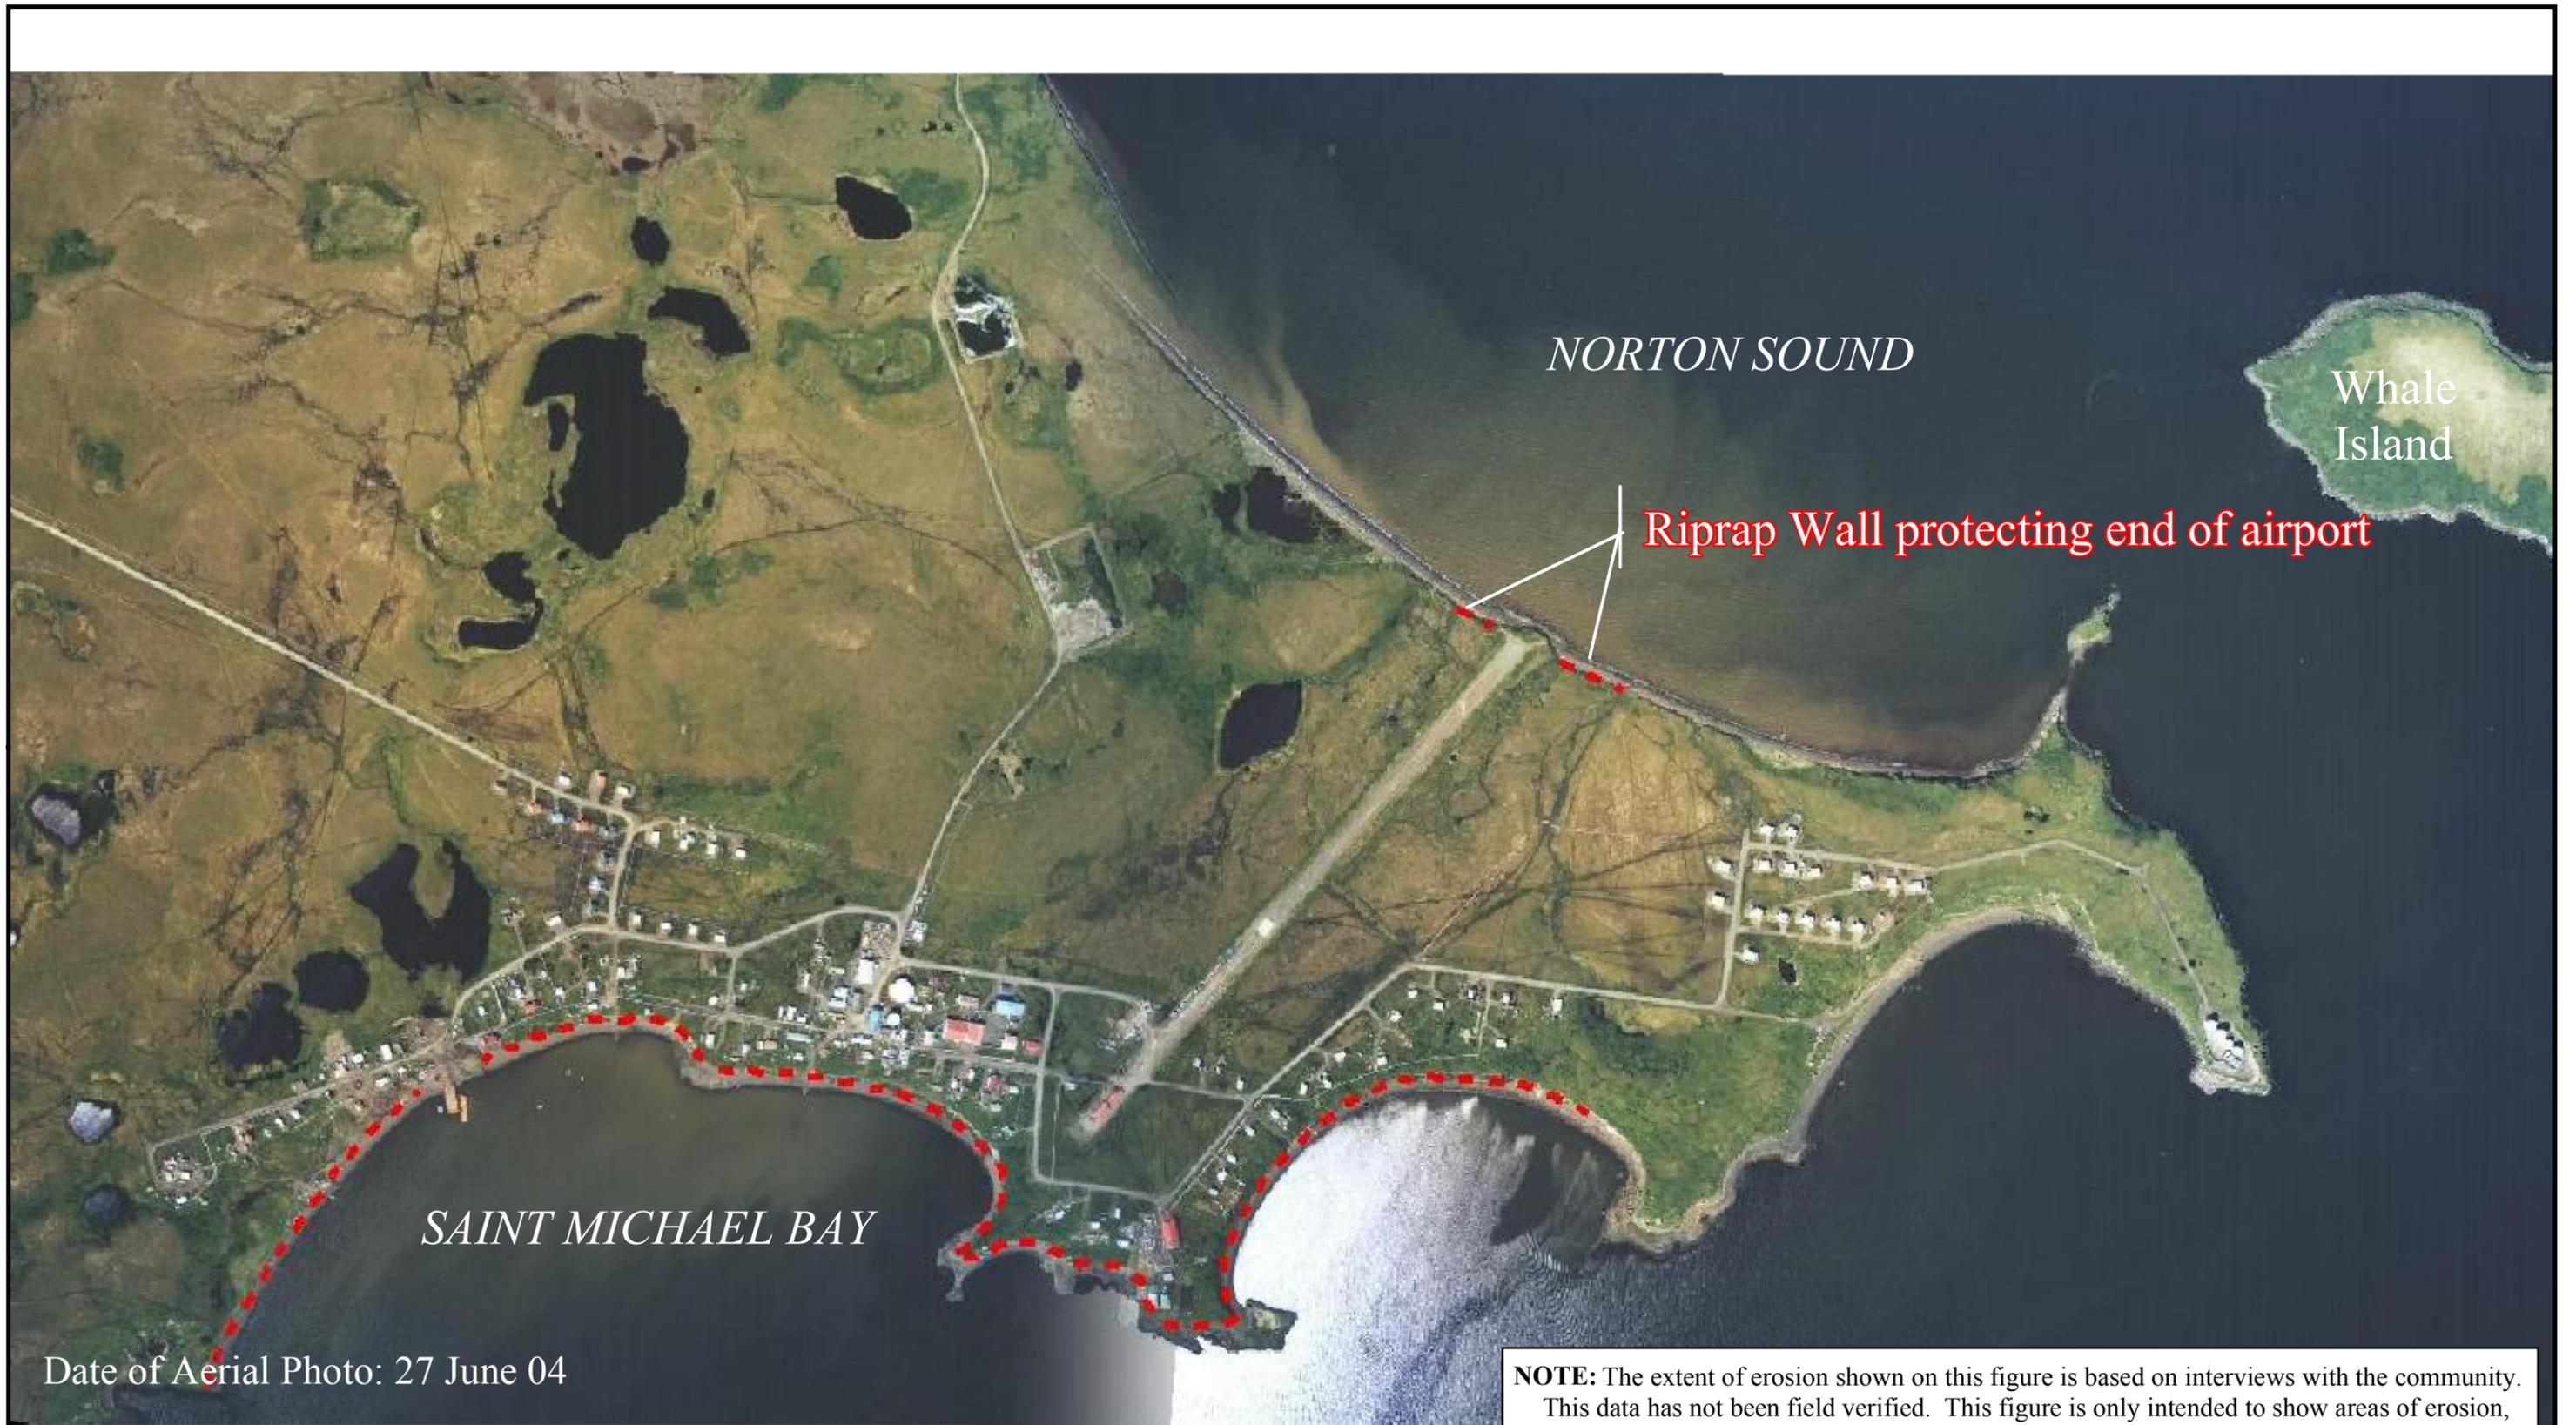
Alaska Baseline Erosion  
Saint Michael, Alaska

Attached is a diagram depicting linear extent of erosion in the community.

----- Linear Extent of Erosion
