## **ALASKA BASELINE EROSION ASSESSMENT**

### **Erosion Information Paper - Tazlina, Alaska**

Current as of February 29, 2008

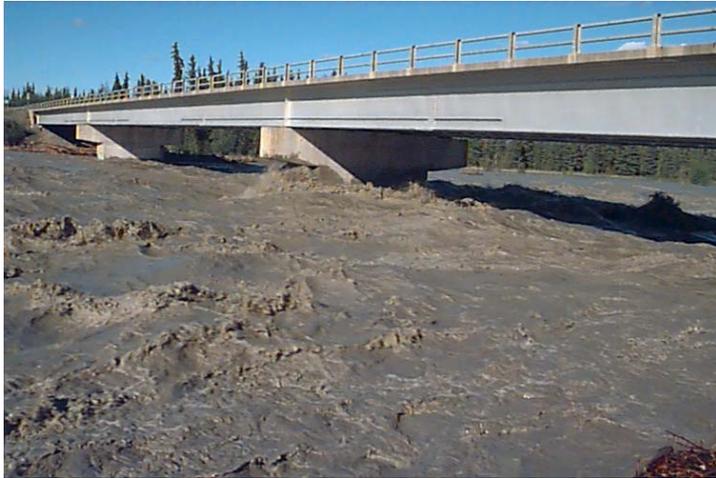
**Photo 1: Tazlina River at the Richardson Highway Bridge, photo courtesy of Michael L. Bird, November 14, 1998.**

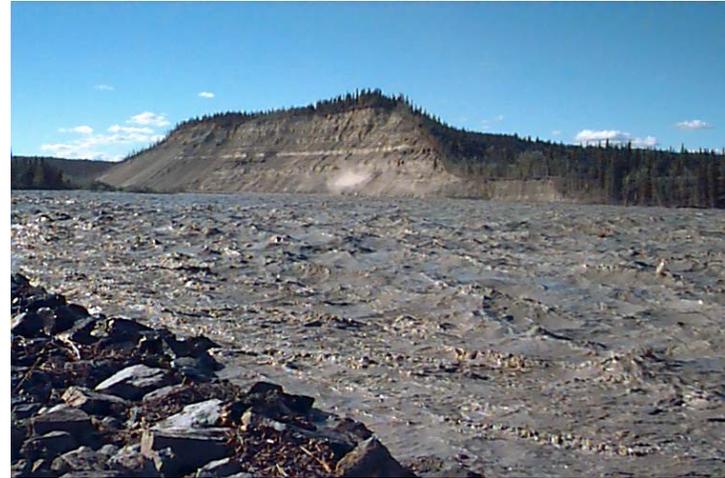
**Photo 2: Tazlina River during November 14, 1998 high water, photo courtesy of Michael L. Bird.**

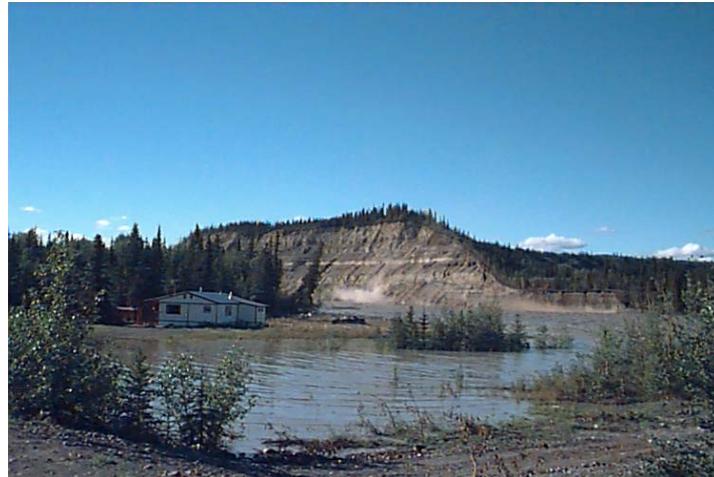
**Photo 3: Home in foreground is upstream and on the south side of the Tazlina River Bridge, photo courtesy of Michael L. Bird, November 14, 1998.**

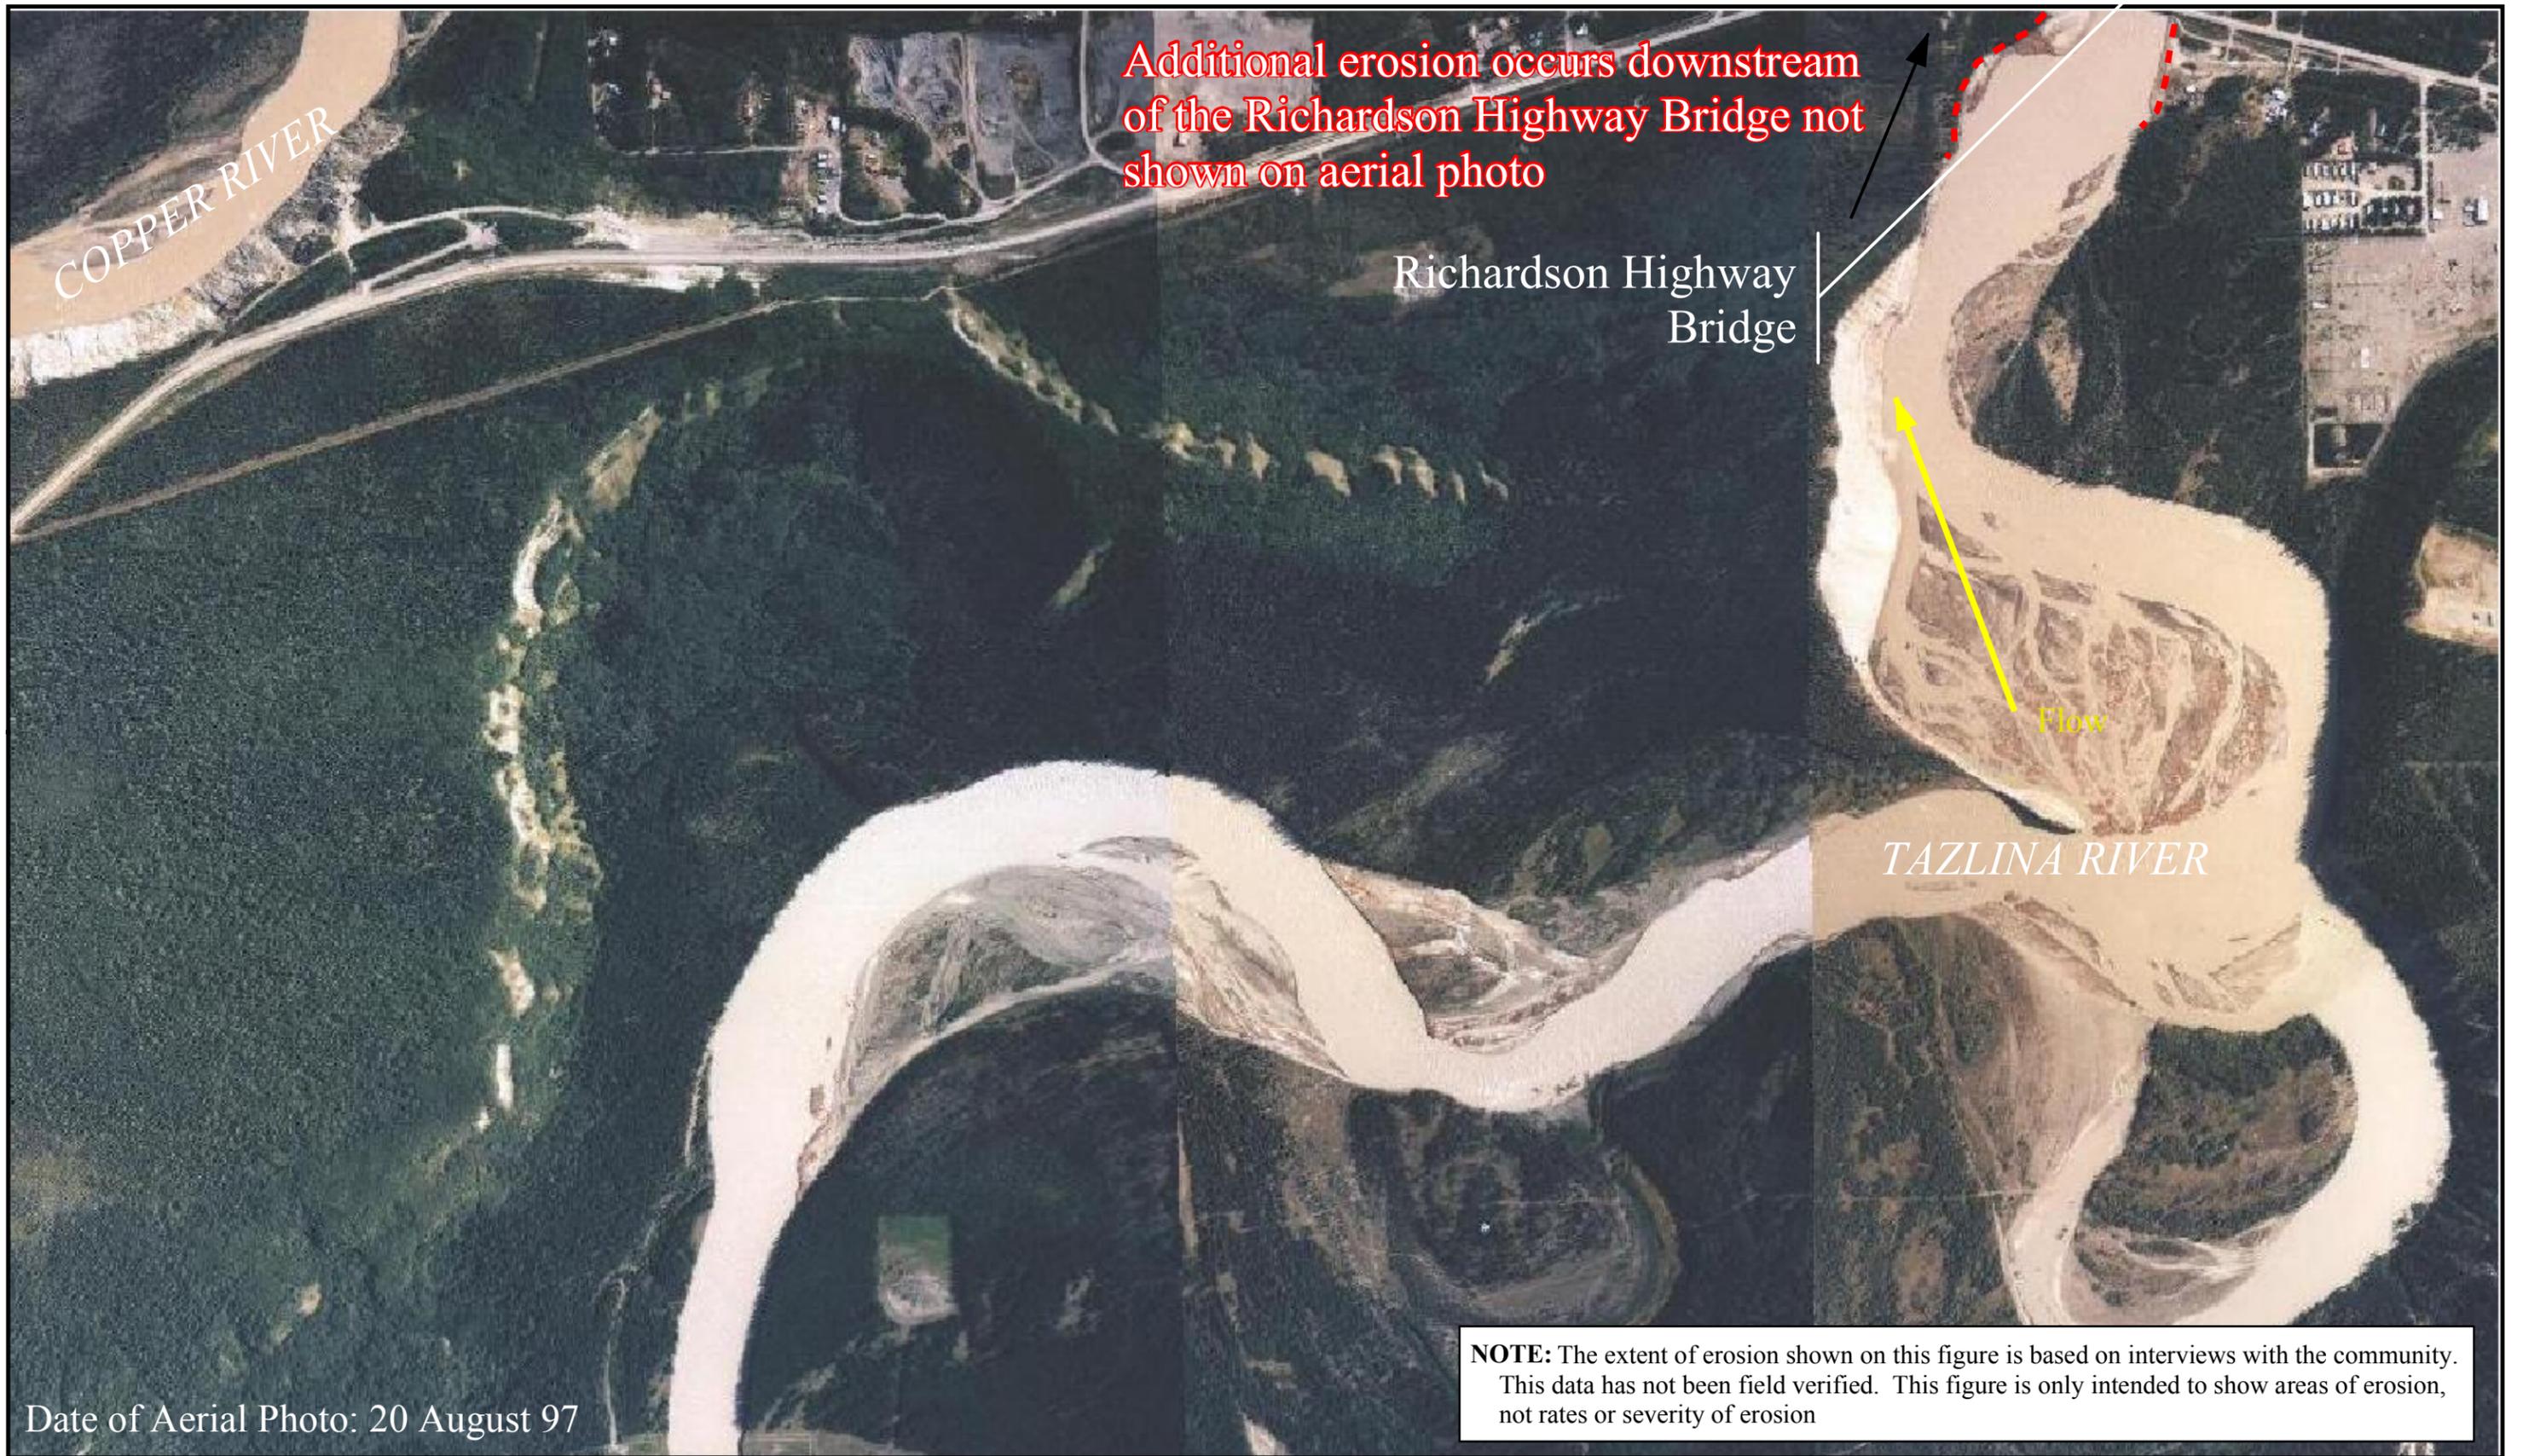
Alaska Baseline Erosion  
Tazlina, Alaska

Photos of erosion provided by Michael L. Bird are attached. Also, attached is a diagram depicting the linear extent of erosion in the community.

--- Linear Extent of Erosion
