**Community Erosion Assessment
Kalskag, Alaska
26 January 2009**

1. Community: Kalskag, Alaska

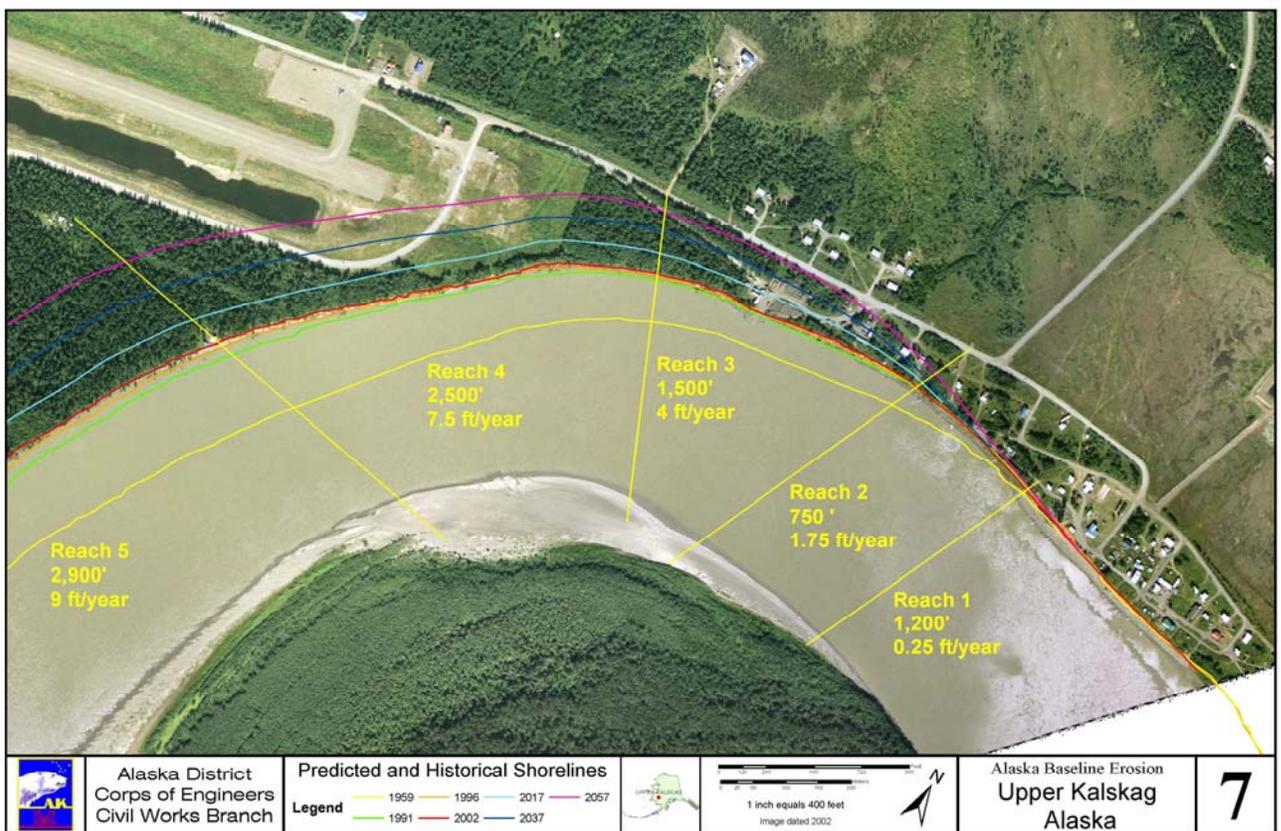
Figure 2. Upper Kalskag Erosion Map

For the purposes of the analysis in this report, the erosion rates were broken up into five river reaches. Reach 1 is located at the upstream end of town and terminates upstream of the cemetery. Reach 1 is approximately 1,200 feet long and is eroding at an average rate of 0.25 feet per year. Reach 2 is comprised of the next 750 feet of riverbank downstream from Reach 1. It is eroding at approximately 1.75 feet per year. Reach 3 is comprised of the next 1,500 feet of bank downstream from Reach 2 and includes the community's barge landing; erosion in this area is estimated to be about 4.0 feet per year on average. Reach 4 consists of 2,500 feet of bank along the apex of the local river bend, at the end of the airstrip; this area is eroding at an average annual rate of 7.5 feet per year. Reach 5 is the last section of erosion concern and is defined as the last 2,900 feet of bank before the community boundary. Most of the expected land loss comes from Reach 5; it is eroding at an average rate of 9.0 feet per year.

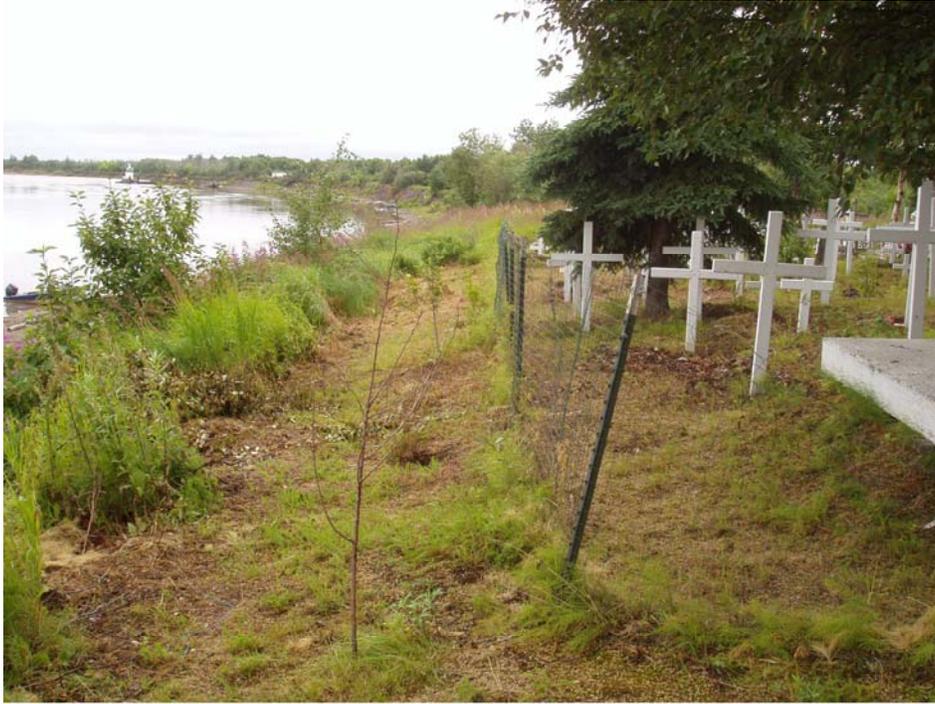
N 61° 32.225' W 160° 18.803' Upper Kalskag P1011159
Photo 1. Top of the bank in front of cemetery. Fence is 6.0' to the top of the bank.

A riprap revetment could be constructed to protect a graveyard. The revetment would be 275-feet long and include a tieback key at the upstream end to prevent erosion from flanking around the structure and a tieback or thickened section at the downstream end. Approximate costs are \$700,000 which is roughly \$2,525 per linear foot of revetment.

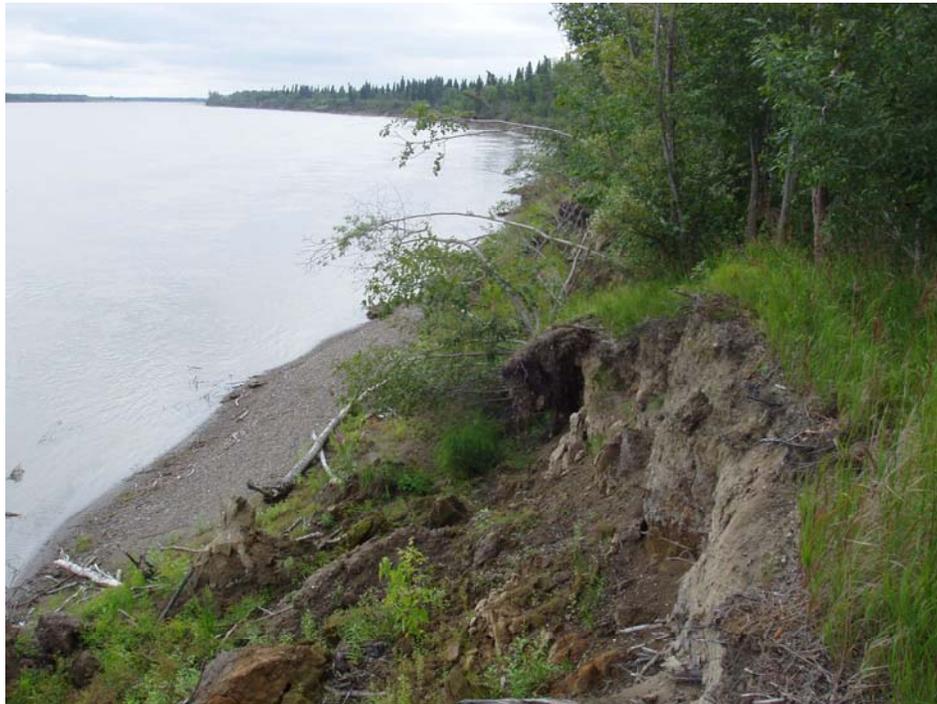
P1011188

Photo 3. Streambank near the airport looking downstream.

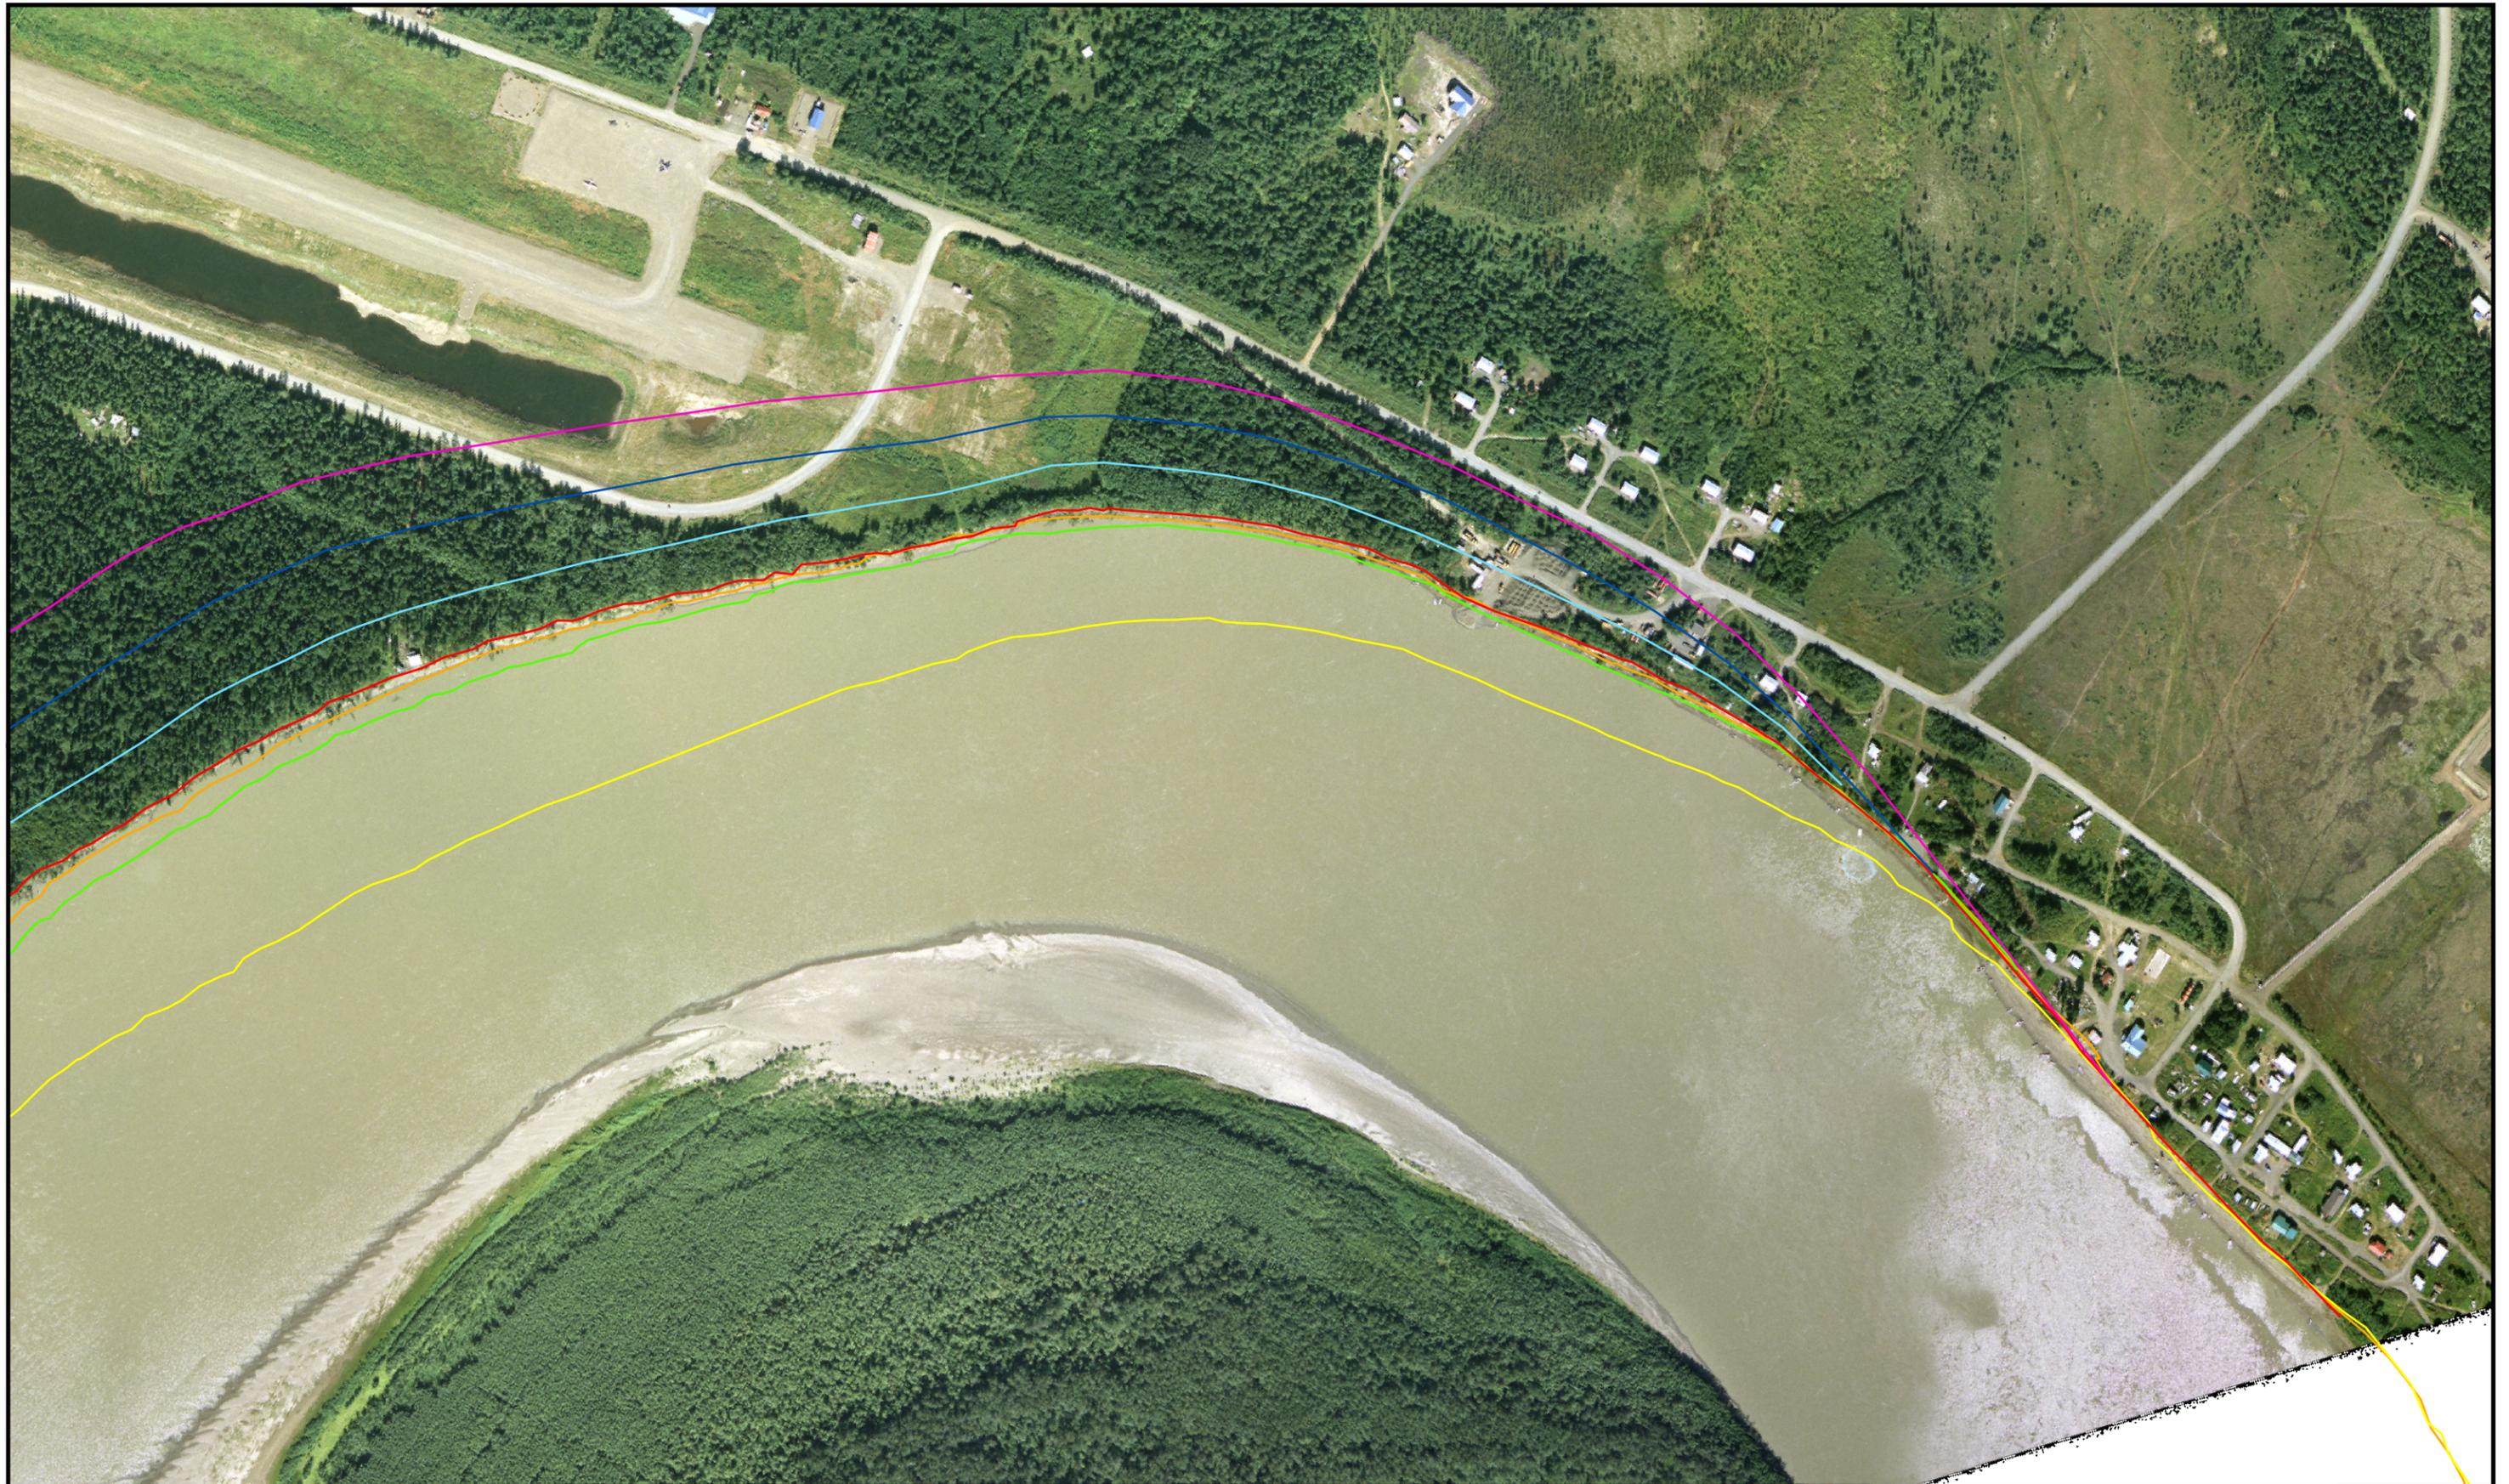
Predicted and Historical Shorelines

— 1959	— 1996	— 2017	— 2057
— 1991	— 2002	— 2037

Image dated 2002
