**U.S. Army Corps  
of Engineers**  
Alaska District

## **ALASKA BASELINE EROSION ASSESSMENT**

# **Erosion Information Paper - Willow, Alaska**

Current as of May 9, 2008

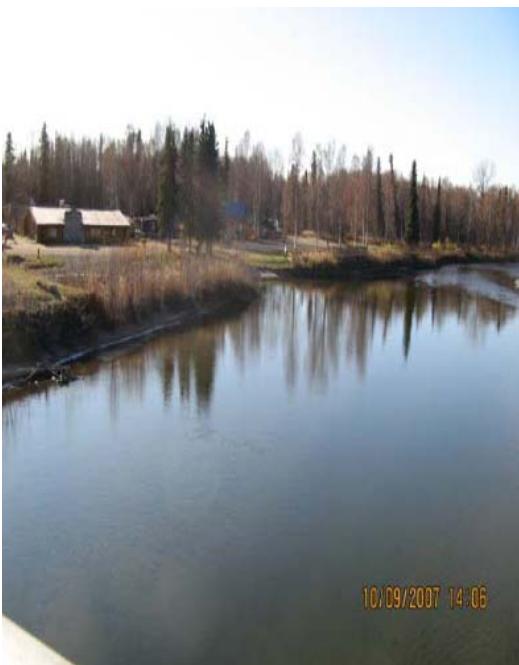
**Photo 1:** Riparian habitat protection installed along left bank Willow Creek; Pioneer Lodge is in background; photo courtesy of Russ Miller, 2007.

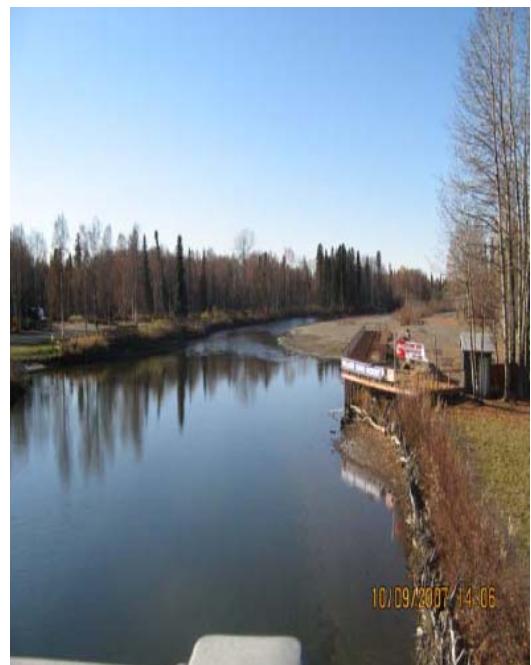
**Photo 2:** Elevated walkway and root wads installed along right bank Willow Creek downstream of Park's Highway Bridge; Willow Creek Lodge is out of photo to the right of project; photo courtesy of Russ Miller, 2007.

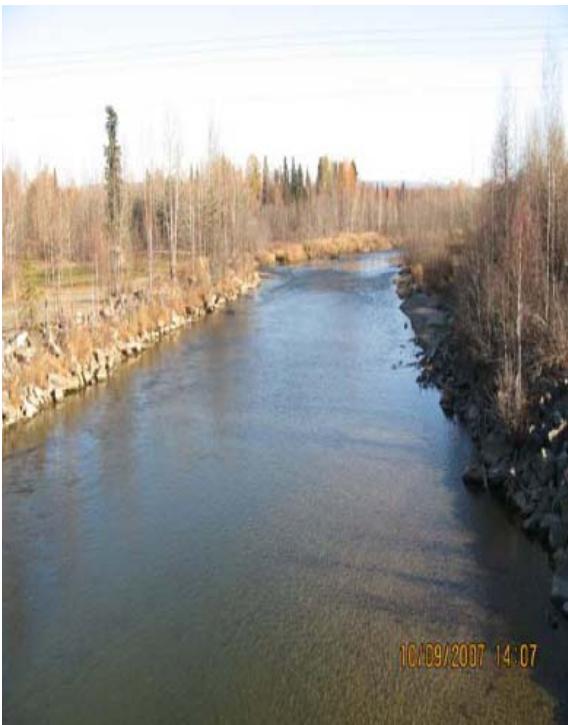
**Photo 3:** Willow Creek upstream of Parks Highway Bridge; photo courtesy of Russ Miller, 2007.

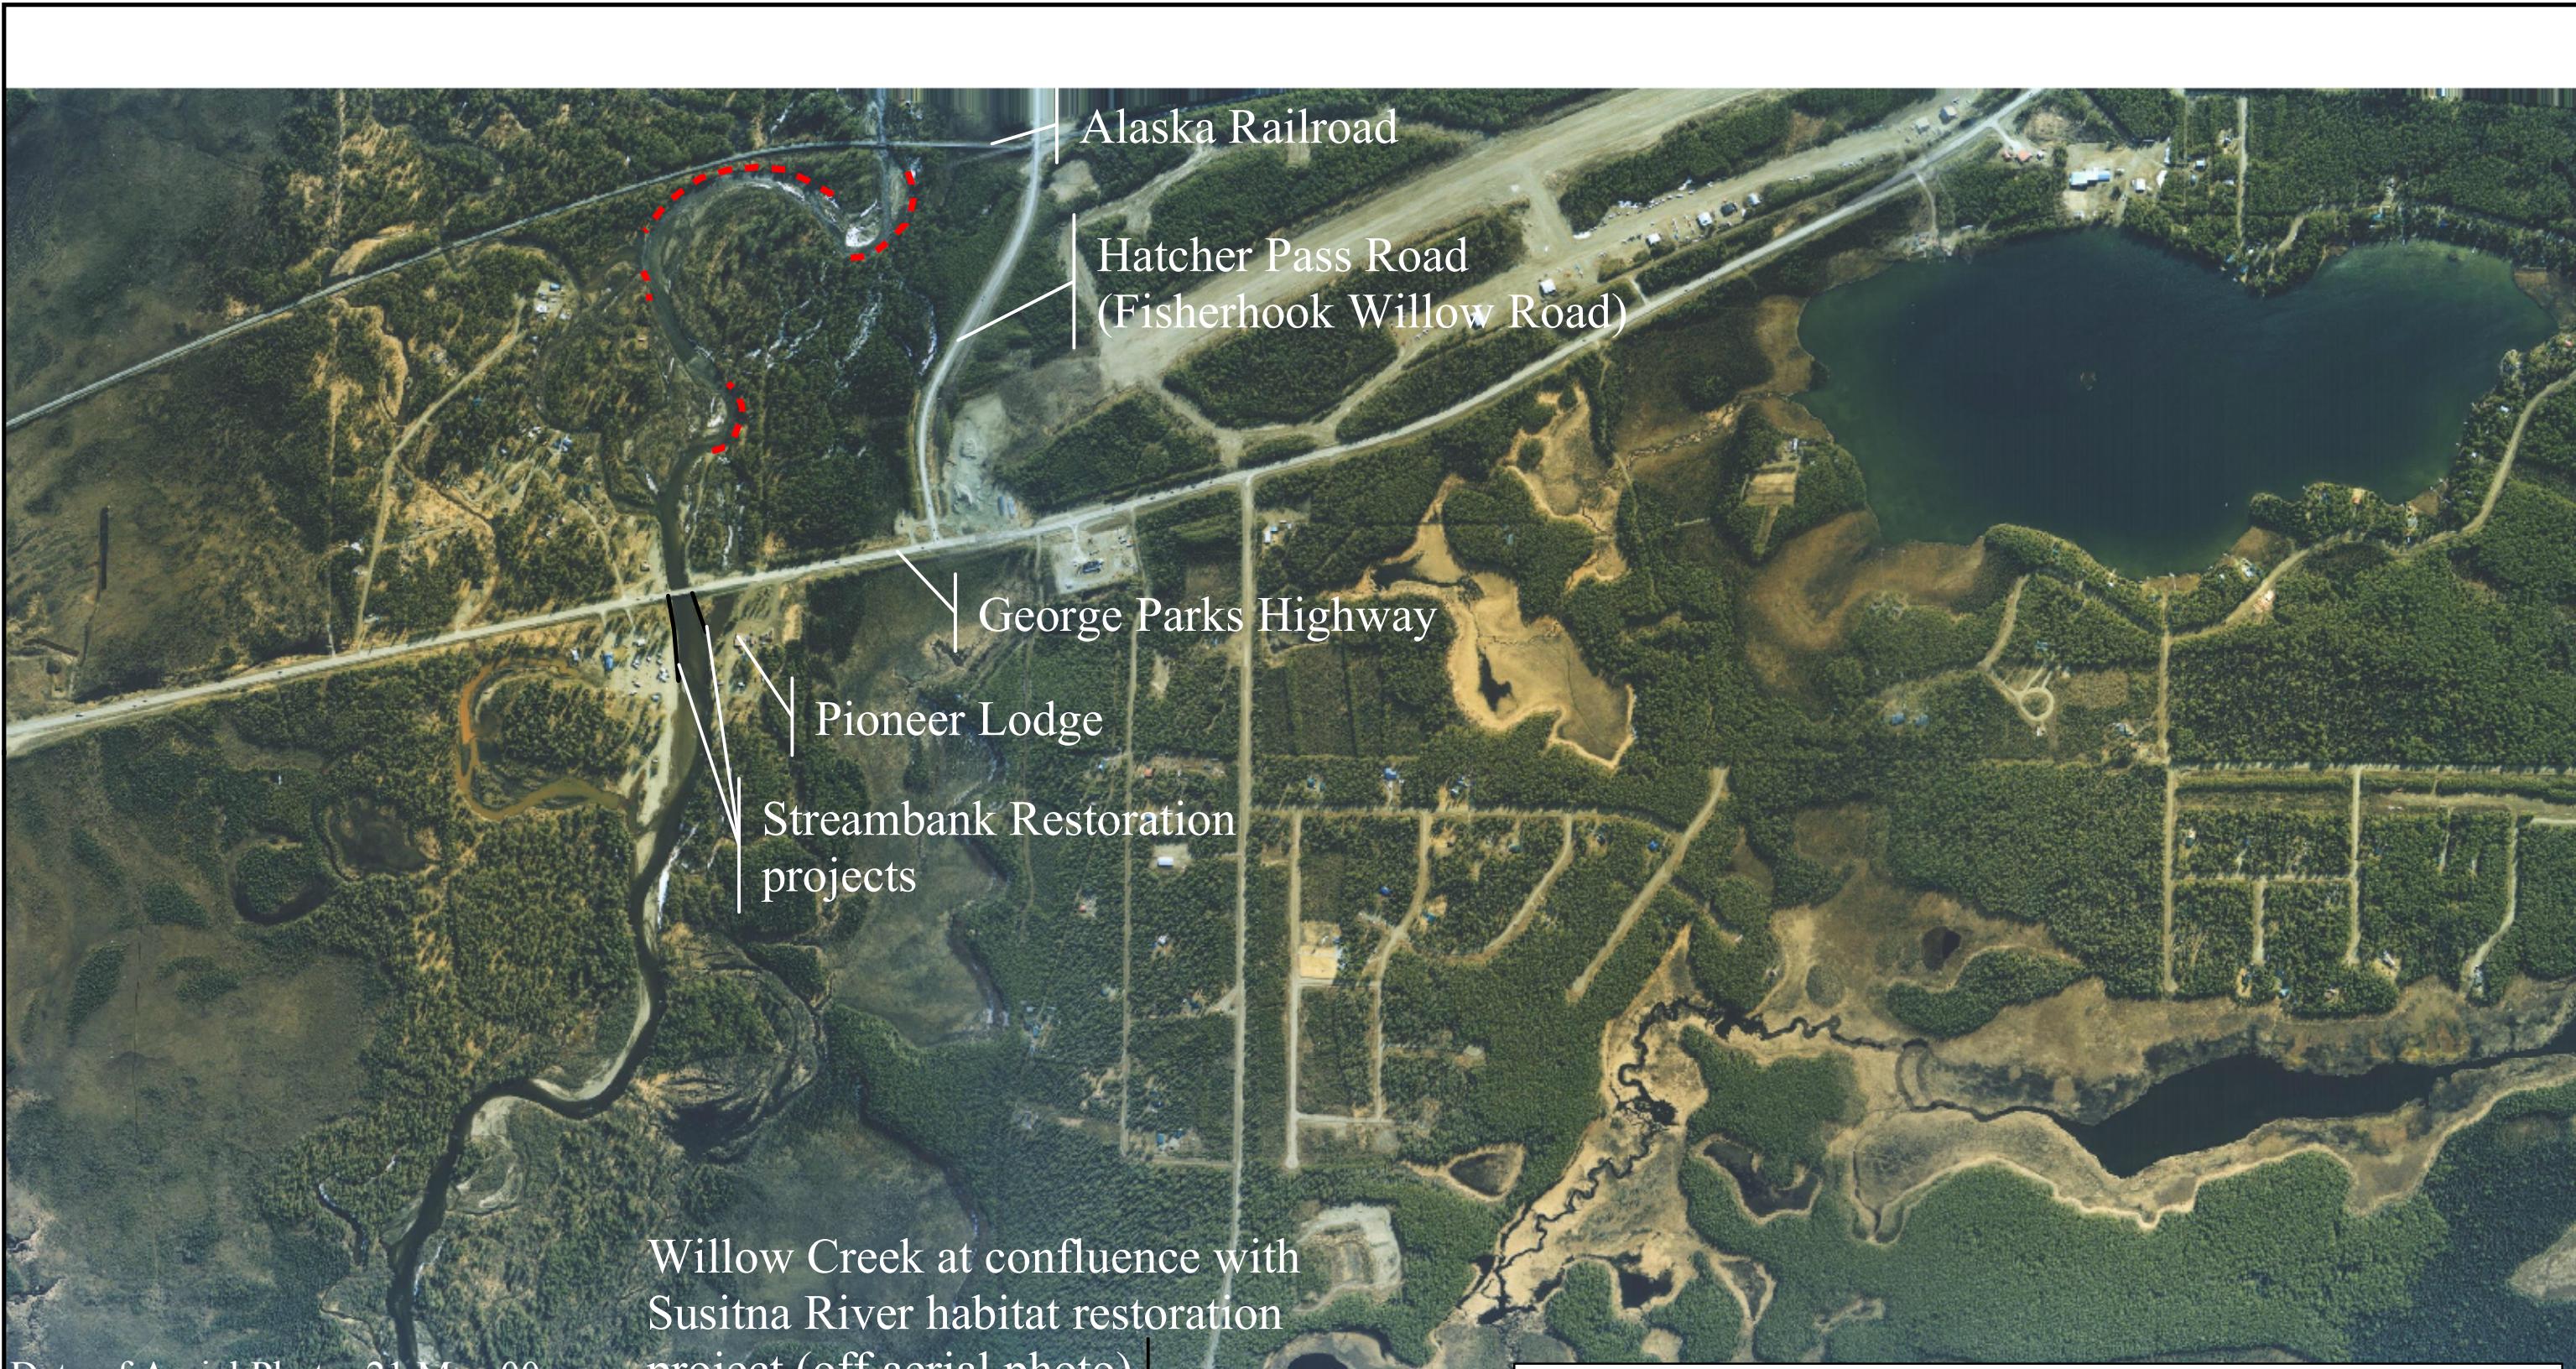
Linear Extent of Erosion

Erosion is ongoing on Friday Drive and Kelly Circle along the north bank adjacent to Willow Creek and Stinson Drive. The Willow Chamber of Commerce reported a log blocked Willow Creek at one time, forcing flows into Iron Creek, a small tributary to the north.

**NOTE:** The extent of erosion shown on this figure is based on interviews with the community. This data has not been field verified. This figure is only intended to show areas of erosion, not rates or severity of erosion
