## **ALASKA BASELINE EROSION ASSESSMENT**

### **Erosion Information Paper - Wiseman, Alaska**

Current as of January 29, 2008

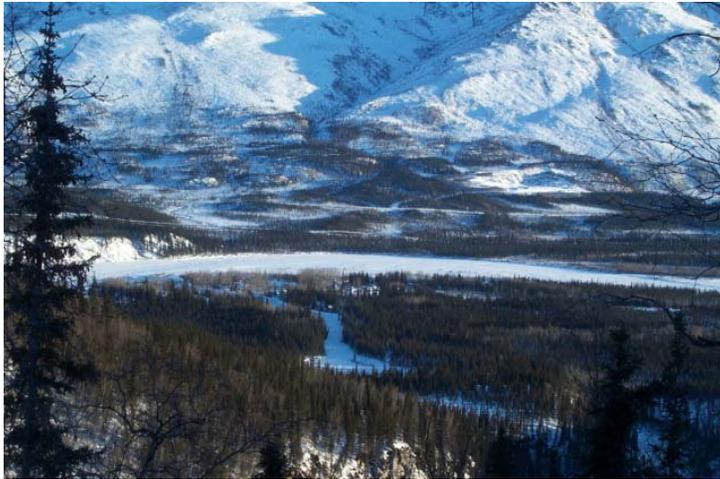
**Photo 1: Wiseman Creek as it winds through Wiseman to The Koyukuk River; photo by Heidi Schopphorst, No photo date available.**

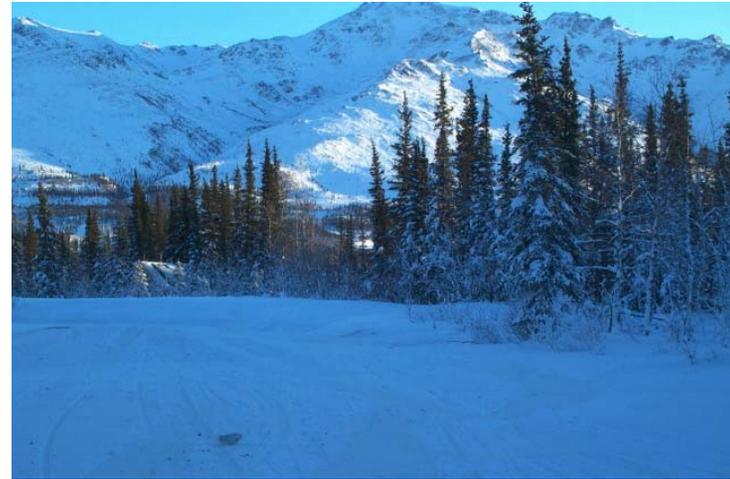
It was also reported by the community that some erosion is occurring on Wiseman Creek at the up-river ends of the dikes built upstream from the bridge that crosses the creek. In 1998, heavy rains and rapid snowmelt caused the creek to cut through its bank and flow through adjacent property. A concern to the community is winter overflow along the creek. During these overflow conditions, which the community reports to be a yearly event, water can flood into the community.

**Photo 2: Wiseman Creek levee; photo by Heidi Schopphorst; No photo date available**

In addition to the rip rap placed by DOT&PF along the Koyukuk River to protect the community access road, additional erosion protection measures to help reduce erosion damage in use in and near the community include placement of riprap-protected dikes along Wiseman Creek upstream from the bridge that connects the 2 parts of the community across the creek. Prior to the adding of riprap to the dikes, yearly repairs were required. The community also reported that since the cutting of Wiseman Creek through adjacent property that occurred in 1998, at least 1 home is endangered by the new creek channel location.

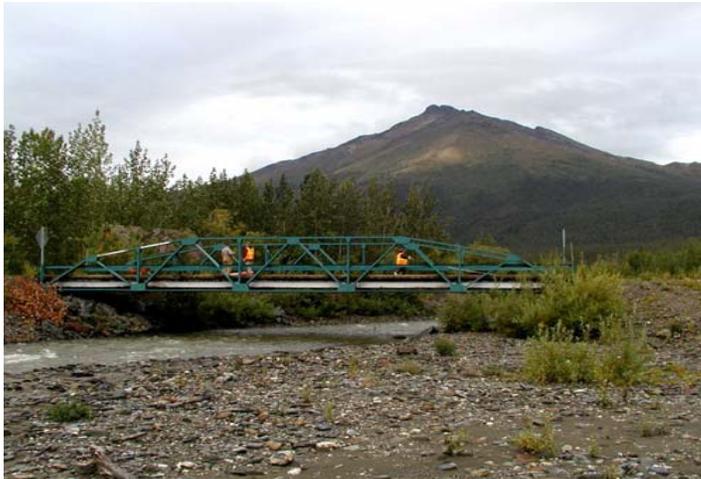
**Photo 3: Wiseman's 1-lane bridge; photo by Nicole Grewe, DCRA©, August 2006.**

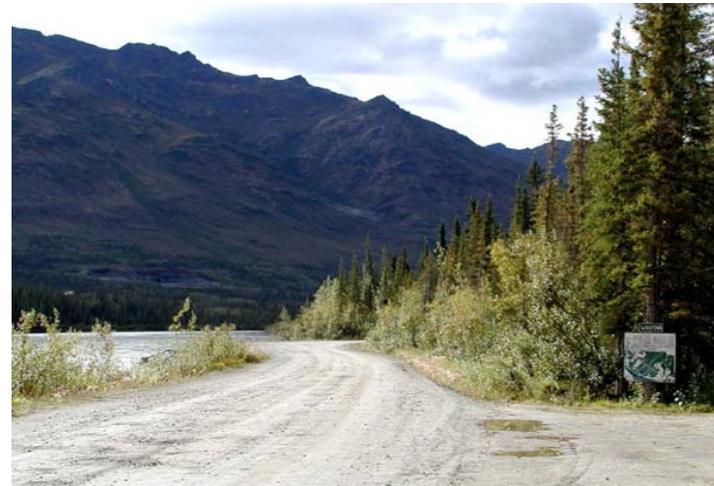
At this time, the most significant erosion threat to the community is to the 3-mile long access road located along the Koyukuk River, which connects the community to the Dalton Highway. The community reported that in 2006, the Alaska Department of Transportation and Public Facilities (DOT&PF) placed riprap along the Koyukuk River to protect the access road. The community also reported that some private property has been lost to erosion along the Koyukuk River, but at this time no structures are threatened.

**Photo 4: Access road to Wiseman is adjacent to the middle fork Koyukuk River; photo by Nicole Grewe, DCRA©, August 2006.**

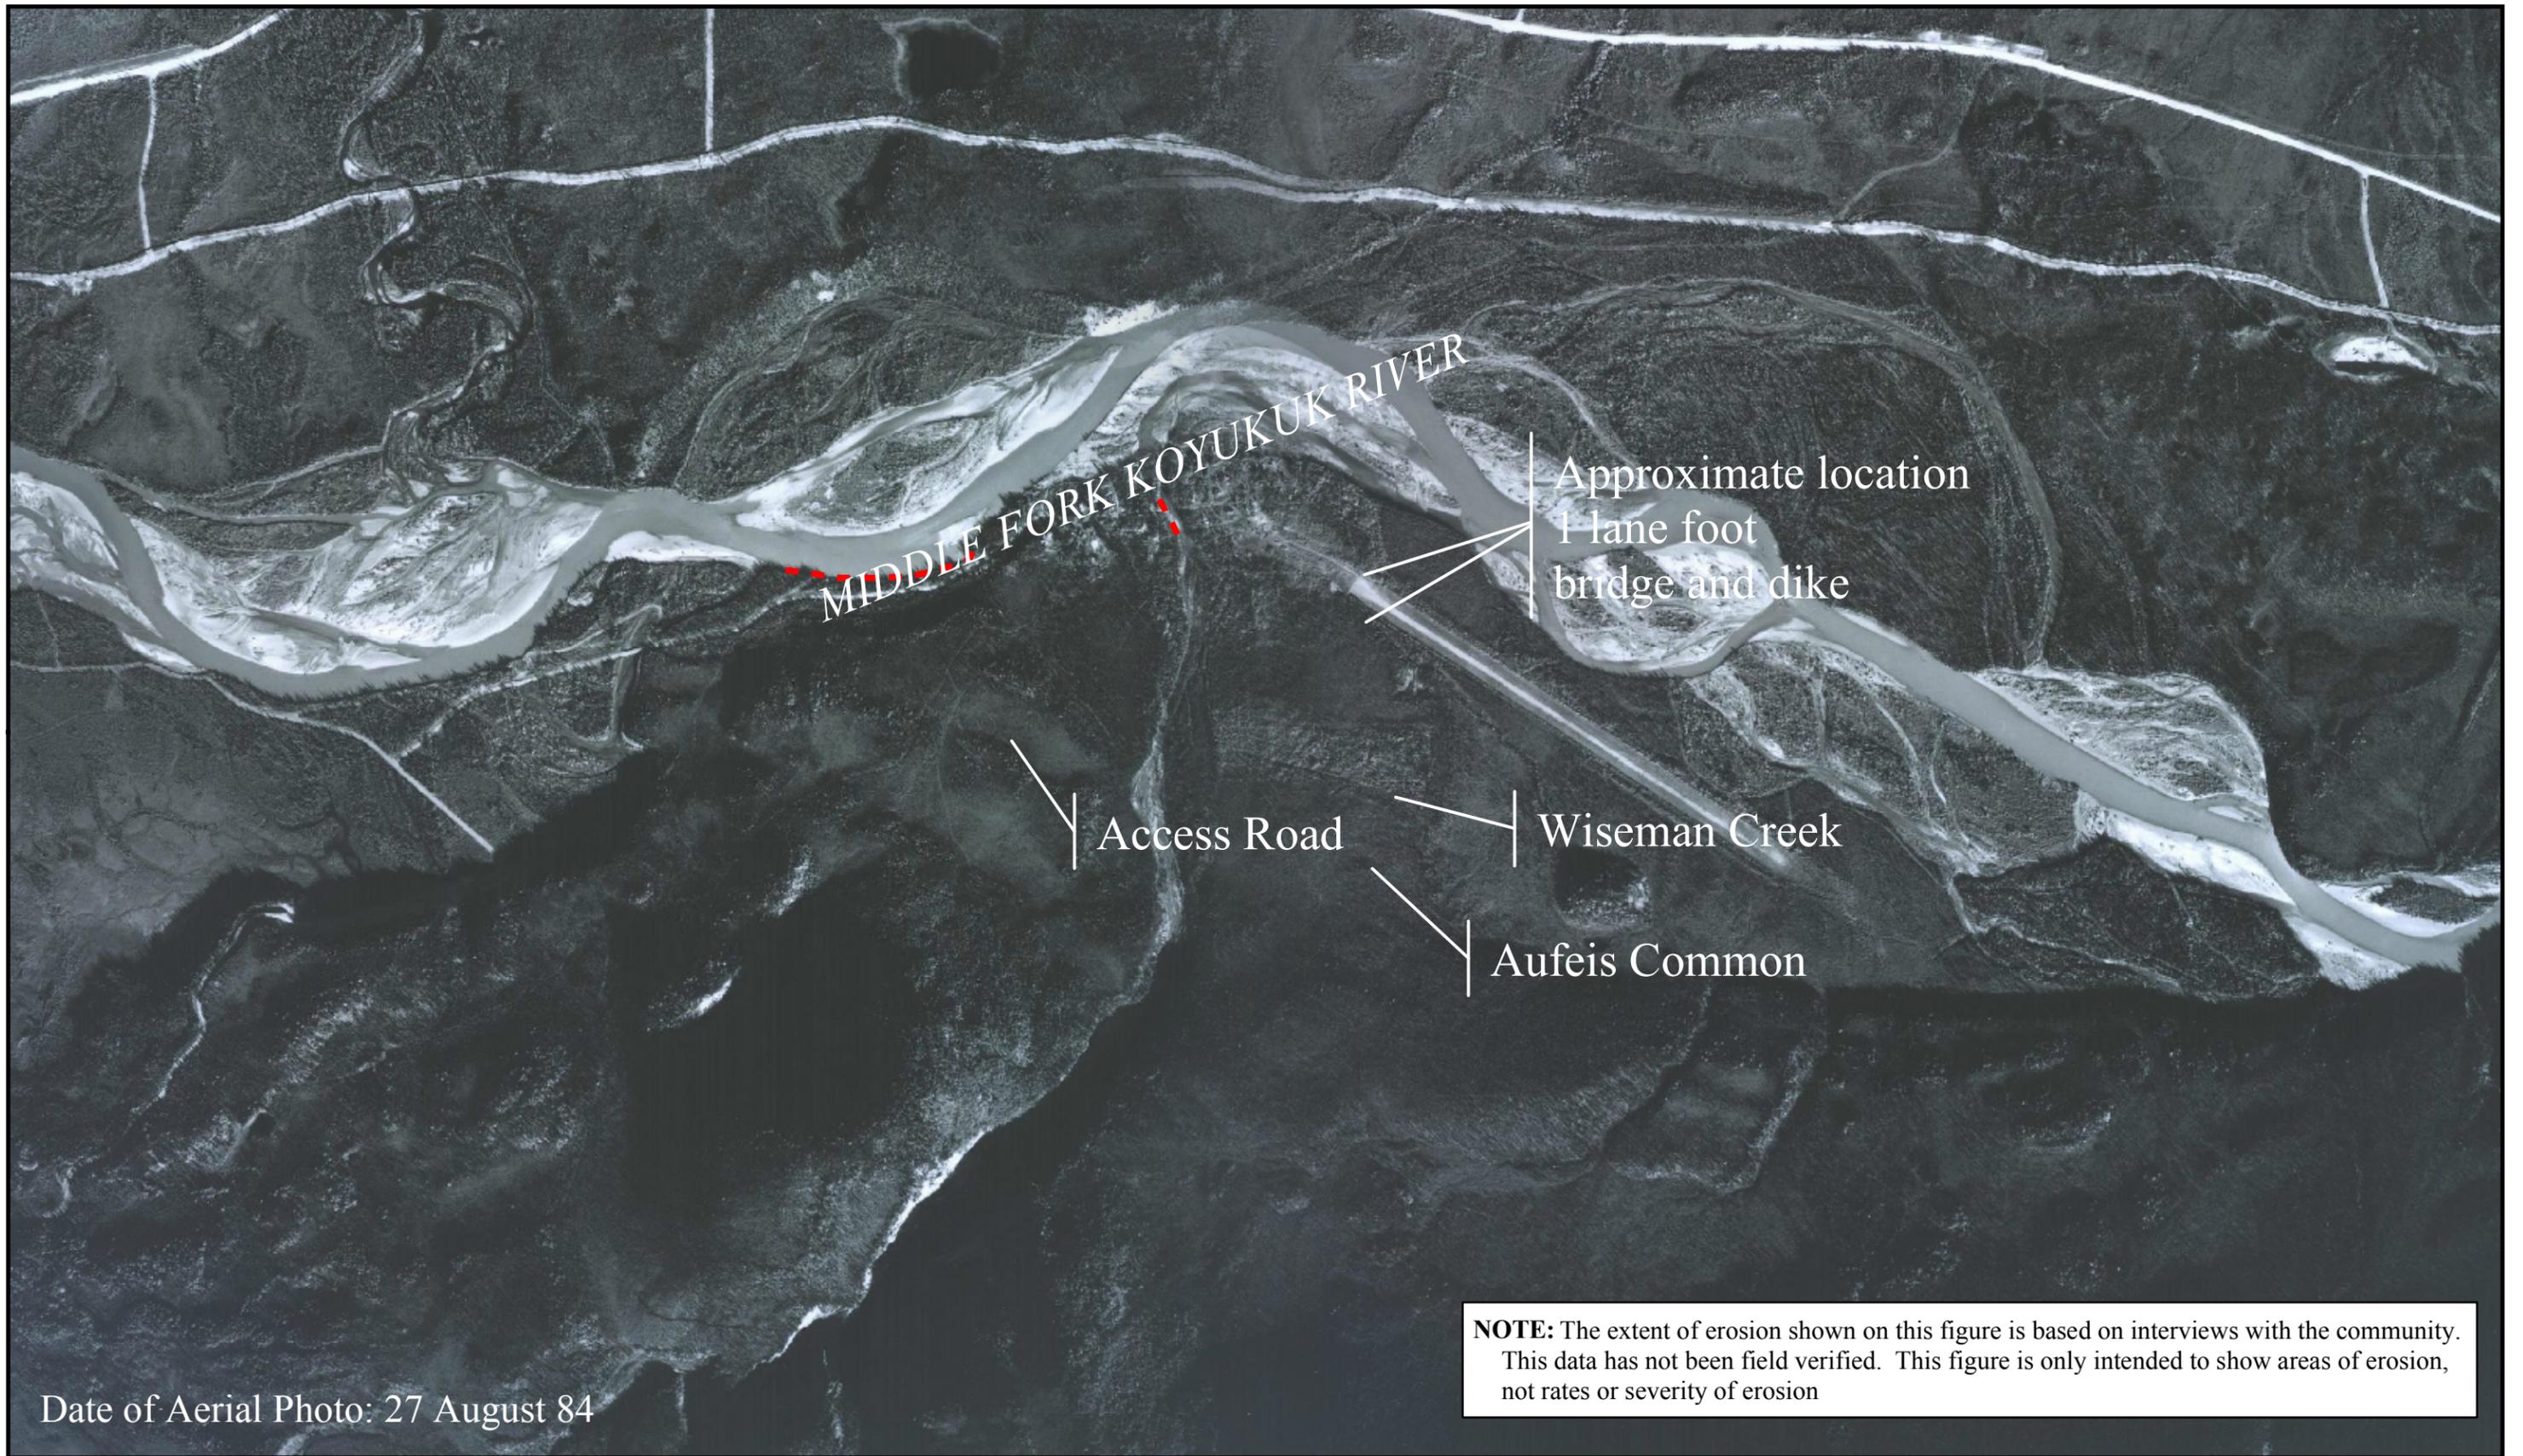
Alaska Baseline Erosion  
Wiseman, Alaska

Date of Aerial Photo: 27 August 84

**NOTE:** The extent of erosion shown on this figure is based on interviews with the community. This data has not been field verified. This figure is only intended to show areas of erosion, not rates or severity of erosion

--- Linear Extent of Erosion
