U.S. Army Corps
of Engineers
Alaska District

ALASKA BASELINE EROSION ASSESSMENT

Erosion Information Paper - Yakutat, Alaska

Current as of September 20, 2007

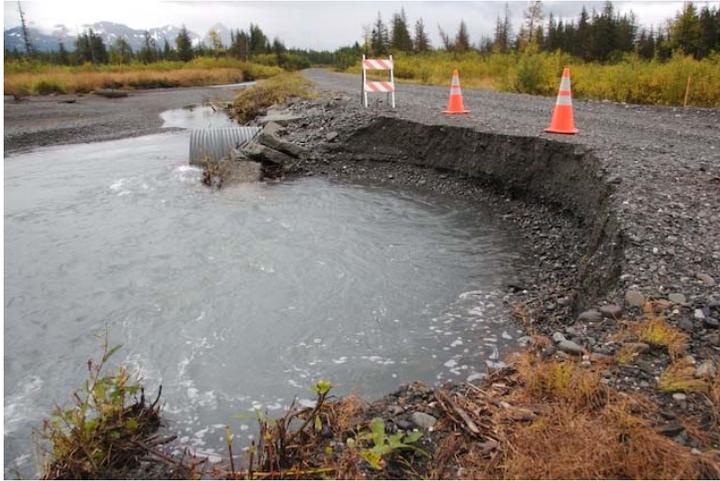
Photo 1: Erosion on Forest Highway, September 2007.

A third erosion area is inland from Yakutat, where unnamed streams in the Lost River basin, the Situk River basin, and Ahrnklin River basin are eroding the Forest Highway about 3 miles before its terminus at Harlequin Lake and at other locations from mile 12 to 24. There also is a subdivision development where the sides of the roads are washing out from local run off.

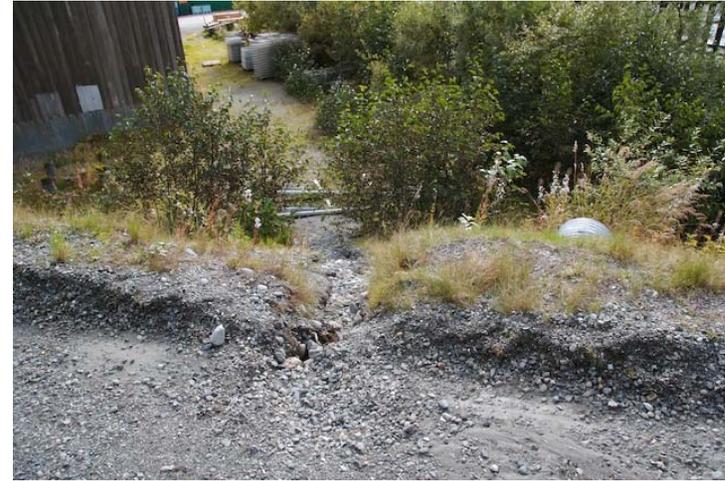
Photo 2: Erosion by Ocean Dock, September 2007.

A second area of concern is the Monti Bay coast near developed areas of Yakutat. The low-lying sand-silt beaches of the south shoreline are susceptible to erosion. Islands and navigation improvements shelter part of the community, but even the sheltered beaches can be eroded by locally generated waves. The community survey reports the active erosion area is 5 to 15 feet wide and 6 to 30 feet high and estimates the rate of erosion is ½ to 2 feet per year. Erosion is also occurring by the Ocean Cape dock next to the fish camp buildings and in a section of washed-out road.

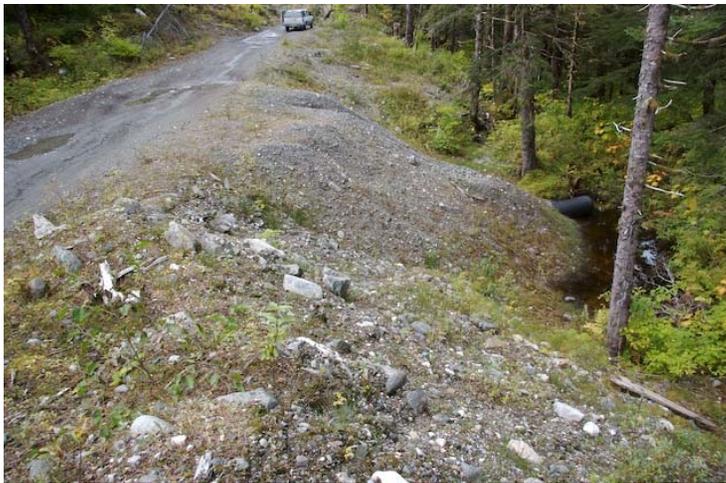
Photo 3: Erosion on inland subdivision road, September 2007.

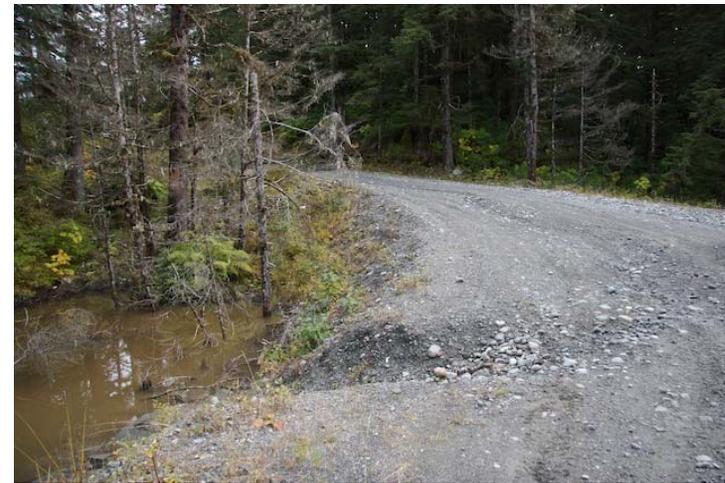
Photo 4: Erosion on inland subdivision road, September 2007.

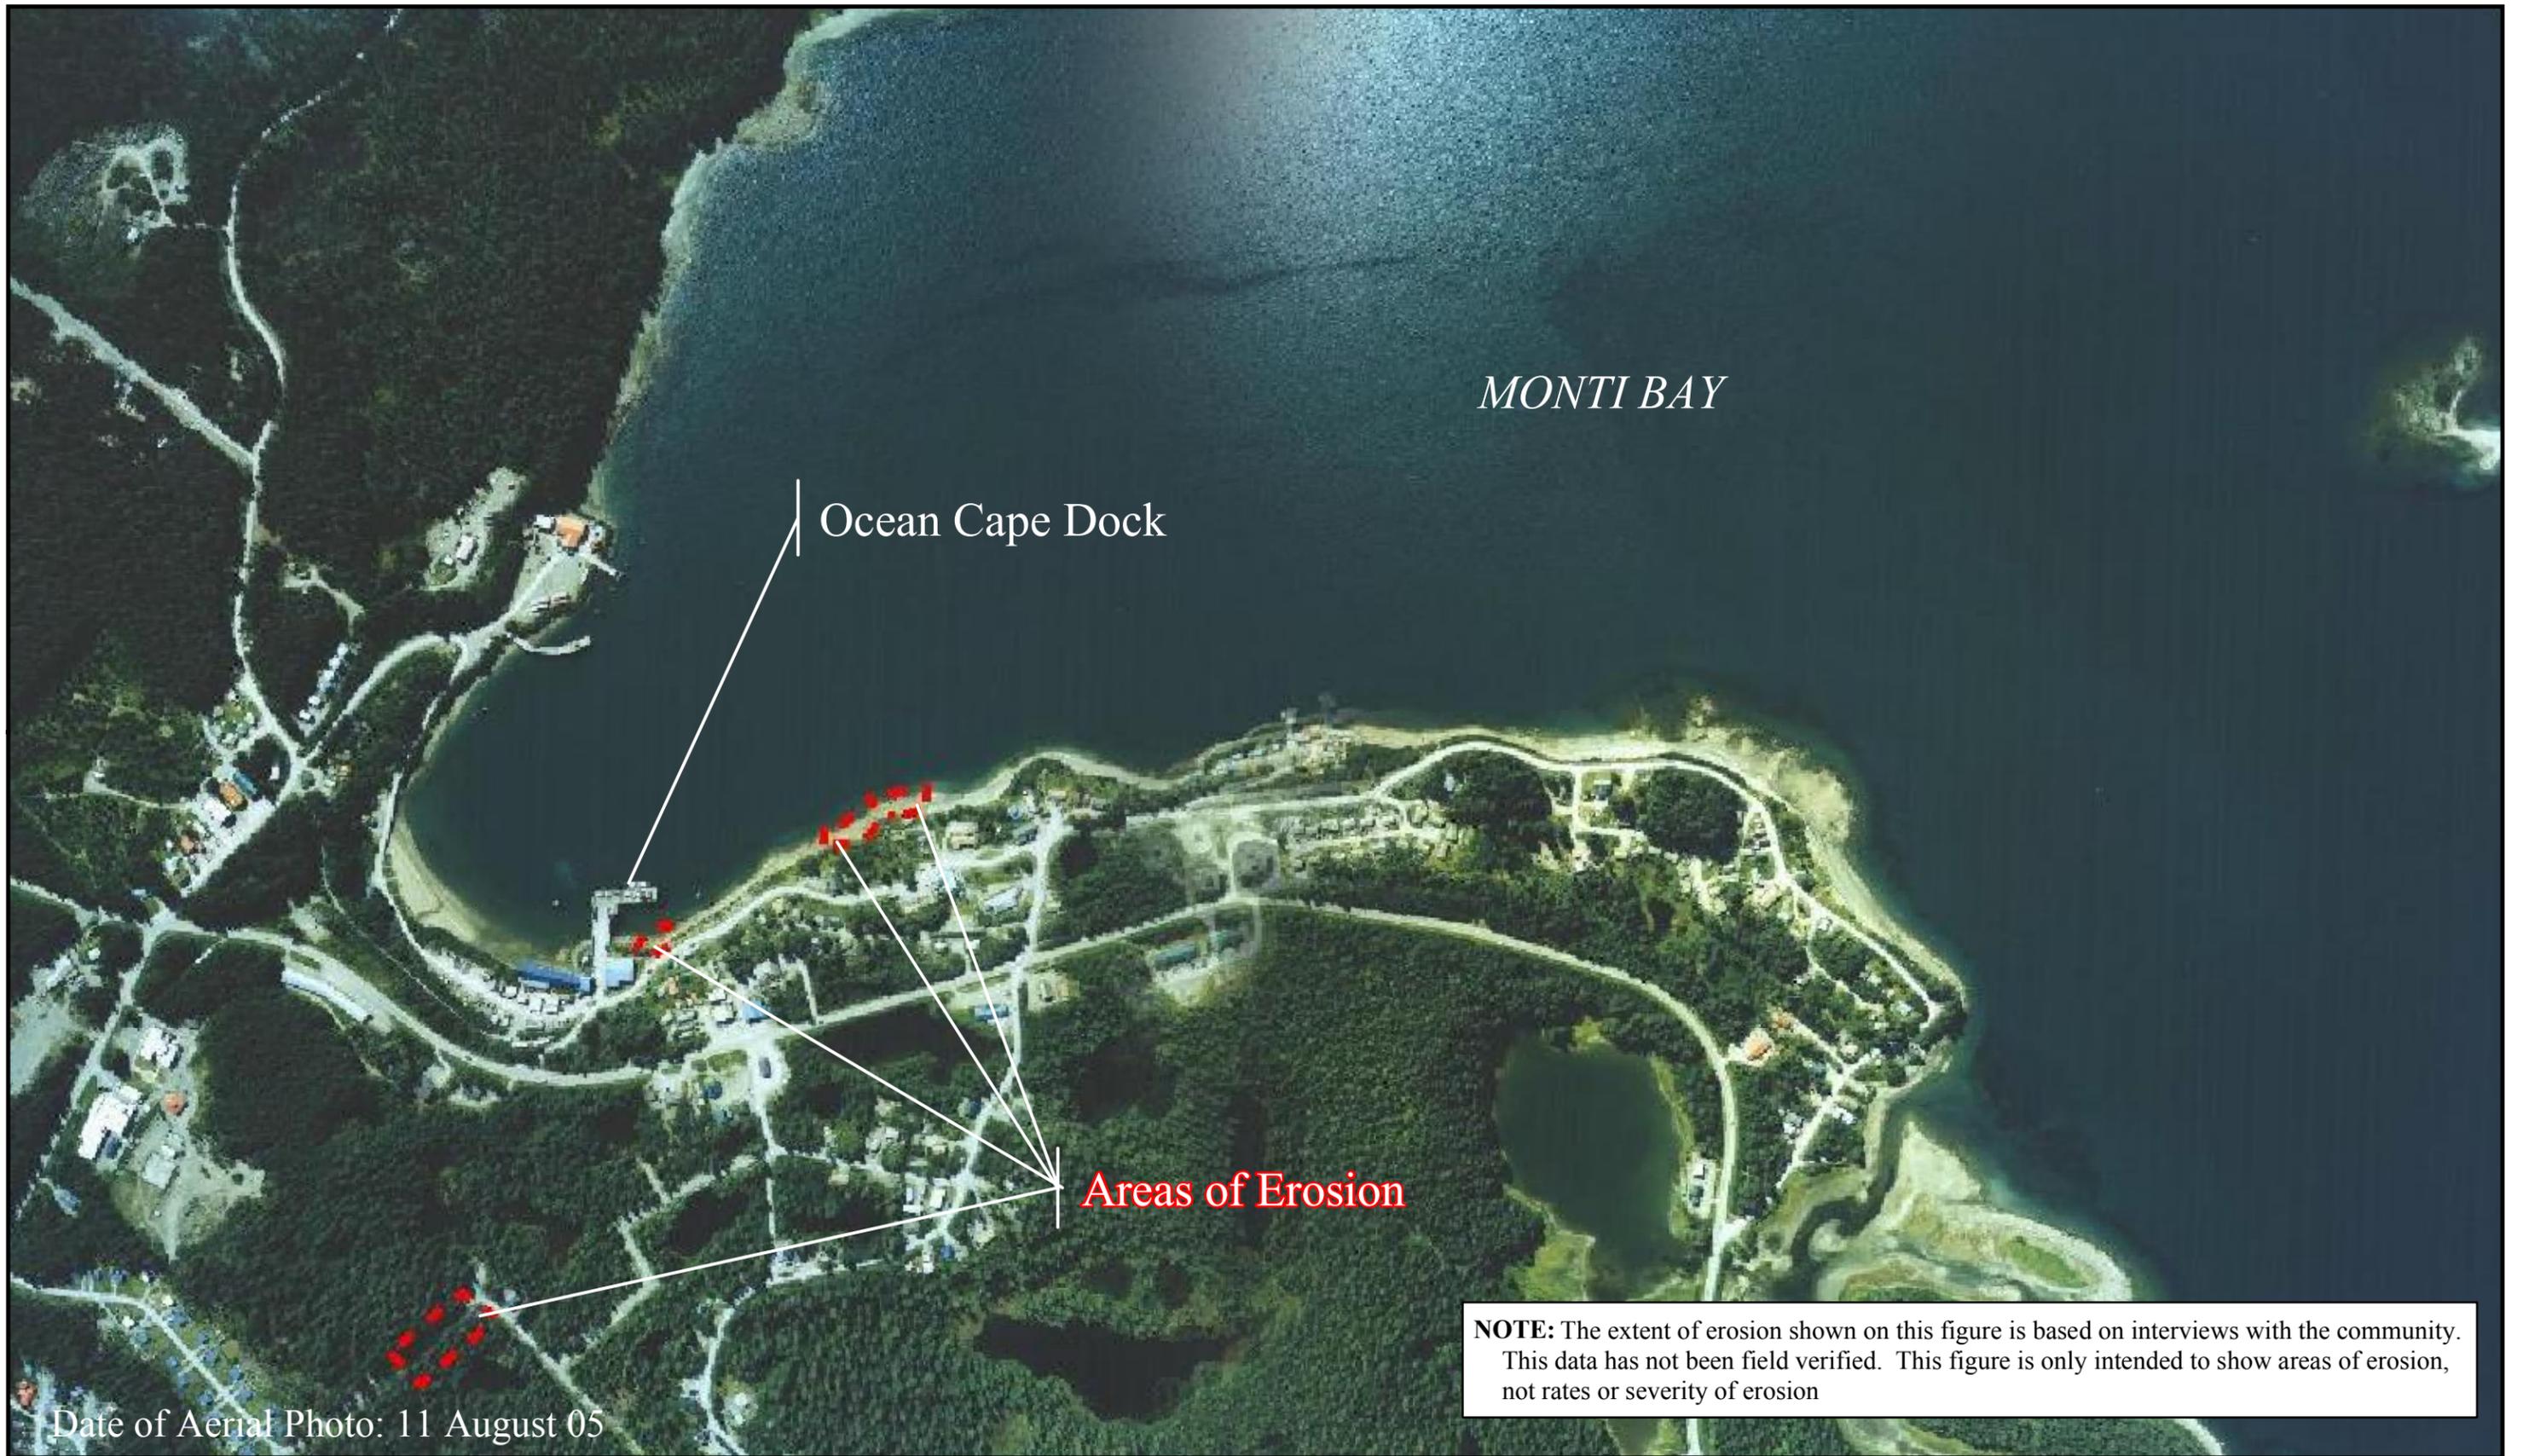
Alaska Baseline Erosion
Yakutat, Alaska

Photos provided by sources other than the community are attached, and no photos have been provided by the community. The attached diagram depicts the linear extent of erosion.

NOTE: The extent of erosion shown on this figure is based on interviews with the community. This data has not been field verified. This figure is only intended to show areas of erosion, not rates or severity of erosion

--- Linear Extent of Erosion
