# **GEOTECHNICAL INVESTIGATION AND SITE CONDITIONS REPORT**

## **KENAI RIVER BLUFF EROSION**

**KENAI, ALASKA**

**CONTRACT NO. W911KB-05-D-0004  
DELIVERY ORDER NO. 0010  
MODIFICATION NO. 01**

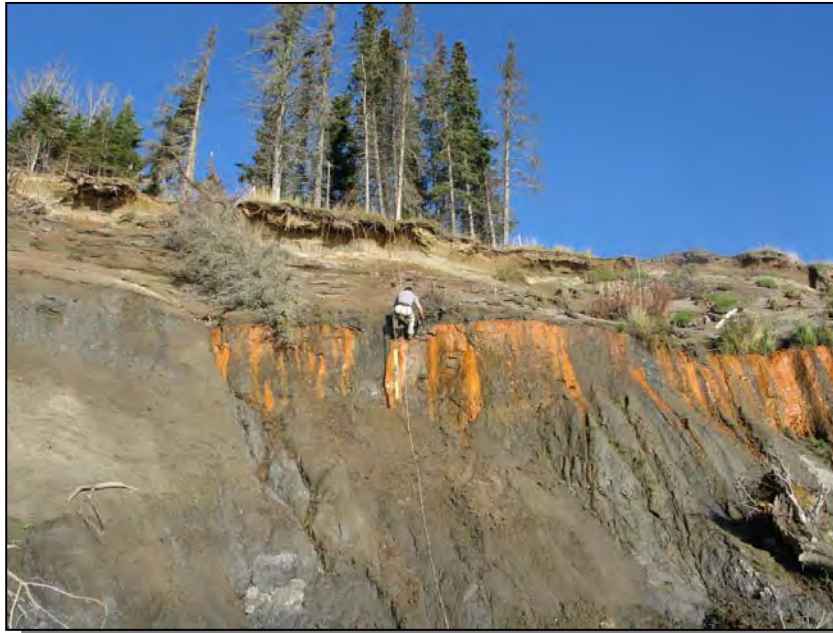
**FIGURE 4**  
**BLUFF MAPPING PHOTOGRAPHS**

a. Rappelling down the bluff face at Soil Profile SP-D. The four-foot yellow electronic level was used to measure slope angle. Slope distances were measured using the white tape. October, 2006.

During the period of December 10 through 13, 2006, a team of two R&M geologists/engineers obtained soil profiles at 10 locations along the bluff face (Soil Profiles SP-A through SP-J). At each profile location, an engineer, secured by harness and climbing rope, traversed the bluff from top to bottom (Figure 4). Data collection included measuring the slope profile using a rope tape and a four-foot digital level. Shallow test pits were excavated to expose soils and collect samples. A detailed description of soil and groundwater conditions was also made. Soil profiles are presented in Appendix D. Soil profile locations are shown in plan on Drawings A-02 and A-

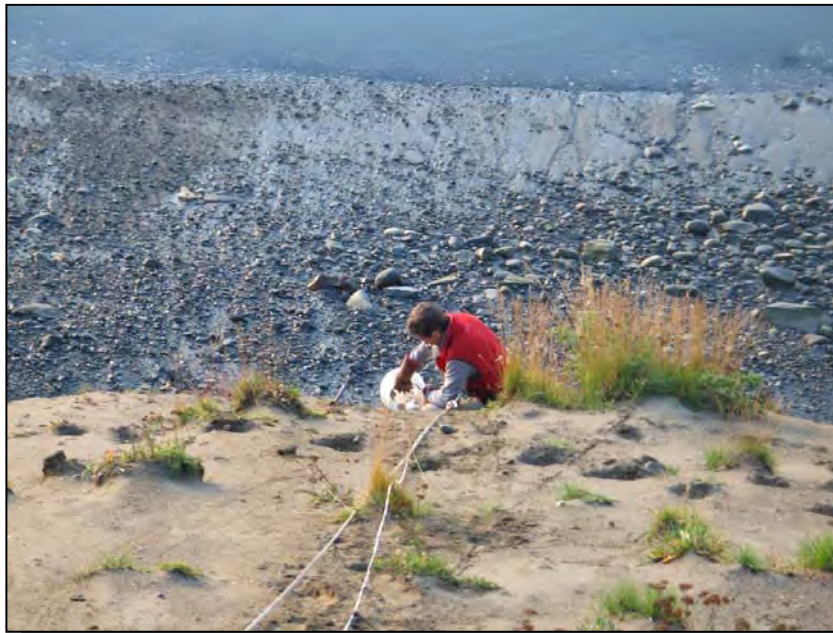
b. Measuring water flow from the bluff at Soil Profile SP-E. The procedure involved catching the flow and then measuring in a bucket. October, 2006.

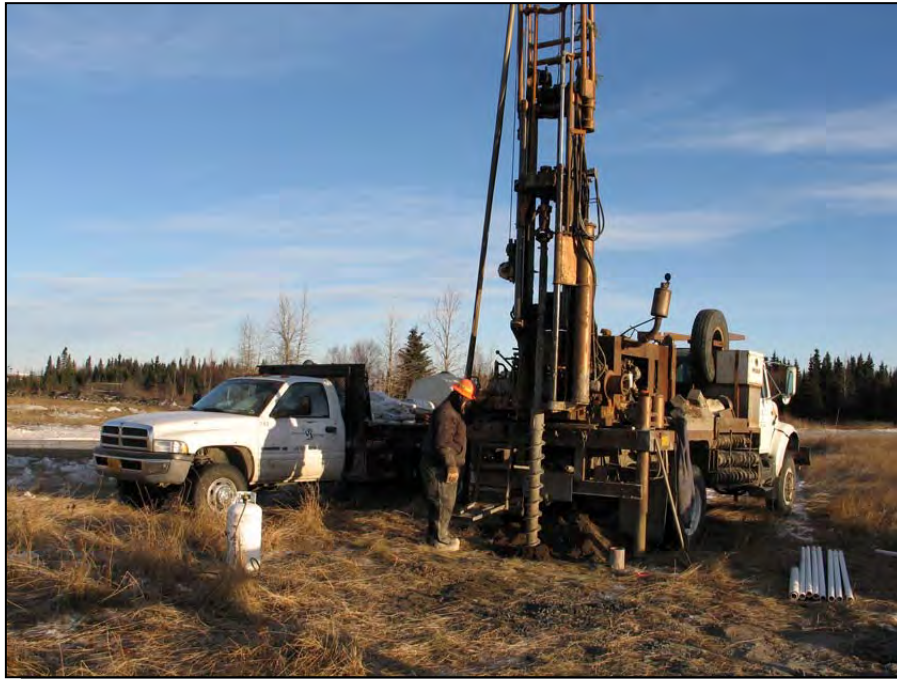
**FIGURE 5**

a. Drilling at Group 4 borings. November, 2006.

Soil boring, sampling, and groundwater well installation on the bluff crest were performed utilizing a truck-mounted CME-75 drill rig (Figure 5a). Soil boring and sampling operations on the bluff toe were performed either with a Nodwell-mounted CME-75 drill rig (Test Boring AP-627 as shown in Figure 6b) or with a helicopter portable CME-45 drill rig (Test Borings AP-622 through AP-626 as shown in Figure 5b). Maritime Helicopters of Homer, Alaska provided a Bell Model 207 helicopter under contract with Discovery Drilling. Test borings were advanced using continuous flight, hollow-stem augers. Representative soil samples were generally obtained at the surface, at 2.5 feet and five feet, and then at approximately five-foot intervals or at obvious changes in soil strata. However at each grouping of three groundwater monitoring well installations (e.g. AP-608-MW through AP-610-MW), only one of the three borings was sampled and logged in detail. The other two borings were only sampled at the bottom of the boring.

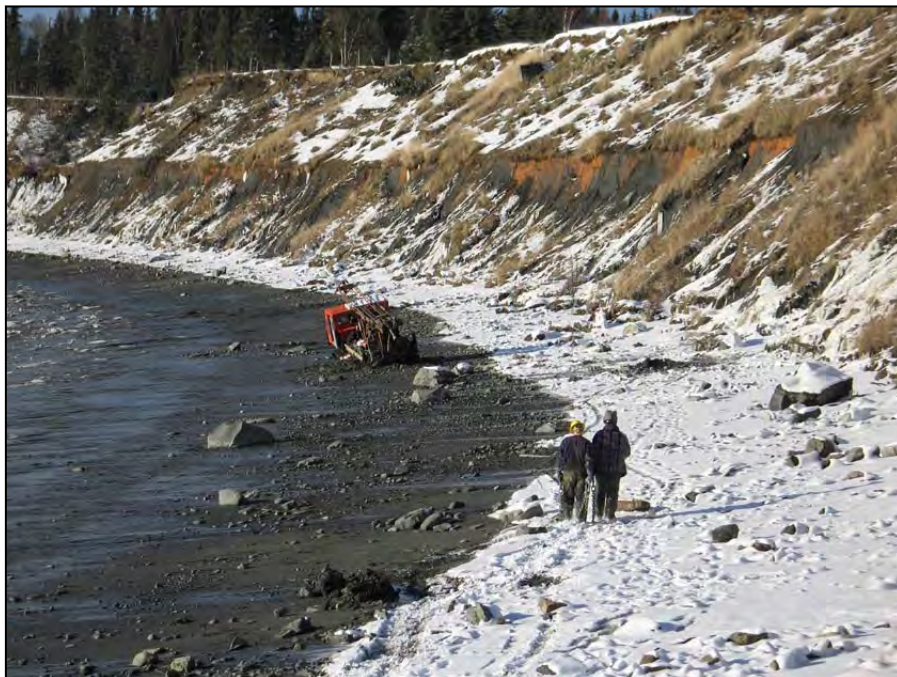
b. Drill stuck in mud near Senior Center.  
The soft mud made it difficult to use tracked equipment on tide flats. November, 2006.

The tide flats located at the base of the bluff lie on a marine platform cut into the glacial till. The platform slopes gently toward the river for a horizontal distance of about 100 to 200 feet. The platform was covered with what appeared to be a thin veneer of boulders, cobbles, gravel and sand apparently washed down from the bluff above. Under this veneer of soil, the clays had become soft in many places making travel on the tide flats treacherous for vehicles or personnel (Figure 6b).

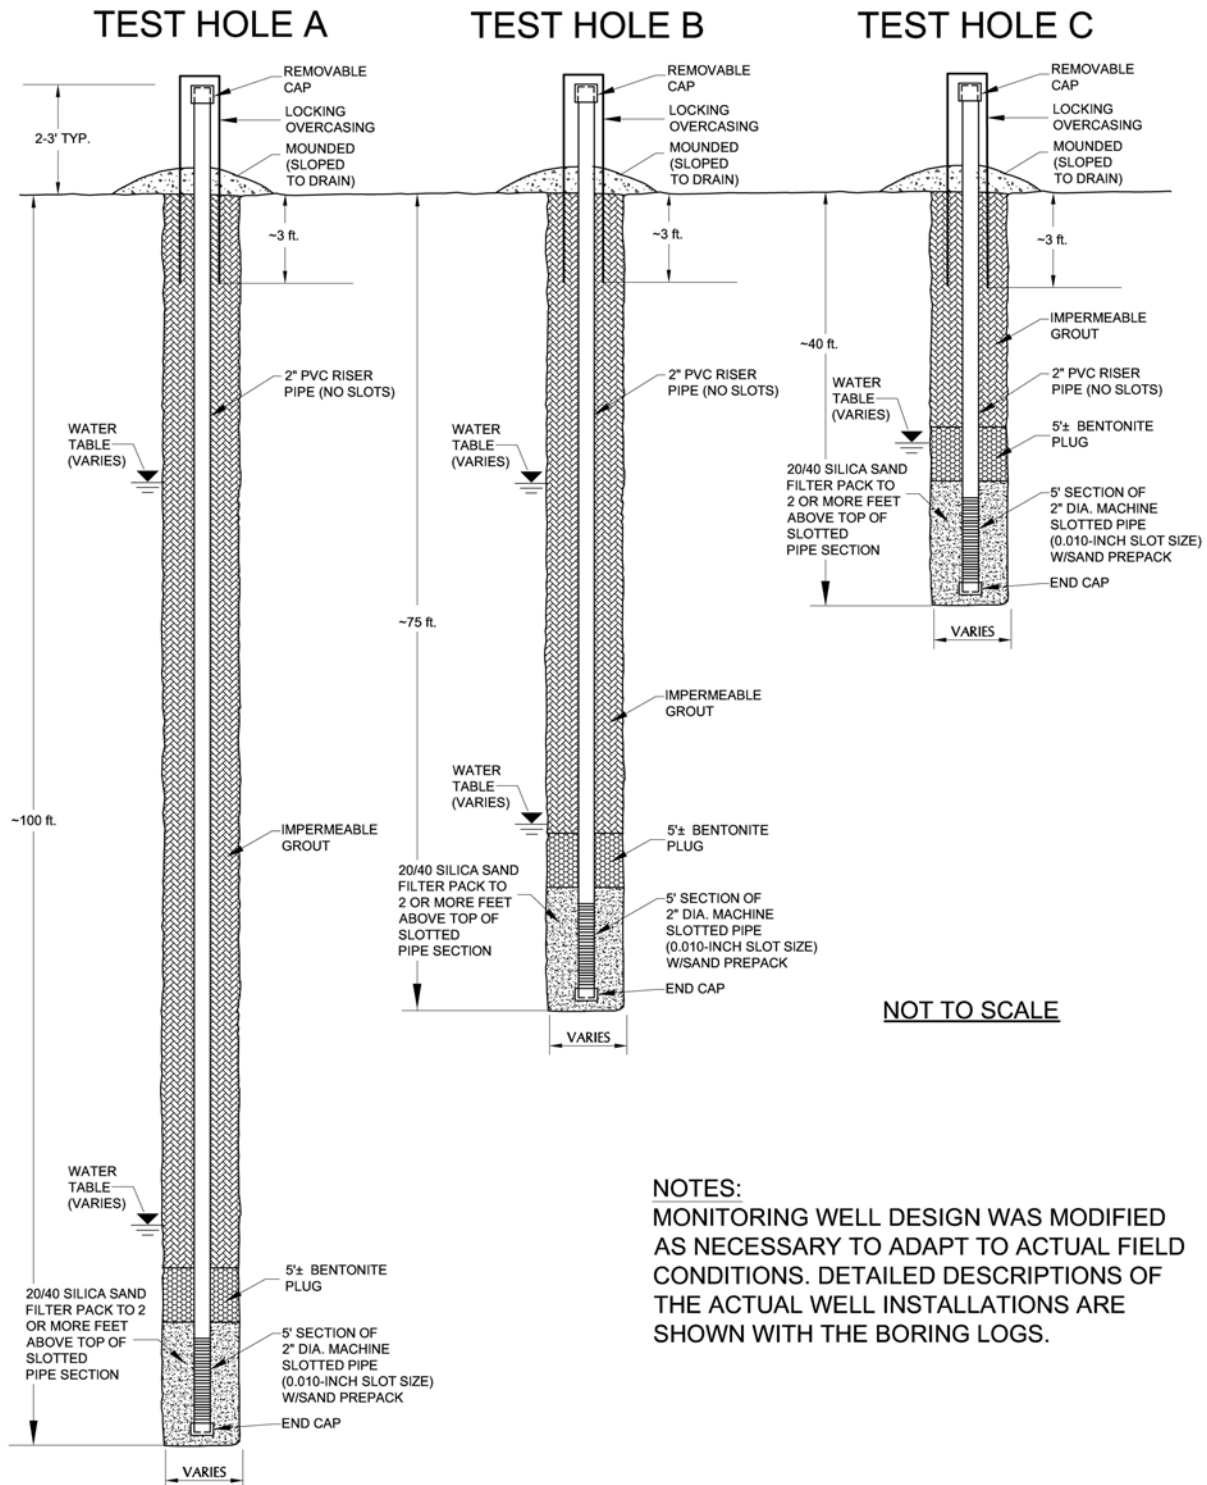
TYPICAL GROUNDWATER MONITORING WELL GROUP

NOTES:  
MONITORING WELL DESIGN WAS MODIFIED  
AS NECESSARY TO ADAPT TO ACTUAL FIELD  
CONDITIONS. DETAILED DESCRIPTIONS OF  
THE ACTUAL WELL INSTALLATIONS ARE  
SHOWN WITH THE BORING LOGS.

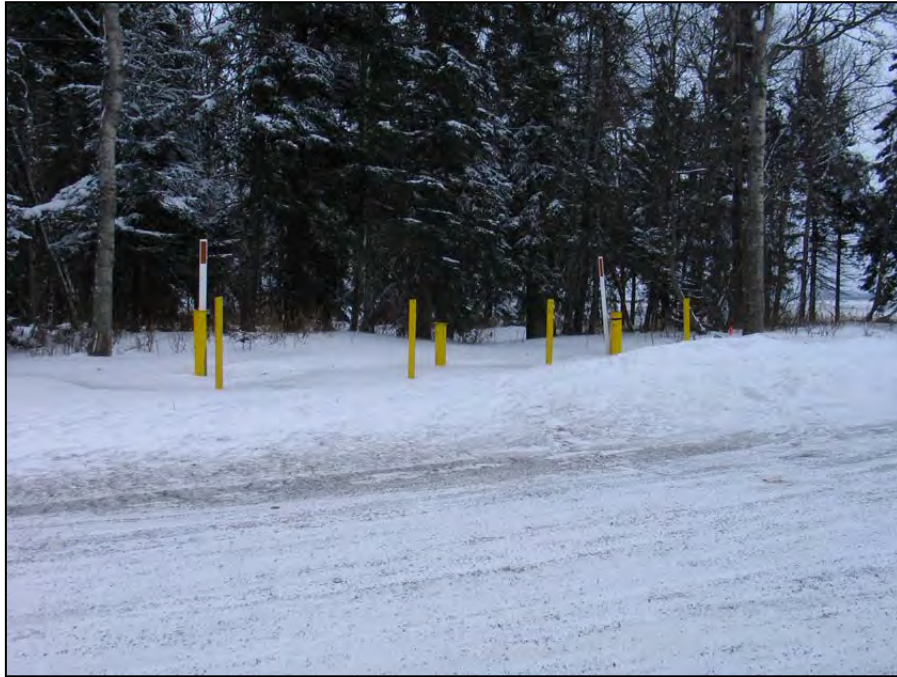
**FIGURE 8**  
**PHOTOGRAPHS SHOWING MONITORING WELLS**

a. Monitoring well installation at Group 3 borings with protective bollards. December, 2006.

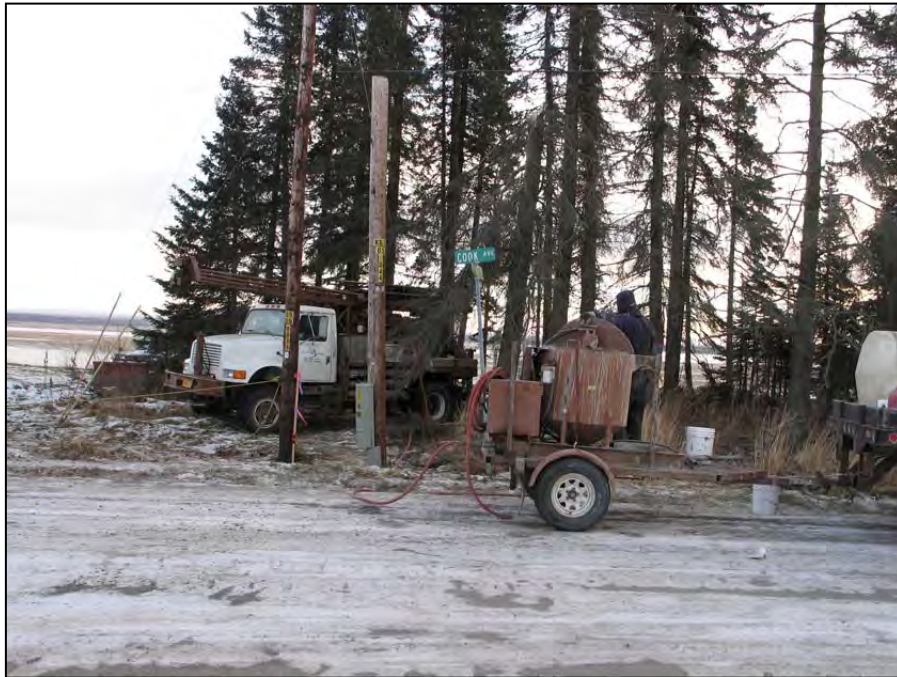
b. Grouting at Group 2 borings. November, 2006.

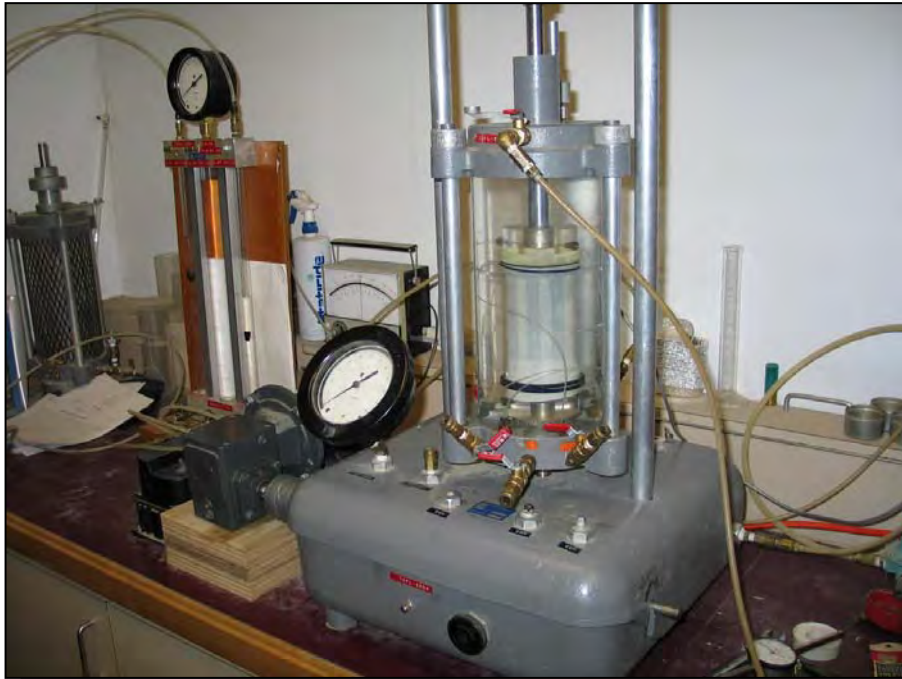
**FIGURE 9**

a. Triaxial test apparatus.

The CU tests could not be run at a rate slow enough to allow equalization of pore pressure. The tests were performed on specimens with diameters of approximately 2.4 inches. Specimen height/width ratios were between 2.0 and 2.5. Because of the presence of small gravel particles in the material it was not possible to trim the specimens to smaller diameters. Filter strips were applied to the perimeter of the specimens to allow radial drainage. However, even with radial drainage, the measured consolidation rate required strain rates of about 0.02 to 0.03% per minute for the equalization of pore pressure. The CU tests were run at about 0.1% per minute, which is the slowest strain rate the test equipment can accommodate. Photographs showing triaxial test procedures are presented in Figure 9.

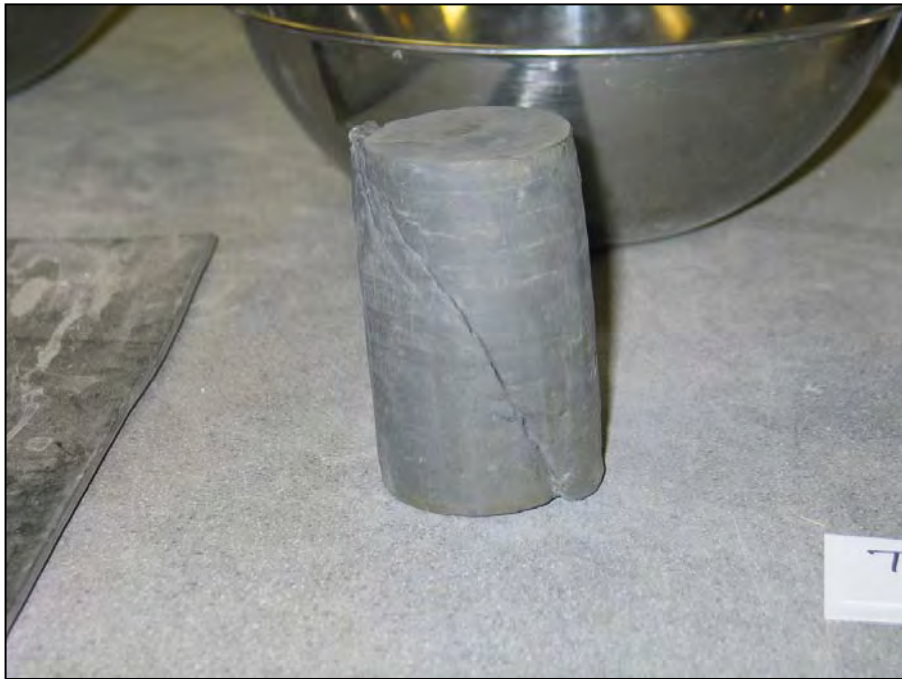
b. Sample TB-2C No. 16 (AP-611-MW) after testing. Note failure plane.

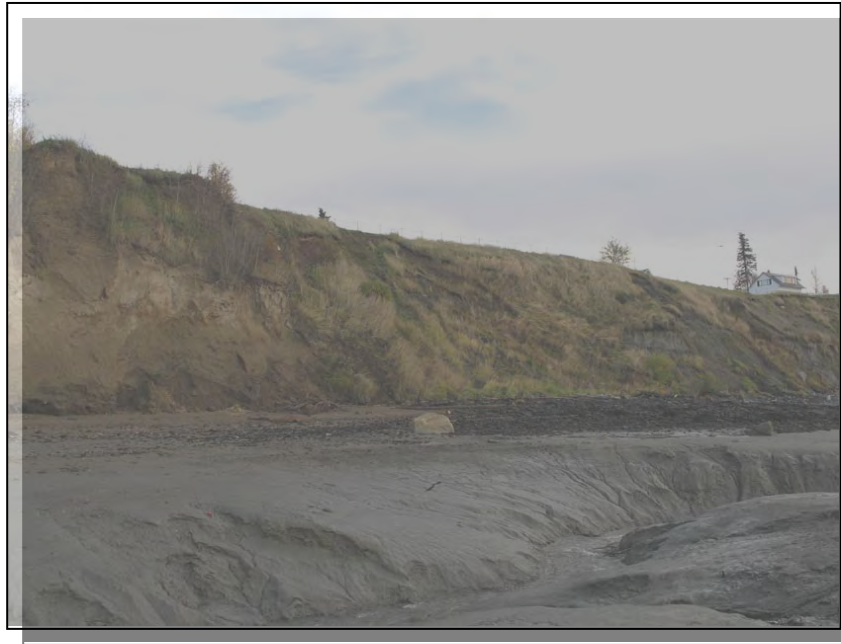
- a. Area adjacent to Mission Road where fill was pushed over the edge of the bluff.  
The black material on the flats was broken asphalt.  
The fill slopes have reportedly failed during the past. September, 2006.

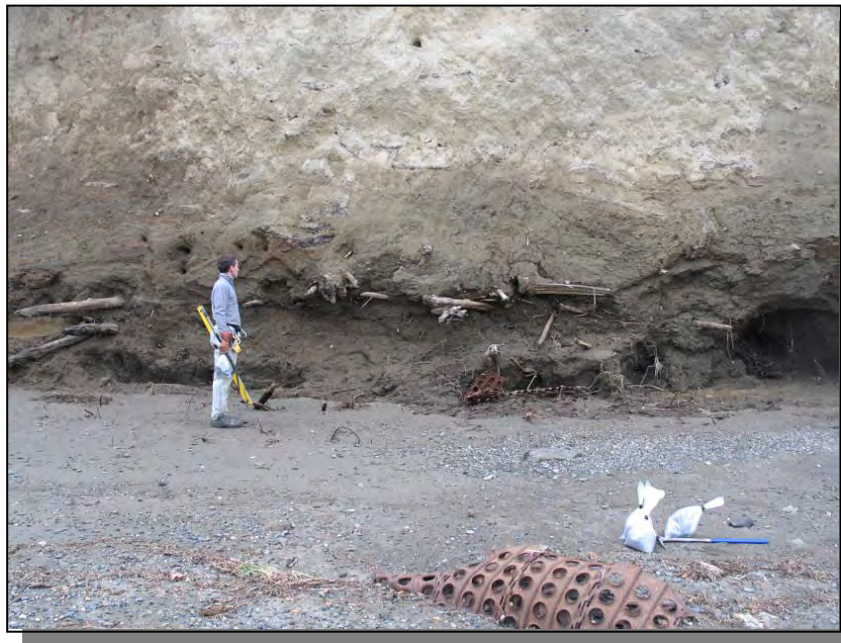
- b. Photograph taken at bottom of slope on left side of photo above.  
Note undermining of the slope and “Marston Mat” in foreground. October, 2006.

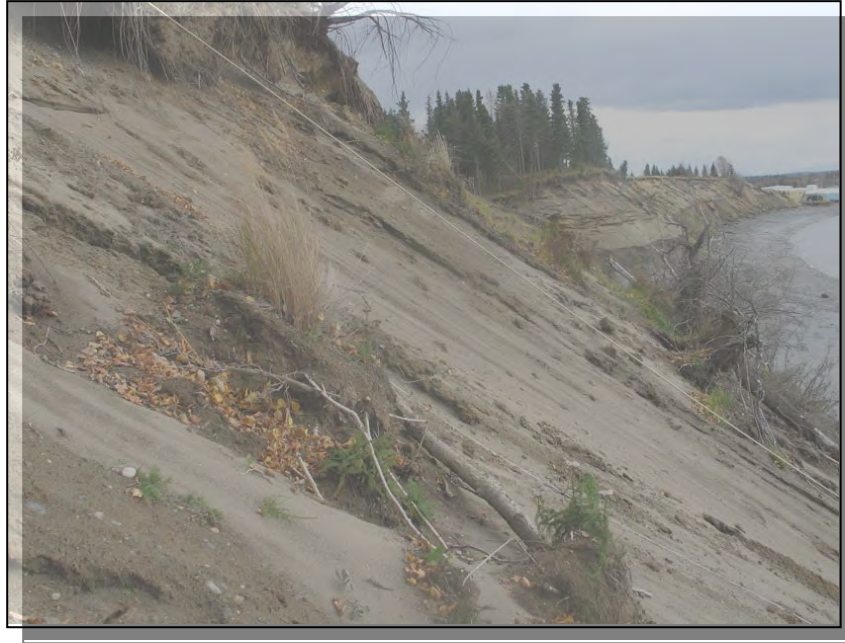
**FIGURE 11**  
**PHOTOGRAPHS OF ALLUVIAL DEPOSITS**

a. Slope in alluvial unit at Soil Profile SP-F.  
Overhanging surficial soil layer can be seen at upper left. October, 2006.

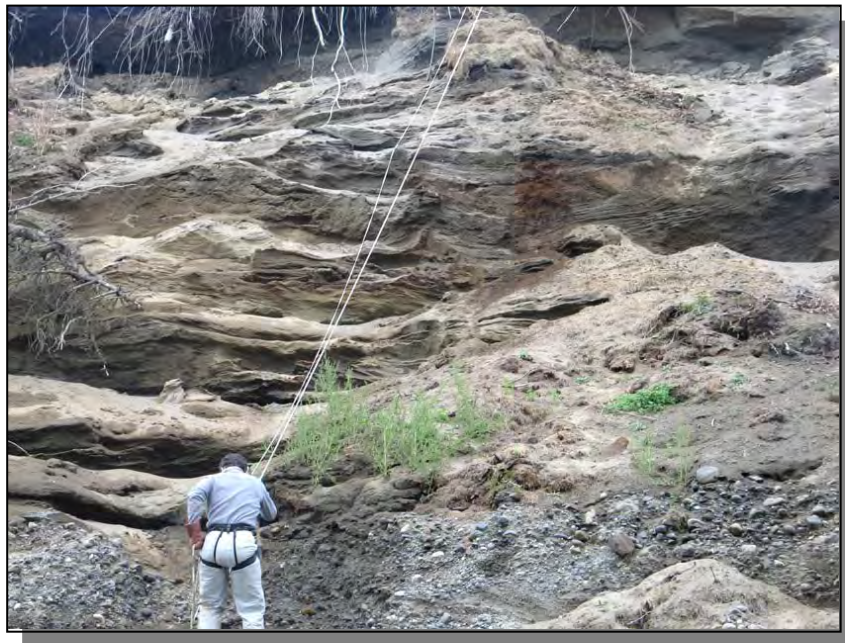
b. Cemented layers of sand at Soil Profile SP-C.  
Cementation appears to allow the sand to stand almost vertical. October, 2006.

Alluvial deposits were found underlying the entire upper bluff area to a depth of about 40 feet (37.5 to 42.5 feet). The material consisted of a thick layer of medium dense, fine to medium sand interspersed with layers of sand with gravel (SP, SP-SM). The gravel was rounded to subrounded, and ranged up to two inches in diameter. The sand with gravel layers typically ranged up to one foot thick. At Test Boring Groups 1 and 3, five-foot thick sand with gravel layers were noted. This unit exhibited horizontal layering and cross bedding. Measured slope angles in the sand ranged from 30 to 40 degrees (see Figure 11a). Slope angles were steepest at Soil Profiles SP-B, SP-C, and SP-D, near the west end of the project. Near Soil Profile SP-C, what appeared to be dark brown to black ferruginous cementation was observed in the sands. The cementation apparently allowed the slopes to stand steeper here than elsewhere (Figure 11b). A temporary increase in drilling resistance noted in the sand layer at other locations may also indicate the presence of cemented sands.

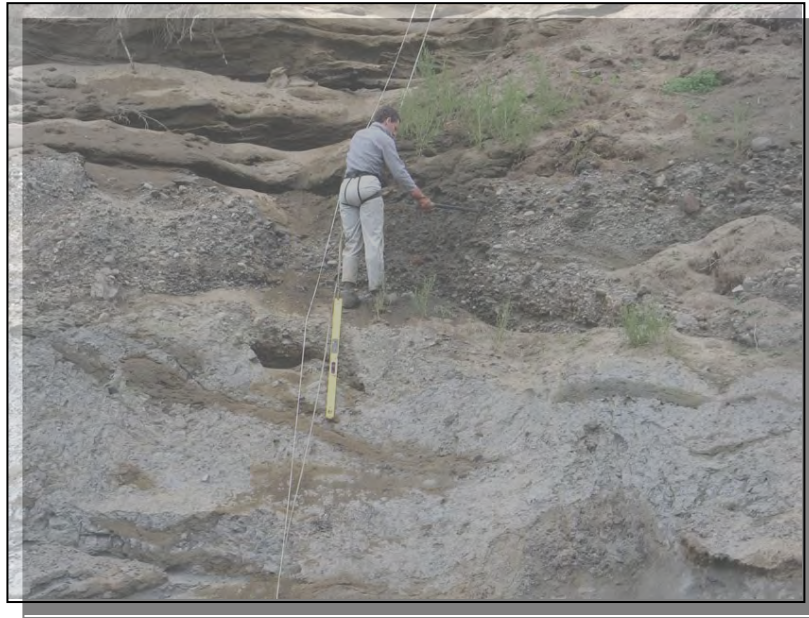
a. Cemented lag gravel (darker center bed in photo) at Soil Profile SP-C. The light gray bed below it was the dense glacial till with cobbles and boulders. There was no water observed seeping from the bluff at this location. October, 2006.

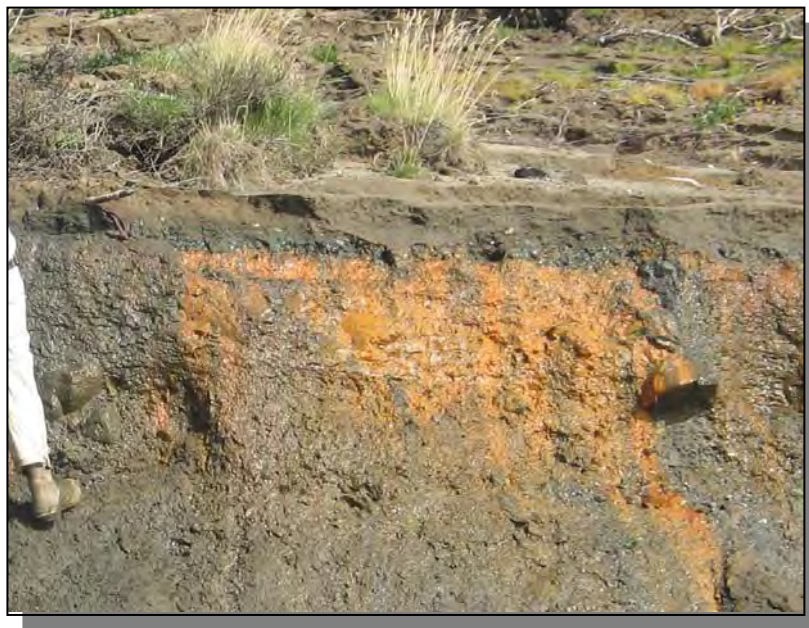
b. Thin layer of lag gravel near Soil Profile SP-H. Layer ranged from two to six inches thick and can be seen between the rust stained glacial till below and brown sand above. Water was observed flowing out of the gravel at this location. October, 2006.

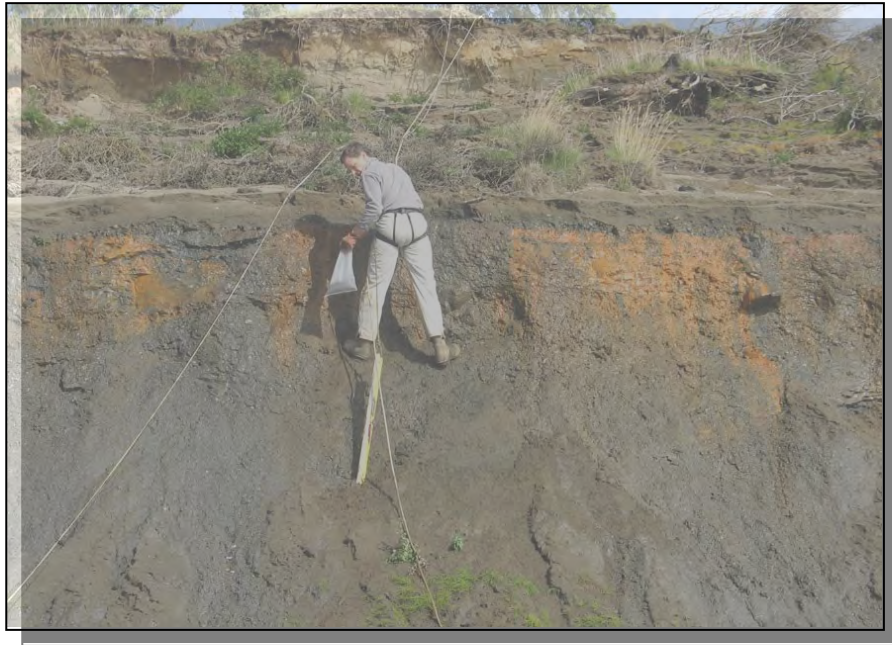
**FIGURE 13**  
**PHOTOGRAPHS OF GLACIAL TILL DEPOSIT**

a. Top of glacial till unit at Soil Profile SP-H. Note gravel layers in till. October, 2006.

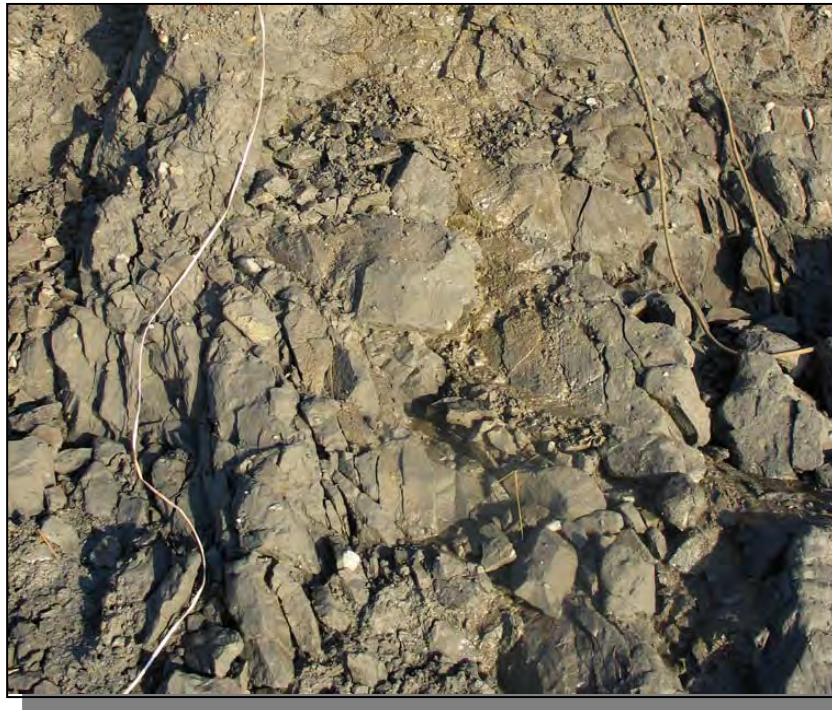
b. Glacial till exposed at the bottom of the bluff.  
Note the bedrock-like jointed appearance of the clay. October, 2006.

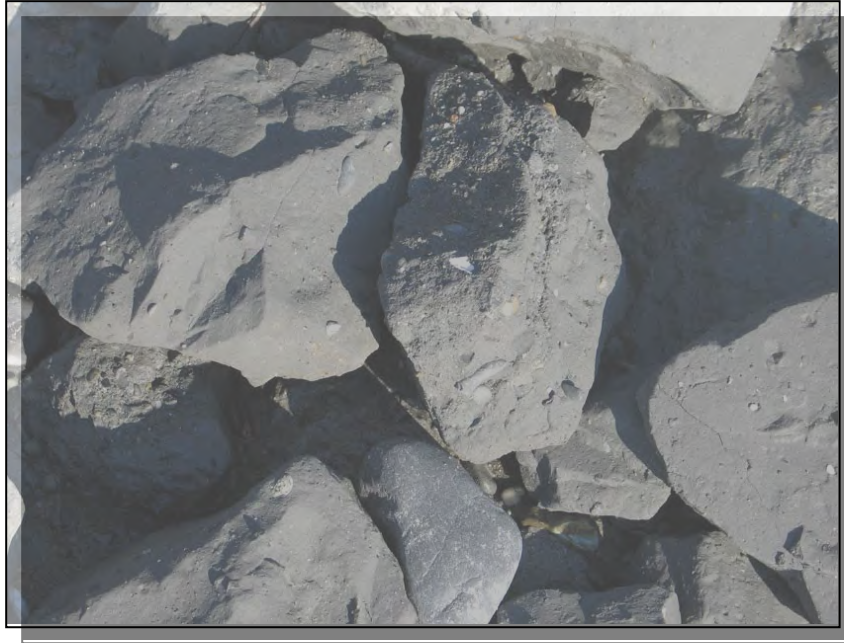
a. Large chunks (boulders) of clay found at bottom of bluff.  
From a distance, these chunks can be mistaken for cobbles and boulders. October, 2006.

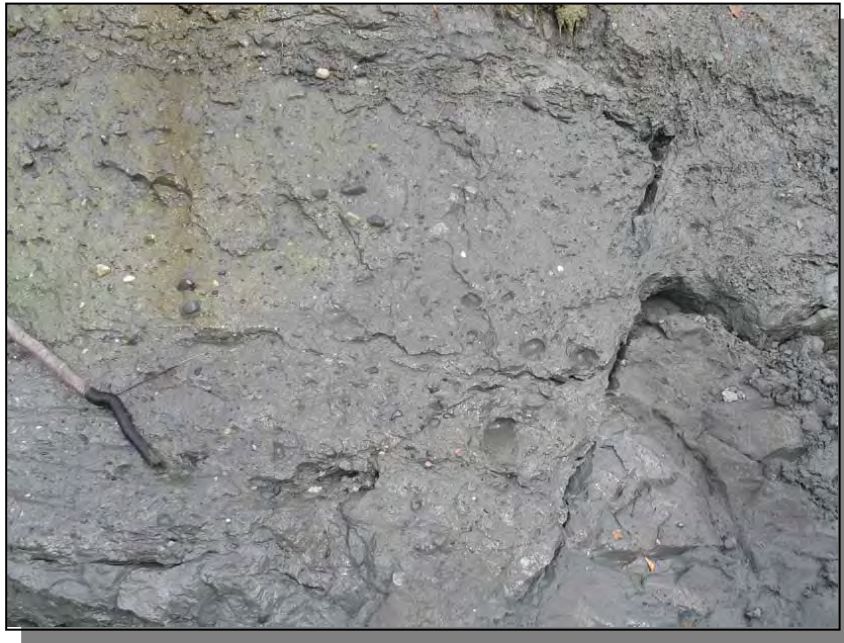
b. Scattered gravel in clayey glacial till.  
Much of this gravel may be “dropstones” derived from floating glacial ice. October, 2006.

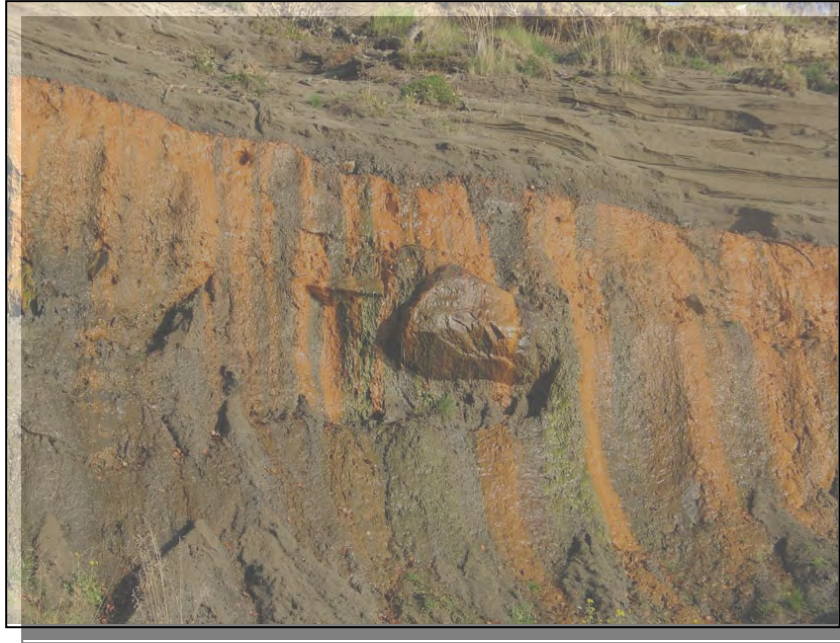
## FIGURE 15

a. Large boulder protruding from glacial till unit in bluff near Soil Profile SP-E. The boulder was approximately five feet in length. October, 2006.

Large glacial erratics were observed protruding from the bluff in several places and there were many large boulders located on the tide flats (Figure 15). Bates and Jackson (1980) define erratics as rock fragments carried by glacial ice and deposited at some distance from the outcrop from which they were derived. Erratics are often randomly scattered throughout glacially derived material.

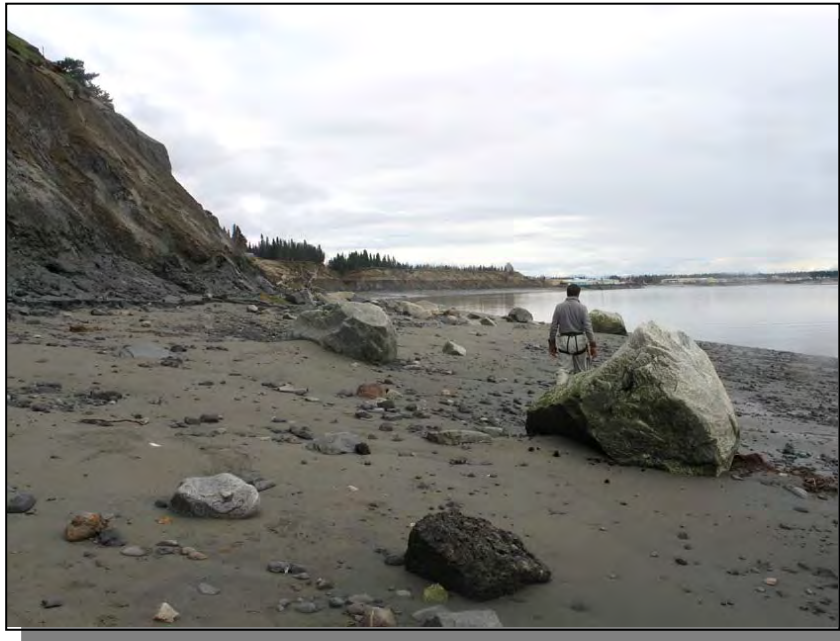
b. Large boulders on beach near Soil Profile SP-C. October, 2006.

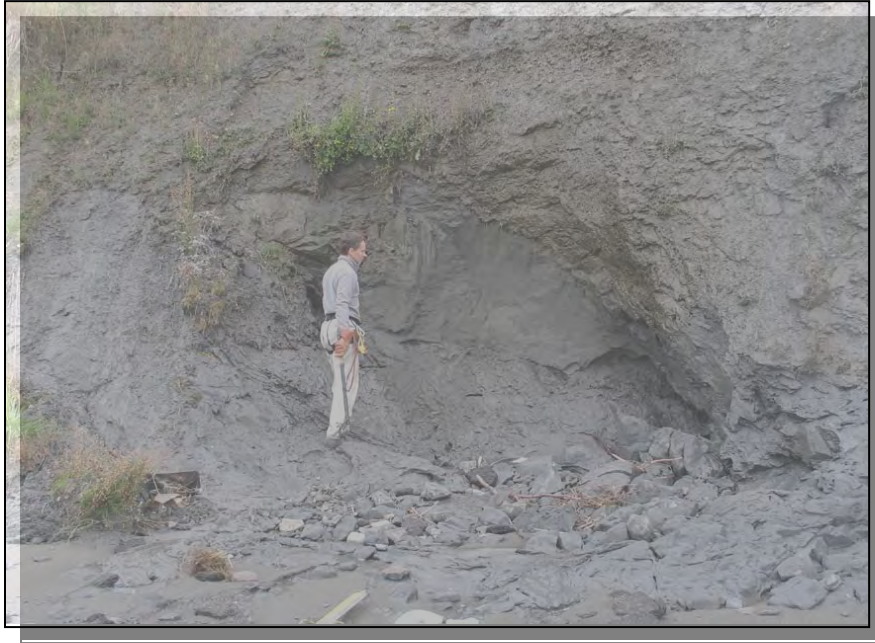
## FIGURE 16

a. Sand pocket in glacial till showing signs of erosion. October, 2006.

Sand pockets within the glacial till consisted predominately of fine sand with some fine to medium dark gray nonplastic sand (SP and SP-SM). Larger pockets of sand were also noted along the bluff (Figure 16a). The largest of these pockets ranged up to about 12 feet high and 100 feet long (Figure 17b). The size and incidence of the sand pockets appeared to increase toward the west end of the project and a significant portion of the glacial till unit was composed of this sand at the Group 1 test boring location.

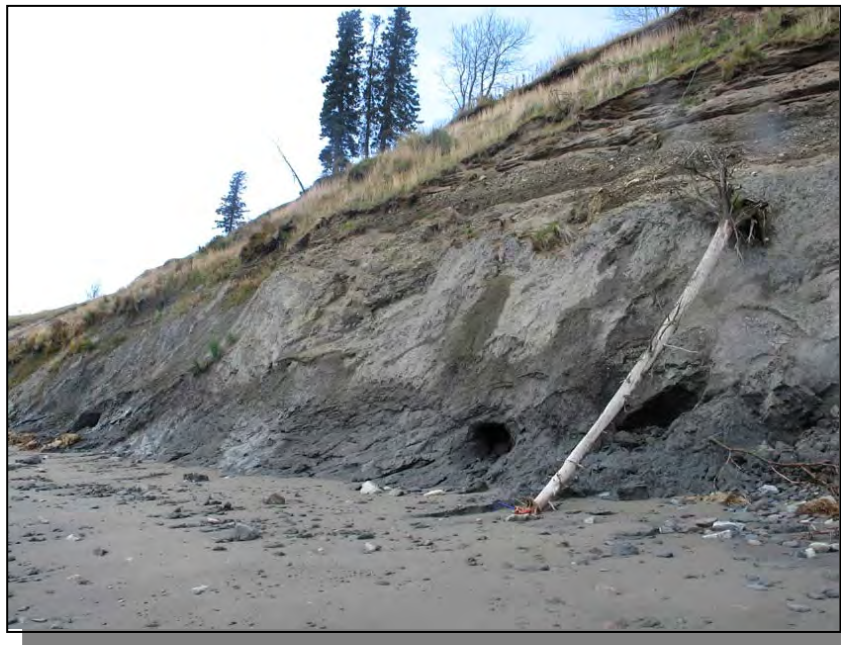
b. Caves interpreted to have been created by the erosion of sand pockets along bottom of the bluff near Soil Profile SP-C. October, 2006.

These sand pockets often occurred along the toe of the bluff, where they were rapidly eroded leaving small caves in the bluff (Figure 16b). The presence of these caves along the toe of the bluff appeared to accelerate undermining of the glacial till (Figure 17a). There were significant quantities of sand encountered in the eight test borings drilled along the tide flats. It appeared that the sand unit was becoming continuous and that the clay lenses were decreasing with depth.

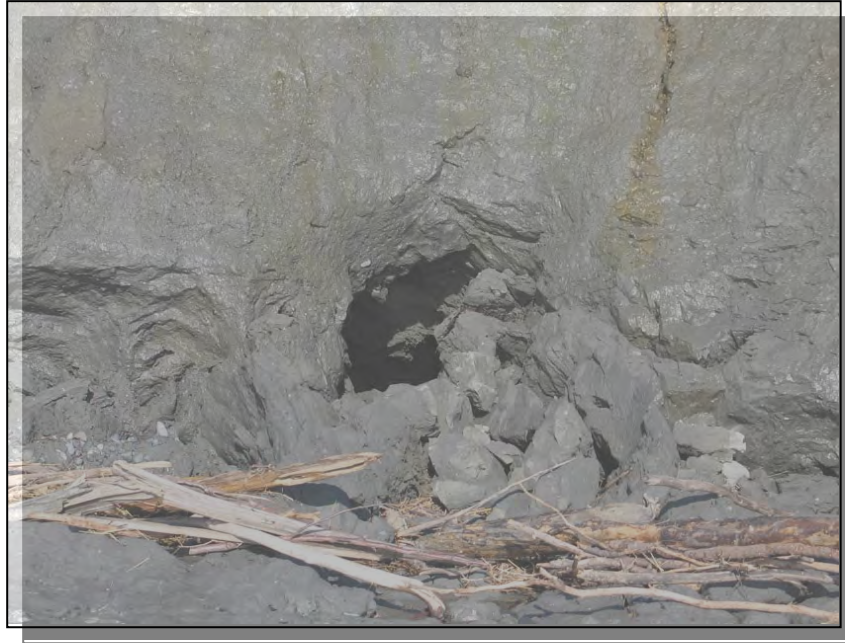
a. Caves formed in bluff by erosion of sand pockets.  
Note caving of clay caused by undermining due to removal of sand. October, 2006.

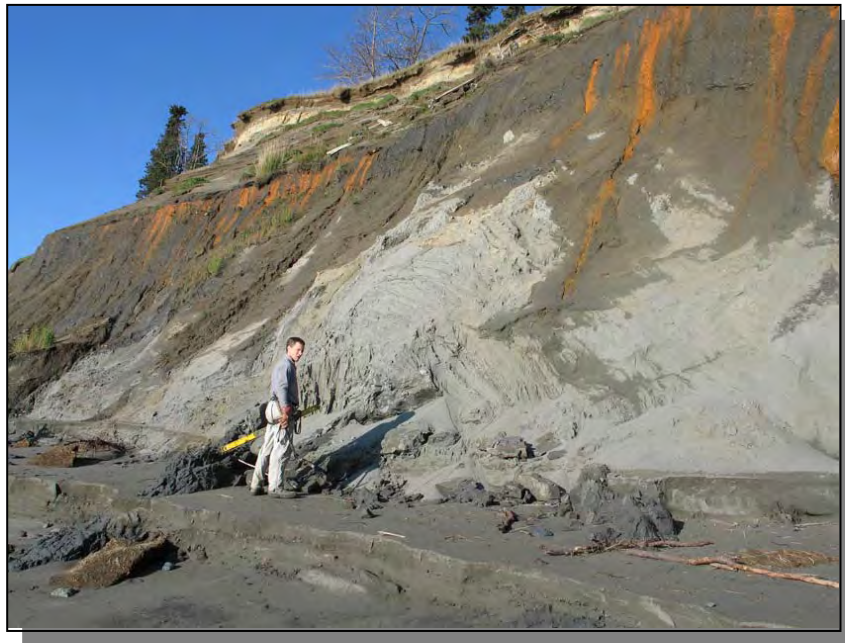
b. Light gray material in center of photo was part of a large  
sand pocket observed west of Soil Profile SP-C. October, 2006.

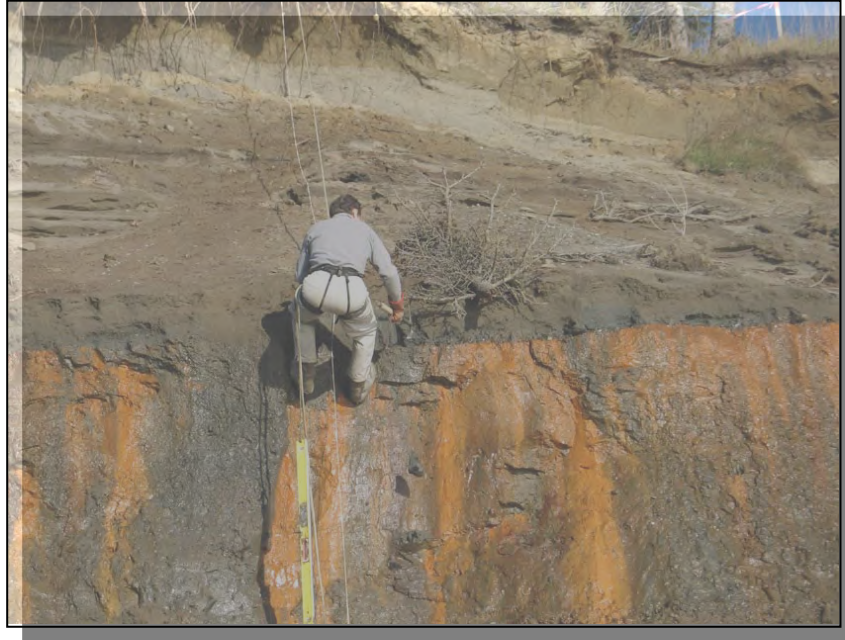
**FIGURE 18**  
**PHOTOGRAPHS OF GROUNDWATER SEEPAGE**

a. Groundwater seeping out of bluff at Soil Profile SP-D west of Ryan's Creek. October, 2006.

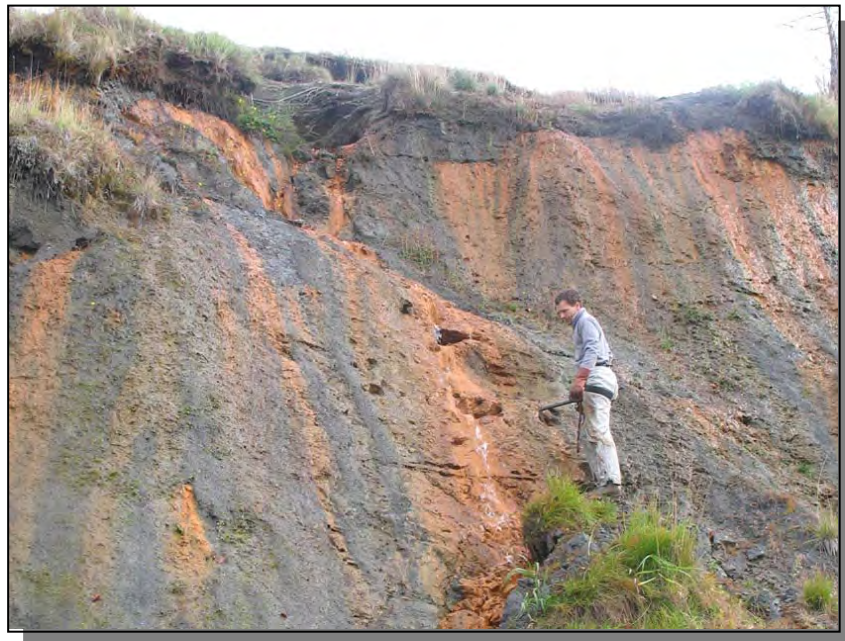
b. Small stream flowing out of bluff face near Soil Profile SP-I, east of Ryan's Creek. October, 2006.

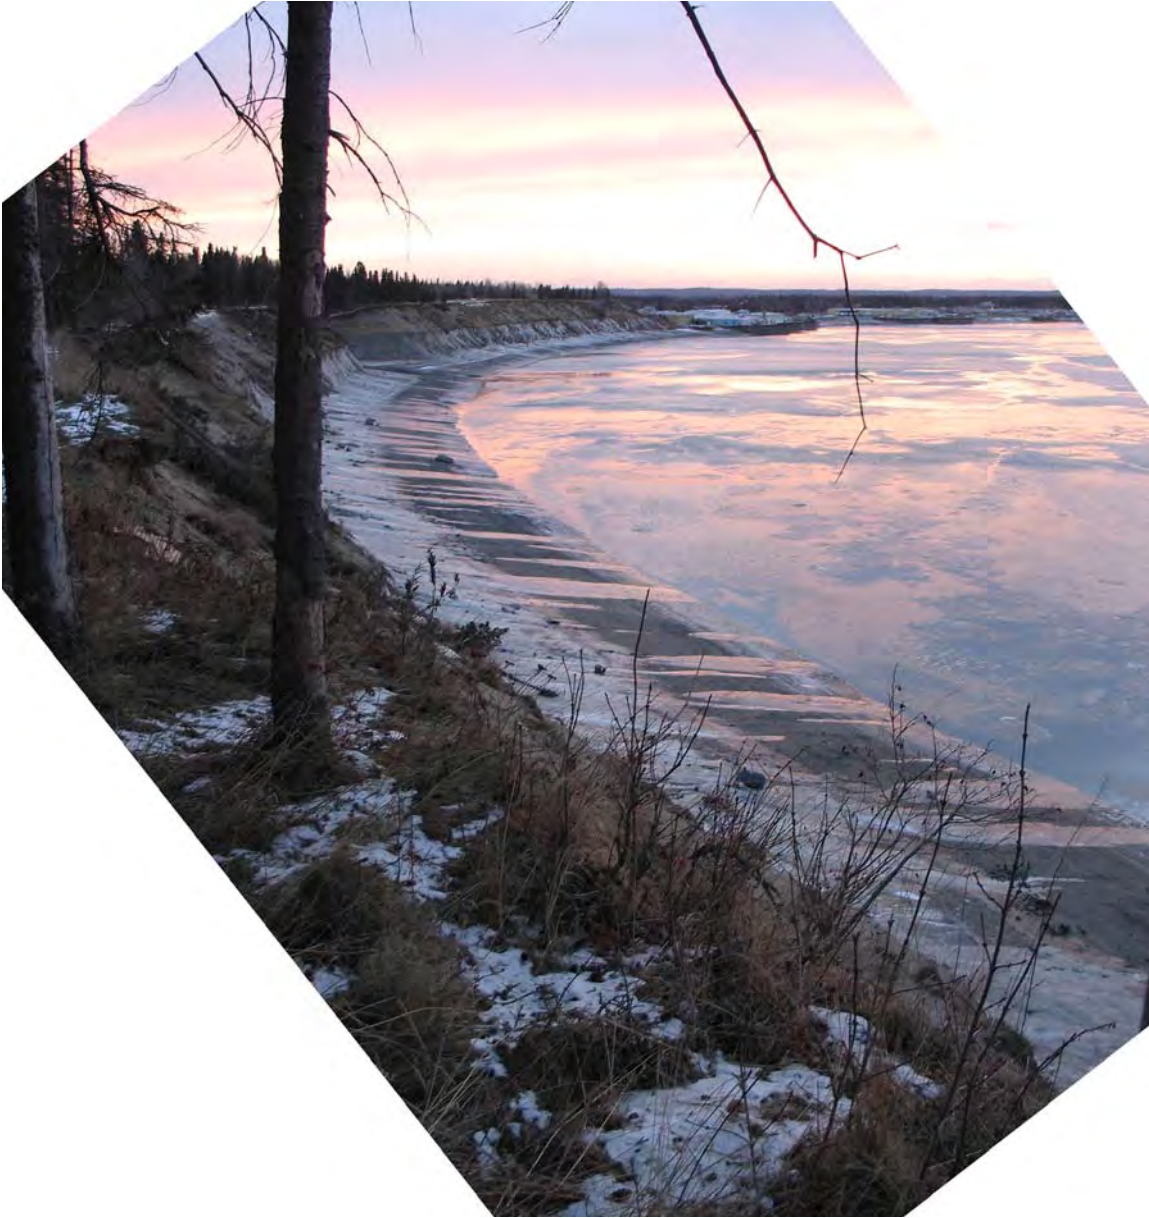
**PHOTOGRAPH OF TIDE FLATS, NOVEMBER, 2006**

Looking east along tide flats from Group 2 test borings at low tide on one of the first cold days of the winter. Later in the winter the flats were completely covered by ice.

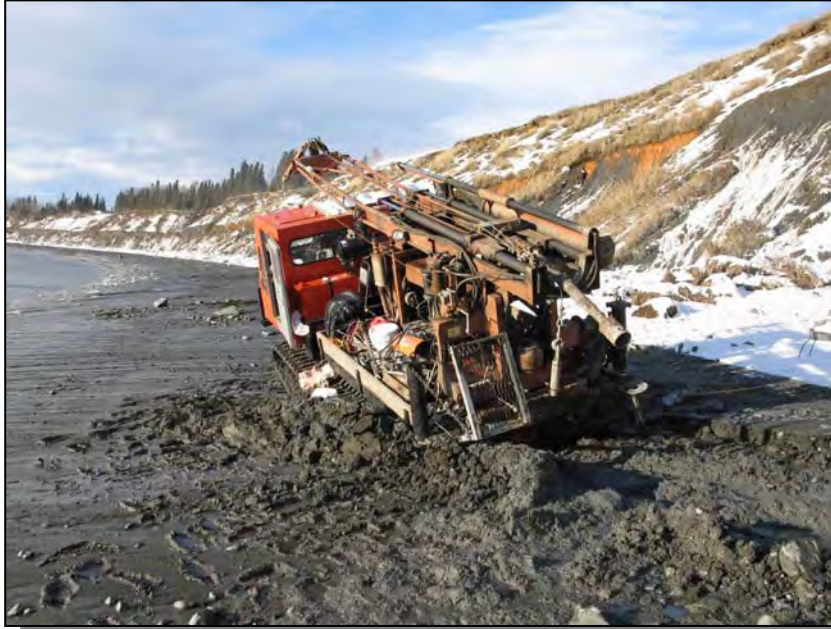
**FIGURE 20**  
**DRILL RIG STUCK ON TIDE FLATS**

a. Nodwell stuck in mud near Test Boring AP-627 at low tide. November 10, 2006.

13. Contractors should also be prepared to deal with the soft, quick conditions of the soils along the tide flats (see Figure 20).
14. Within three months of the 1964 Great Alaska Earthquake, the bluff had receded as much as 20 feet within the project area. This was attributed to regional subsidence, rapid removal of sloughed debris along the toe, and undercutting by waves and the river.

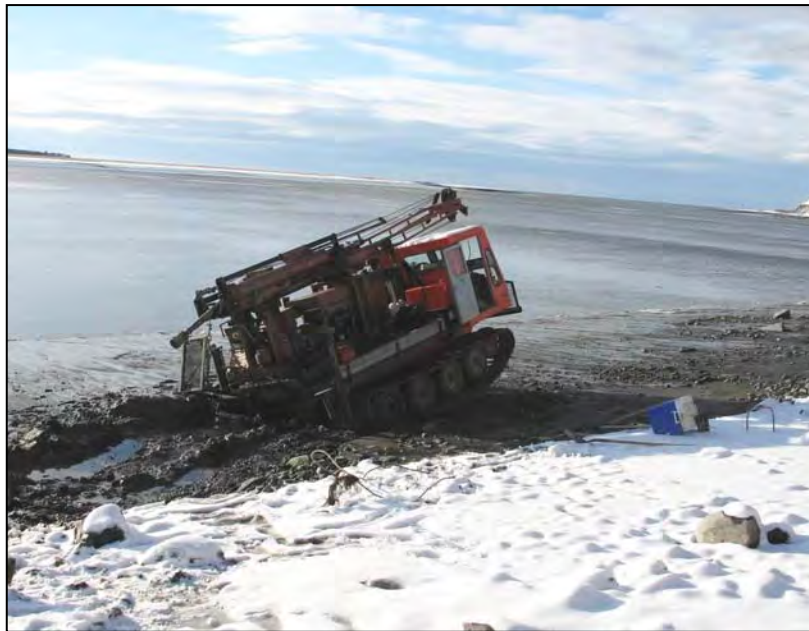
b. The Nodwell has sunk into unfrozen mud below the high tide line (edge of snow covered area). The surface of the mud was frozen under the snow covered area. November 10, 2006.

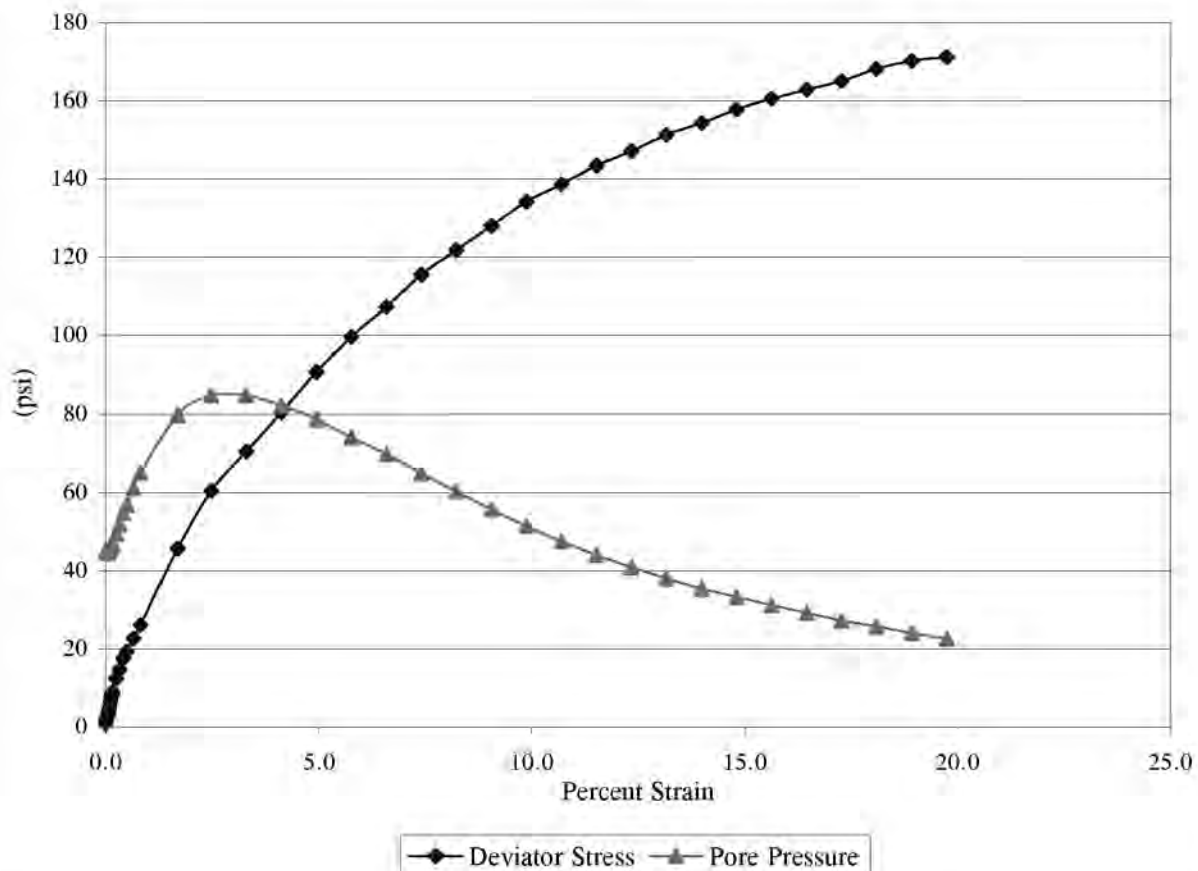
Initial Dry Density	121.9 pcf
Initial Moisture Content	14.3 %
Final Moisture Content	13.9 %
Initial Height	6.08 inches
Initial Diameter	2.33 inches
Effective Confining Pressure	44.5 psi
Back Pressure	44.7 psi
B Pore Pressure Parameter	0.96
T <sub>50</sub>	144 min
Load Rate	0.0055 in/min
