# **GEOTECHNICAL INVESTIGATION AND SITE CONDITIONS REPORT**

## **KENAI RIVER BLUFF EROSION**

**KENAI, ALASKA**

**CONTRACT NO. W911KB-05-D-0004  
DELIVERY ORDER NO. 0010  
MODIFICATION NO. 01**

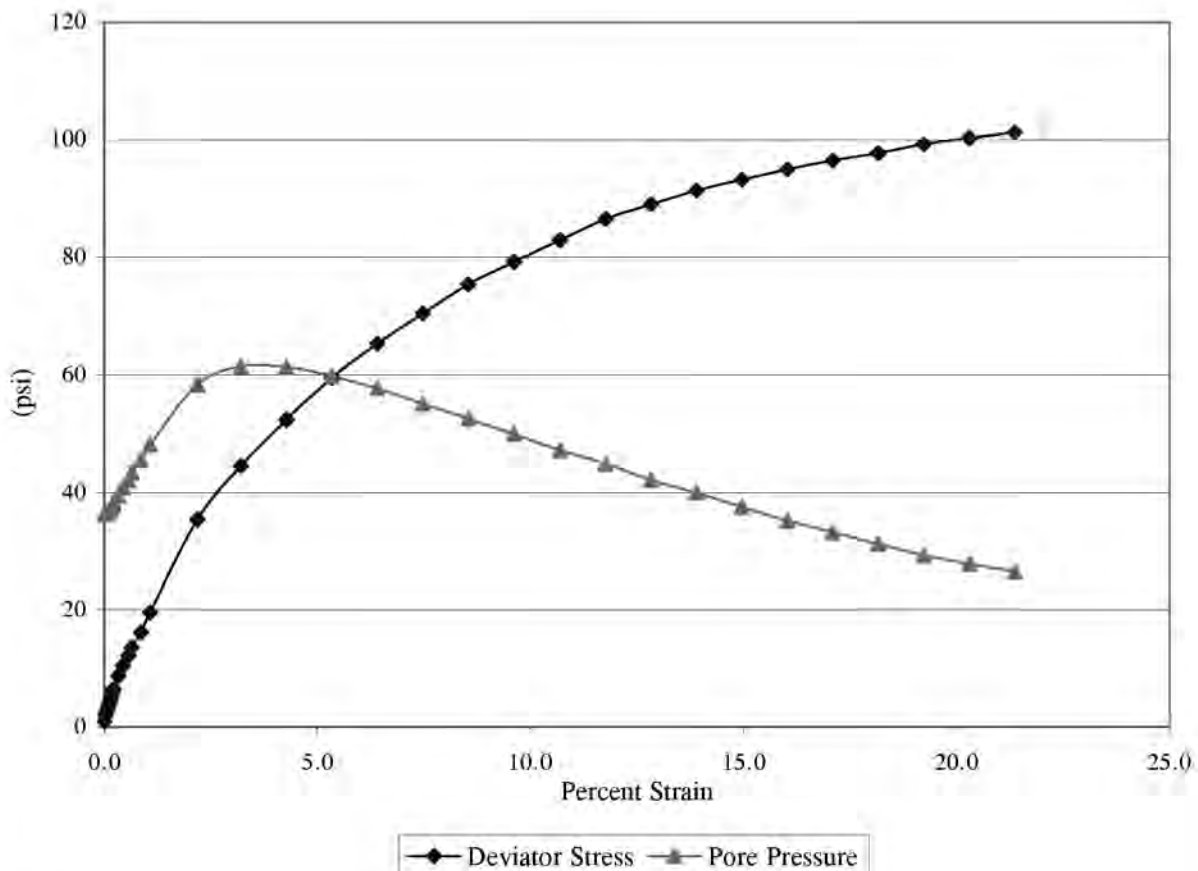
Initial Dry Density	124.9 pcf
Initial Moisture Content	13.2 %
Final Moisture Content	14.8 %
Initial Height	4.68 inches
Initial Diameter	2.33 inches
Effective Confining Pressure	32.1 psi
Back Pressure	35.4 psi
B Pore Pressure Parameter	0.97
T <sub>50</sub>	70 min
Load Rate	0.0057 in/min

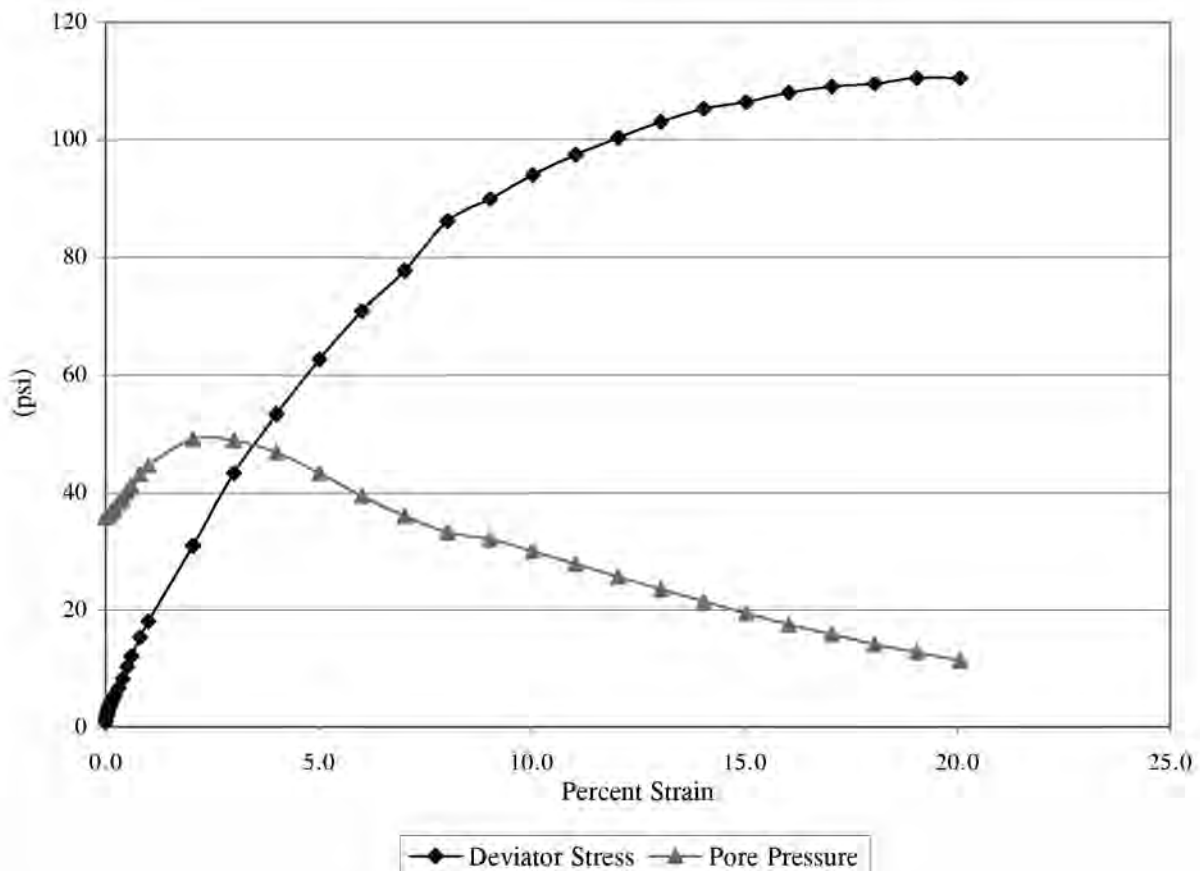
Initial Dry Density	117.4 pcf
Initial Moisture Content	15.7 %
Final Moisture Content	15.9 %
Initial Height	4.98 inches
Initial Diameter	2.36 inches
Effective Confining Pressure	15.5 psi
Back Pressure	34.5 psi
B Pore Pressure Parameter	0.97
T <sub>50</sub>	90 min
Load Rate	0.0066 in/min

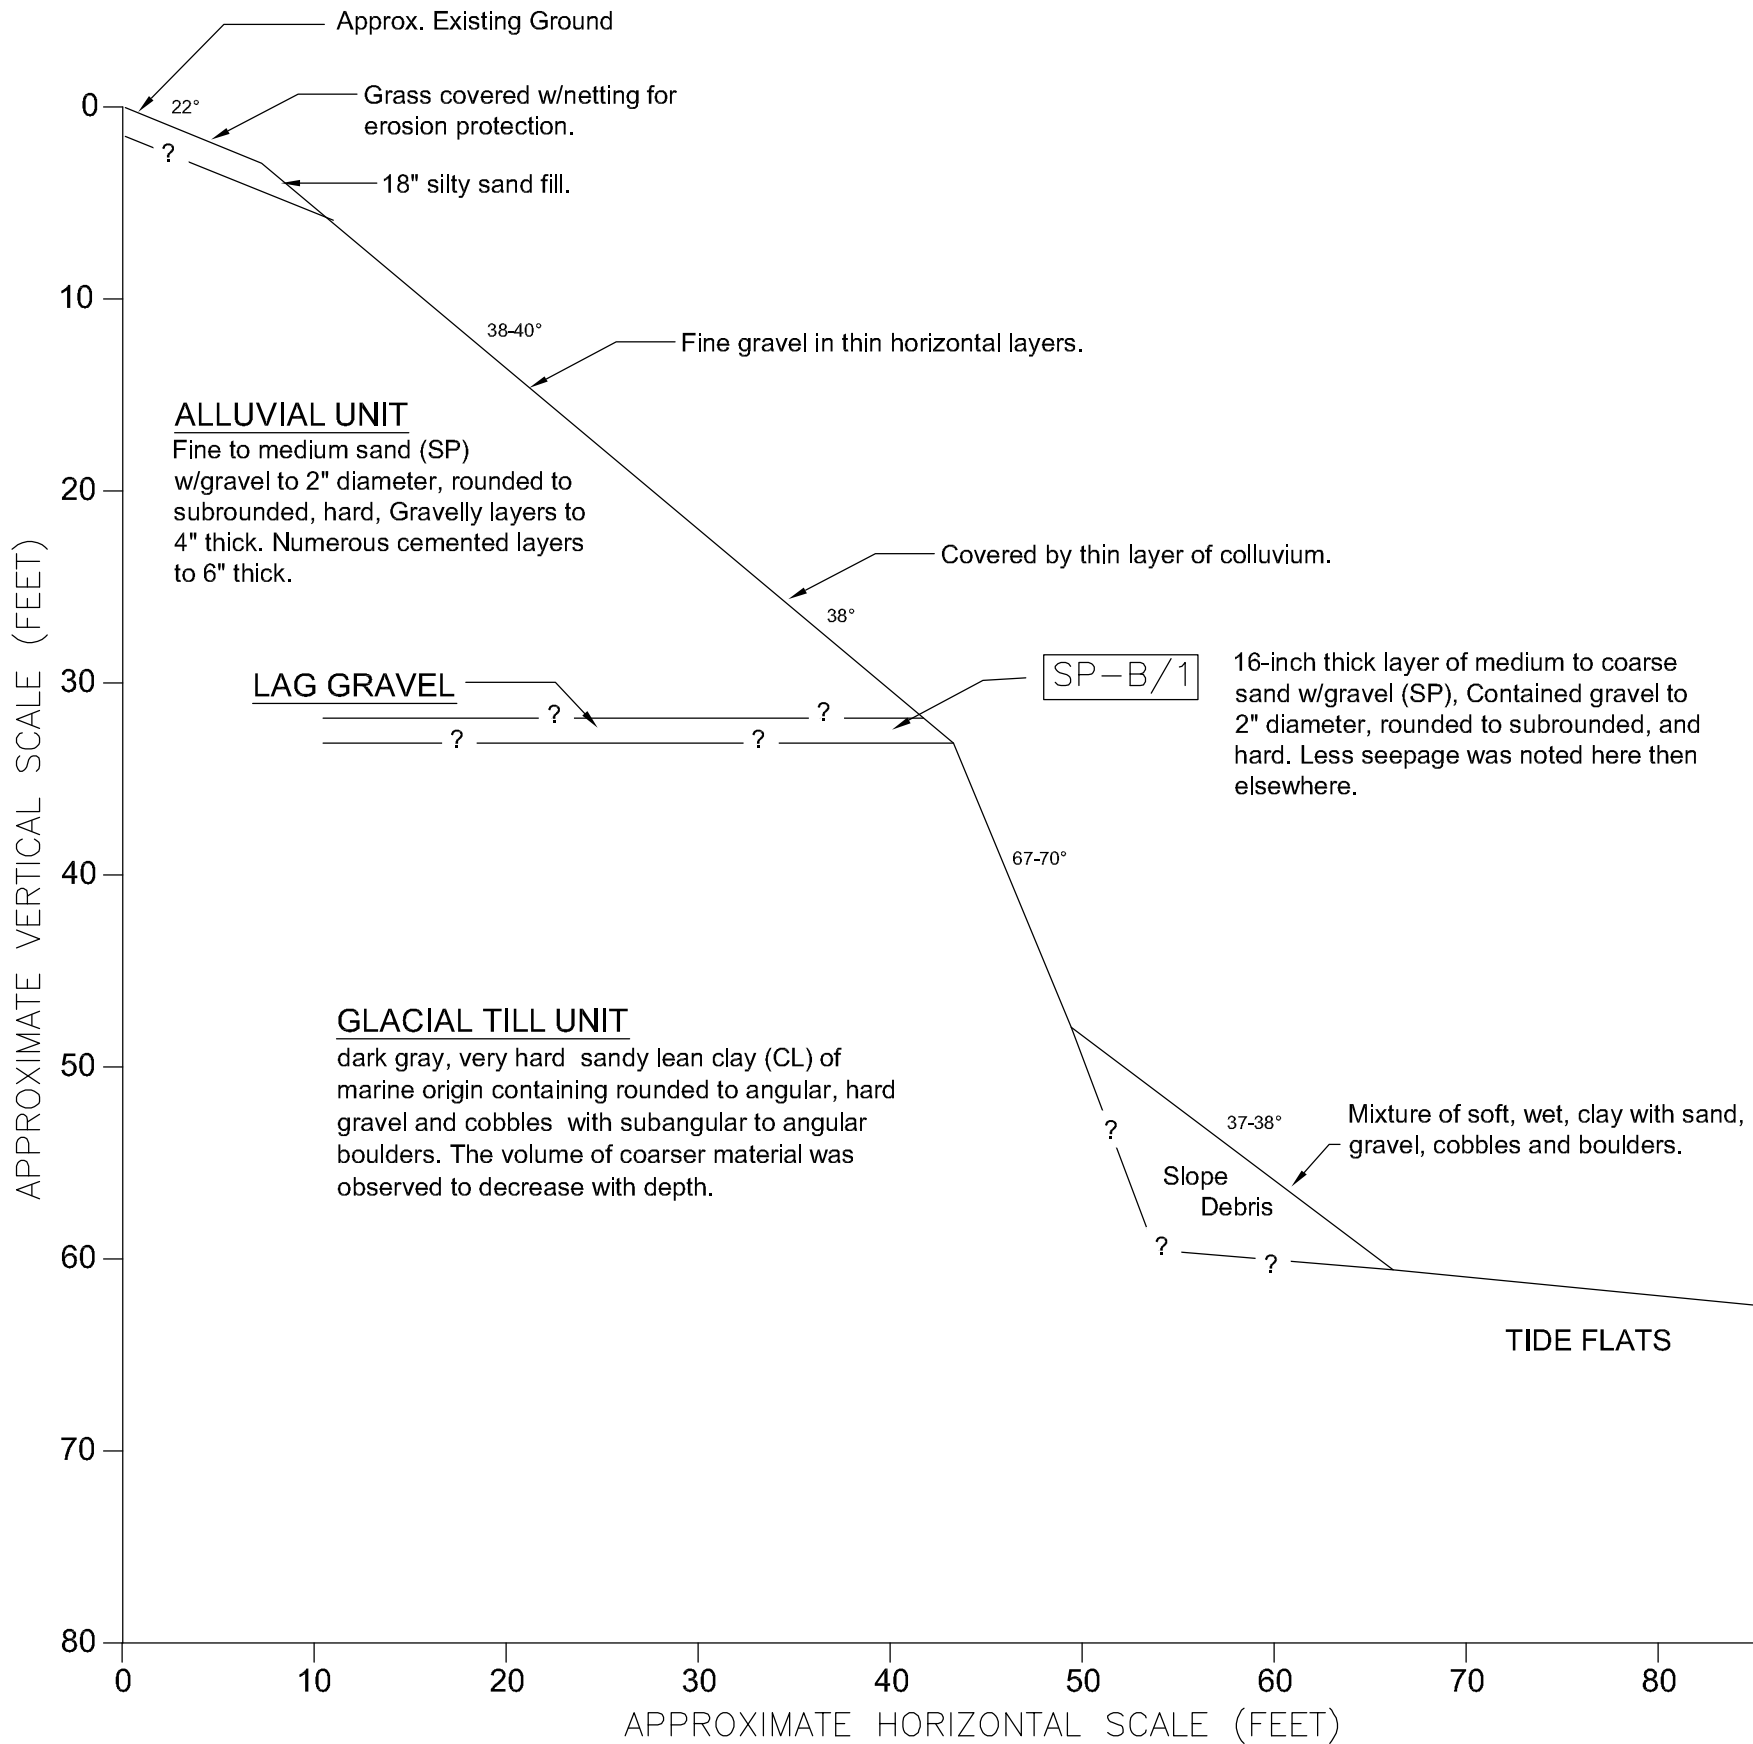
# SP-B

LOOKING NORTH AT SP-B. THE SLABS AT THE BASE OF THE SLOPE CONSIST OF ASPHALT.  
10 OCT. 2006

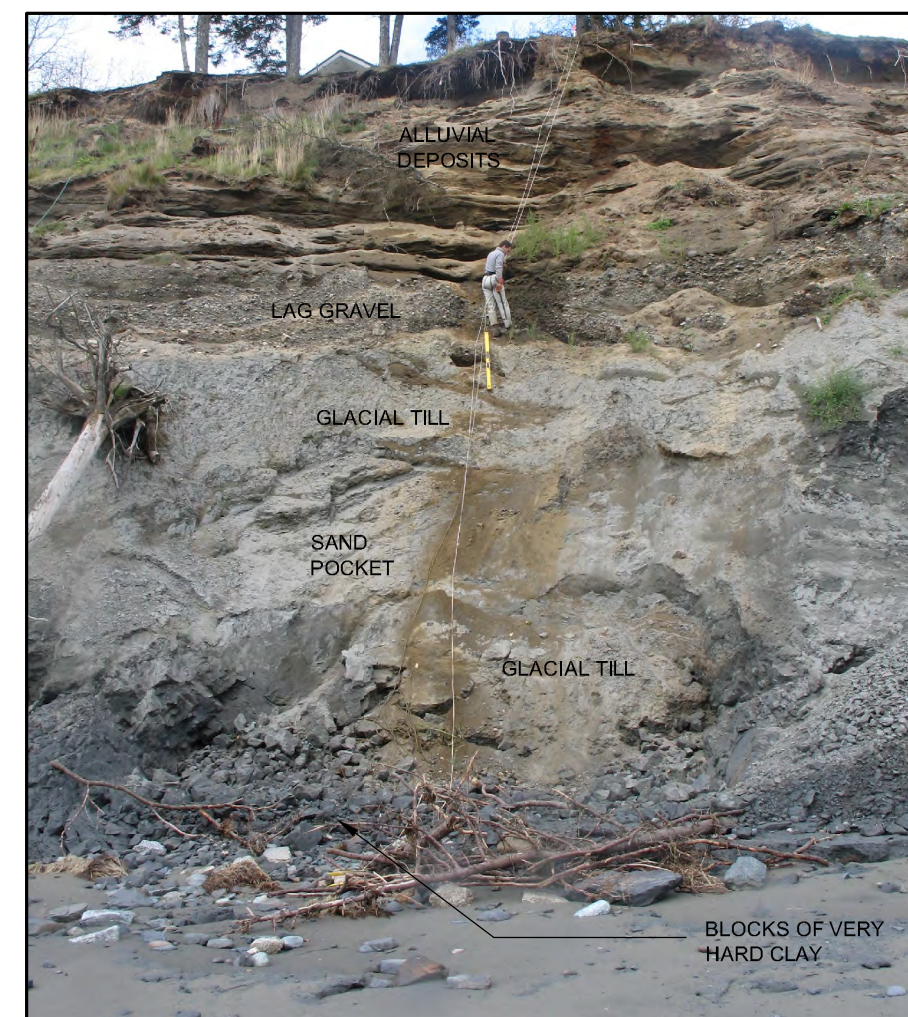
LOOKING NORTH AT SP-C. UPPER SLOPES ARE STEEPER THAN ELSEWHERE, APPARENTLY DUE TO CEMENTATION. THE PRESENCE OF THIS CEMENT MAY BE BLOCKING WATER FLOW OUT OF THE SLOPE IN THIS AREA. WHAT APPEAR TO BE LARGE DARK GRAY BOULDERS AT THE BOTTOM OF THE BLUFF ARE COMPOSED OF VERY HARD CLAY.

Near Soil Profile SP-C, groundwater seepage was observed as being minor or nonexistent. A significant amount of cementation was noted in the alluvial deposits and lag gravels at Soil Profile SP-C and this may have been the cause of the decreased flow in this immediate area (see Figure 12a). However, the cementation itself may be a result of lower groundwater flow. Water levels in Test Boring AP-620-MW and in Group 2 borings indicate there may be a lower groundwater gradient toward the bluff face in this area, but with limited data this was not conclusive. Flow rates out of the bluff varied, with higher flow rates at locations where the top of the bluff was slightly lower. This appeared to concentrate water flow across the flats producing small drainages that become more apparent in the winter (Figure 19).

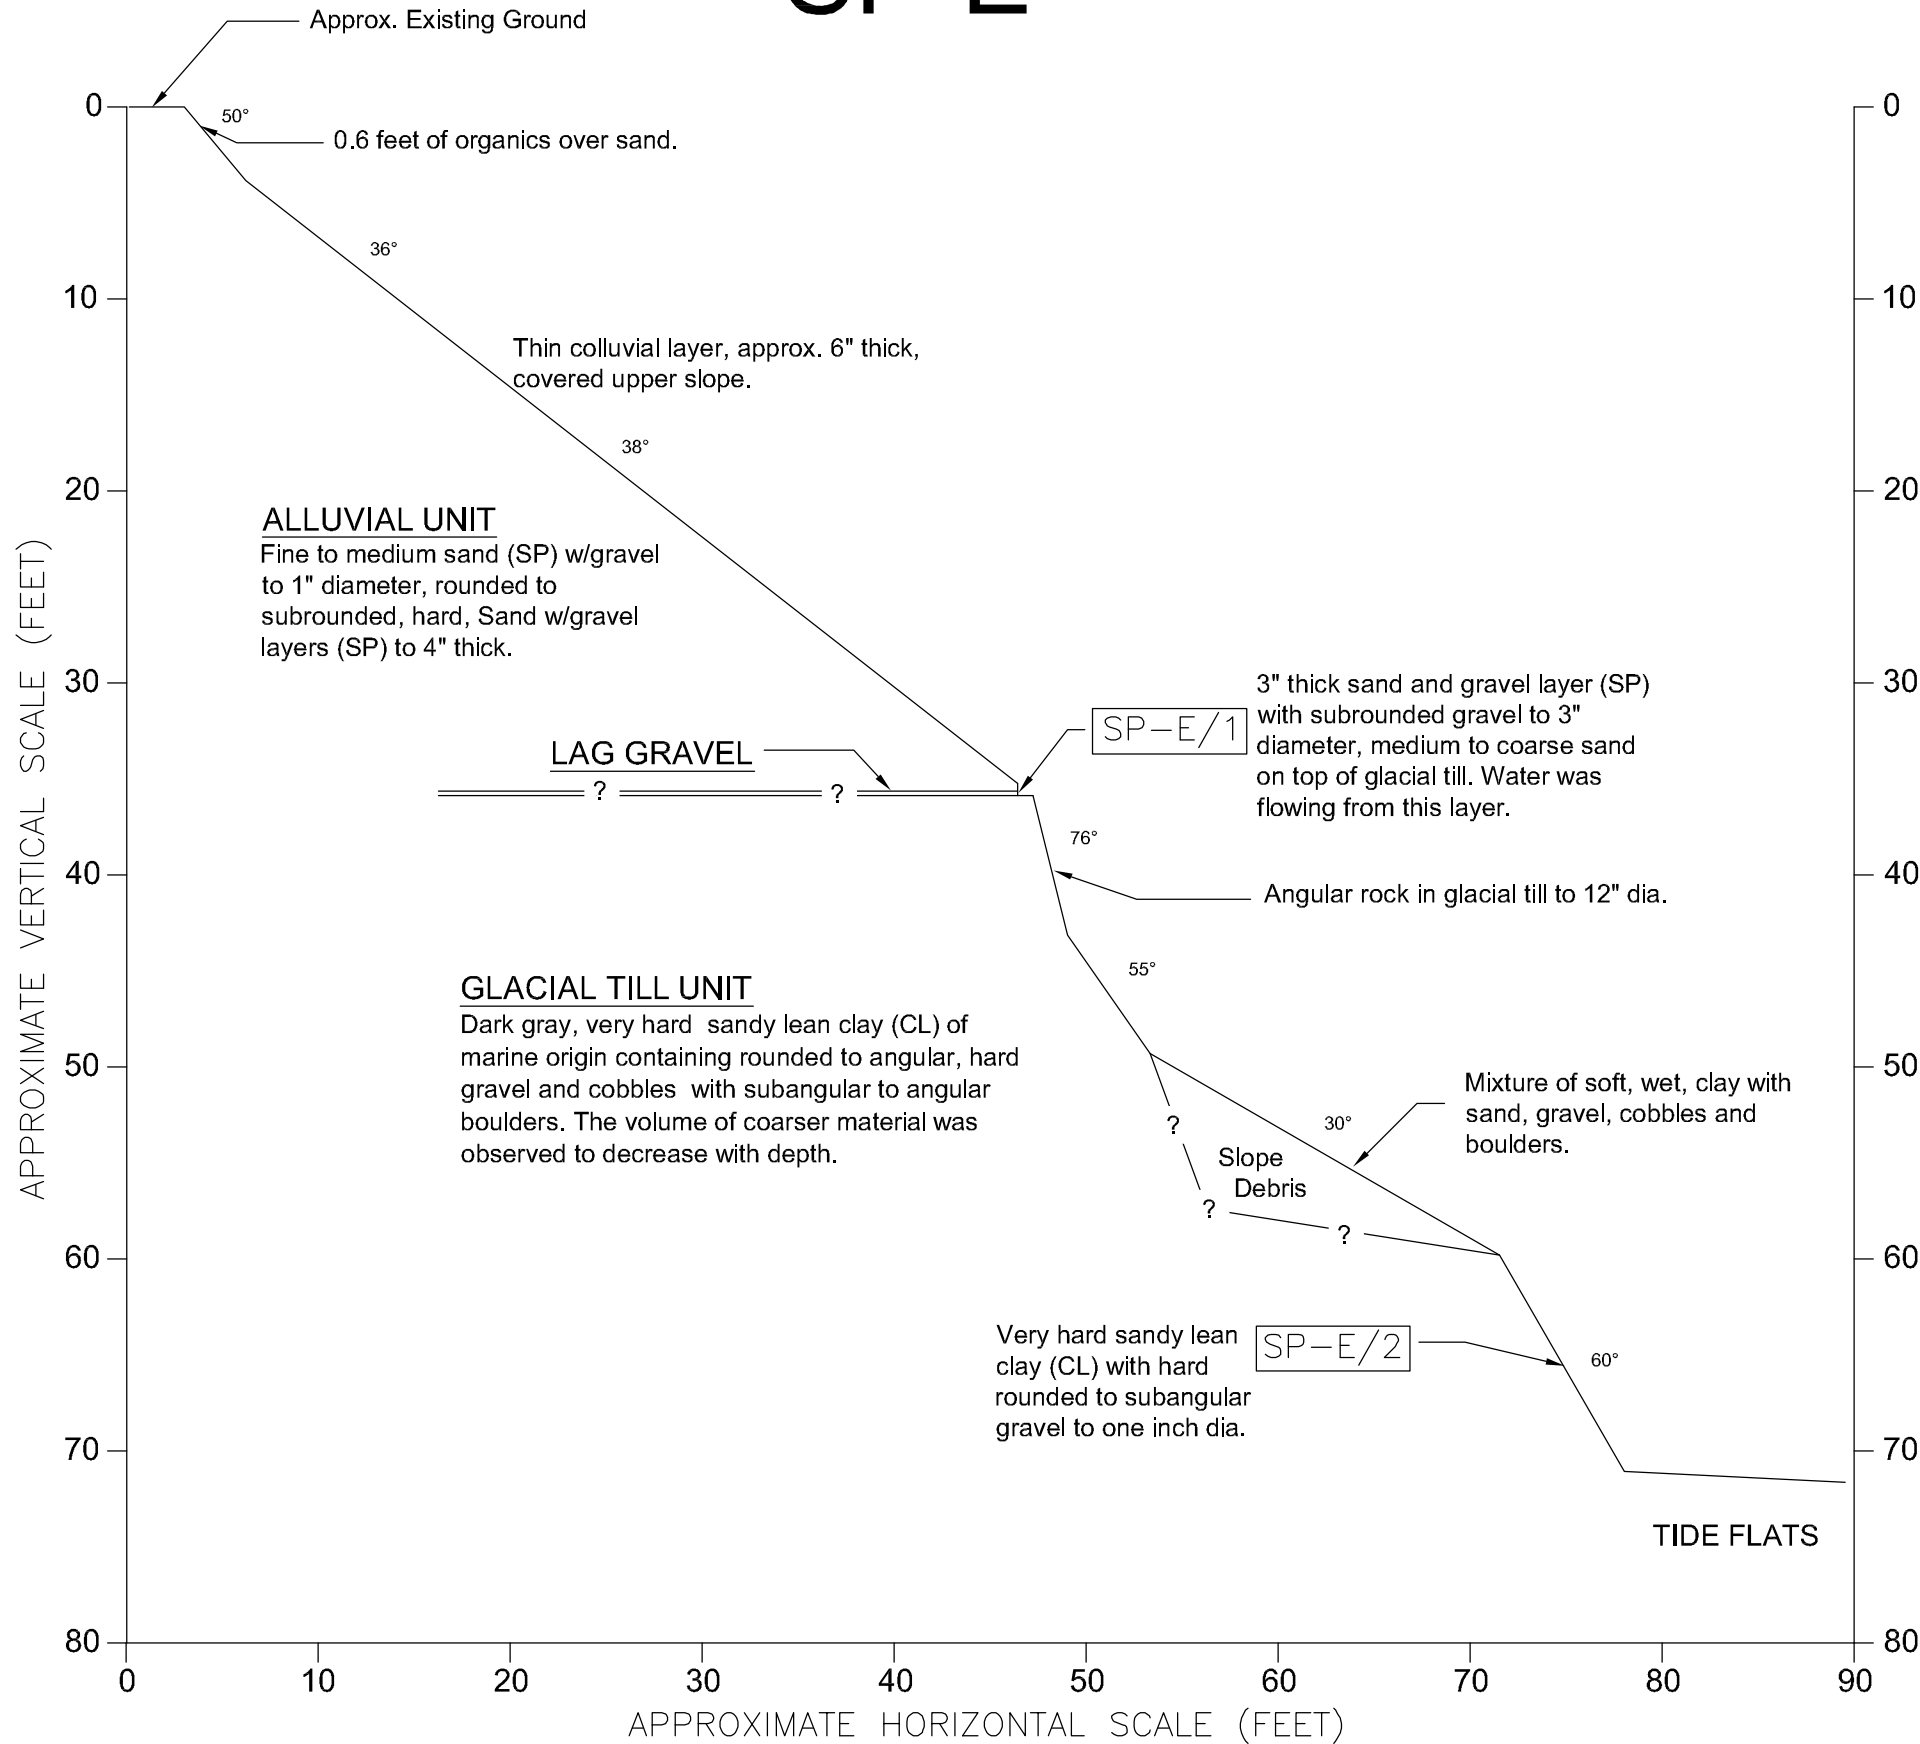
# SP-E

LOOKING NORTH AT SP-E. THE GLACIAL TILL EXHIBITS THE CHARACTERISTICS OF SOFT BEDROCK SUCH AS JOINTS AND OTHER STRUCTURAL FEATURES.  
13 OCT. 2006

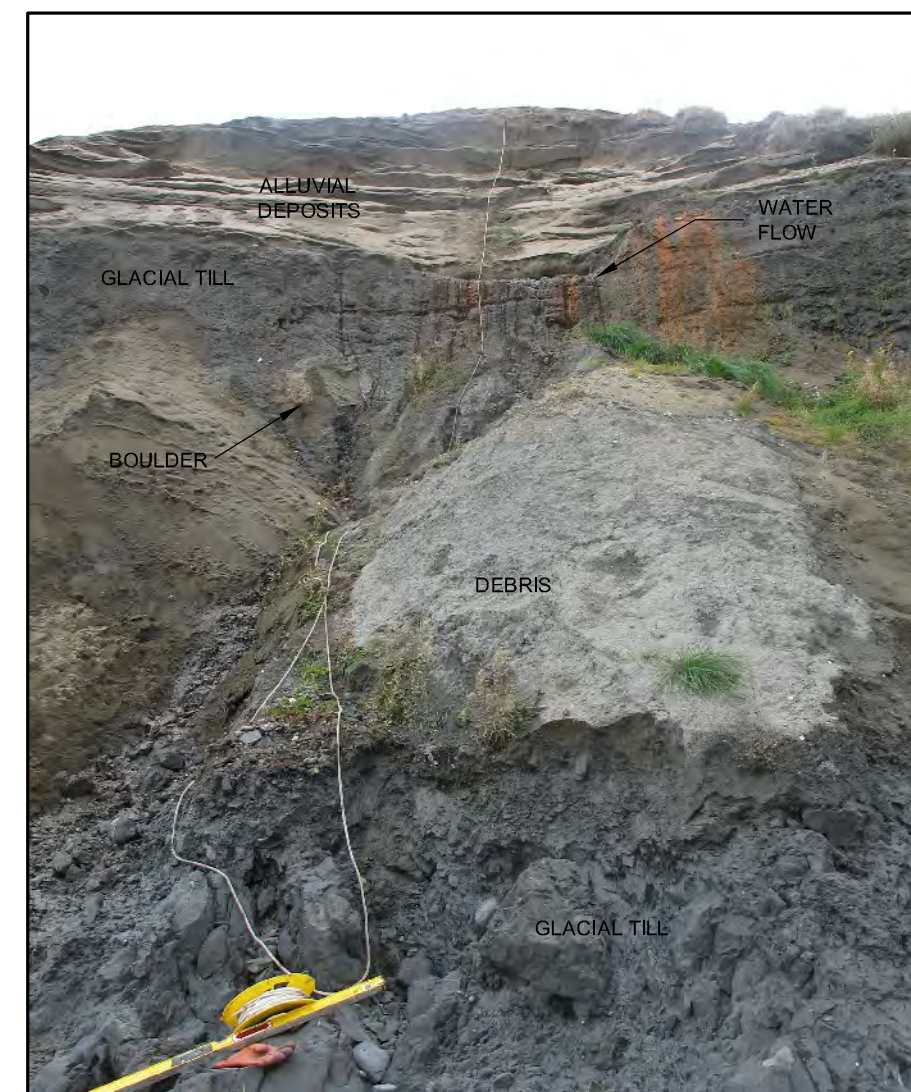
LOOKING NORTH AT SP-F. WATER FLOW IS HIGHER  
FROM LOW SPOT ON TOP OF GLACIAL TILL. OLD  
DRAINAGE CHANNELS ON TOP OF GLACIAL TILL MAY  
CONCENTRATE WATER FLOW IN SOME AREAS.  
10 OCT. 2006

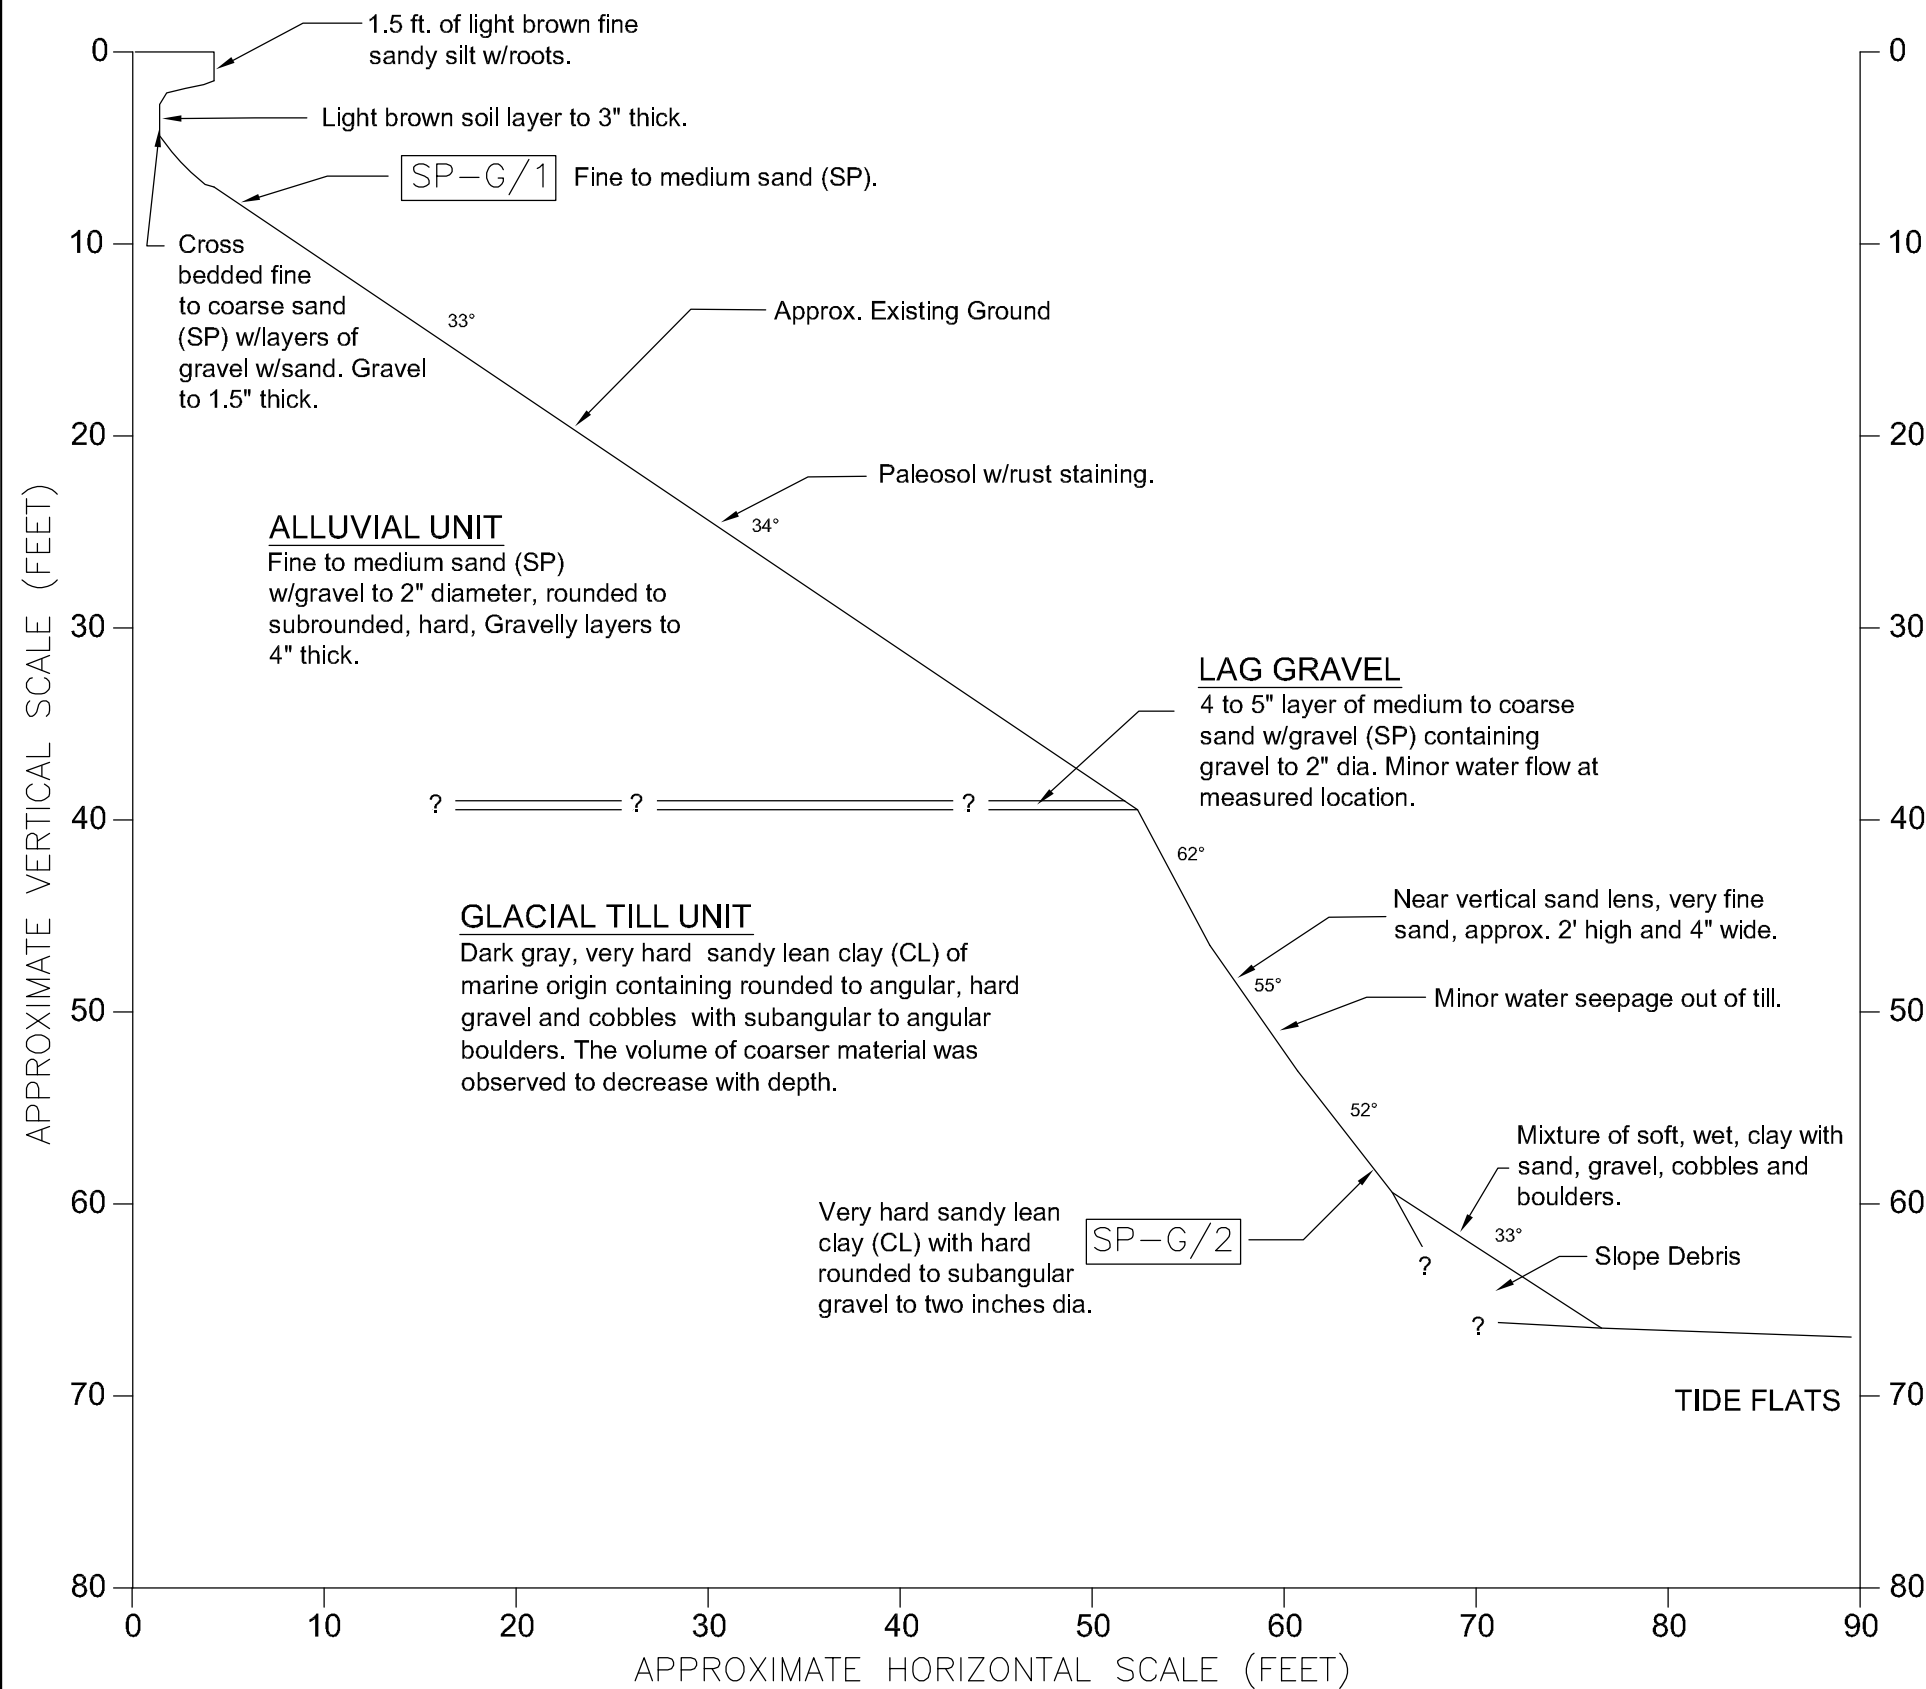
# SP-G

LOOKING NORTH AT SP-G. MOST OF THE EXPOSURE IS COVERED BY A THIN LAYER OF SAND. NOTE CHUNKS OF DARK GRAY CLAY AT BASE OF SLOPE.  
10 OCT. 2006
