Elim Subsistence Harbor Feasibility Study

Appendix B: Geotechnical

Elim, Alaska

April 2020

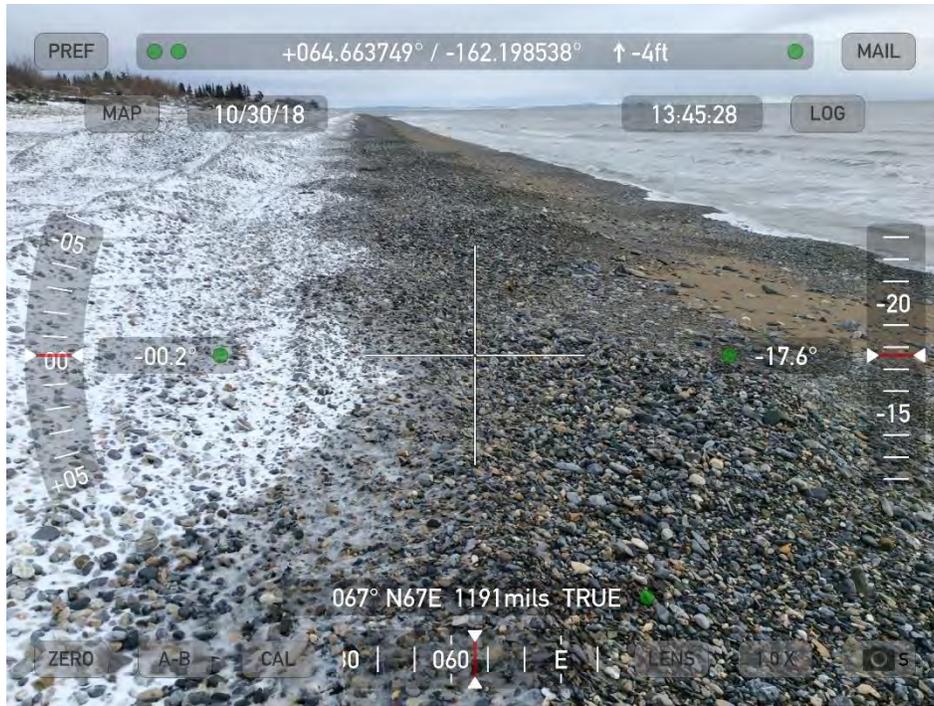
Figure 10. Iron Creek Beach looking Northeast by TP-8.

Surface material at the Iron Creek Beach consisted of poorly to well graded gravel, sand, cobbles, and boulders. The Iron Creek Beach included sub-angular to sub-rounded gravel, fine to coarse sand, and cobbles ranging in size from three to 12-inches, and boulders larger than one foot in diameter. The volume of cobbles and boulders ranged from 10 to 65 percent at various locations along the beach. Sampling was difficult due to the presences of cobbles and boulders. Figures 10 through 13 provide an example of surface conditions along the Iron Creek Beach.

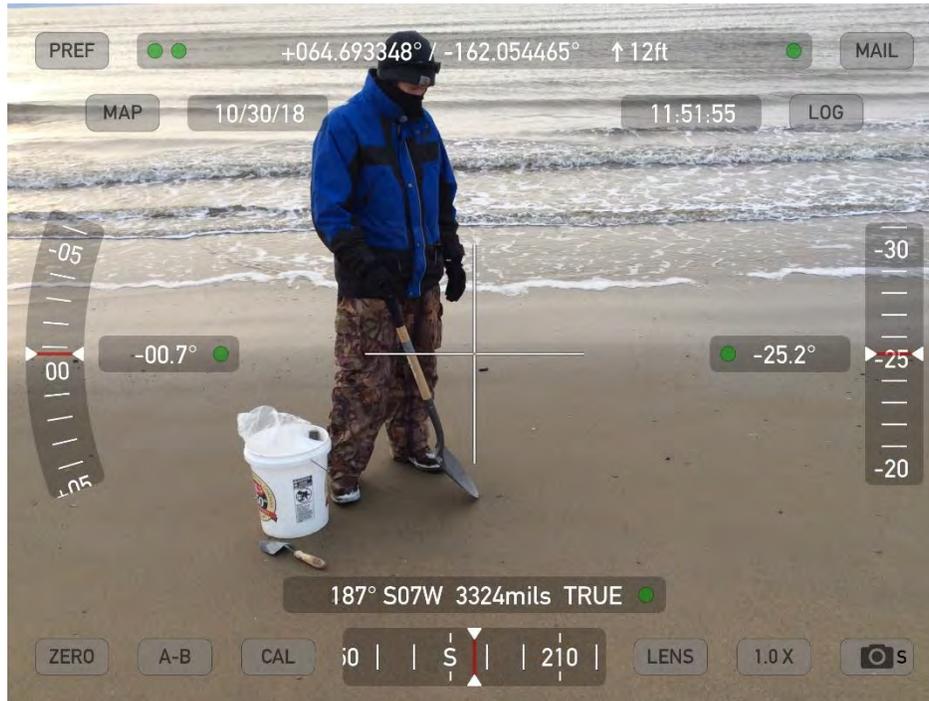
Figure 14. Moses Point Beach at TP-13.

Surface material at the Moses Point Beach consisted of poorly graded fine to coarse sand with gravel. Hand excavating shallow test pits was not difficult in the beach soils and the percentage of gravel general increased with depth. Figures 14 and 15 provide an example of surface conditions along the Moses Point Beach.
