St. George Environmental Assessment

Appendix E: NHPA Section 106 Documentation

**Civil Works Program
Site Investigation and
Survey Results**

**Cultural Resources Survey of the
St. George Outside Landing (XPI-194) and the St.
George Inside Landing (XPI-195) within the
Seal Rookeries National Historic District,
St. George, Alaska**

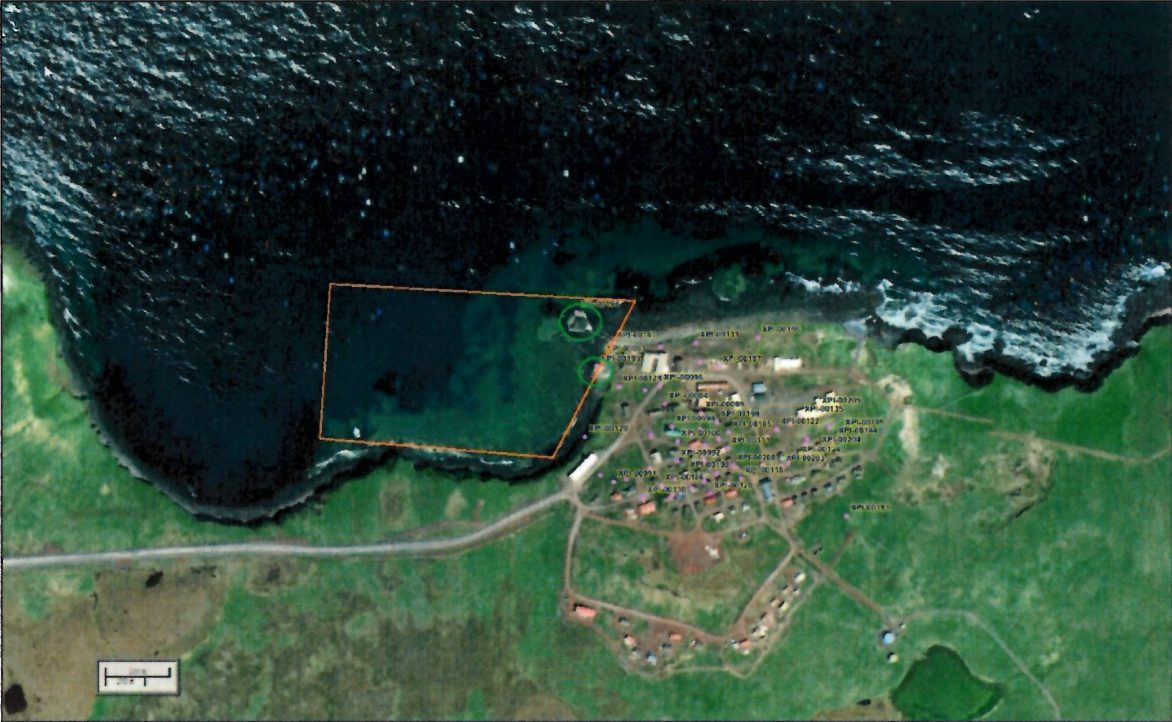
Initial review of the Alaska Heritage Resources Survey (AHRS) concluded that the construction would involve removing or covering two existing cultural resources, two "buildings" which are actually docks listed as XPI-194 and XPI-195. All current design proposals for the harbor would involve building a breakwater over site XPI-194, as well as the construction of a small boat pullout at the site XPI-195 (Figure 2).

Figure 2: Proposed APE for the northern harbor in the orange polygon, XPI-194 and XPI-195 circled in green.

A proposed area of potential effects (APE) was presented in Figure 2, but was not accompanied by a discussion of what components of the project are encompassed by the APE or what types of effects were taken into account with the proposed APE. Common project elements discussed in a project description and/or APE section include material sources, laydown areas, construction camps, and access routes. Our office is uncertain whether these aspects of the project are included in the APE as they were not discussed and welcome additional information in the future. We are also concerned about effects the project may have on the Seal Islands Historic District National Historic Landmark (NHL) and request USACE consider broadening the APE to include potential indirect and cumulative effects the project may have on the NHL.

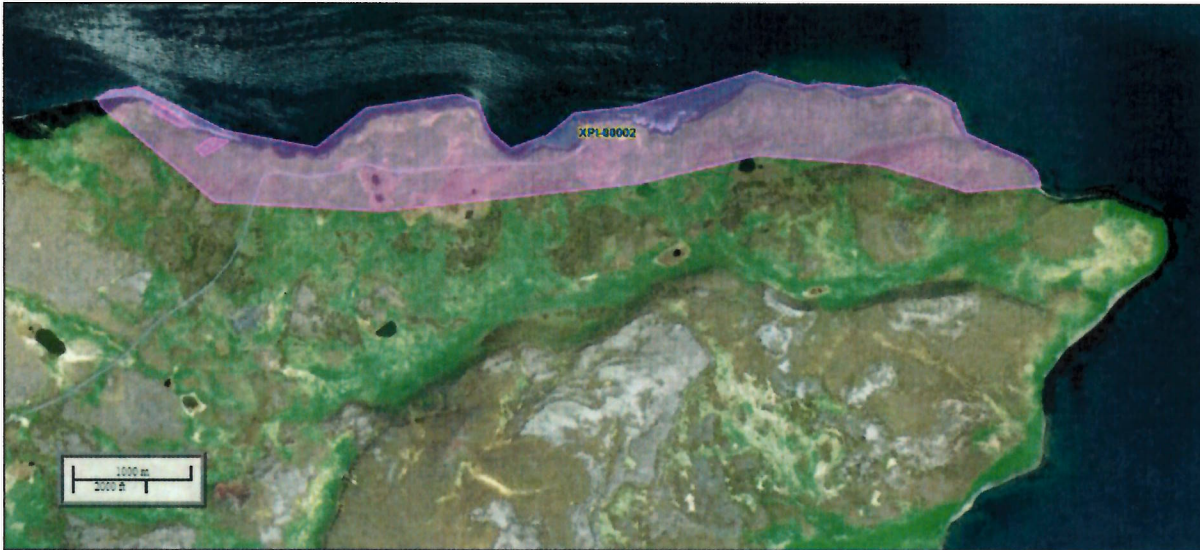
Figure 3: Seal Islands Historic District NHL on Saint George Island (AHRS 2018).

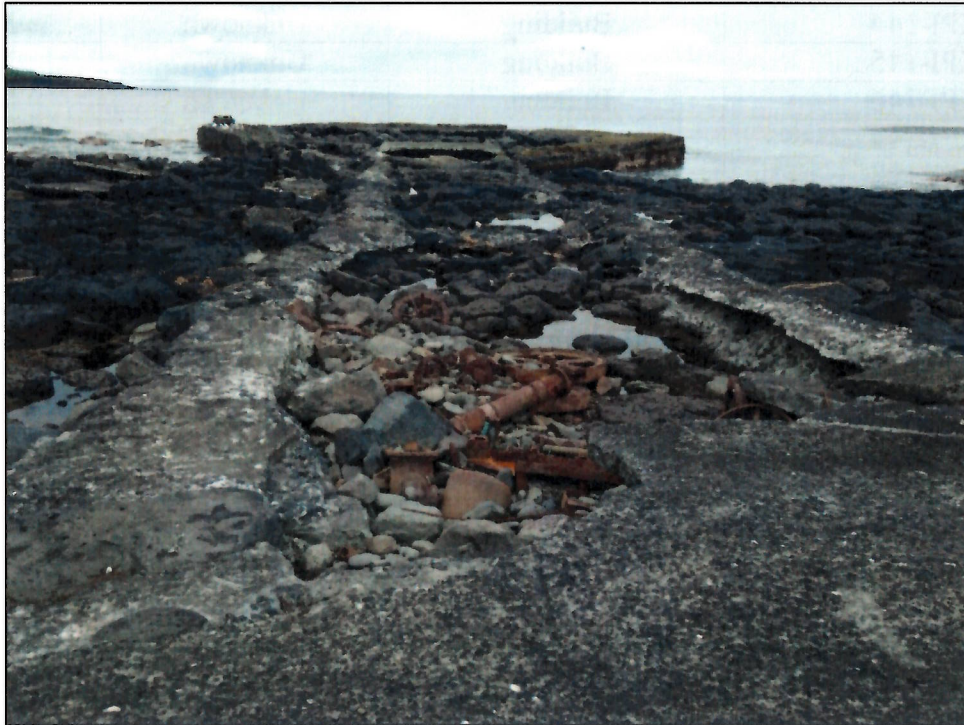
Figure 4: View of the dock (XPI-194) at St. George looking northwest.

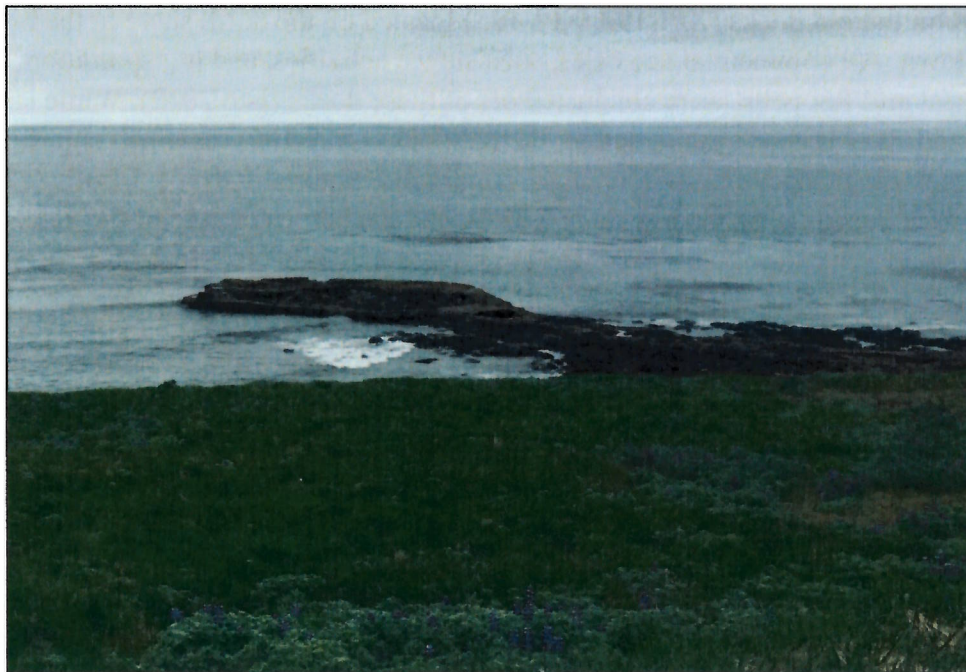
Figure 5: XPI-195 in view from the bluffs to the southwest. Rocky shoreline continues out with the structure.

A second, smaller dock (XPI-195), was identified directly south of XPI-194. XPI-195 does not extend out into the bight, but instead sticks next to the shoreline. The historic purpose of this second dock is unknown; however, it would have required boats with small drafts (Figures 4 and 5). Assumptions can be made that it either was a secondary dock, or possibly part of the processing stations for seal and fish to allow disposal into the bay.

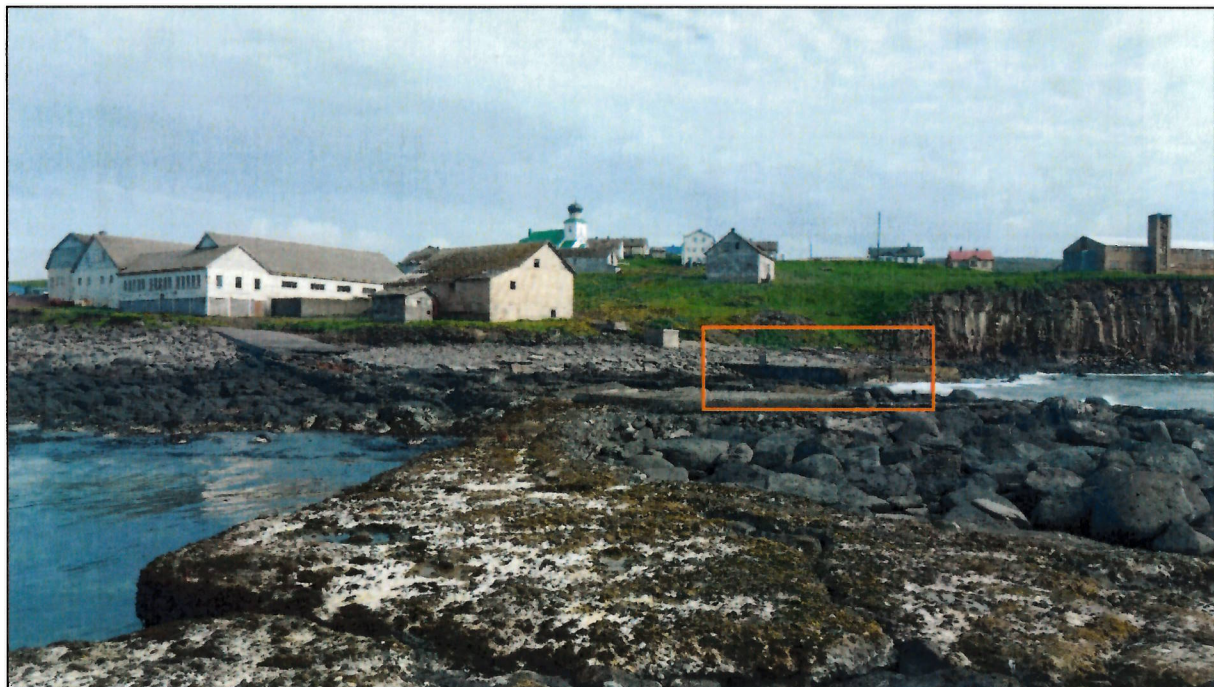
Figure 4: View of St. George Village from XPI-194. The smaller dock, XPI-195 is on the right in the orange outline.

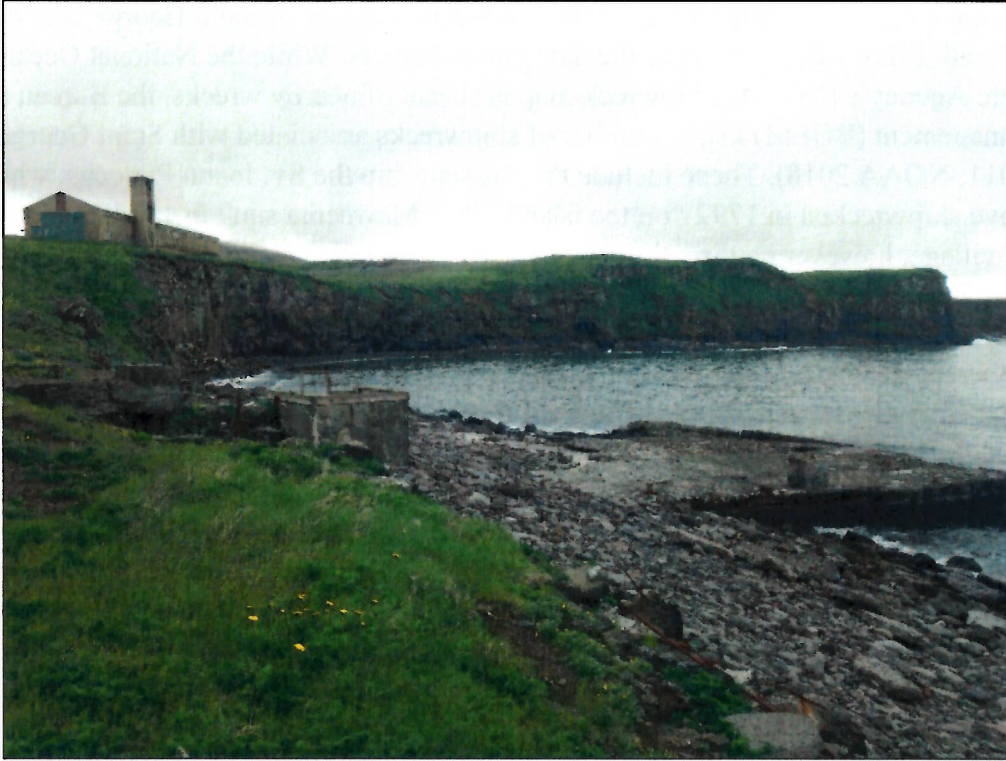
Figure 7: A closer view of XPI-195. The base of a small crane is on the right side.

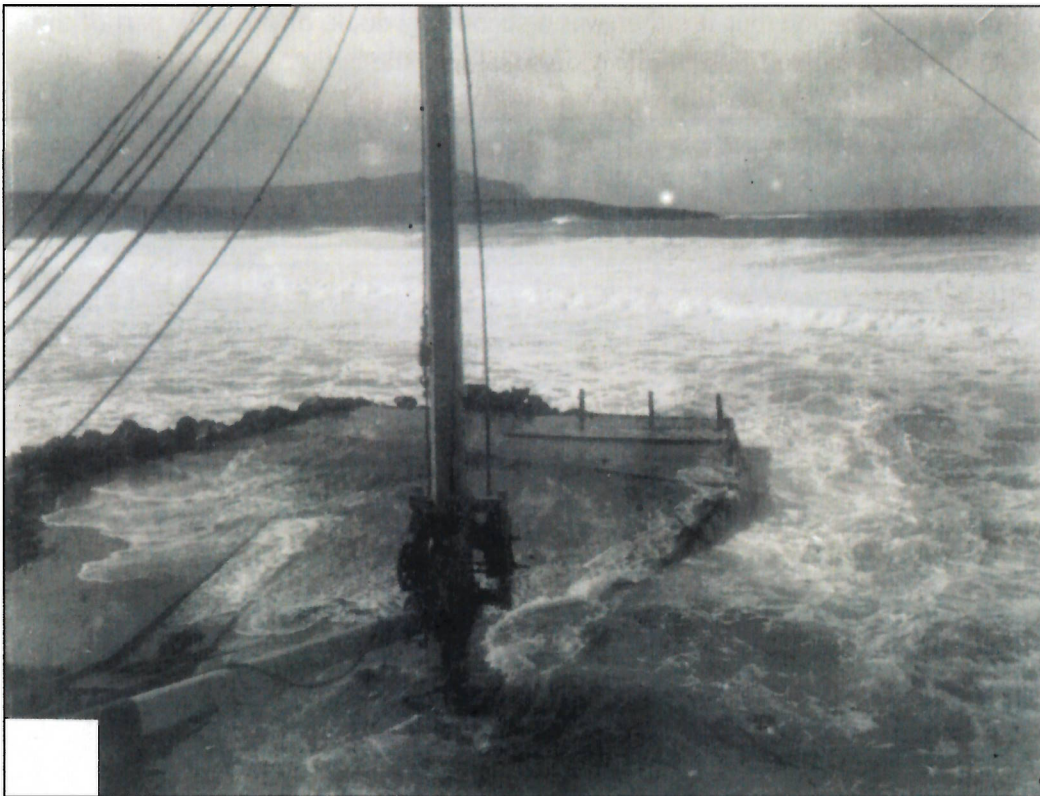
Figure 8: Historic photo of the small dock (XPI-195), date unknown, catalog number RG22-95-ADMC-2863 (NARA 2018).

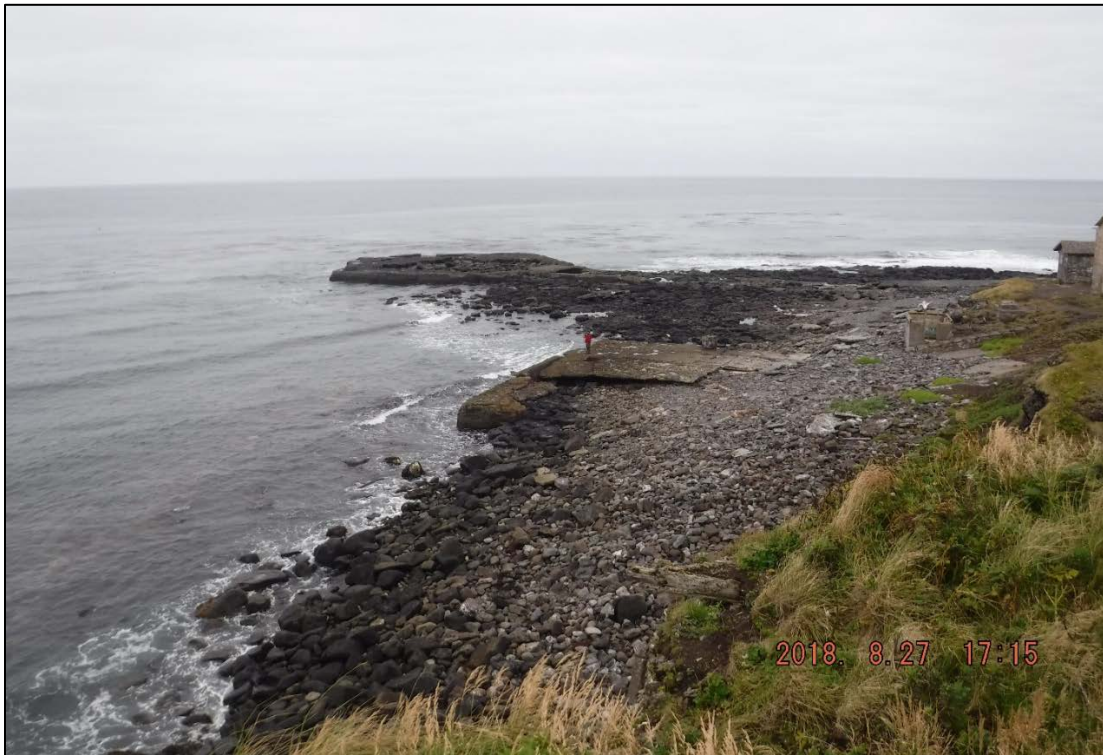
Figure 2. The two historic docks at St. George. The St. George Outside Landing (XPI-195) is stretching out into the Bearing Sea, while the Inside Landing (XPI-194) is the square feature along the shore upon which USACE personnel is standing.

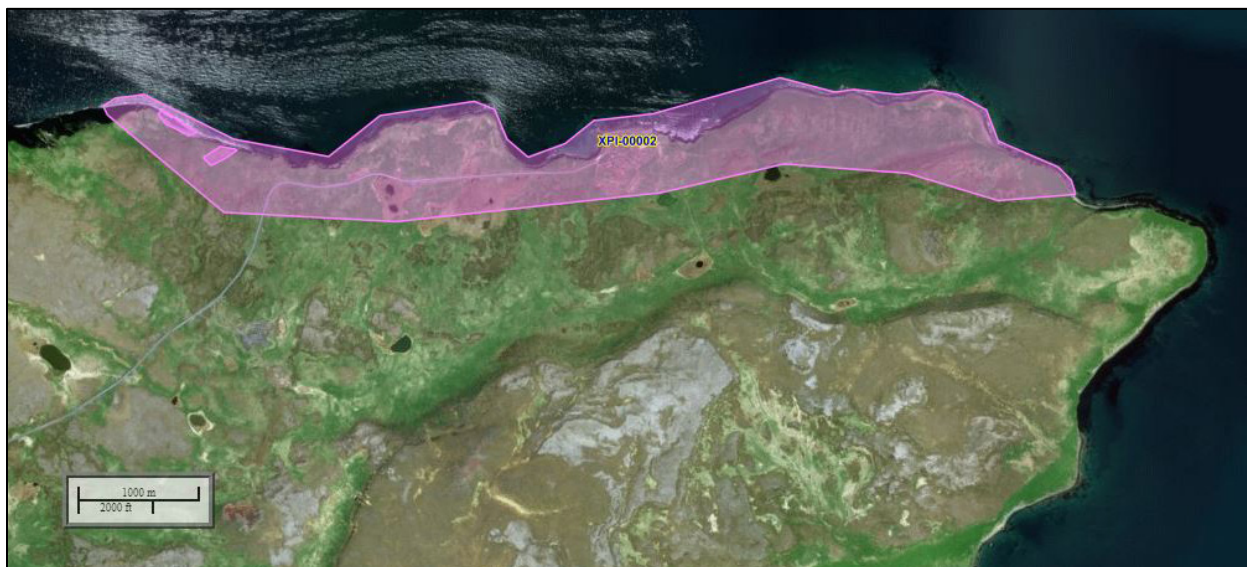
Figure 5. Seal Islands Historic District NHL on Saint George Island (AHRs 2018).

Saint George Island has a number of known cultural resources. These are associated with both the Russian and American fur trades; a large portion of the northern shore of Saint George has been registered as a National Historic Landmark (NHL; Figure 5). The Seal Islands Historic District NHL (XPI-002) is located on both Saint Paul and Saint George Islands. In its entirety, the Seal Islands Historic District NHL includes 106 contributing buildings, two contributing structures, 12 historic sites, and nine archaeological sites. There are 68 known cultural resources and one NHL listed in the Alaska Heritage Resources Survey (AHRs) within the boundaries of the City of St. George; the vast majority of the resources are “buildings” associated with the Seal Island Historic District NHL; it is important to note that, although identified as such, many of the structures are not actually buildings (Tables 1 and 2).

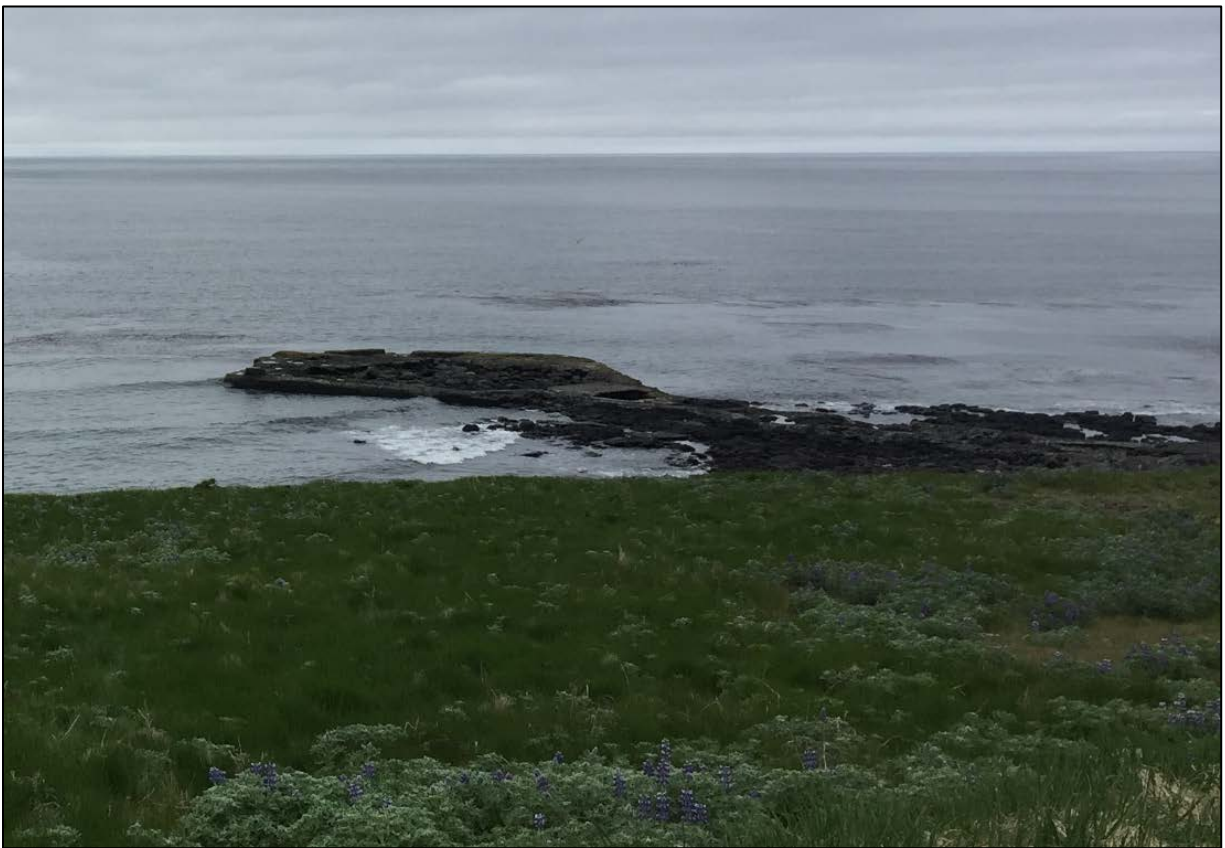
Figure 6. View of the outside landing (XPI-194) at St. George from the bluffs to the southwest (Sparaga 2018).

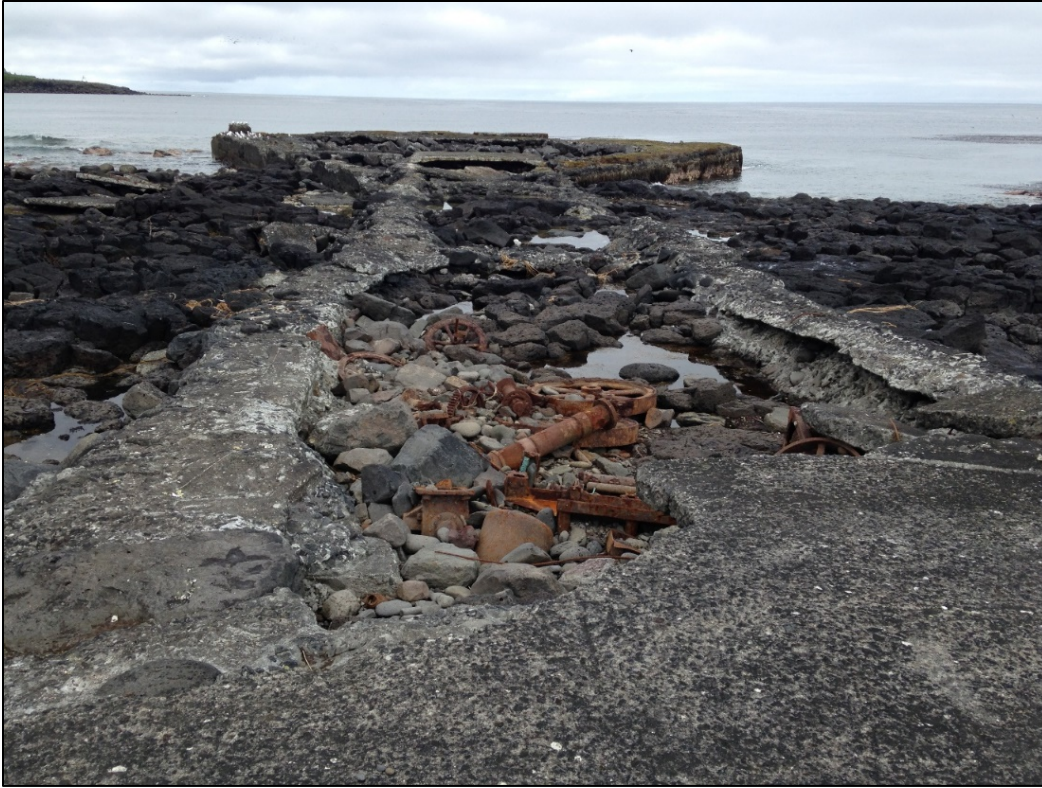
Figure 7. View of the outside landing (XPI-194) at St. George, looking northwest (Sparaga 2018).

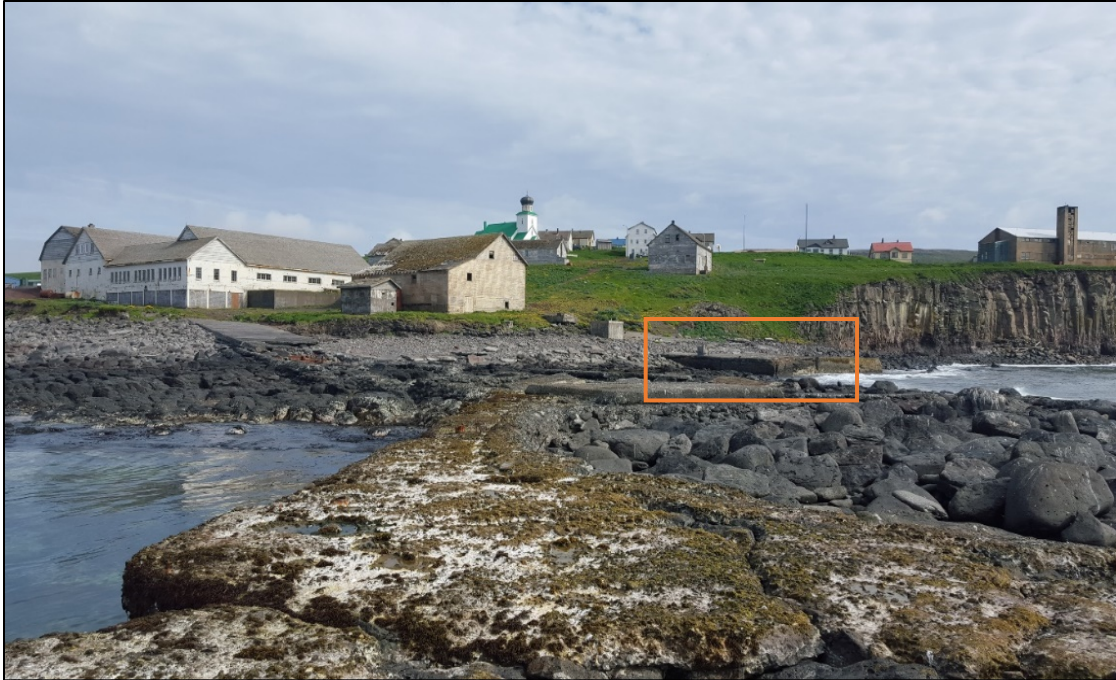
Figure 8. View of St. George Village from XPI-194. The inside landing (XPI-195) is on the right in the orange outline. The Seal Skin Plant (XPI-018) is the large white building on the left, while the Great Martyr Orthodox Church (XPI-004) is uphill near the center (Sparaga 2018).

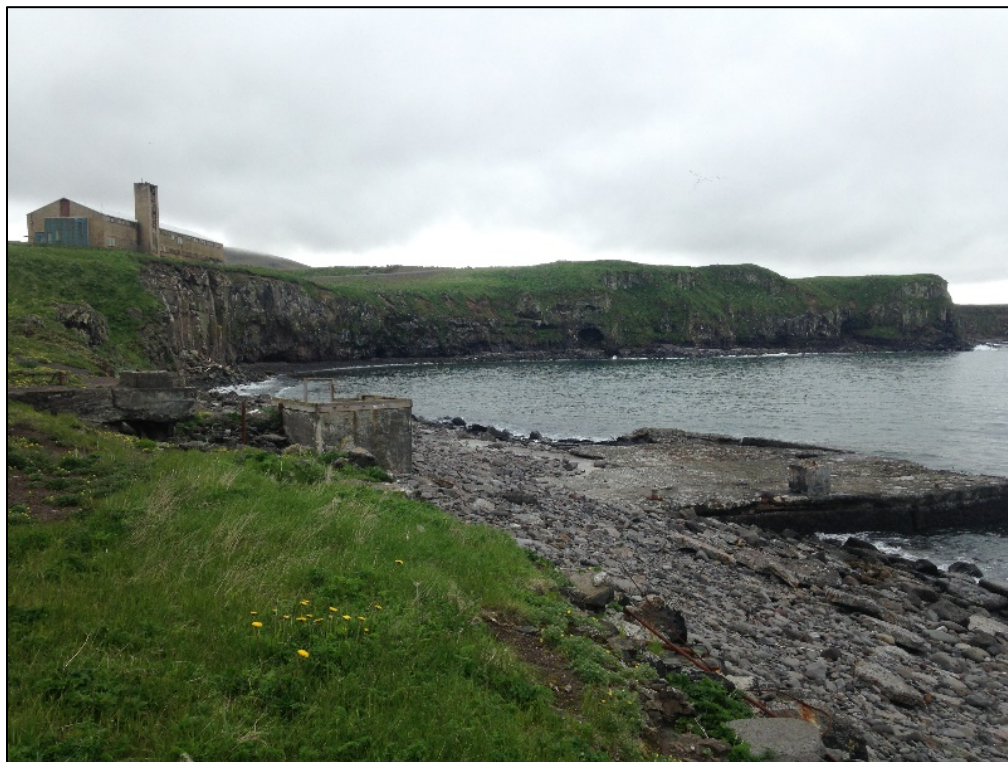
Figure 9. A closer view of XPI-195. The base of a small crane is on the right side. The old Community Store of the Swalling Construction Company (XPI-129) is in the top left, while the Second Pump House (XPI-147) is visible behind and upland of the two sites (Sparaga 2018).

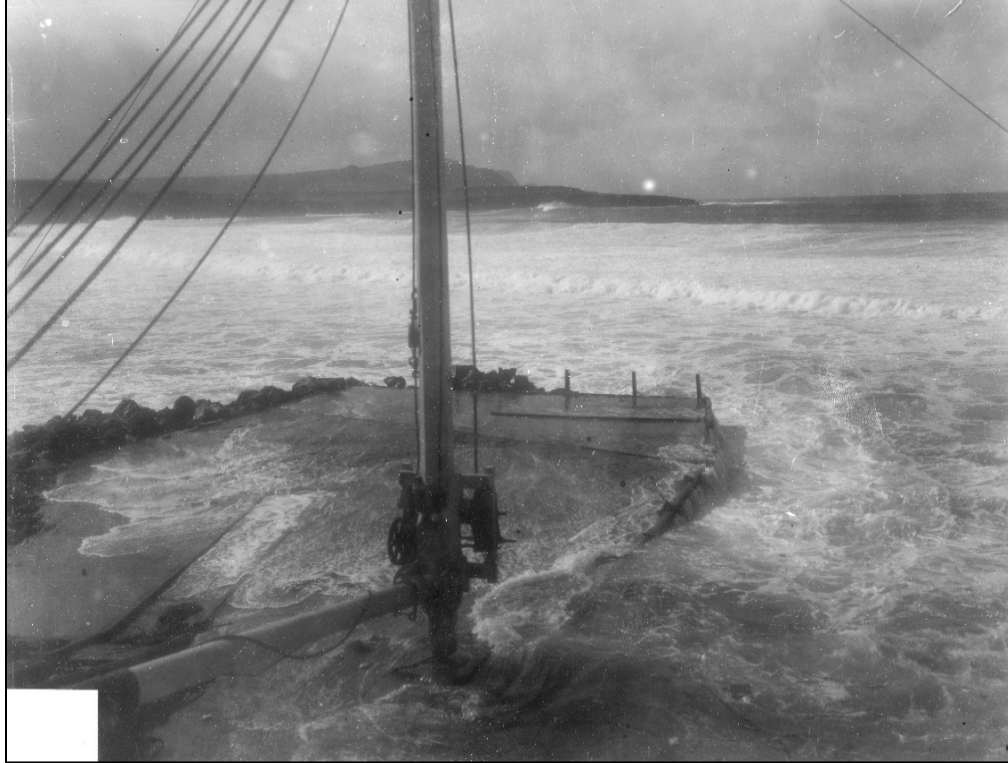
Figure 10. Historic photo of the St. George Inside Landing (XPI-195), date unknown, catalog number RG22-95-ADMC-2863 (NARA 2018).

The original dock for the community of St. George, the St. George Inside Landing (XPI-195), is directly south of the St. George Outside Landing (XPI-194). XPI-195 does not extend out into the bight, but instead was constructed along the shoreline. This dock was used primarily for offloading the seal carcasses from hunting around the rookeries and community goods, and for loading barrels of processed seal skins onto boats with shallow drafts (Figures 8 and 9). The original construction of this dock is unknown; historic documents note that it was damaged from weathering and from a fire, and then repaired (NOAA 2010a:16). Historic photographs also show rigging for lever booms to assist in moving goods from dock to boat and back (Figure 10).

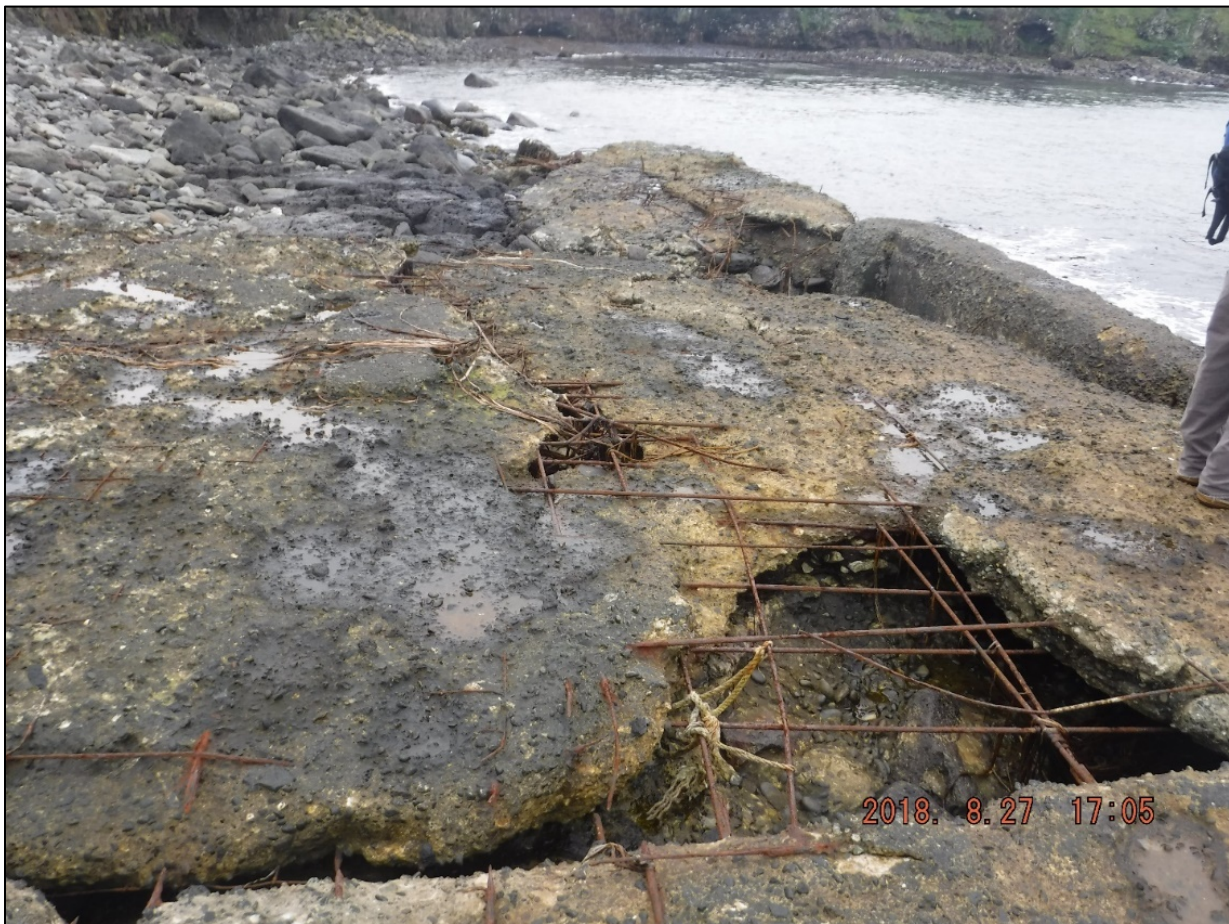
The St. George Inside Landing (XPI-195) is the older dock, which was built prior to 1922 (NOAA 2010a). There is no specific date known for the original installation of the dock. It was heavily refurbished in 1922 after a storm destroyed most of the dock. During this reconstruction, the bight was blasted with dynamite and dredged to remove 18 inches of rock from the sea floor, from the shoreline to 30 feet out from shore (NOAA 2010a). The St. George Inside Landing was also damaged during a fire in 1950; it was likely repaired afterward. Over the last 70 years, the inner dock has been worn away and damaged; today the exposed rebar from its reinforced

concrete is exposed (Figures 11 and 12). The identifiable concrete dimensions of the St. George Inside Landing is approximately 30 feet (ft) by 50 ft. Historic photographs indicate that the dock may have originally been slightly wider; however the dock to the non-concrete sections of the dock are no longer present. Historic photographs show that there wooden boards covered the floor of the structure, and met up with wooden walkways heading into town (Figure 13 and 14). The 2018 survey found that both the Inside and Outside landings were made with a combination of local stone and concrete, in addition to reinforced concrete. The local cobble and concrete mixture appears to provide the base structure of the Outside Landings walkway and the fill for the Inside Landing, while the reinforced concrete consists of the walls and horizontal sections of the Landings. Reinforcing concrete with rebar was a common building method by the 20th century (Moussard et al. 2017).

Figure 11. The weathered reinforced concrete on the St. George Inside Landing (XPI-195). Interior sections of the dock are exposed and show substantial concrete degradation and loss of fill.

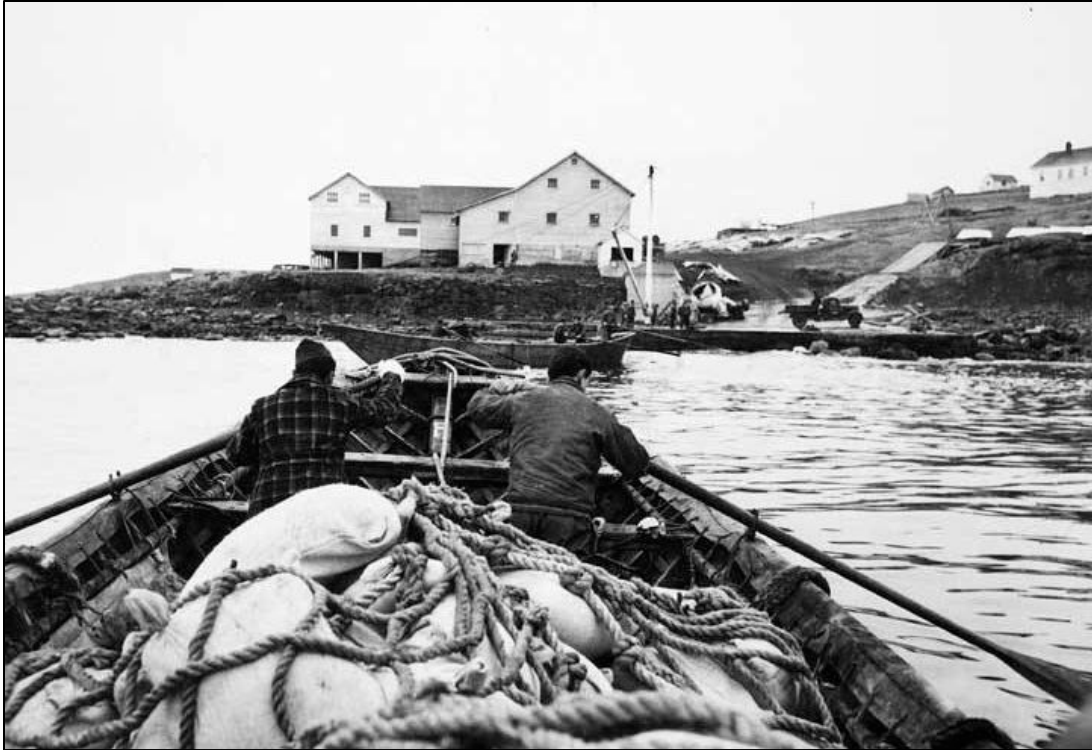
Figure 12. A 1948 photograph of the St. George Inside Landing (XPI-195) with a row boat lightering supplies to the dock (Alaska Digital Archives UAF-1970-11-96).

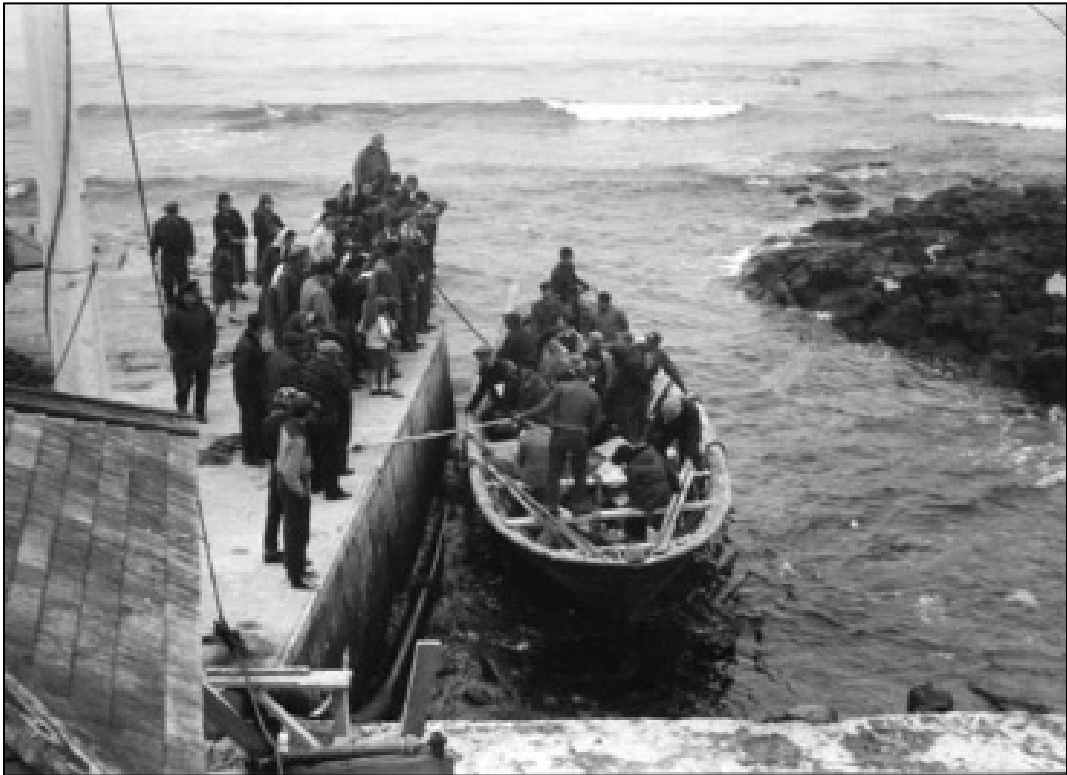
Figure 13. Community members docking a baidar at the St. George Inside Landing (XPI-195) in 1954 (Swalley 2018).

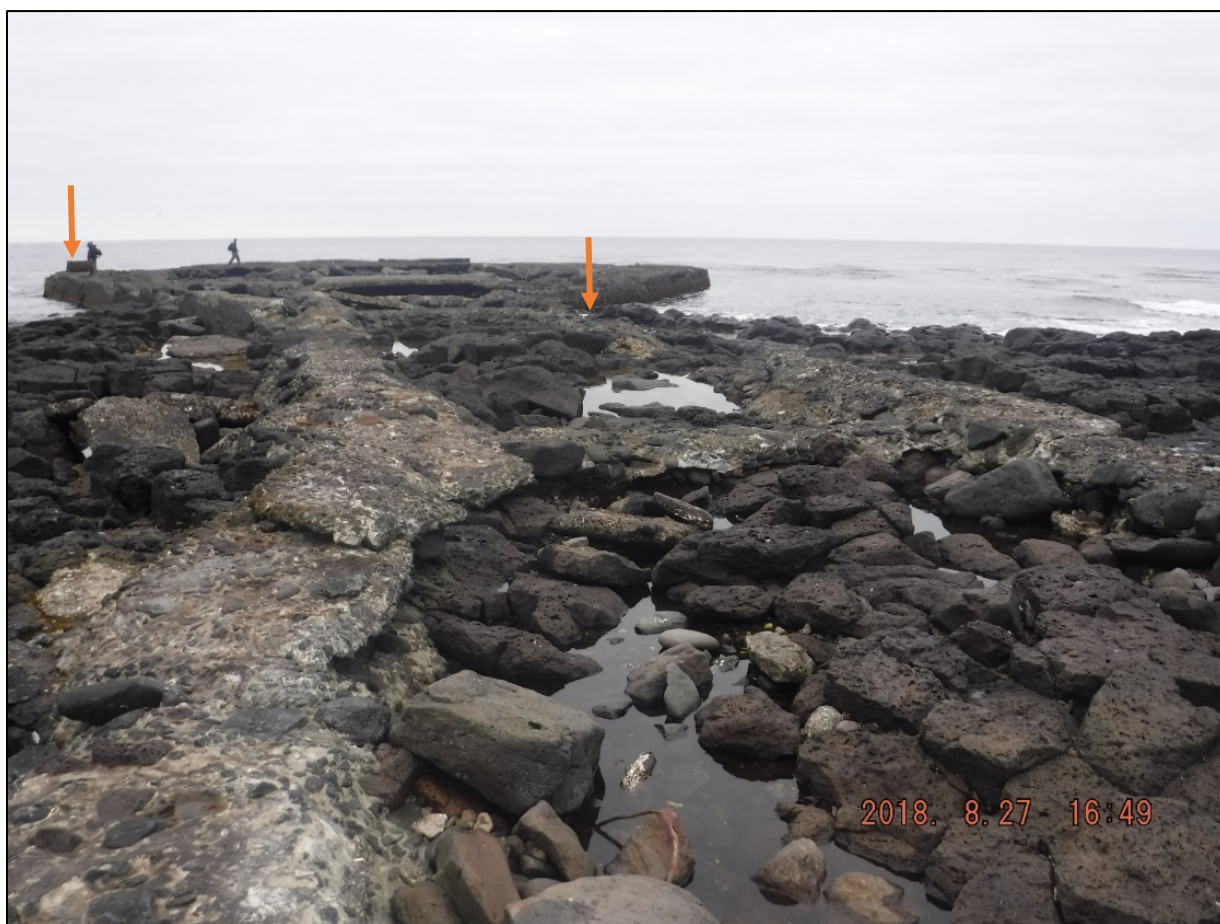
The St. George Outside Landing (XPI-194) was constructed in 1957 to improve access to the community by increasing usable docking days. In 2018, the dock was approximately 260 ft by 20 ft for the length of the entire dock and the width of the ramp, with an octagonal dock at the end which was 30 ft across (Figure 16). This dock was constructed with a reinforced concrete surface and heavy concrete retaining walls, overlaid on a natural outcrop and local scoria fill. Metal structures indicate that this dock, similar to the St. George Inside Landing, had a wooden crane at the end to move cargo between the docks and the boats (Figures 17 and 18). The outer dock had two benefits over the first dock: it was usable at low tide, and it created a wave barrier for the inner harbor during rough weather. Presently, the St. George Outside Landing has suffered from considerable weathering; the concrete slabs which lined the walkway have been moved from their original location, with portions of the concrete walkway strewn across the beach, and the reinforced concrete has weathered to expose rebar and other set metal parts.

Figure 14. The St. George Outside Landing (XPI-194); view from the base of the dock on the shore (Sparaga 2018). The orange arrows are where Figure 10 (left) and Figure 11 (right) are located.

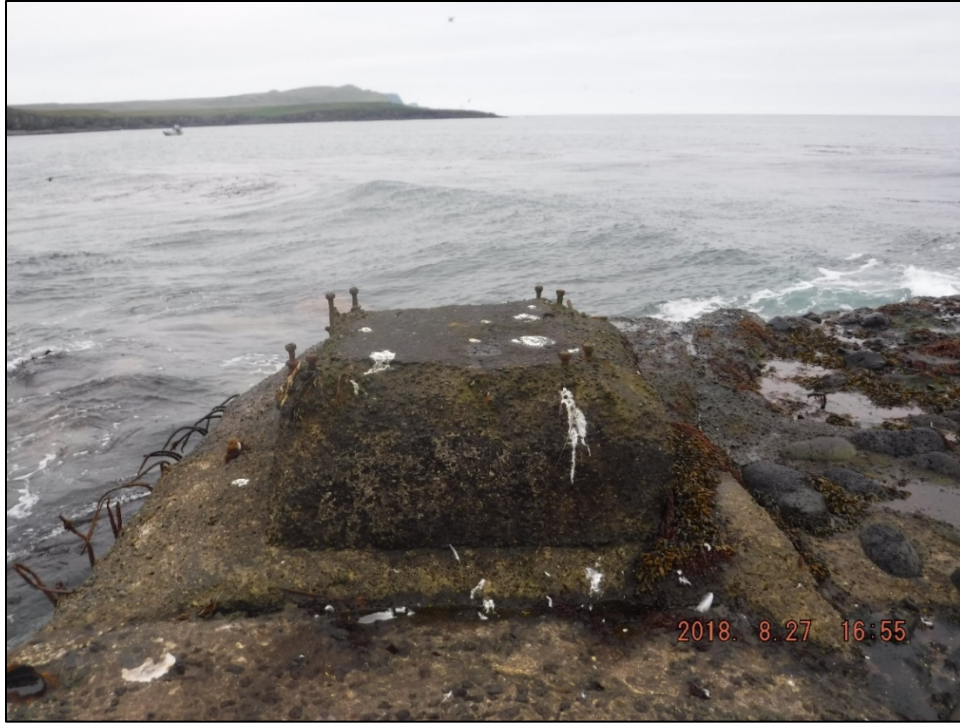
Figure 15. Concrete and metal object at the end of the St. George Outside Landing (XPI-194); this would likely have supported a boom lever attached to unload supplies from boats (Sparaga 2018).

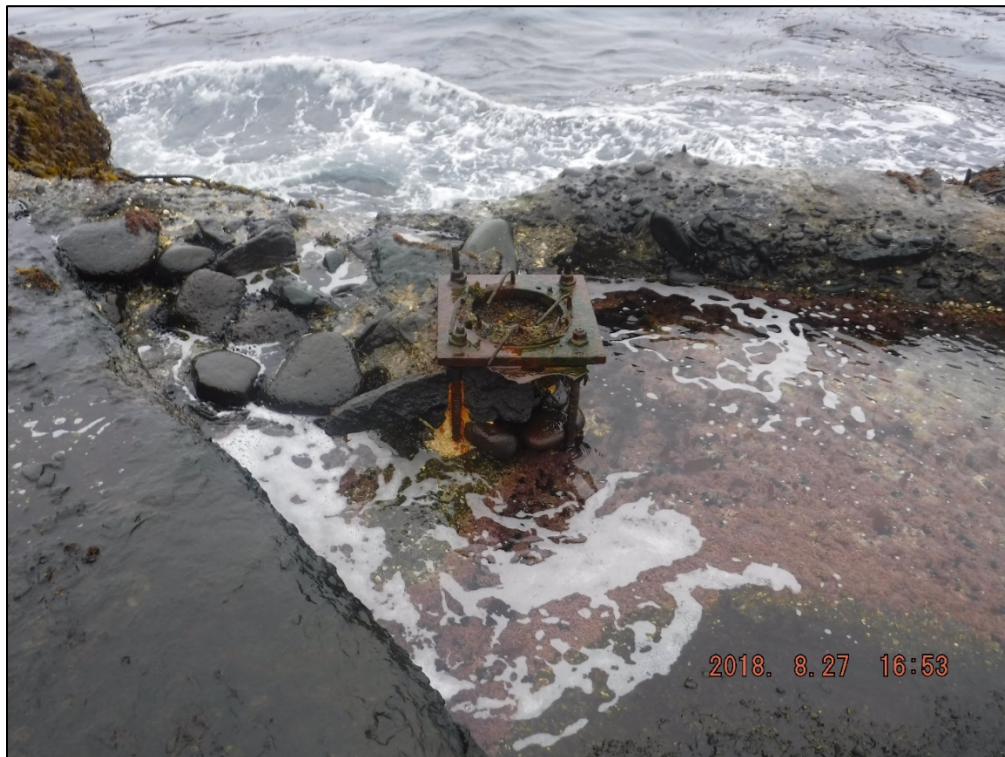
Figure 16. An exposed metal base for a wooden lever joist is located just off the St. George Outside Landing (XPI-194) near where the dock connects to the shoreline (Sparaga 2018).
