**Robe Lake Ecosystem Restoration
Appendix A: Hydraulics and Hydrology | DRAFT
Feasibility Study
Valdez, AK**

**U.S. Army Corps
of Engineers**
Alaska District

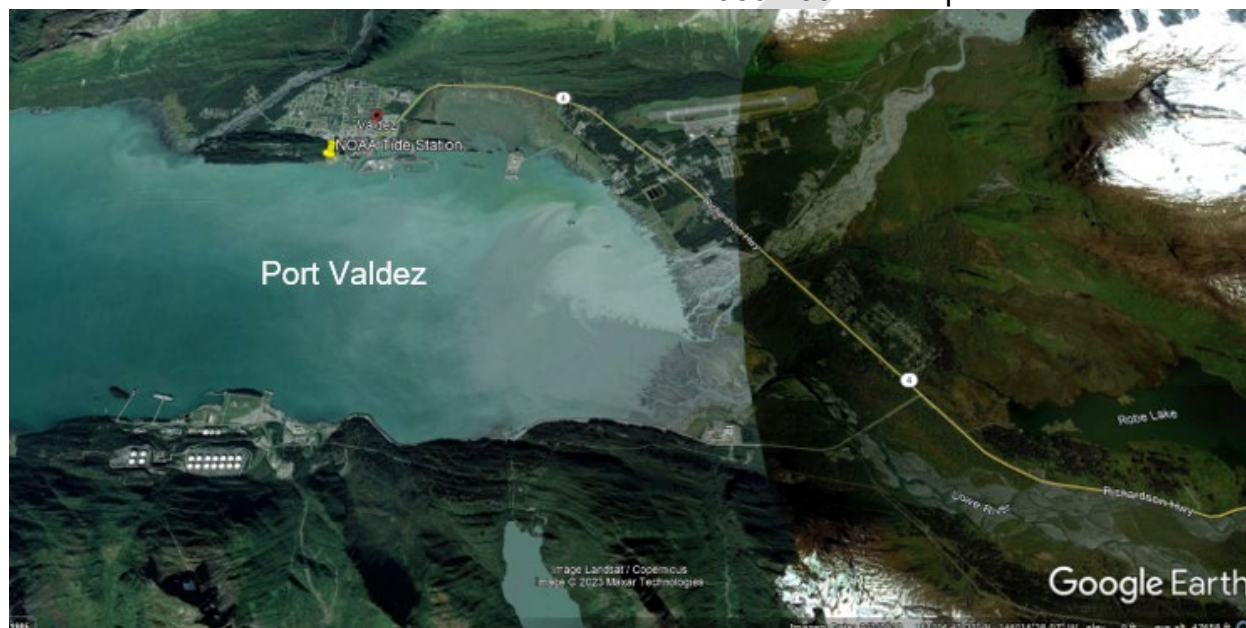
Figure 5. Location of Port Valdez NOAA Tide Station

Tide datums at Port Valdez (NOAA Station ID 9454240) (Figure 5), referenced to mean lower low water (MLLW) and mean higher high water (MHHW), are provided in Table 2. The tidal datums shown below are based on the 1983-2001 tidal epoch.

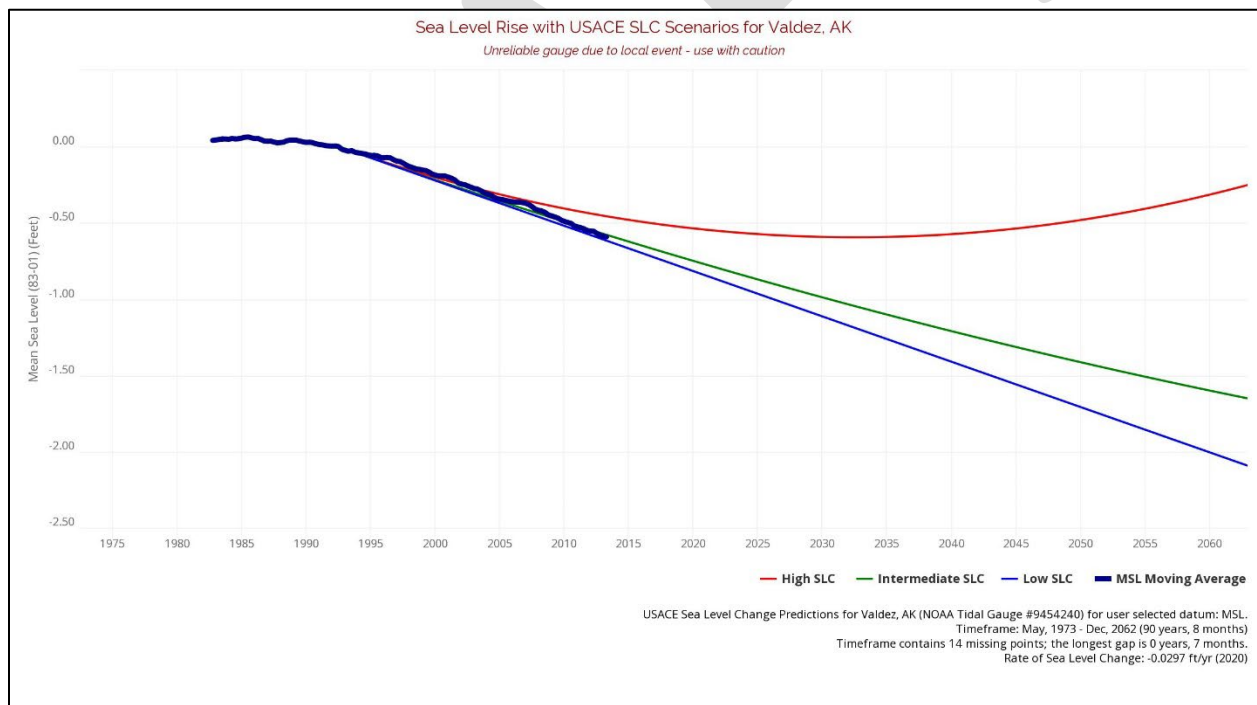
Figure 6. Sea level change projections for Valdez, Alaska.

USACE sea level change (SLC) projections for the City of Valdez, Alaska can be seen in Figure 6. All sea level change projections, excluding the high SLC, show a downward trend. A decrease in sea level over time should not impact the Robe Lake watershed. The high SLC curve shows a slight upward trend, with a maximum increase of -0.3 feet change to MSL. All trends may cause some impact to the model's boundary condition due to backwater effects on the Lowe River, but these would be minor. The Lowe River was also determined to not influence the stage on the Robe River in the area of concern near the residential development.

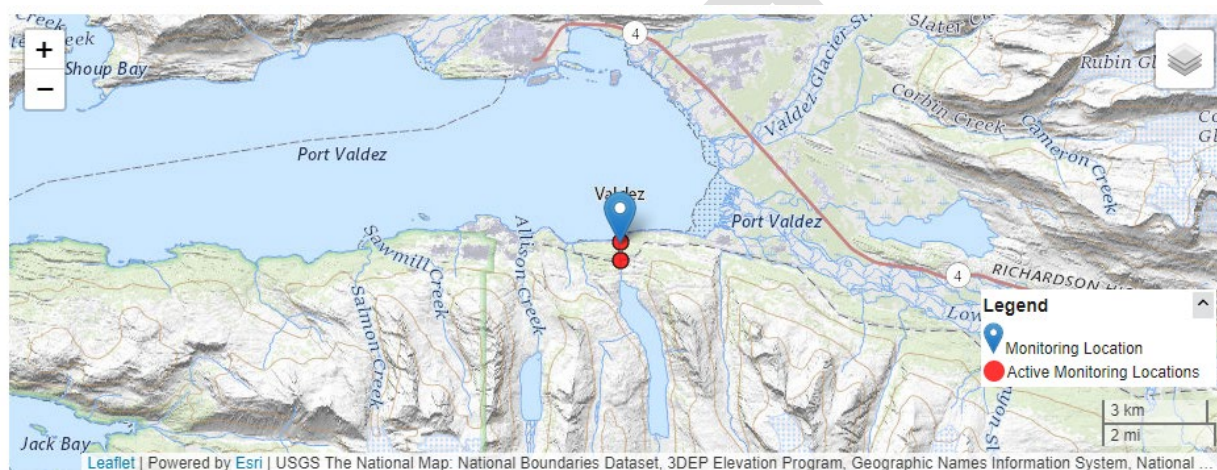
Figure 9. Solomon Gulch Bypass gage location (USGS).

There are no gages on any of the creeks that flow into Robe Lake. The closest gage with instantaneous flow measurements in the area that would most closely resemble the hydrograph for Corbin Creek is the gage located on the Solomon Gulch Bypass (USGS gage 15225998; Figure 9). Solomon Gulch Bypass is of similar size and slope to Corbin Creek and is also glacially fed. The 30-minute instantaneous flow data is available from 1991-1994. The hydrographs were similar over the four-year period, so the event from 21-29 August 1992, was chosen for the unsteady analysis within HEC-RAS (Figure 10). Since no other gage information was available, this hydrograph was used and scaled to the flows determined for Corbin Creek from the USGS regression equations listed in Table 3.

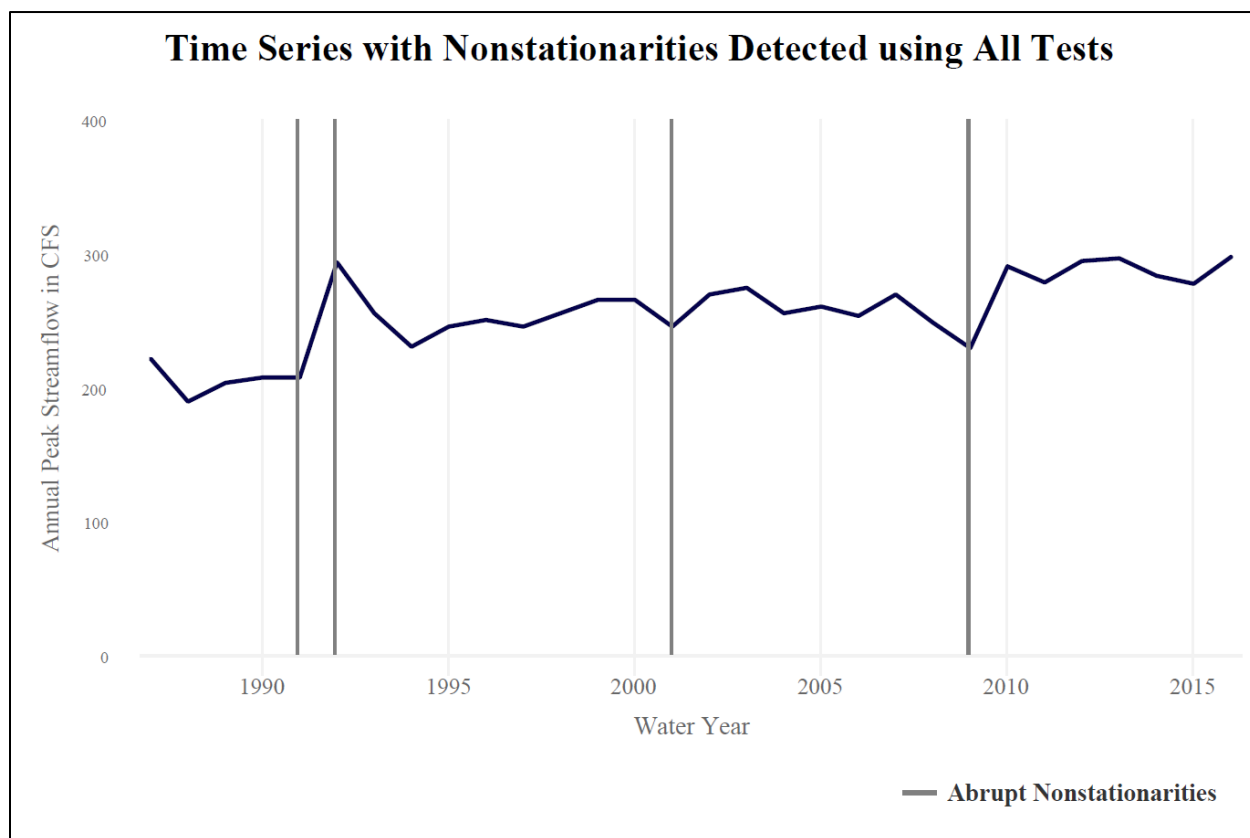
Figure 11: Nonstationarity detection tool results for the Solomon Gulch Tailrace near Valdez gage.

To investigate whether a trend of changing peak annual flow is occurring in Valdez, the Solomon Gulch Tailrace near Valdez gage record (USGS 15225996) was tested using the Nonstationary Detection Tool in accordance with Engineering Technical Letter 1110-2-3 (Figure 11). The tool notes four abrupt nonstationarities in the data set.

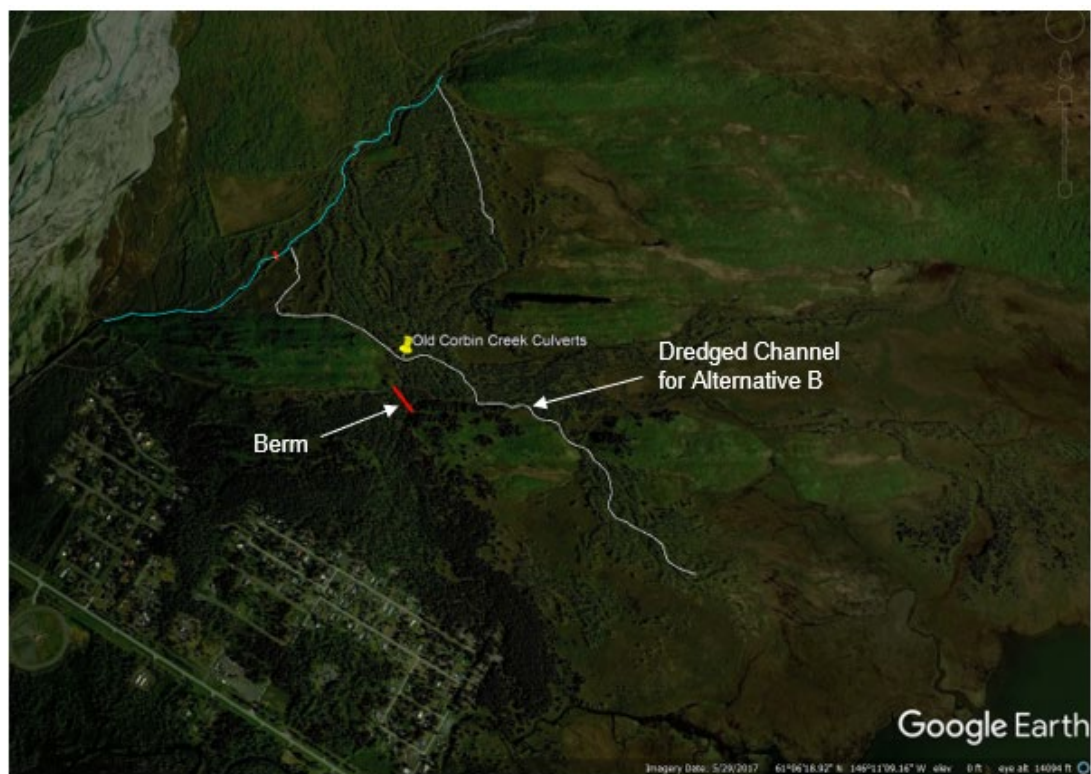
Figure 15. Full extent view of the 1.5-mile-long dredged channel on Old Corbin Creek for Alternative B.

A training dike (Figure 17) will be constructed across Corbin Creek to divert all the flow into Old Corbin Creek. The dike will be 7 feet high (84' NAVD88) and 250 feet long with 3H:1V side slopes with an armored toe and 10-foot crest width. The armor rock (A rock) will have median rock size of 1,200 pounds, B rock has a median rock size of 120 pounds, and the C rock (core rock) will have rock less than 120 lbs. A 275-foot-long channel will need to be excavated to connect the relic channel of Old Corbin Creek to Corbin Creek. The channel will be 30 feet wide, 3 feet deep, and have 3H:1V side slopes. Additionally, roughly 1.5 miles (8,237 feet) of the relic channel of Old Corbin Creek will be excavated to a depth of 3 feet and be 12 feet wide with 2H:1V side slopes. The culverts under ALPETCO trail on Old Corbin Creek will be replaced with a trail bridge. A 450-foot-long berm (Figure 18) will be placed in the low-lying area between the two bluffs near the Old Corbin Creek culverts to prevent overland flow from entering old relic channels that flow towards the Valdez subdivision. See Figure 14 and Figure 15 for locations.

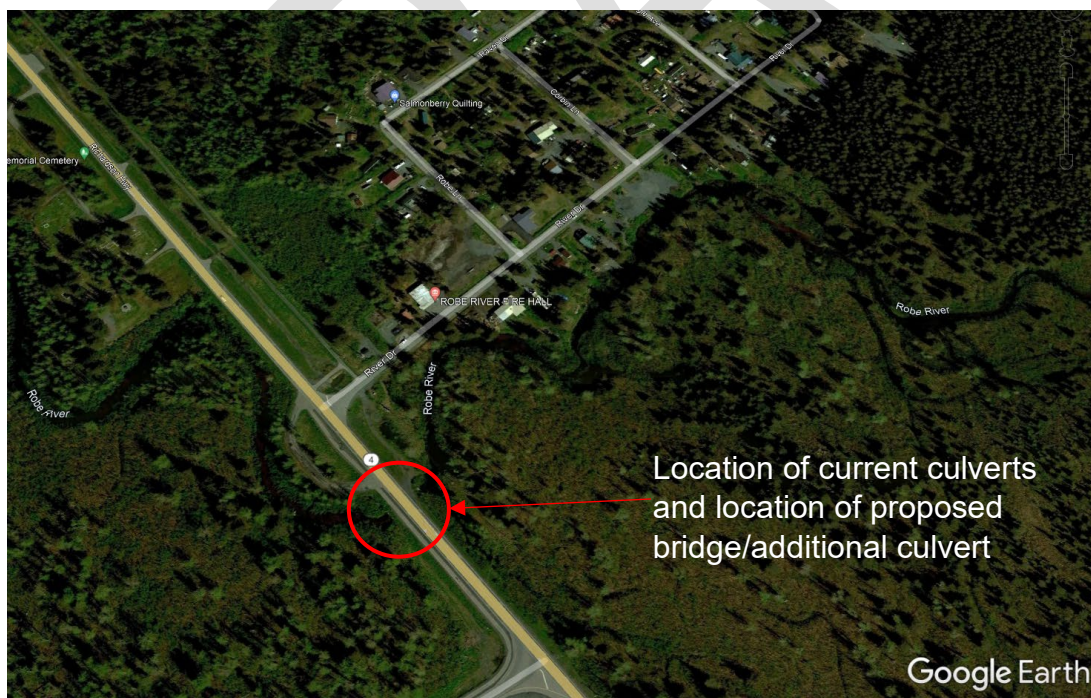
Figure 16. Location of culverts at the Robe River crossing under the Richardson Highway.

Different alternatives were developed to restore and improve the habitat within Robe Lake to a less degraded state while ensuring flood levels do not increase from the future without project condition levels. Four main alternatives were modeled using the hydrologic engineering centers river analysis system (HEC-RAS) (see Section 5), with some of the alternatives having sub-alternatives with slight variations. Figure 14-Figure 15Figure 16 show the layout of the alternatives. Prior to the gravel berm being constructed in the 1950's (Figure 13) that diverted Corbin Creek into Valdez Glacier Stream, macrophytes were not an issue, and this was hypothesized to be due to the cold, turbid, glacial water that was entering the lake. Thus, the focus of these alternatives was to divert a portion or all the flow from Corbin Creek back into Robe Lake through either Old Corbin Creek or Brownie Creek. To divert all the flow, a dike would be implemented; and to divert a portion of the flow, a weir would be used. To ensure flooding was not induced, different scenarios were modeled for the culverts under the Richardson Highway (Figure 16).

Three different options for the culverts at the Robe River crossing under the Richardson Highway (Figure 16) were proposed and modeled. The first was keeping the culverts and not making any changes to this area (Alternative A-1). The second was replacing the two culverts for new culverts of the same size and adding an additional 12.75-foot diameter CMP culvert next to them to convey more flow (Alternative A-2). The third was replacing the culverts with three new 14-foot diameter CMP culverts (Alternative A-3).

Three different options for the culverts at the Robe River crossing under the Richardson Highway (Figure 16) were proposed and modeled. The first was replacing the two culverts under the Richardson Highway with a 50-foot span DOT designed bridge (Alternative B-1). The second was replacing the two culverts for new culverts of the same size and adding an additional 12.75-foot diameter CMP culvert next to them to convey more flow (Alternative B-2). The third was replacing the culverts with three new 14-foot diameter CMP culverts (Alternative B-3).

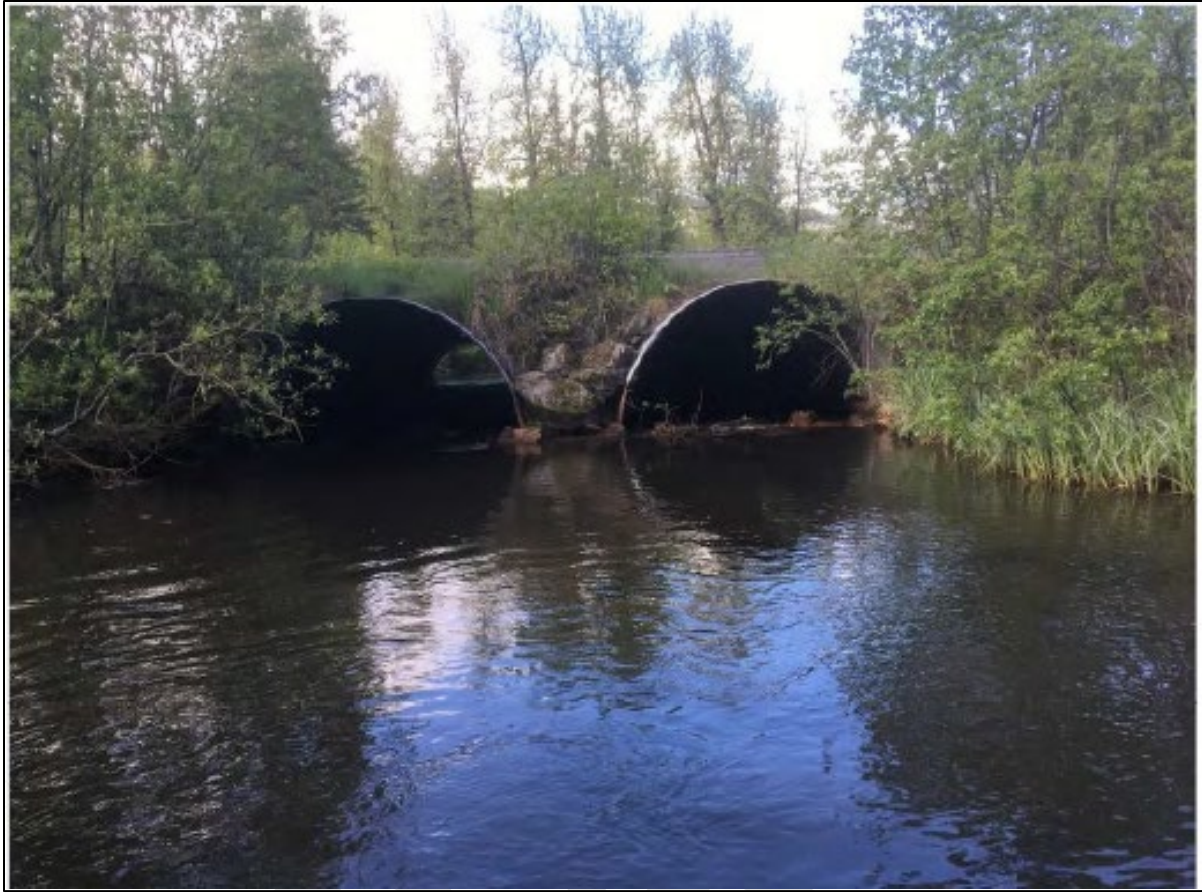
Figure 22. Robe River culverts under the Richardson Highway.

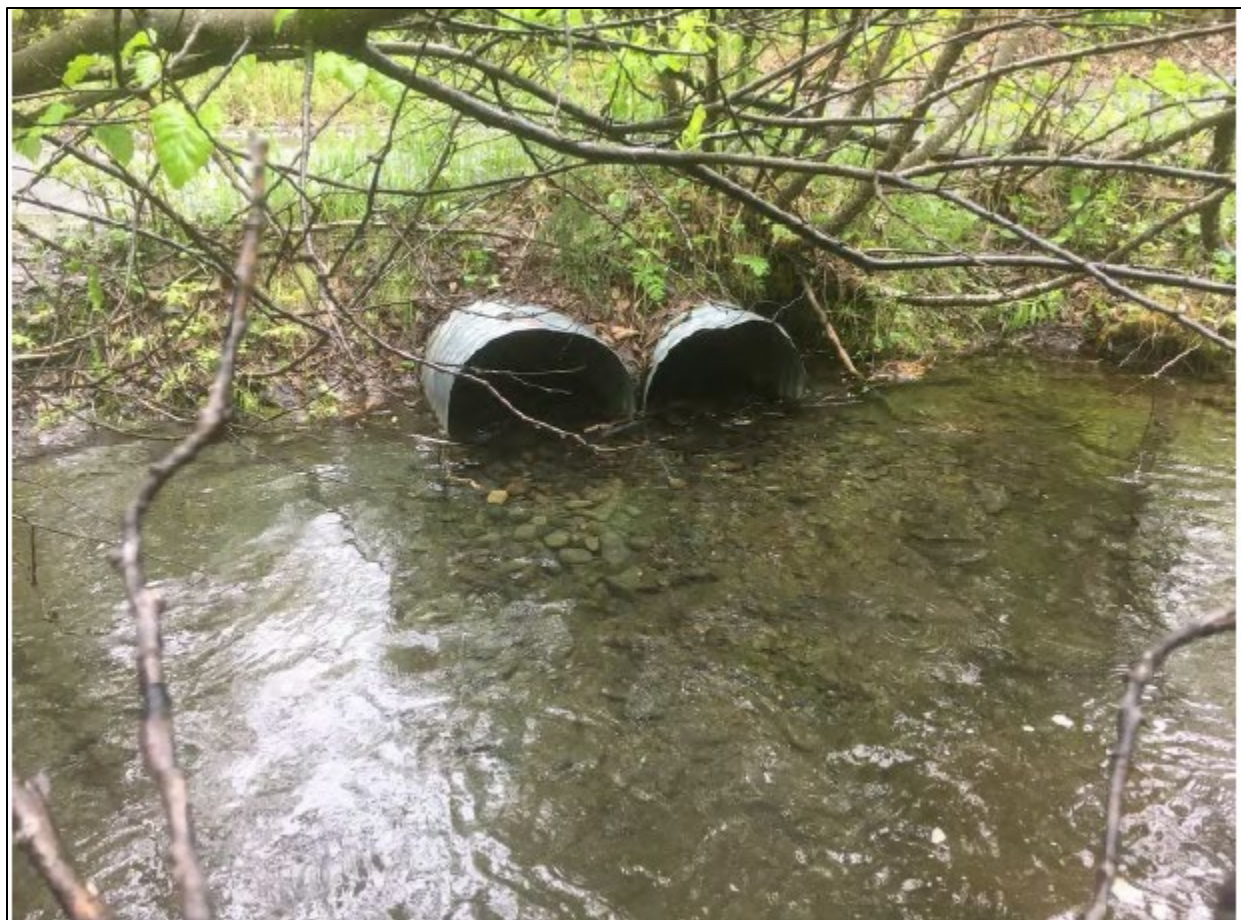
Figure 23. Old Corbin Creek culverts under the ALPETCO trail.

the ALPETCO trail near the two 24 inch-diameter CMP culverts that go beneath the trail (Figure 23). The Brownie Creek gage was installed near a beaver complex on the 0.3-mile reach closest to the ALPETCO trail. The Corbin Creek gage was installed where bedrock outcrops form a pool with a sheltered embayment. The Brownie Creek, Old Corbin Creek, and Corbin Creek gages can be seen in Figure 21. The culverts under the Richardson Highway and on Old Corbin Creek under the ALPETCO trail were included in the model, except for alternatives where they were to be taken out.

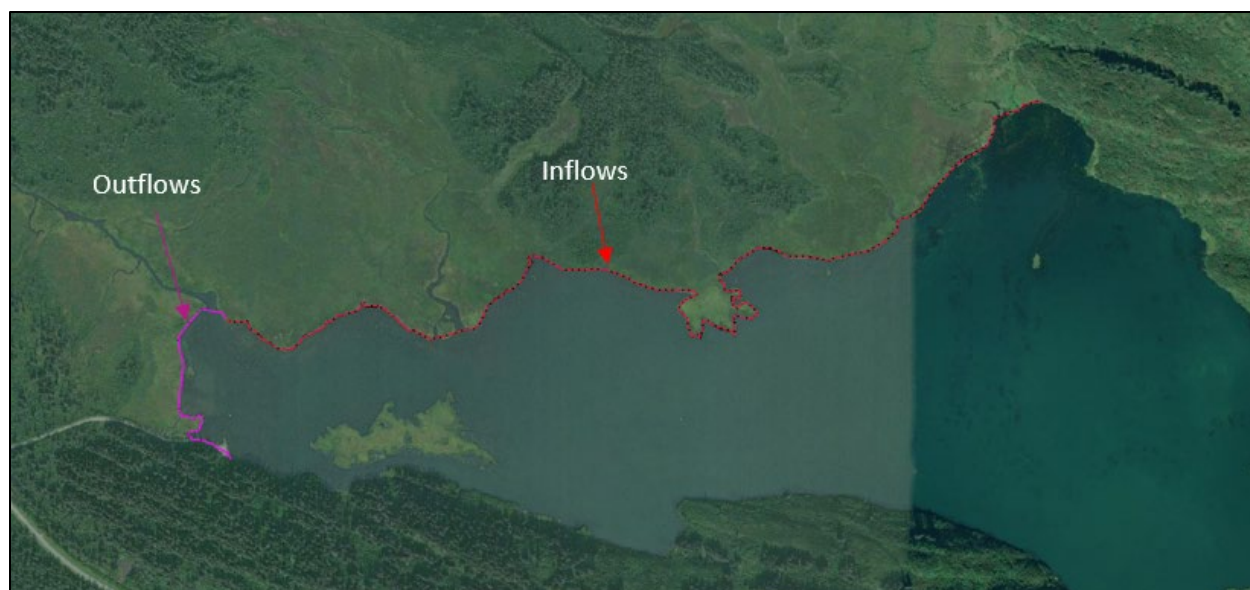
Figure 25. SA/2D connections to Robe Lake.

Robe Lake was modeled as a storage area within HEC-RAS. The lake has an area of 618 acres and the volume-elevation curve that is based off the terrain can be seen in Figure 24. The 2D perimeter mesh is connected to Robe Lake via 2D/SA connectors, with elevations based off the terrain. These connectors run along the entire north section of the lake that is low lying. Anything to the east of the Robe River mouth was modeled as inflows to the lake, whereas the Robe River mouth and to the west of the mouth were modeled as outflows (Figure 25).

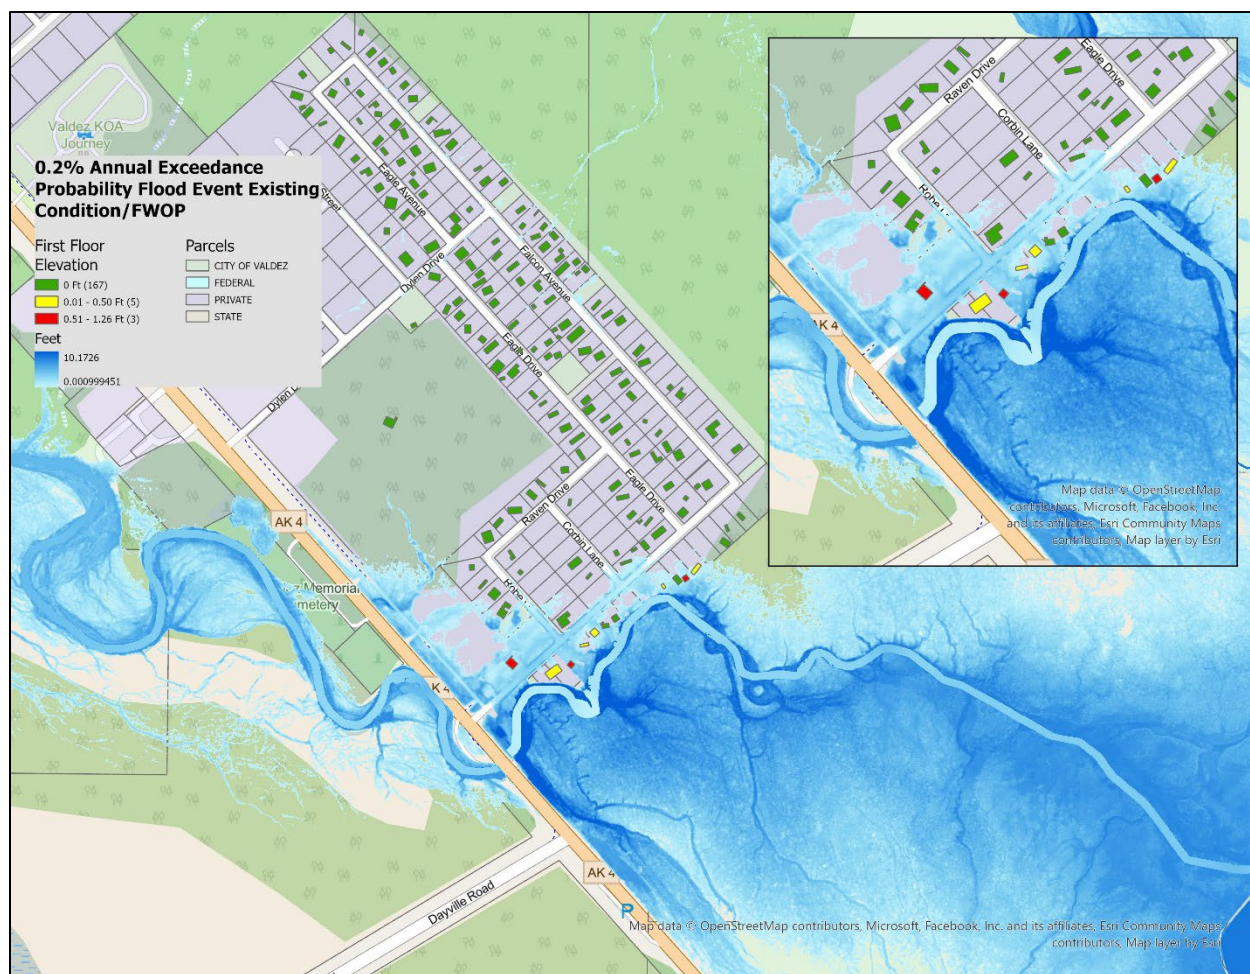
Figure 28. 0.2% annual exceedance probability for FWOP conditions.

The existing FWOP conditions HEC-RAS 1% and 0.2% annual exceedance probabilities for Robe Lake in Valdez are presented in Figure 27 and Figure 28. The full HEC-RAS profiles for all modeled FWOP conditions recurrence intervals in the Robe Lake study area are in the *HEC-RAS Output Attachment* at the end of this report in Appendix A.

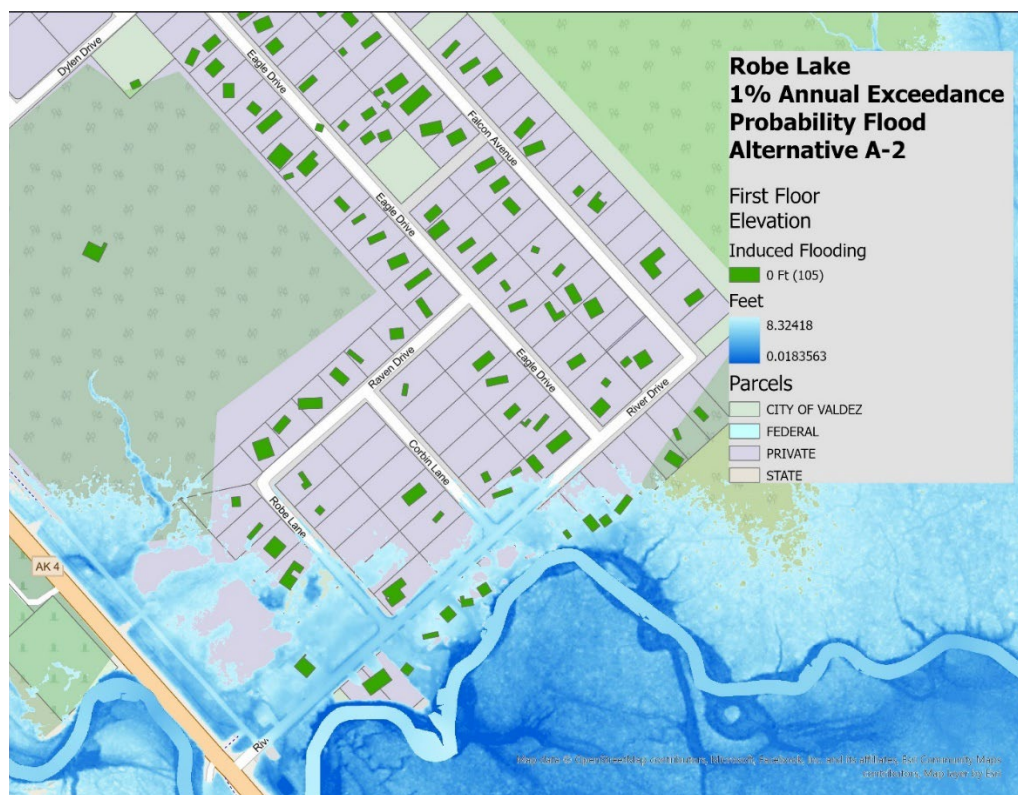
Figure 31. 1% annual exceedance probability for Alternative A-2.

The future with project conditions HEC-RAS 1% and 0.2% annual exceedance probability depth grids for Robe Lake are presented in Figures 29-44. The full HEC-RAS profiles for all modeled with-project conditions recurrence intervals in the Robe Lake study area are in the *HEC-RAS Output Attachment* at the end of this report in Appendix A.

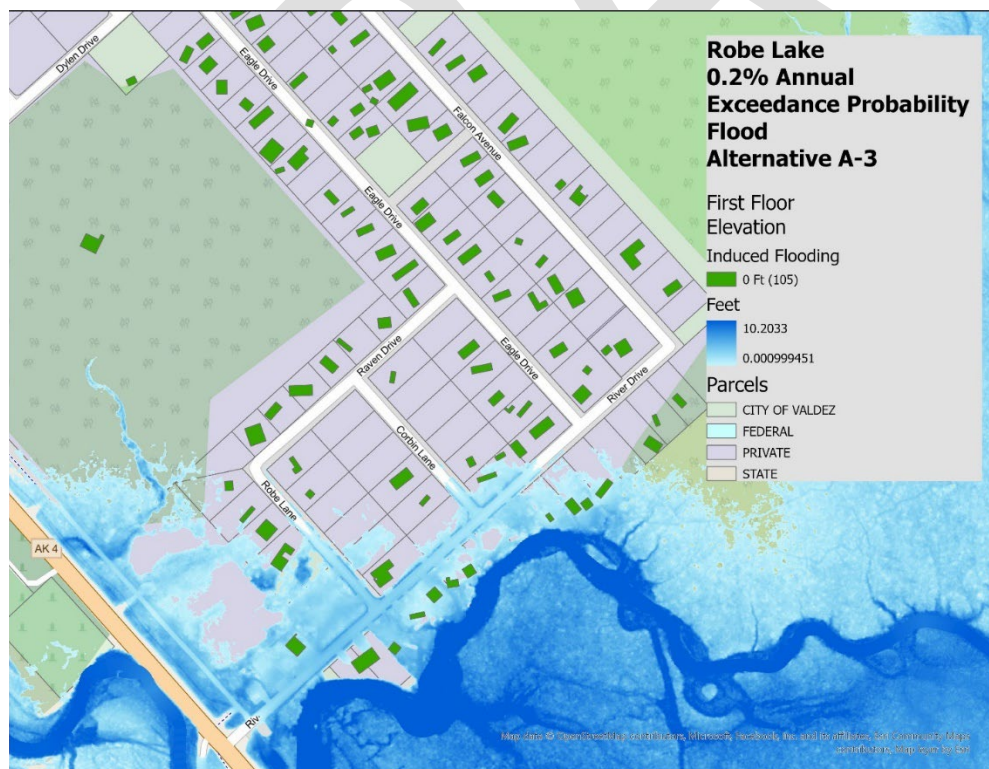
Figure 34. 0.2% annual exceedance probability for Alternative A-3.
