**Appendix B-1:
Geophysical Survey Report**

Unalaska (Dutch Harbor) Channels

**GEOPHYSICAL SURVEY REPORT
CHANNEL NAVIGATION IMPROVEMENTS
FEASIBILITY STUDY, DUTCH HARBOR, ALASKA**

CHANNEL NAVIGATION IMPROVEMENTS FEASIBILITY STUDY DUTCH HARBOR, ALASKA

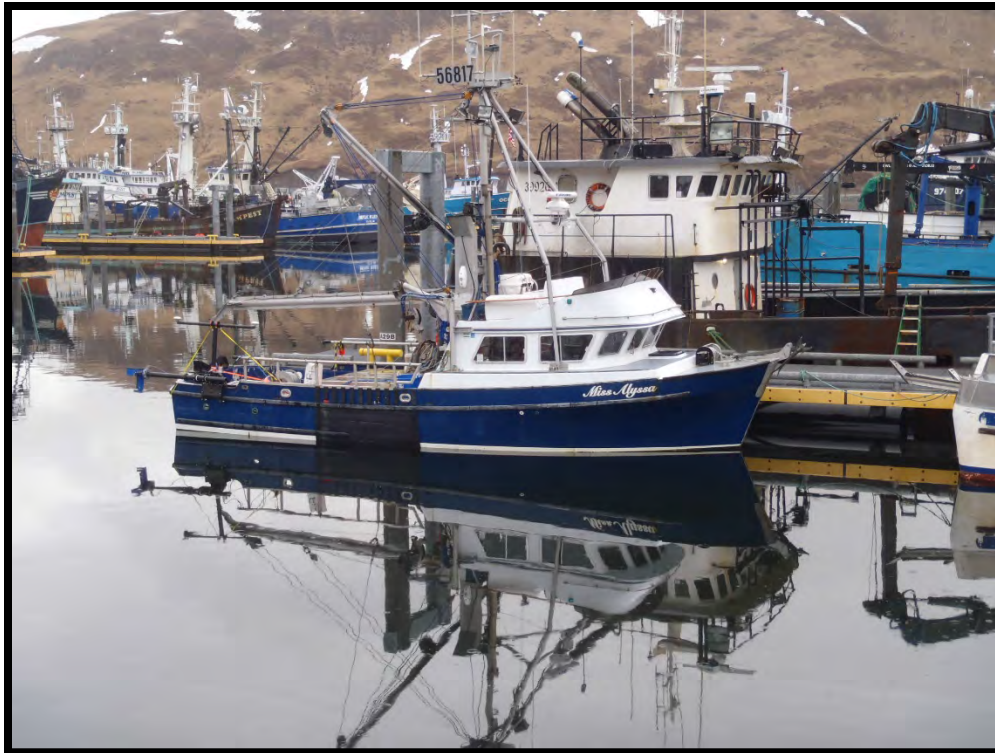
Vessel of Opportunity Photograph

Charter vessel Miss Alyssa moored at the Carl E. Moses boat harbor; 15 April 2017

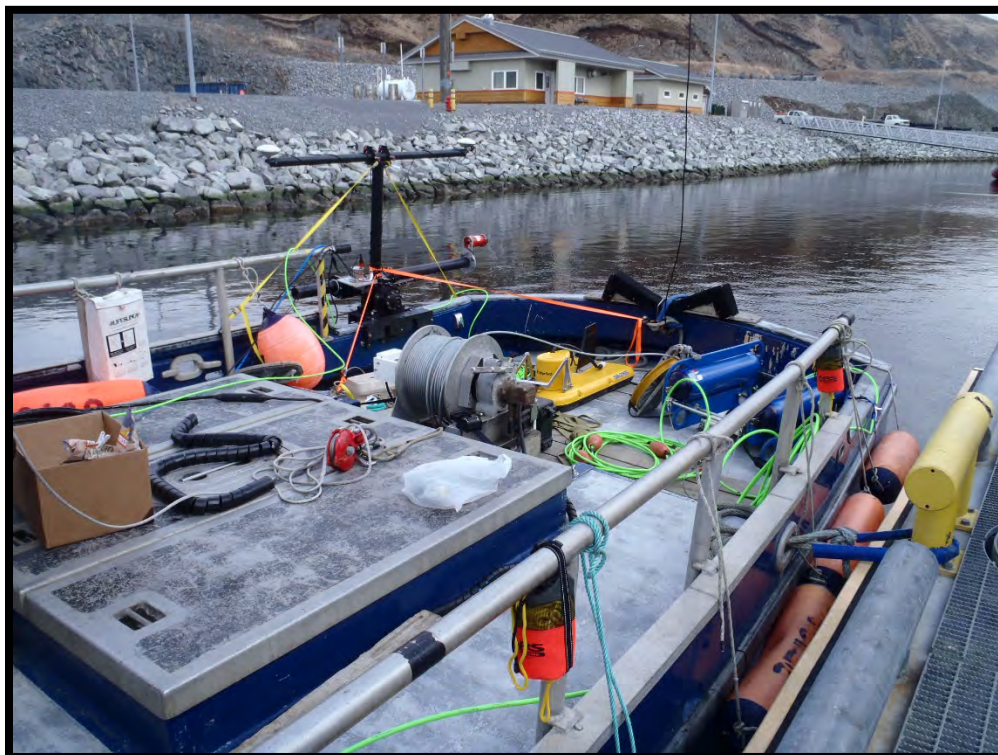
Vessel of Opportunity Mobilization Photograph

Installation of geophysical survey equipment and systems at the Carl E. Moses boat harbor;
17 April 2017

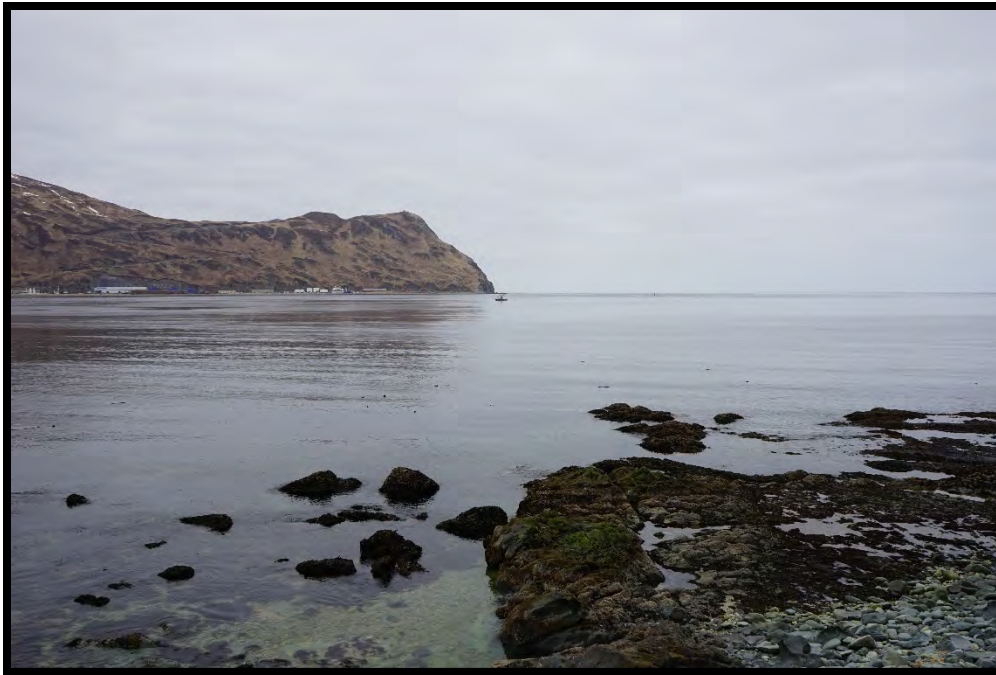
Iliuliuk Bay Photograph 2

Overview of Iliuliuk Bay; Shoal crest is orientated parallel along viewers line of sight and the Miss Alyssa and headland located center of frame; Facing northwest; 13 April 2017

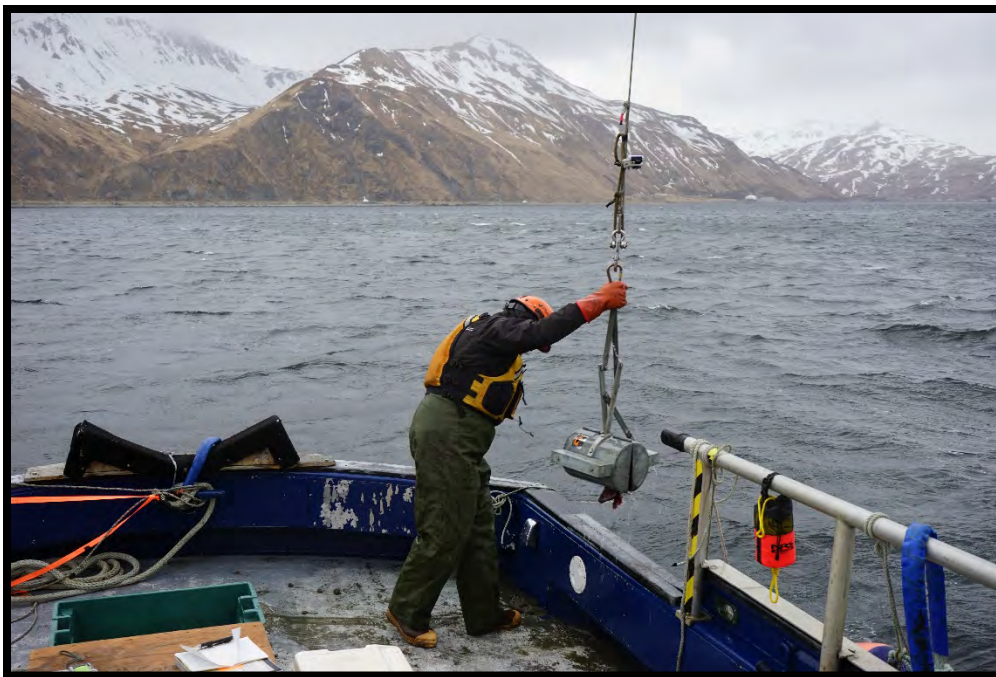
Sediment Sampling Photograph

Ponar grab sample deployment and retrieval operations; 14 April 2017

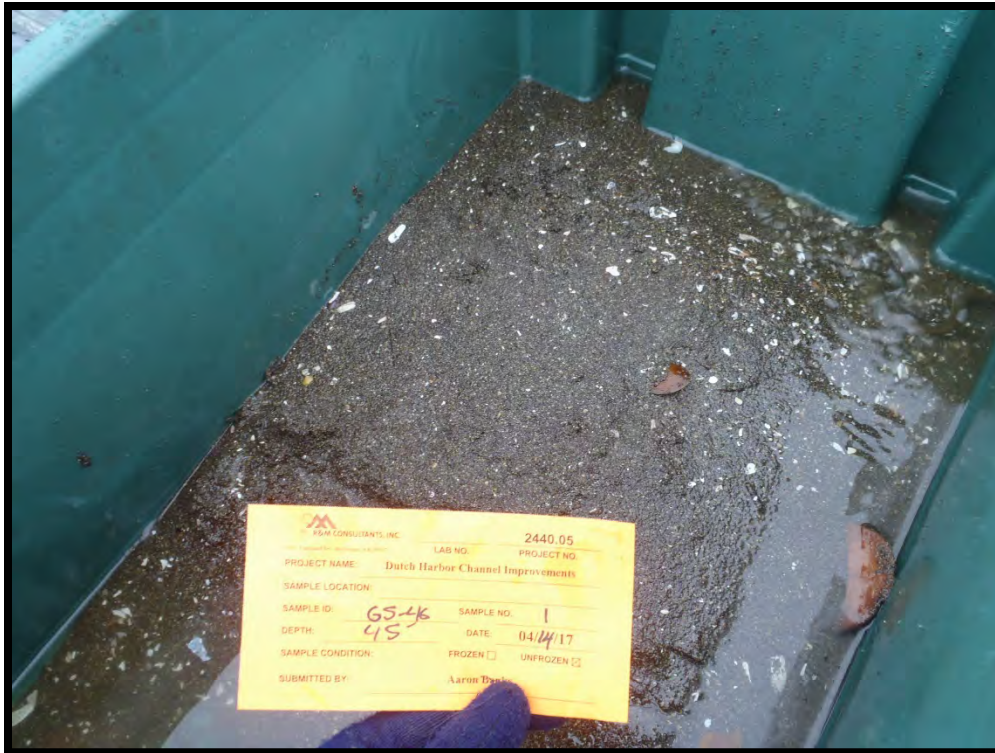
Sand (SP) Surface Sediment Photograph

Representative sand surface sediment; Grab sample No. 46; From 45-foot depth; 14 April 2017

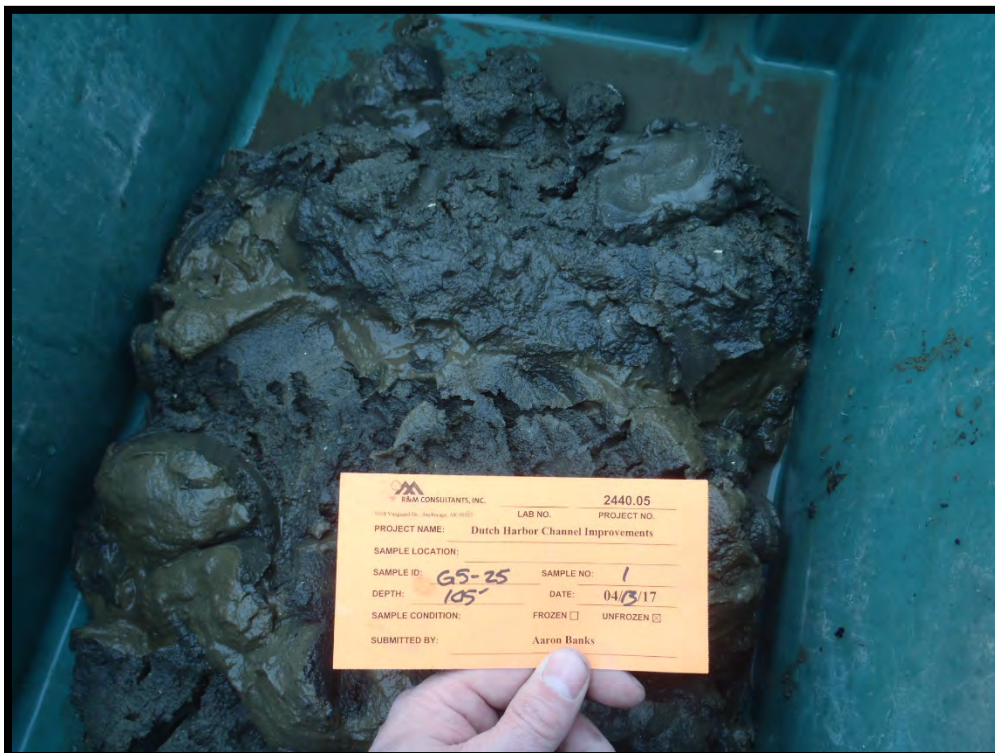
Silt (ML) Surface Sediment Photograph

Representative silt surface sediment; Grab sample No. 25; From 105-foot depth; 13 April 2017

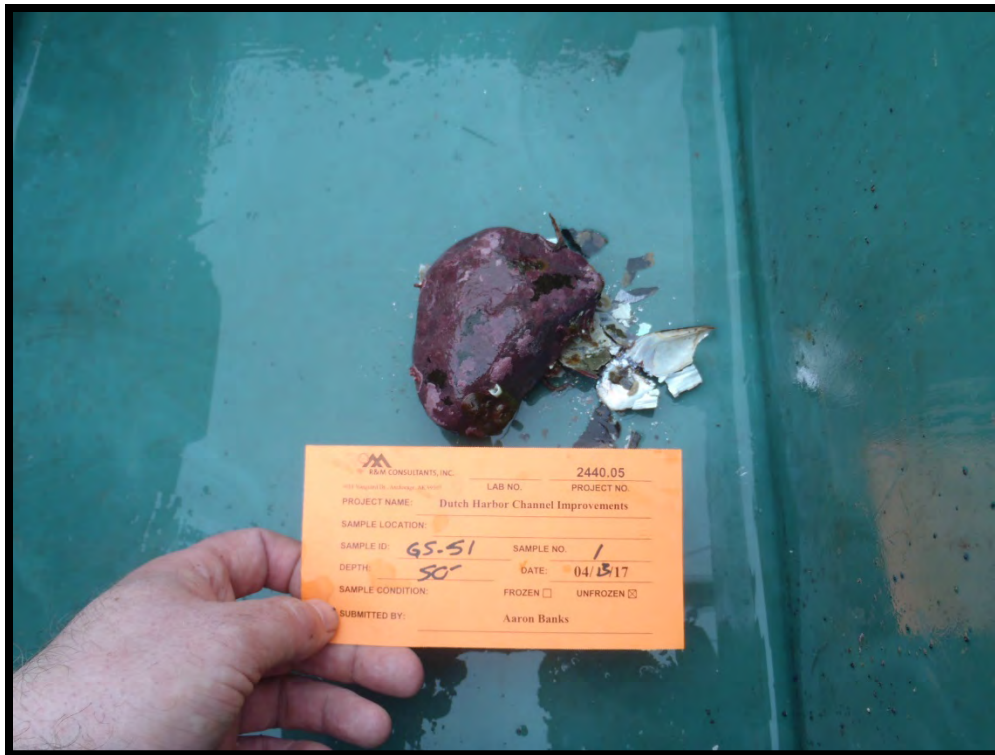
Hard Bottom Surface Sediment Photograph

Representative low-recovery conditions from “hard bottom” surface sediments; Grab sample No. 51; From 50-foot depth; 13 April 2017

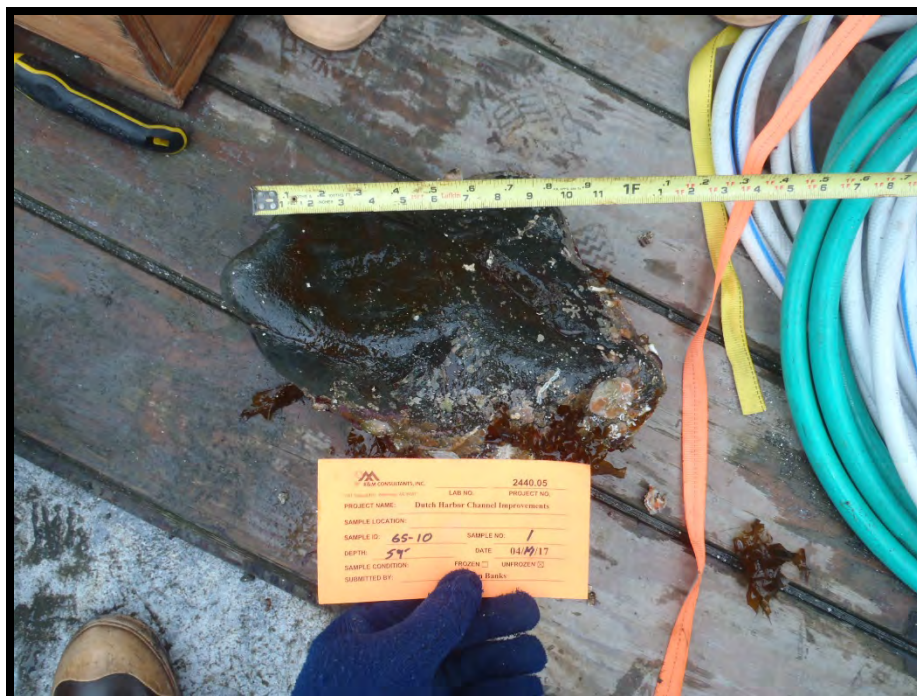
Boulder Surface Sediment Photograph

Representative sample of cobbles and boulders interpreted to armor the shoal; Boulder is 0.9 feet by 1.3 feet; Grab sample No. 10; From 59-foot depth, 14 April 2017

NOTE: The size of recoverable particles was limited by the size of the sampling system. Larger particles than grab sample No. 10 are interpreted to armor the shoal.

The shoal is interpreted to be armored with a layer of subrounded to subangular cobbles and boulders of varying thickness. This armor layer was most likely formed from the erosion of fines (sands and silts) due to wave action transporting the fines off the shoal, into deeper surrounding waters, and leaving the cobbles and boulders remaining on the shoal. Evidence of these cobbles and boulders was observed during sediment sampling operations both in recovered samples and in limited underwater video collected along the shoal. These cobbles and boulders are estimated to generally range from 3-inch particle size up to about 3-foot particle size and were observed to consist generally of subrounded to subangular; tabular to blocky clasts. It should be noted that particles greater than 3 feet in diameter may present on any portions of the shoal.

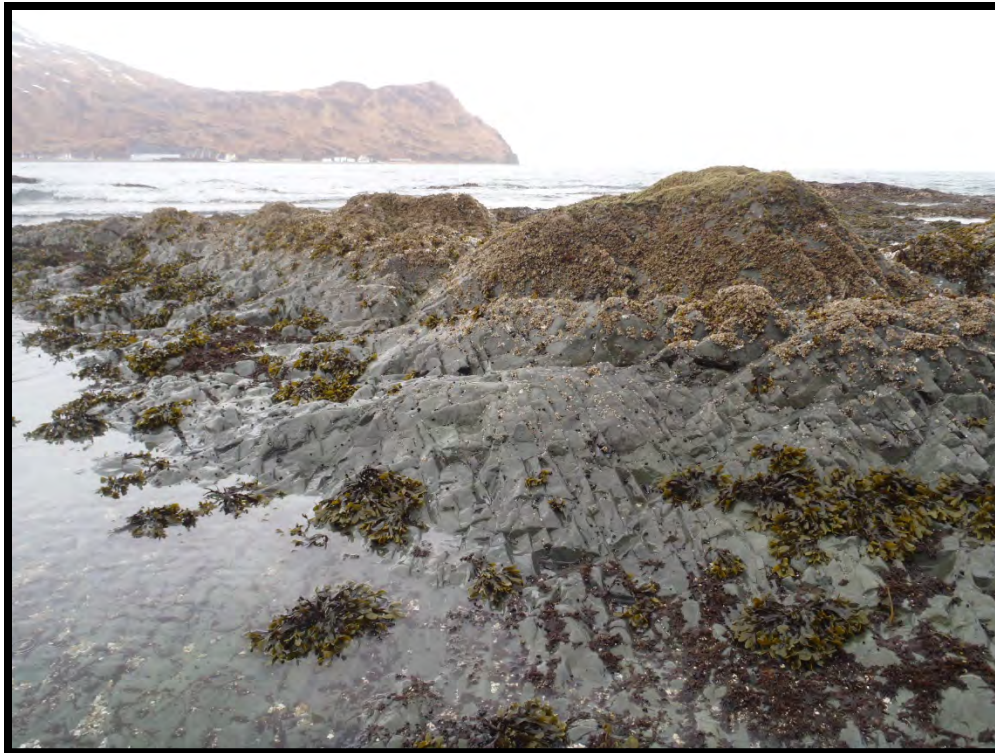
Onshore Exposed Bedrock Photograph

Representative exposed bedrock conditions onshore and off the southern end of the shoal;
Facing northwest; 15 April 2017

Along the southeastern shore of Iliuliuk Bay, numerous exposed shelves consisting of bedrock were observed within the intertidal zone. Immediately southeast of and in line with the longitudinal axis of the underwater shoal of interest, an exposed bedrock shelf was observed. This shelf was measured to be approximately 230 feet in width and extended about 150 feet into the bay. It was observed to consist of a gray, very hard, faintly to slightly weathered aphanitic andesite. This shelf exhibited consistent structure and its primary joint set was measured to strike in a northwest/southeast trend ($\approx 160^\circ/340^\circ$) and dip about 60° to 70° towards the northeast. A photograph of this shelf is presented on Page A-06 of Appendix A.

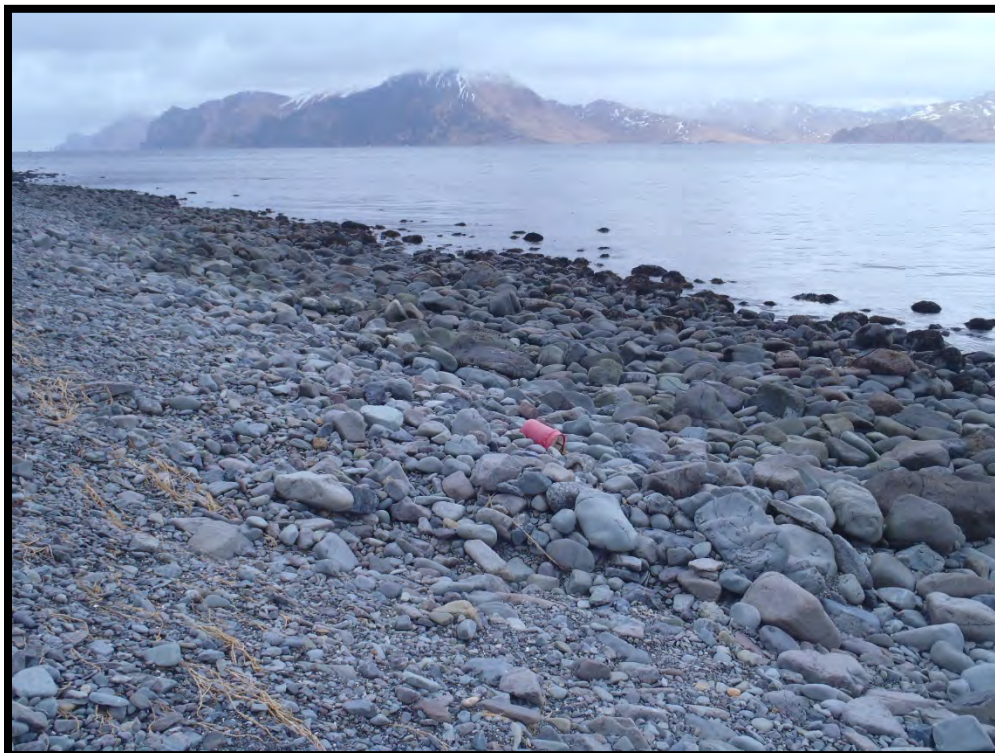
Dutch Harbor Spit Conditions Photograph

Representative cobble and boulder armor layer conditions along the spit toe off the northern
extents of the shoal; Average size 2 to 3 feet, Facing northeast; 16 April 2017

Situated along the northwestern shore of Iliuliuk Bay is the Dutch Harbor marine spit. It is mapped as consisting of Quaternary alluvial beach deposits (Drewes et al., 1961). This spit was observed to be armored with a layer of gray, gray-green and brown mixture of andesitic and basaltic cobbles and boulders averaging about one to three feet in diameter. Average particle size of these cobbles and boulders was observed to decrease from the spit-toe, in the north, to the spit-head, in the south. This particle size sorting may indicate that long-shore current deposition contributed to the formation and southward propagation of the marine spit.

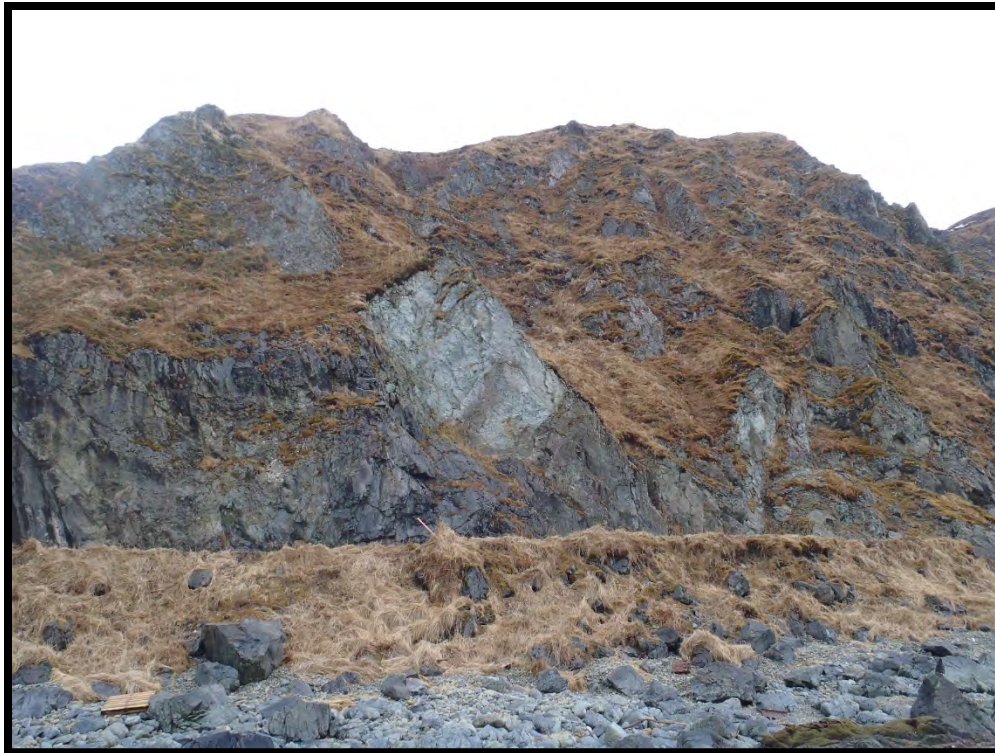
Onshore Geologic Conditions Photograph 1

Representative onshore geologic conditions off the southern end of the shoal; Facing southeast;
15 April 2017

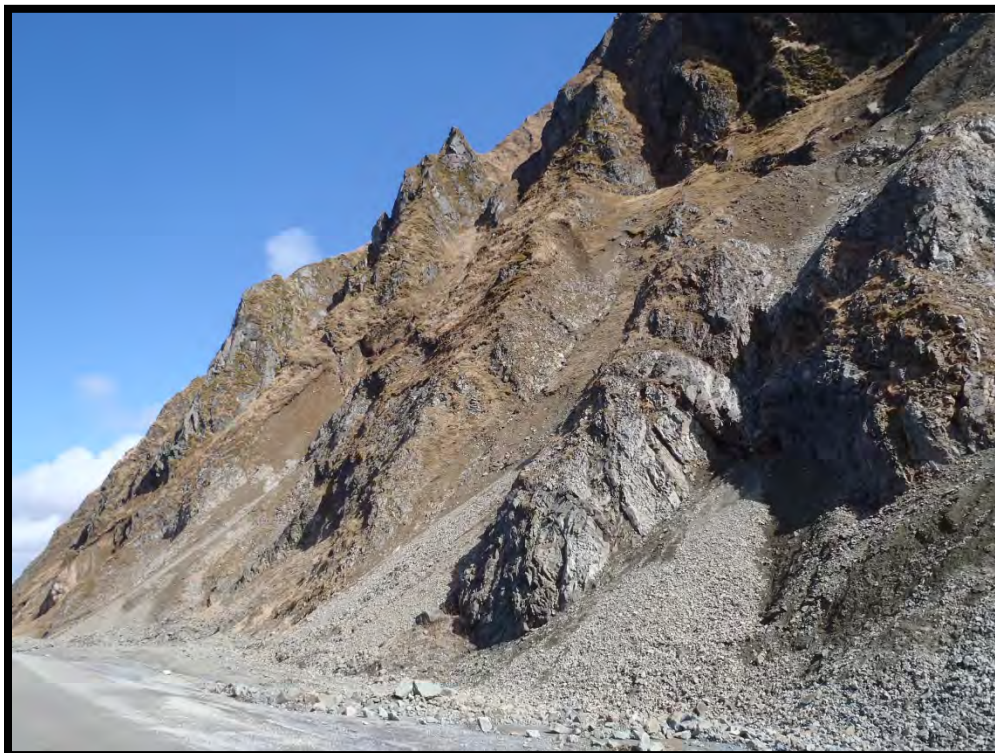
Onshore Geologic Conditions Photograph 2

Representative onshore geologic conditions off the southern end of the shoal; Facing northeast;
15 April 2017

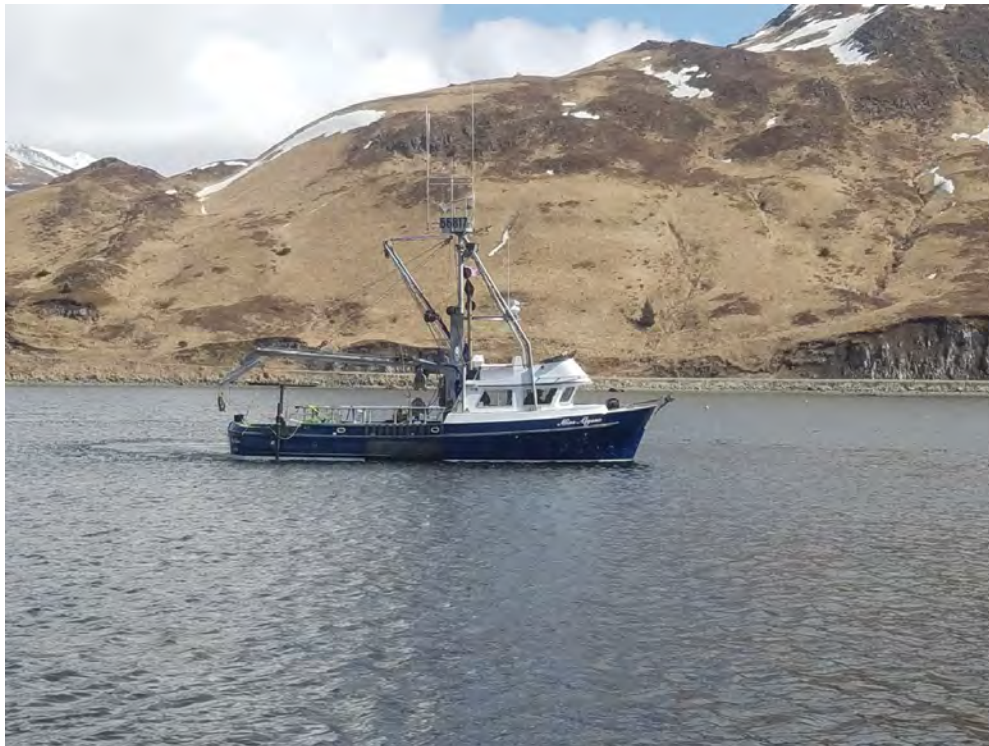
Figure 4 Vessel Miss Alyssa

eTrac Inc. used charter vessel Miss Alyssa for hydrographic and geophysical survey operations for the Channel Navigation Improvements Feasibility Study in Dutch Harbor, Alaska. Vessel Miss Alyssa is a 43 foot all fiberglass twin diesel powered commercial fishing/dive support and charter vessel (see Figure 4 for an image of the mobilized vessel). A positioning and motion detection system was installed on the vessel with a long antenna base allowing maximum heading accuracy. A multibeam system and USBL system were mounted with a Universal Sonar Mount (USM) – Vessel of Opportunity (VOOP) kit. The sediment sampler was deployed and retrieved via the onboard hydraulic winch. The narrow band subbottom system was towed from two tie points off the stern of the vessel. The Chirp subbottom system and the Gradiometer were towed using a sheave with a block and winch off the stern of the vessel.

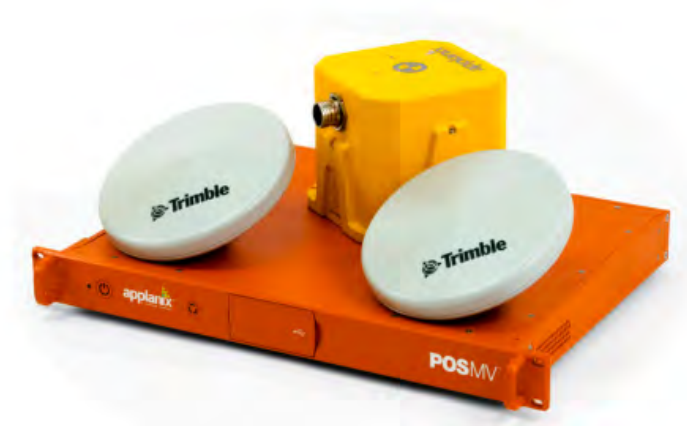
Figure 5 Applanix POS MV Oceanmaster

The vessel was positioned and motion accounted for using an Applanix POS MV5 Oceanmaster. The system allows high accuracy real time kinematic (RTK) positioning as well as a post processed kinematic (PPK) solution. All tidal stages are accounted for in real-time through the RTK or PPK vertical position. Details of the system are below in Figure 5.

- Position Accuracies PPK: Horizontal: $\pm (8 \text{ mm} + 1 \text{ ppm} \times \text{baseline length})$ Vertical: $\pm (15 \text{ mm} + 1 \text{ ppm} \times \text{baseline length})$
- Motion Accuracies, Roll and Pitch: 0.008° in PPK
- Heading Accuracies: 0.01° (4 m baseline)
- Real time Heave 5cms and Trueheave Solutions available increasing to 3 cms
- With POSpac Processing allows PPK solution with GLONASS AND GPS satellites.

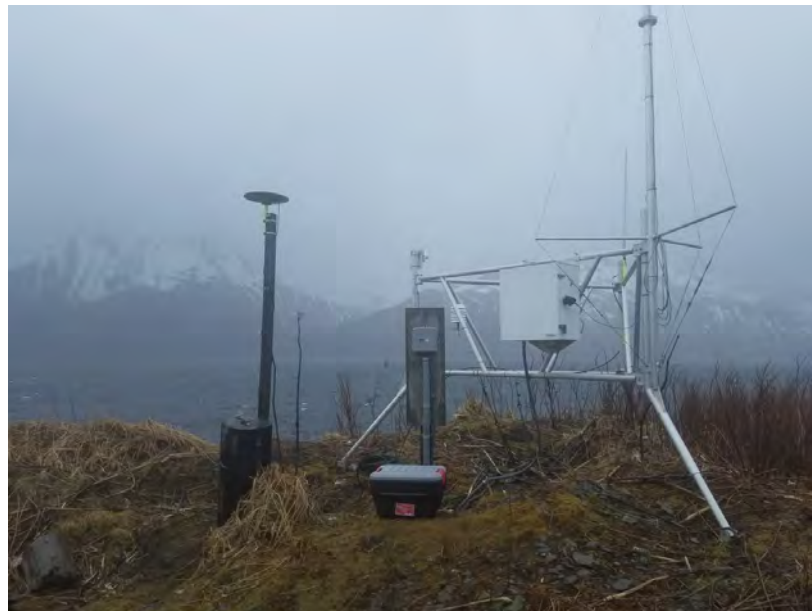
Figure 7 Trimble SP 855 RTK base station "SPIT" GNSS & VHF Antennas set-up for the project

The base station used was a Trimble 855 with radio for broadcasting CMR correction to the vessel. The system as set-up on point "SPIT" is shown below in Figure 7.

- Broadcasting RTK CMR+ and CMR 94 corrections
- Logging data with NetR5
- GPS and GLONASS

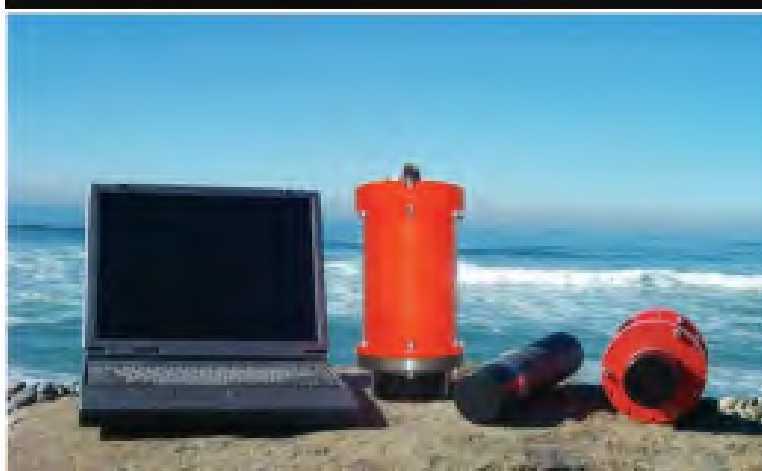
Figure 8 LinkQuest Tracklink 1500 USBL Details

A LinkQuest Tracklink 1500 USBL system was used to position the Chirp subbottom system and gradiometer along with the POSMV which positioned the vessel on which the USBL was mounted. Listed below are the details of the USBL used (see Figure 8).

- Positioning Accuracy: 3 degrees (better than 5% of slant range)
- Slant Range Accuracy: 0.20 meters
- Targets Tracked: 16
- Operating Frequency: 31.0 to 43.2 kHz
- Operating Beamwidth: 120 to 150 degrees
- Transmit Mode Power Consumption: 10 Watts
- Receive Mode Power Consumption: 1.6 Watts
- Working Range With Ship Noise: 1000 m
- Maximum Transponder Depth: 1500 m

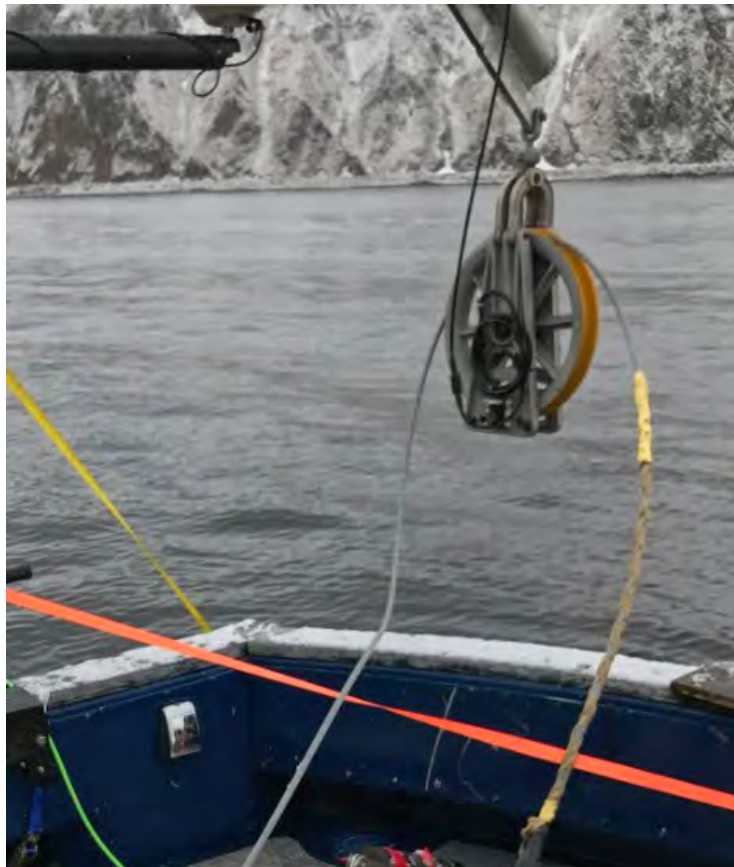
Figure 10 HSP Cable Counter Details

A Hydrographic Survey Products cable counter was used as a secondary positioning system for the chirp and gradiometer systems. The cable counter was set-up as a separate computation in QINSy and the computed solution from the cable counter would be used during USBL dropouts. Details of the system can be seen below in Figure 10.

- Power: 8 to 24V dc @ 1amp
- Max Count: 99999.9 meters (10kM)
- Min Count: 00000.0 meters
- Resolution 10 cm (determined by magnet spacing)

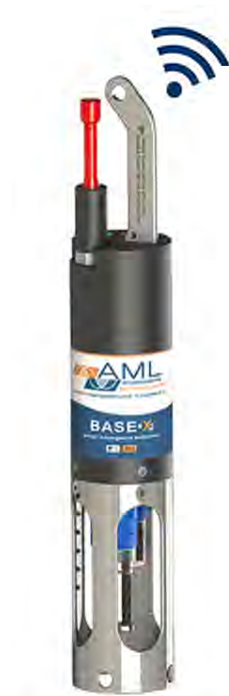
Figure 13 AML Base X 2 Sound Velocity Profiler

- Depth Range: up to 500 meters
- Sound Velocity Range: 1375 to 1625 m/s
- Sound Velocity Precision (+/-): 0.006 m/s
- Sound Velocity Accuracy (+/-): 0.025 m/s
- Sound Velocity Resolution: 0.001 m/s
- Pressure Range: Up to 6000 dBar

An AML Base X 2 Profiler (See Figure 13 for image and details) was used as the sound speed profiler due to its high accuracy time of flight sound speed sensor, which is capable of measuring sound speed in

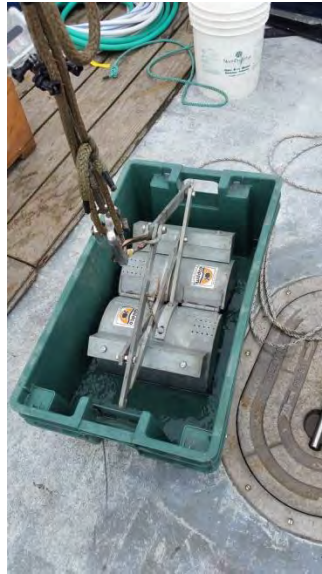
Figure 15 WILDCO Ponar Grab Sampler

A WILDCO Ponar grab sediment sampler system was used for all sediment collection (shown in Figure 15). The Ponar grab is a self closing stainless steel grab sampler and has a sample volume of 500 Cubic Inches and measures 9'Wx9'L. A full mobilization report for the grab sampler system can be found in Appendix A.

A WILDCO Ponar® Grab sampler was utilized to collect sediment from the sea floor to aid in the classification of surface sediment types. The grab sampler is a "clamshell" type stainless steel sampler with a volume of approximately 500 cubic inches and measures 9 inches wide by 9 inches long. The system was deployed and retrieved via the onboard hydraulic winch. All recovered soil samples were handled, characterized and logged in accordance with R&M's Standard Procedure for "Soil Classification, Logging, and Sampling".

It should be noted that while sampling along the shoal, there were several instances when the grab sampler was unable to retrieve a sample. This lack of recovery is due to the limitations of the Ponar® Grab sampler in gravelly conditions or in areas of cobbles and boulders. When in gravelly conditions, it is common for clamshell type samplers to fail to fully close due to a gravel particle becoming lodged between the two halves of the sampler and thereby washing the remainder of the sample out upon retrieval. In areas of cobbles and boulders, the grab sampler is limited simply due to its size.

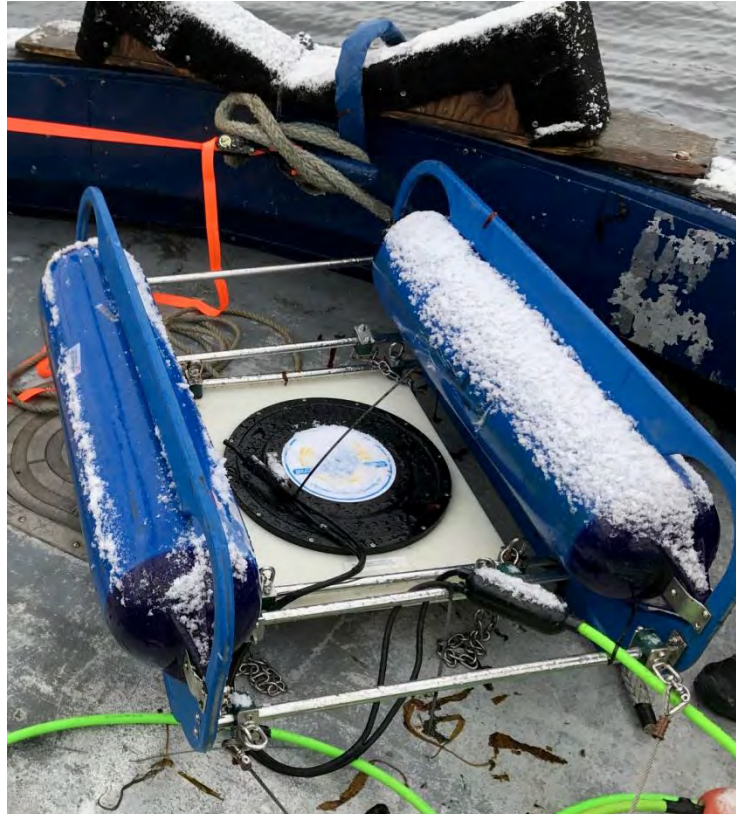
Figure 16 Falmouth HMS-620 Bubble Gun

The Falmouth HMS-620 Bubble Gun (shown in Figure 16) was used to determine the deep subsurface stratification (up to 300 feet below the seabed). The system is a narrow band low frequency boomer subbottom profiler capable of penetrating coarse sand and gravel sediments. This system can differentiate bedrock from other geological environments. The Bubble Gun has frequency of 400 kHz. The Bubble Gun system is designed to be flown at the surface.

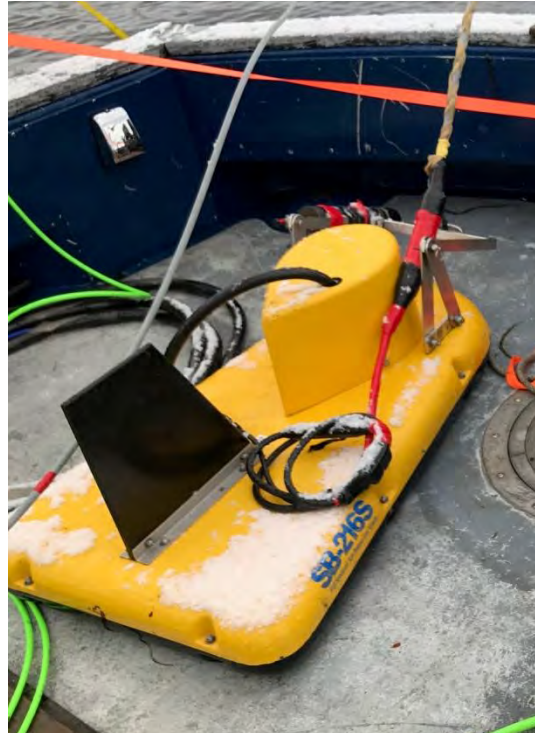
Figure 18 Edgetech 216s

To understand the shallow subsurface stratification (up to 30 feet below seabed) and subsurface object detection an Edgetech 216S Chirp Subbottom profiler with a 3200 topside was used. The system is shown in Figure 18 above. The system has a frequency modulated pulse and can be set-up to 2-16 kHz at 5 m/s. The Chirp system has an optimal range of flight between 5 – 10 meters about the seafloor.

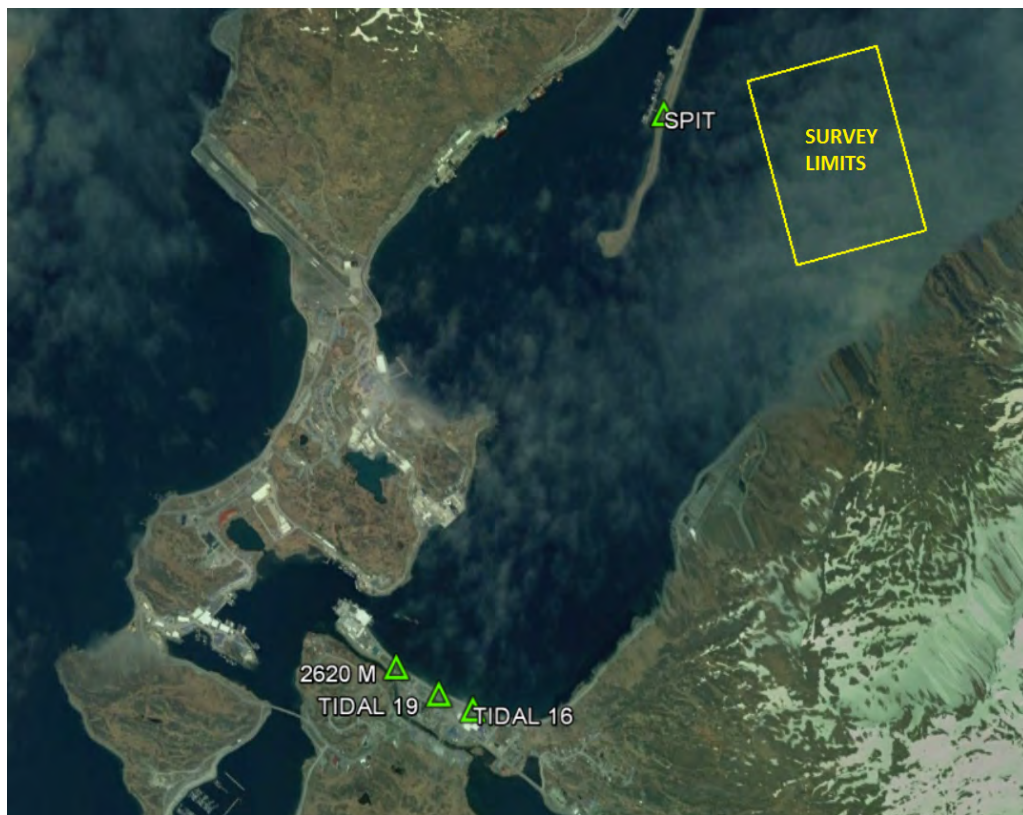
Figure 23 Semi-Permanent RTK Base Station "SPIT" established near project area

Local Project Control is based on NGS (OPUS) and NOAA published values for NOAA Tidal Station “946 2620 Unalaska, Dutch Harbor, Alaska”. Tidal bench mark “946 2620 TIDAL 19” was held as the primary control point. Differential Leveling was conducted between “946 2620 TIDAL 19” and three other bench marks from the same station: “946 2620 TIDAL 16”, “946 2620 M”, and “946 2620 P”. A Static GNSS survey was conducted in order to compute the position of semi-permanent RTK Base Station “SPIT” established near the project site. The location of benchmarks and the semi-permanent RTK Base Station “SPIT” as well as an image of “SPIT” are displayed in Figure 23 and Figure 24 below.

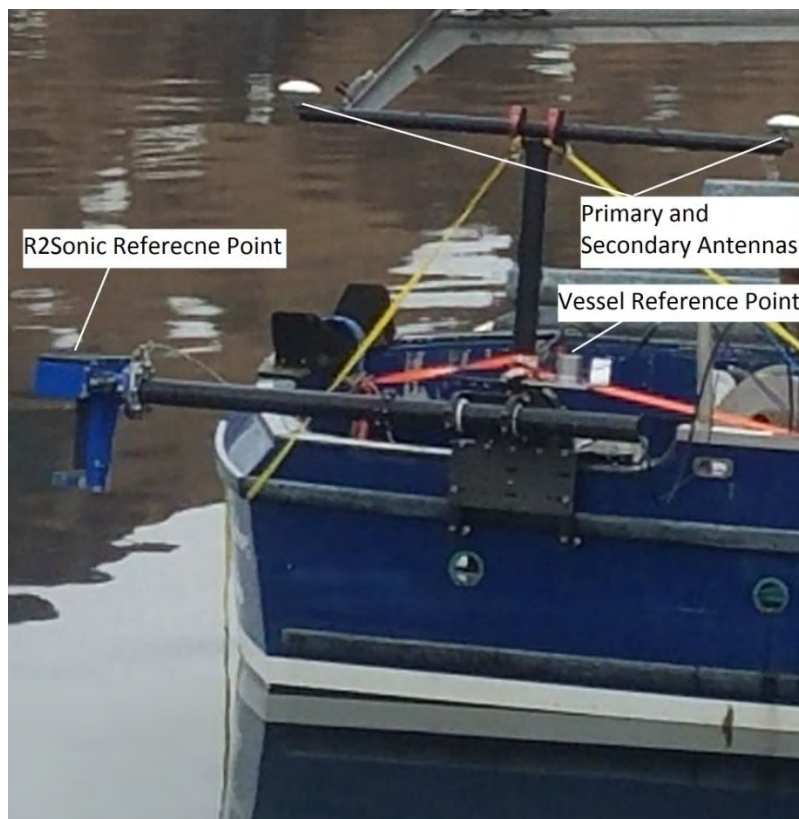
Figure 5 Vessel Central Reference Point

An R2 Sonic 2024 multibeam system was mobilized onto Miss Alyssa. The sonar was mounted with a UUSM – VOOP kit. The IMU, GPS Antennas, and the R2 Sonic sonar were mounted on the VOOP (see Figure 5). The top center of the IMU was chosen as the Reference Point (RP) in order to reduce offsets which would reduce error. The distance between the primary and secondary antennas was measured.

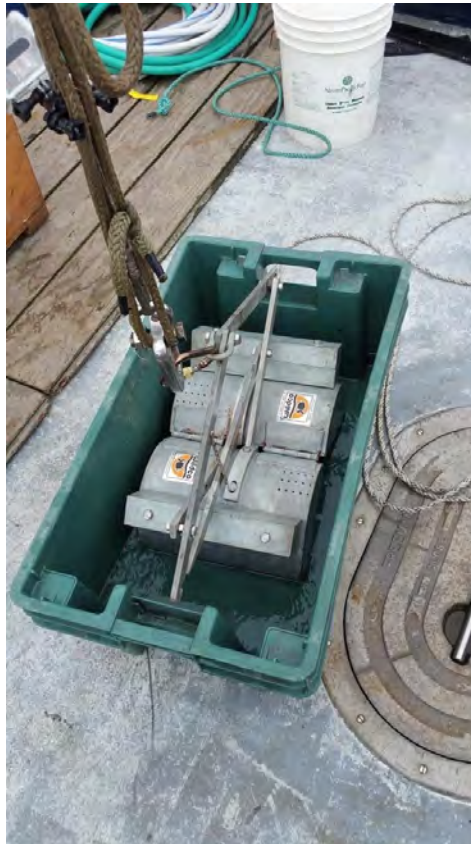
Figure 18 WILDCO Ponar Grab Sampler on Vessel Miss Alyssa

A WILDCO Ponar grab sample system was mobilized onto Miss Alyssa (see Figure 18). The sampler was deployed and retrieved via the onboard hydraulic winch. The IMU and GPS antennas that were used during multibeam acquisition remained mounted on the VOOP with the top center of the IMU as the Reference Point (RP). An offset from the vessel reference point to the winch was input and used to calculate the eventual, estimated sample position (see Table 5).

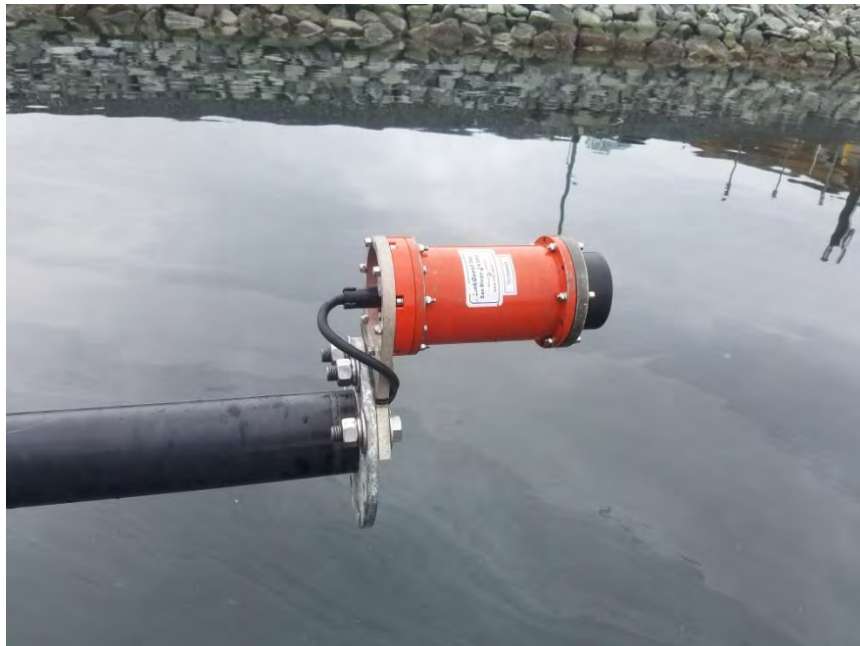
Figure 25 USBL Mounted on end of VOOP USM

A Link Quest 1500 was mobilized onto Miss Alyssa. The USBL was mounted onto the VOOP kit in place of the R2Sonic 2024. The IMU and GPS antennas remained mounted on the VOOP in their previous locations with the top center of the IMU chosen as the RP. An offset to the acoustic center and thus the reference point of the USBL was measured and used to position the system. Figure 25 below shows the USBL system mounted onto the VOOP USM set up. Table 7 lists the measured offsets for the USBL system from the vessel reference point.

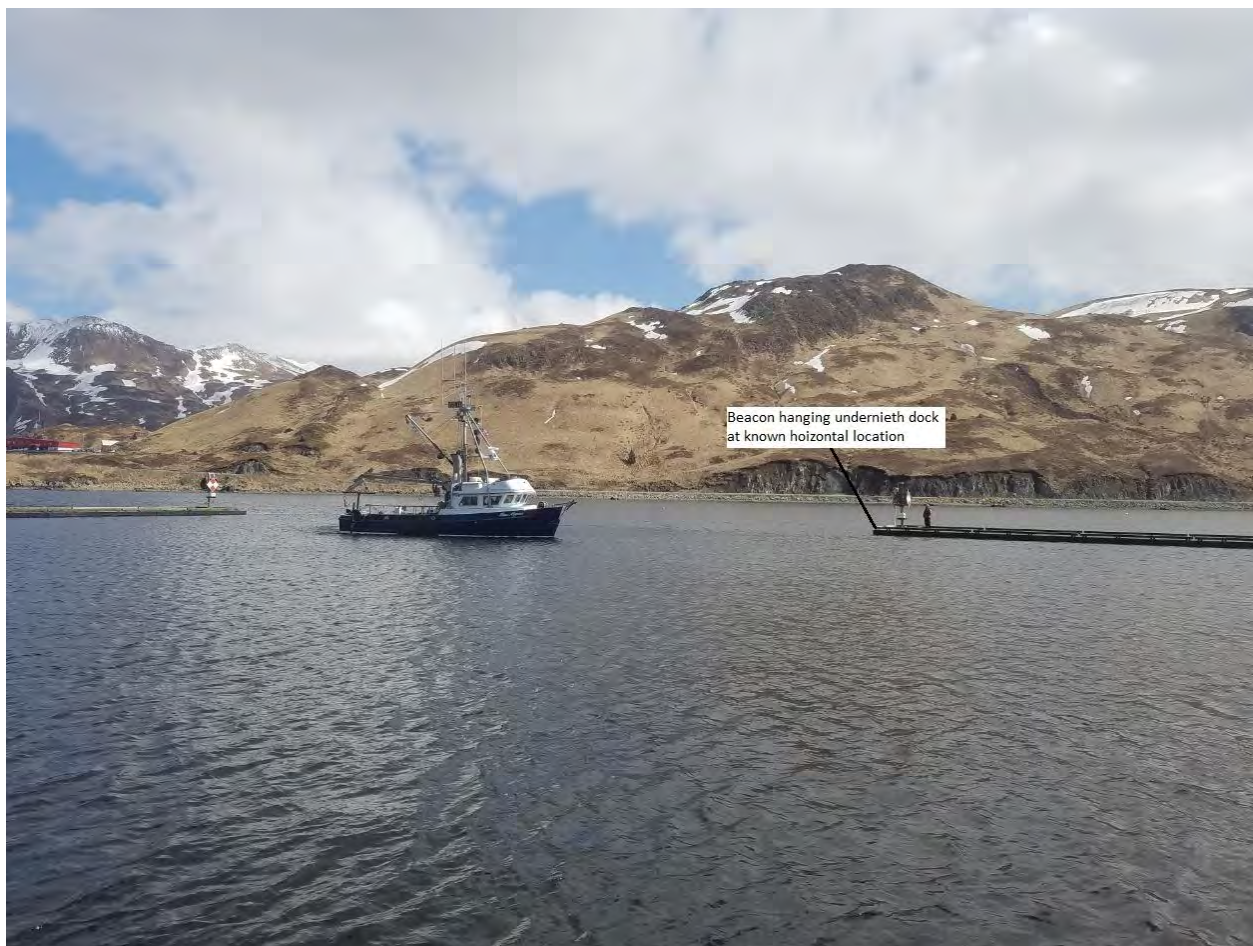
Figure 26 Vessel performing USBL Calibration

The USBL system was calibrated using the QINSy USBL calibration utility with two known positions. The beacon was set at a known horizontal location (edge of dock that was RTK shot with a rover). For each position Miss Alyssa maneuvered around and across the transponder beacon at different angles in the Omni or tracking transducer head pattern. Upon completion of the pattern, using the QINSy USBL calibration utility a least squares calibration was run. The known point was then added into the data to complete calibration.

A beacon was hung underneath a dock and a position taken for the beacon using an RTK rover. This became the known position for the USBL calibration. The edge of a floating dock was used (see Figure 26).

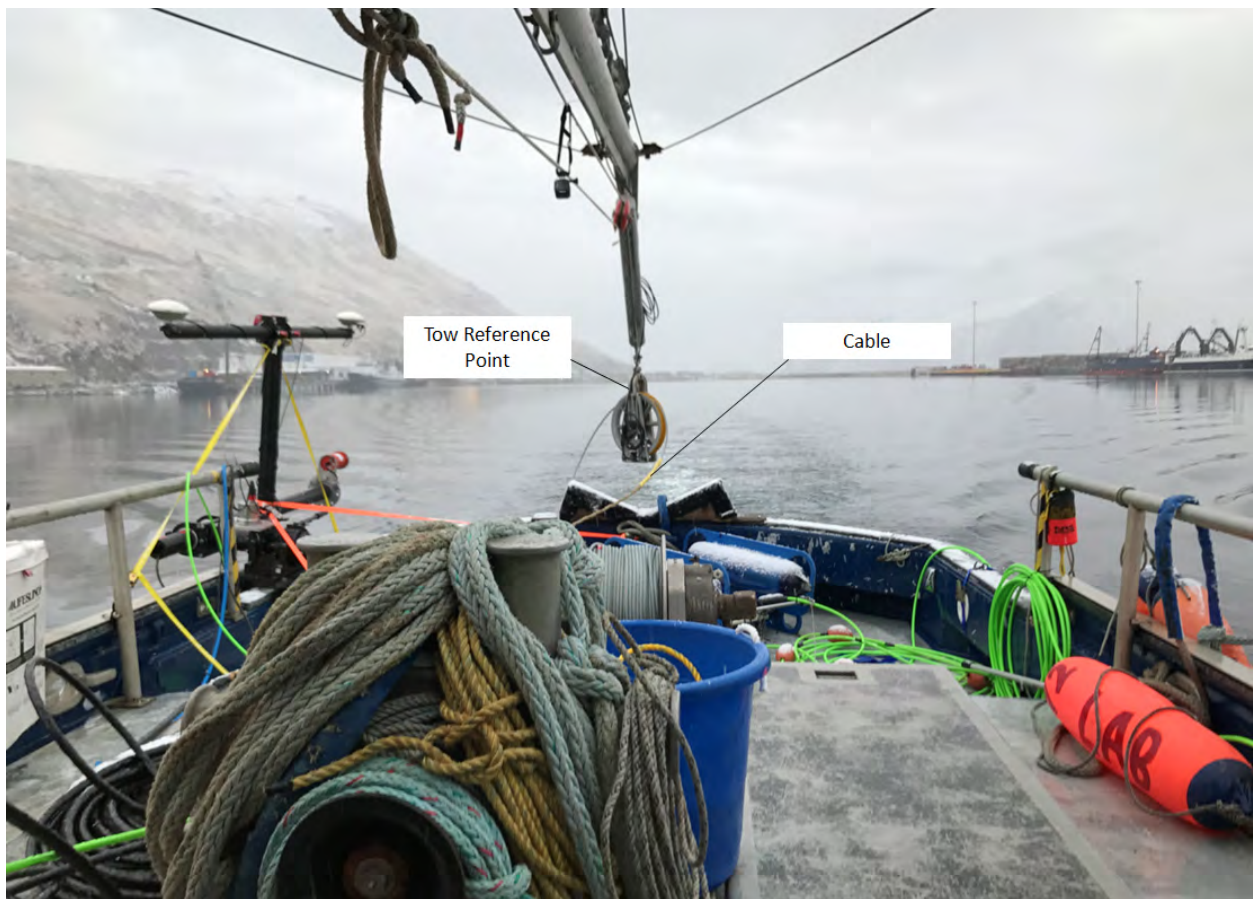
Figure 31 Tow Point for Cable Counter Reference Point

The cable counter was mobilized on the sheave of the winch. The system counts the number of rotations of the sheave in order to calculate the amount of cable let out. Using the depth of the fish below the water, the amount of cable out and the course over ground of the vessel, QINSy calculates the position of the fish behind the vessel. The IMU, GPS Antennas, and the USBL were mounted on the VOOP with the top center of the IMU chosen as the RP (see Figure 31). An offset to a selected towing point on the sheave was measured from the IMU RP (see Table 9).
