**Appendix B-1:
Geophysical Survey Report**

Unalaska (Dutch Harbor) Channels

**GEOPHYSICAL SURVEY REPORT
CHANNEL NAVIGATION IMPROVEMENTS
FEASIBILITY STUDY, DUTCH HARBOR, ALASKA**

CHANNEL NAVIGATION IMPROVEMENTS FEASIBILITY STUDY DUTCH HARBOR, ALASKA

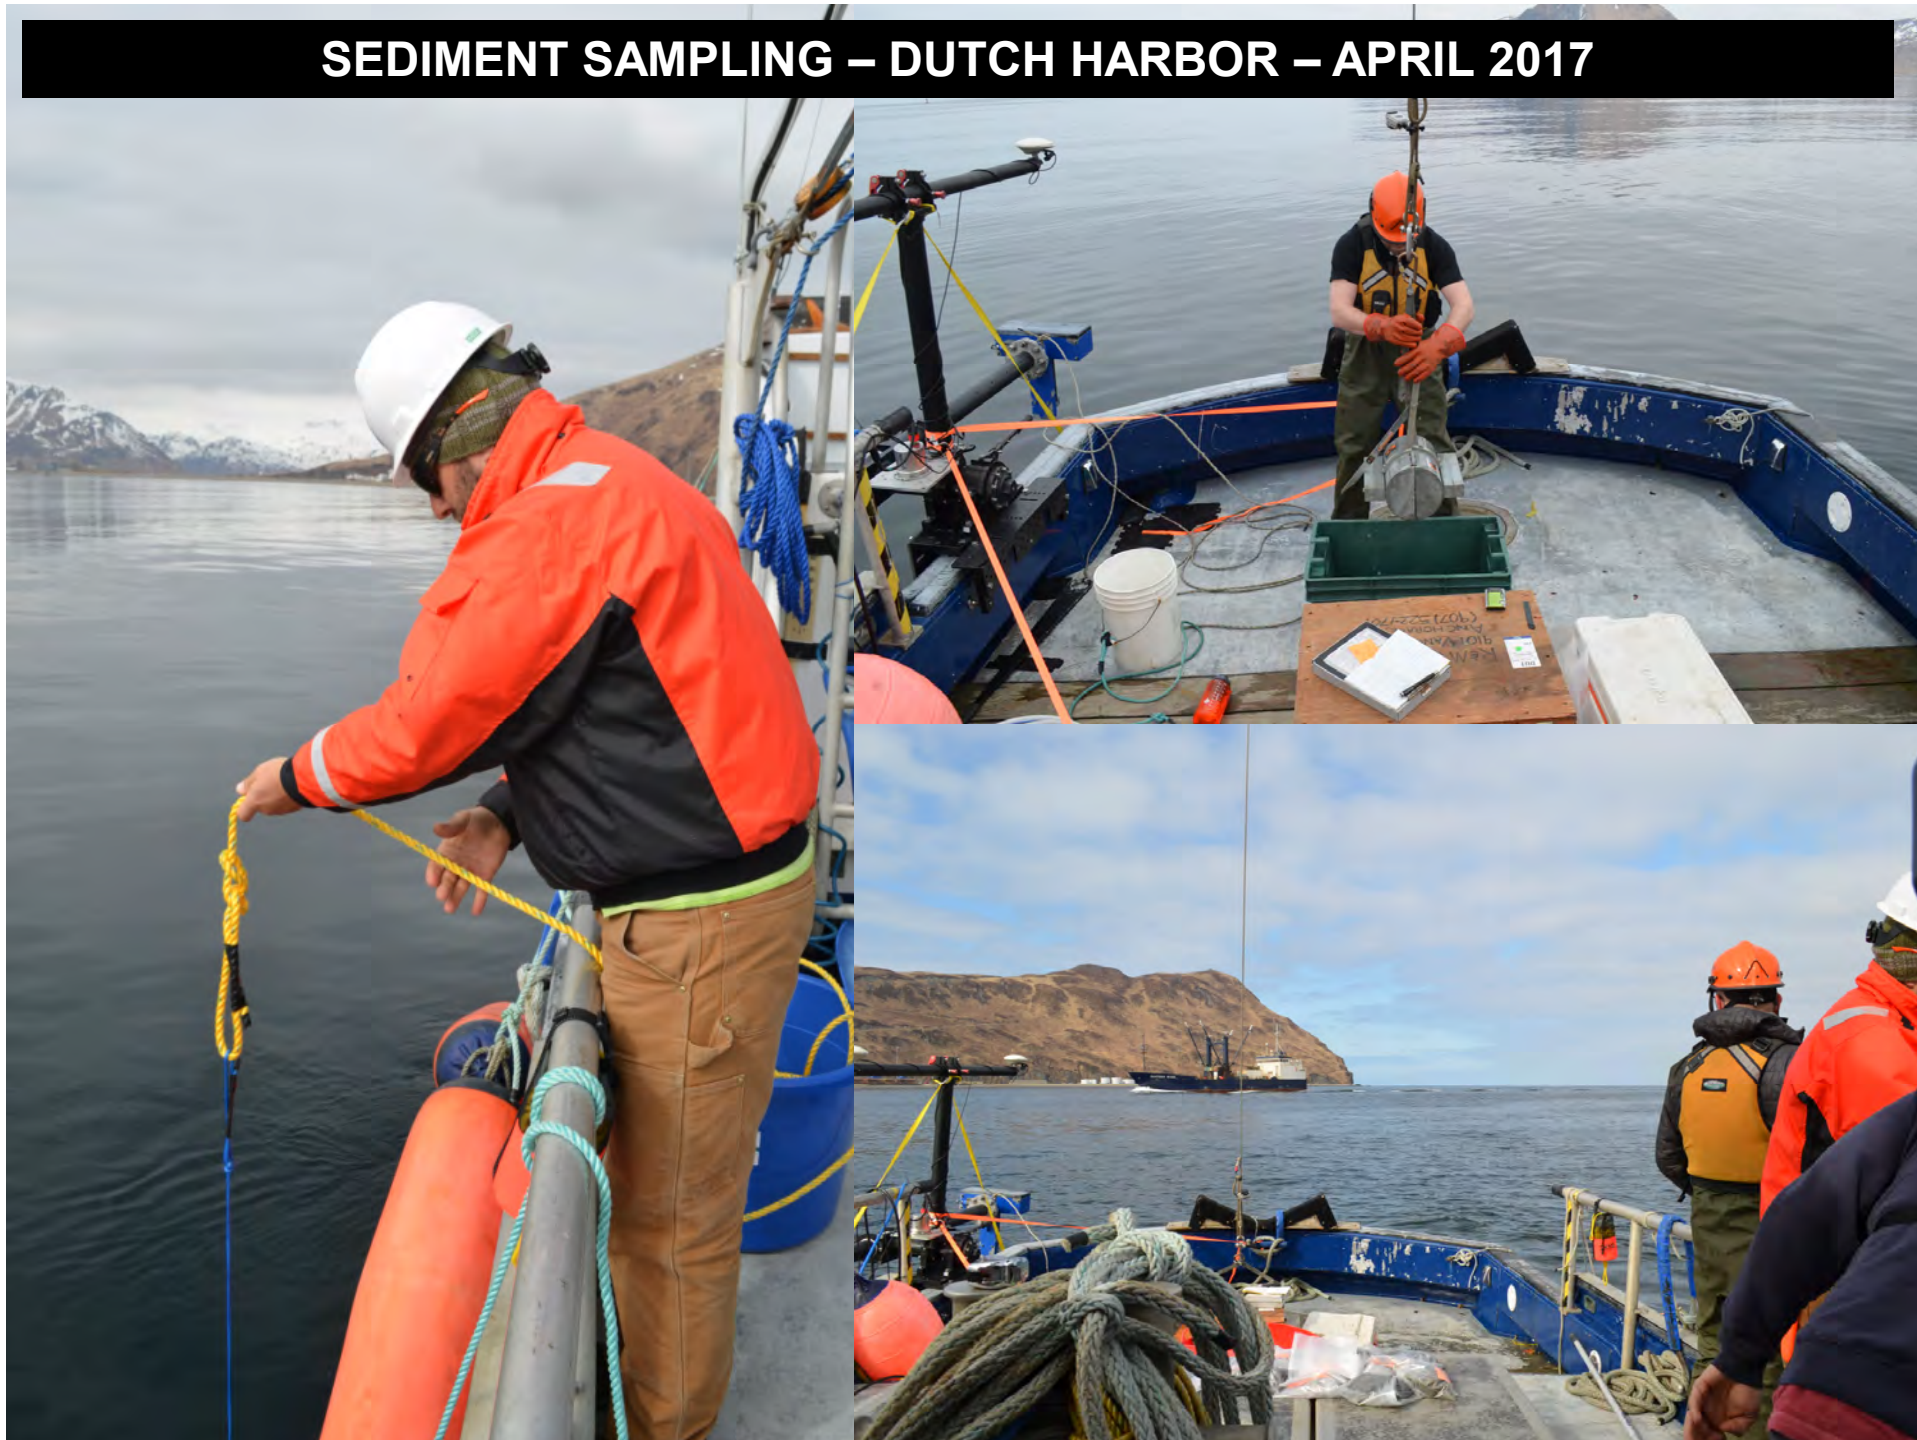
SEDIMENT SAMPLING – DUTCH HARBOR – APRIL 2017

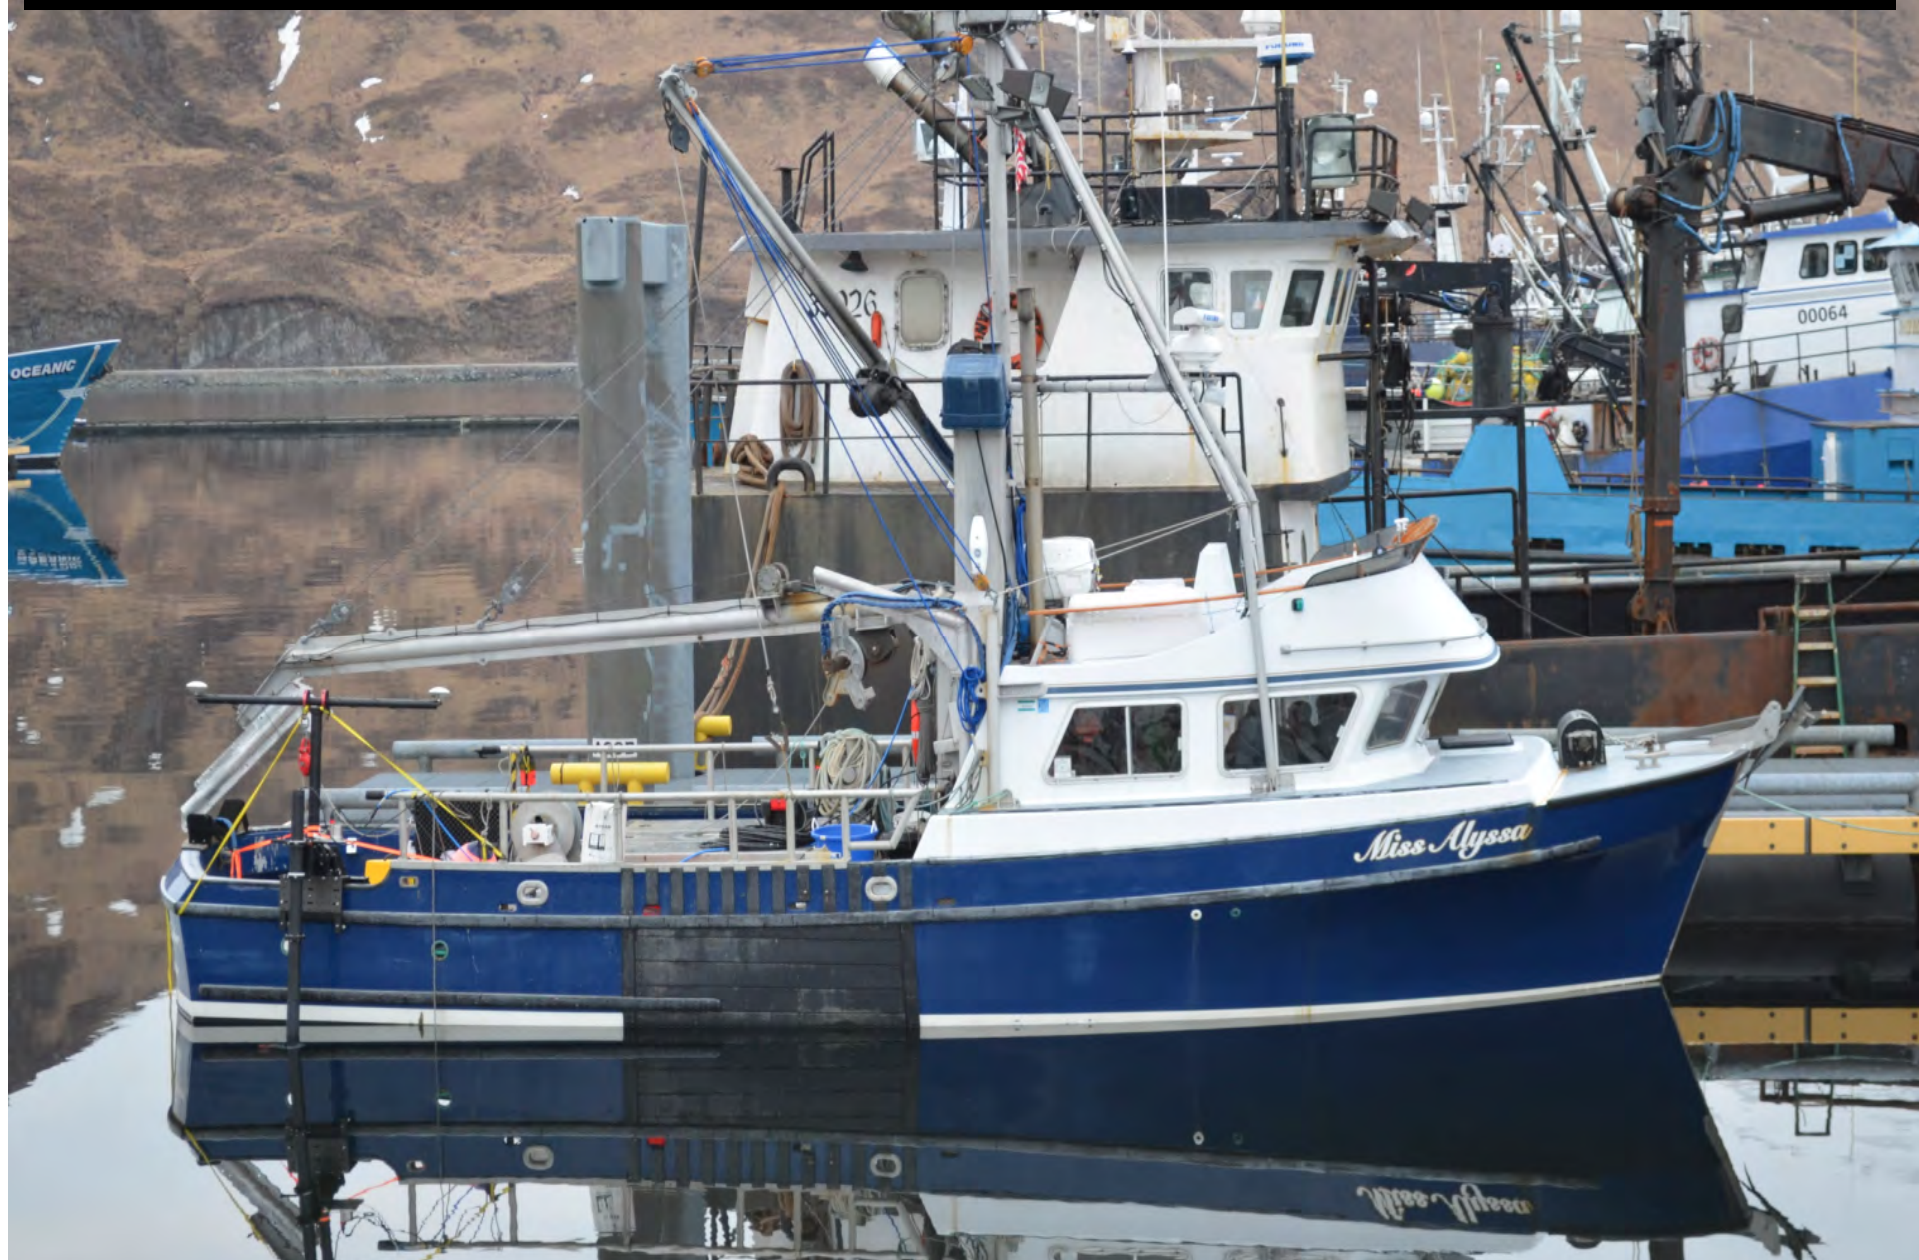
SURVEY VESSEL

MULTIBEAM OPERATIONS – DUTCH HARBOR – APRIL 2017

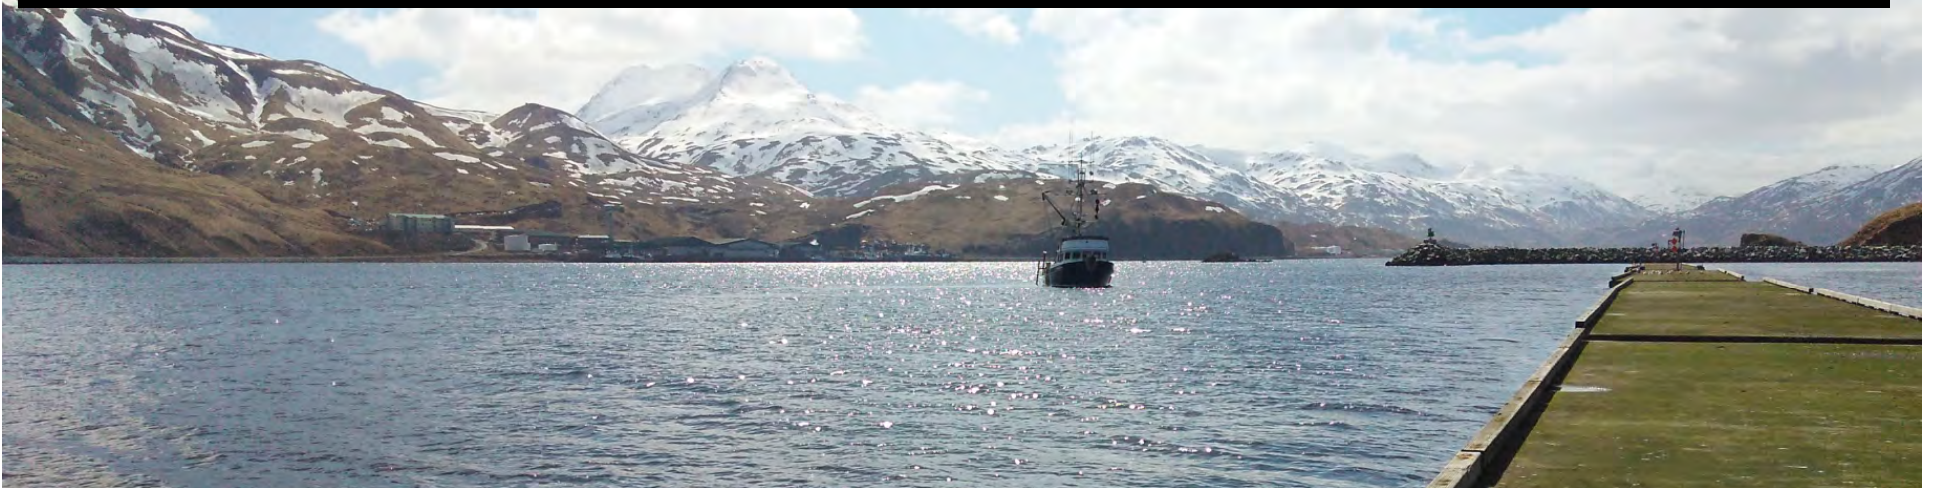
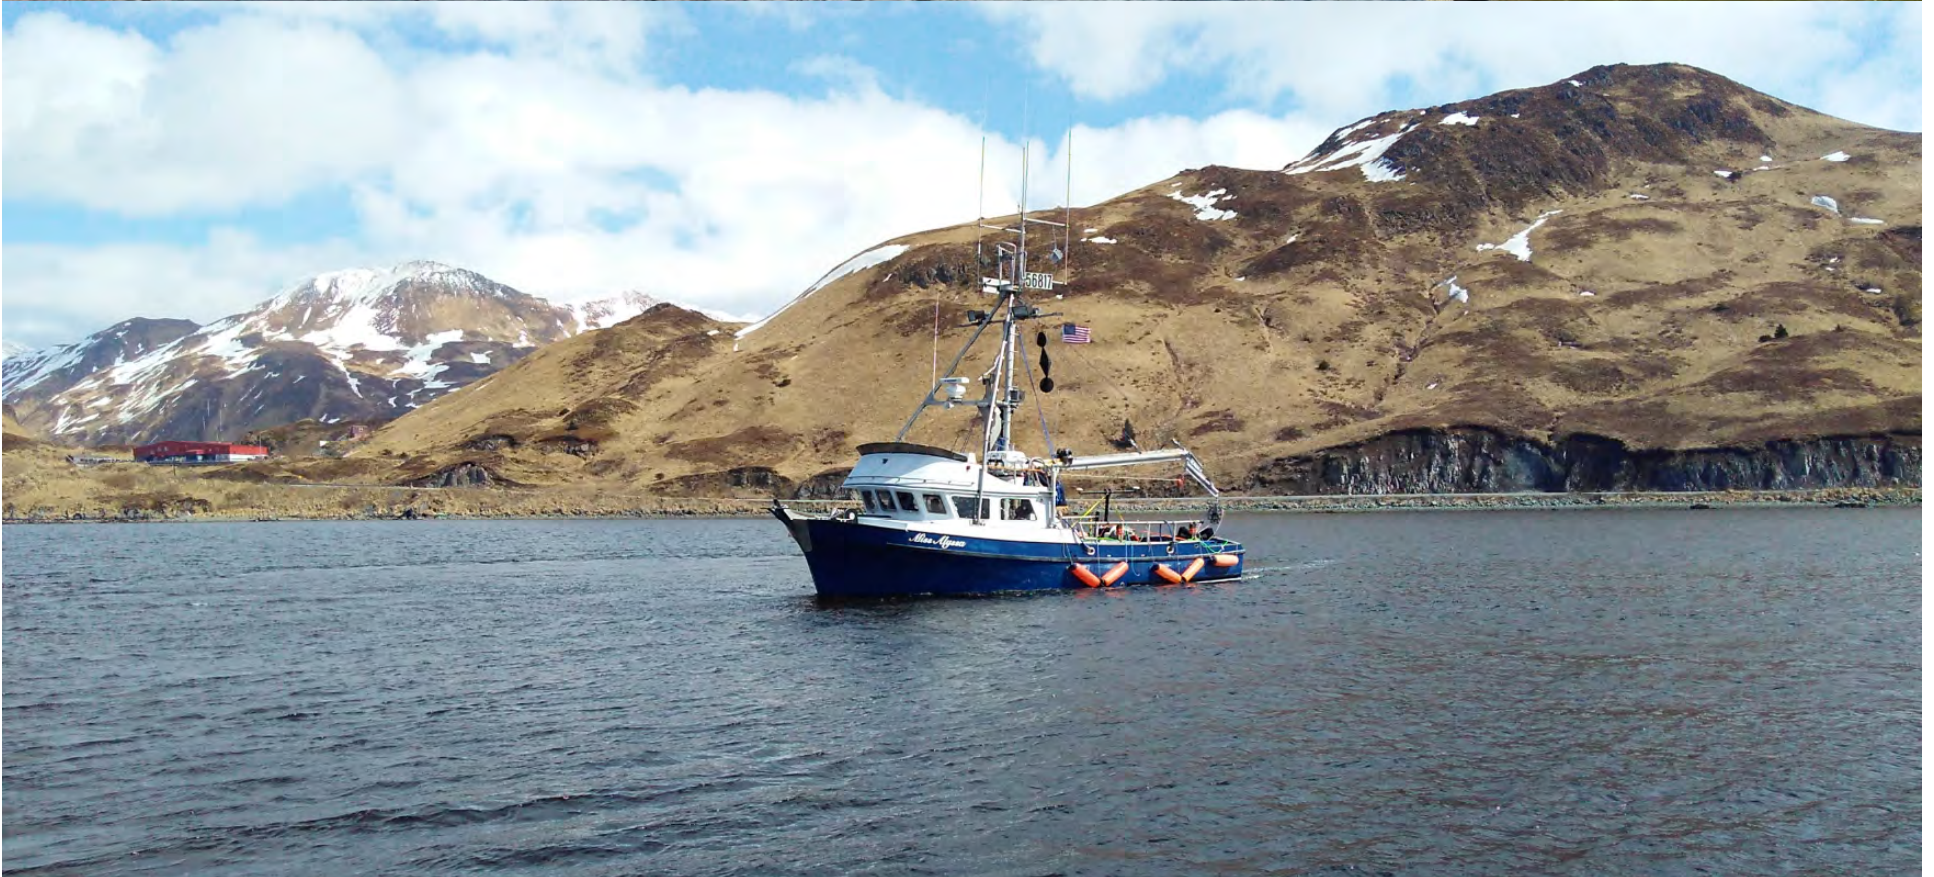
USBL CALIBRATIONS – DUTCH HARBOR – APRIL 2017

A cable out of 38 m with a percentage cable out catenary factor of 85% was found to give the most consistent positioning for the system.

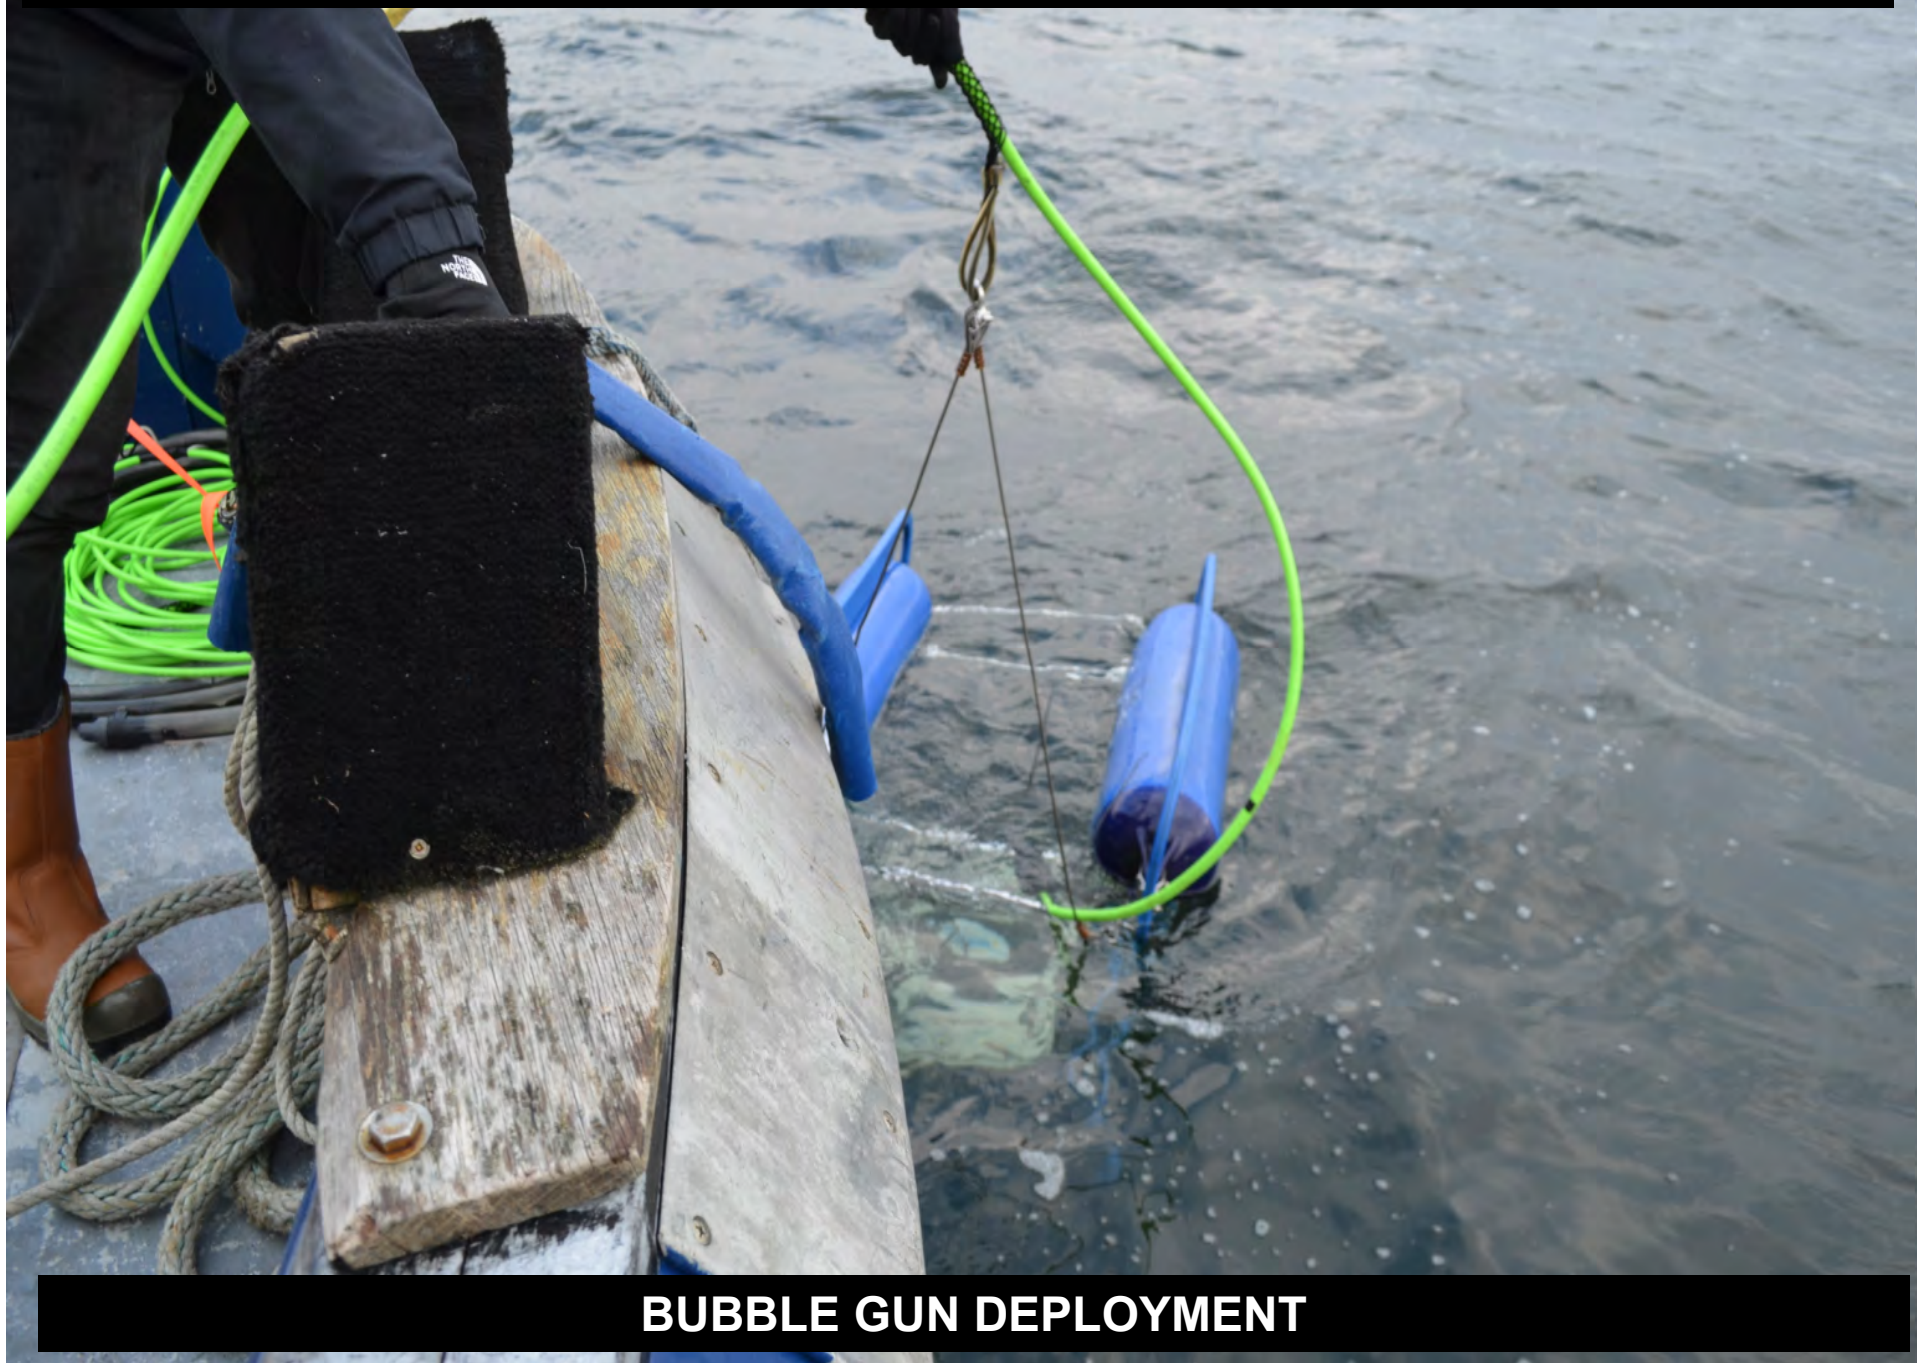
SUBBOTTOM PROFILER OPERATIONS – DUTCH HARBOR – APRIL 2017

BUBBLE GUN DEPLOYMENT

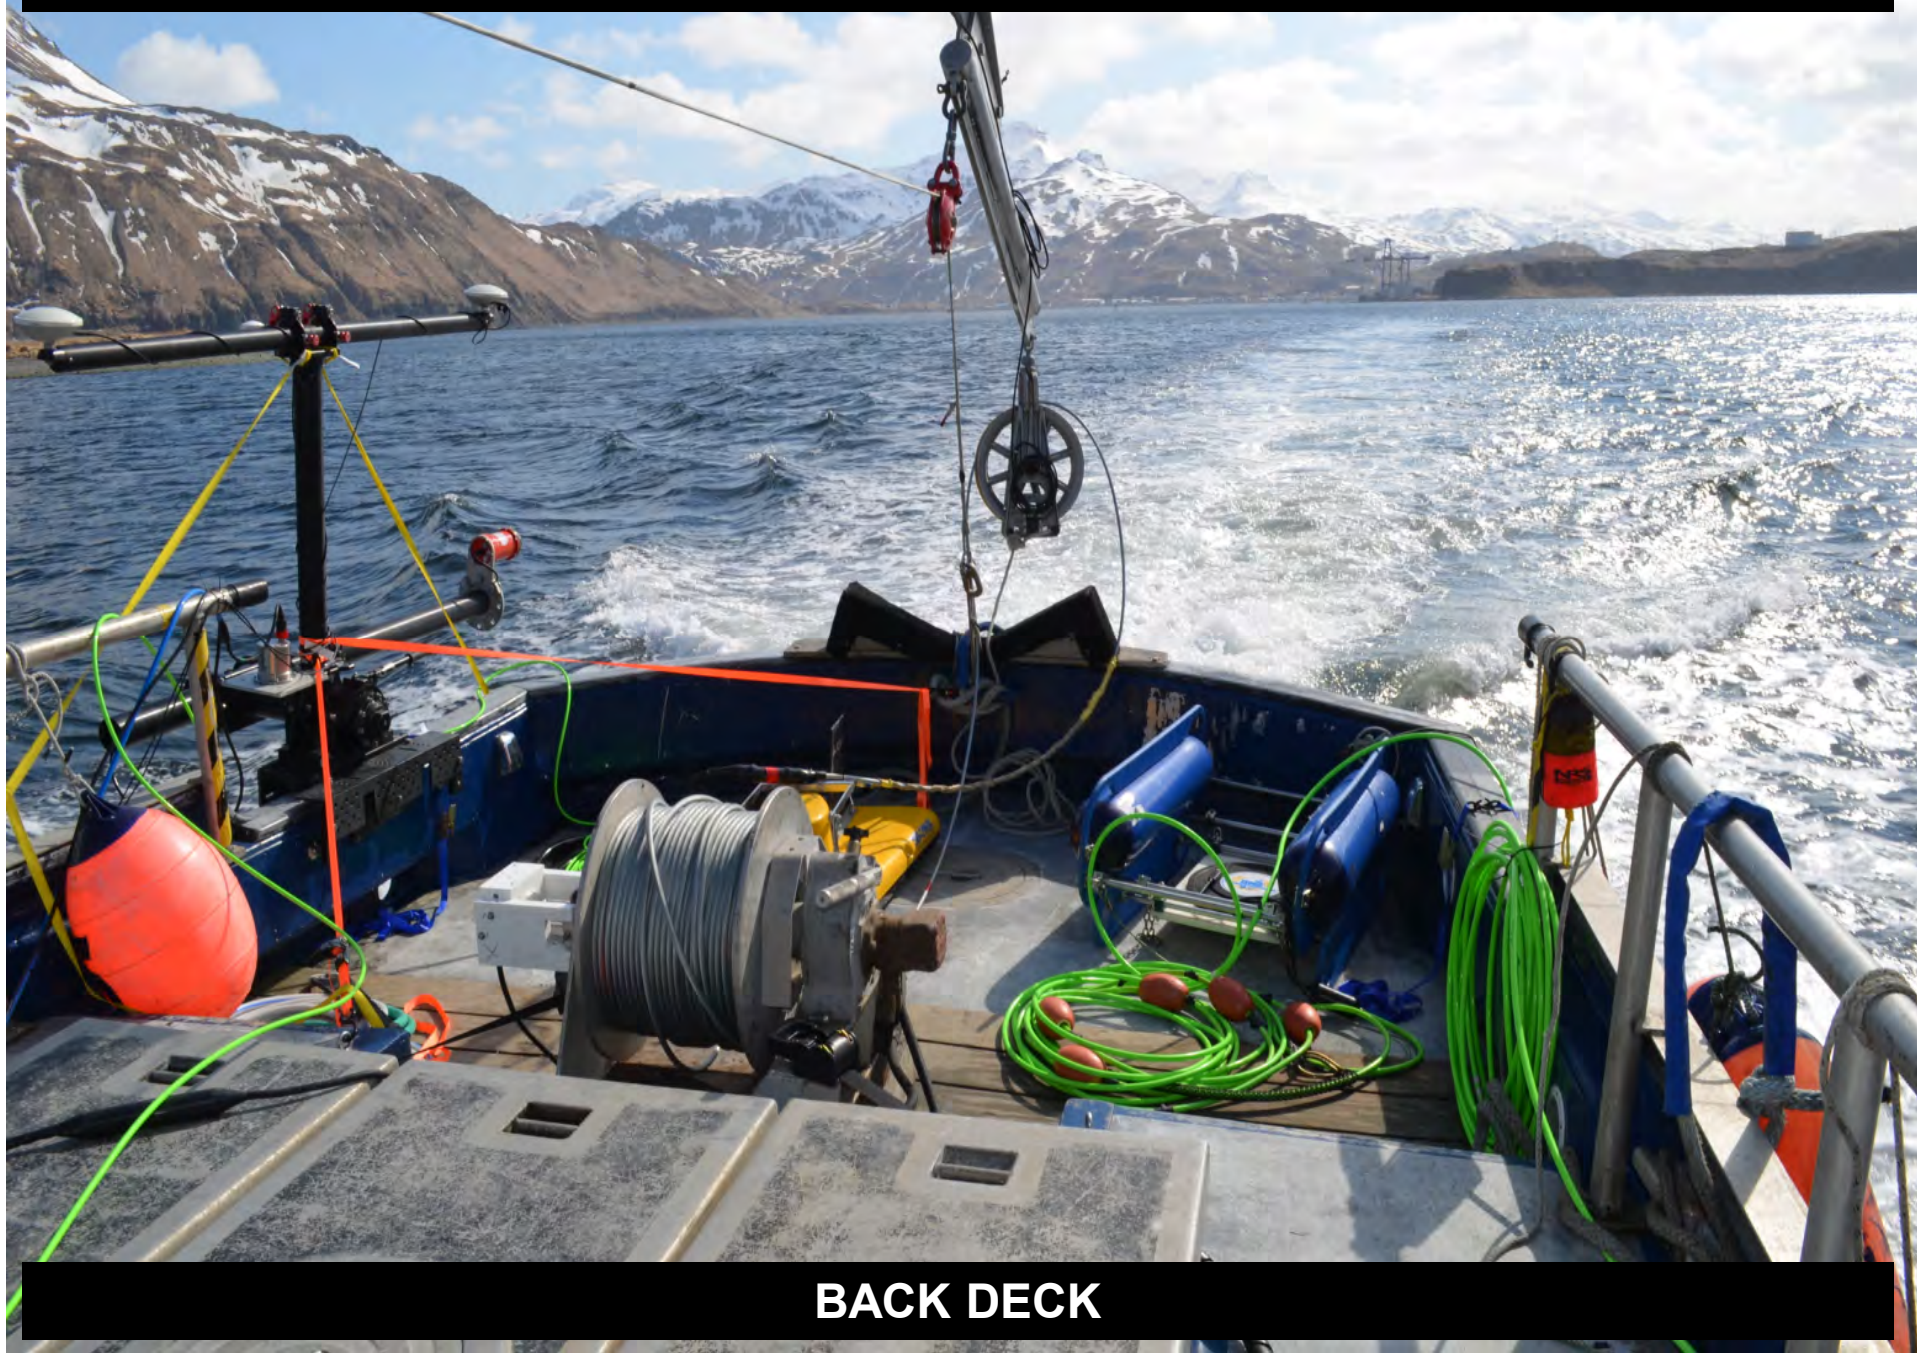
SUBBOTTOM PROFILER OPERATIONS – DUTCH HARBOR – APRIL 2017

BACK DECK

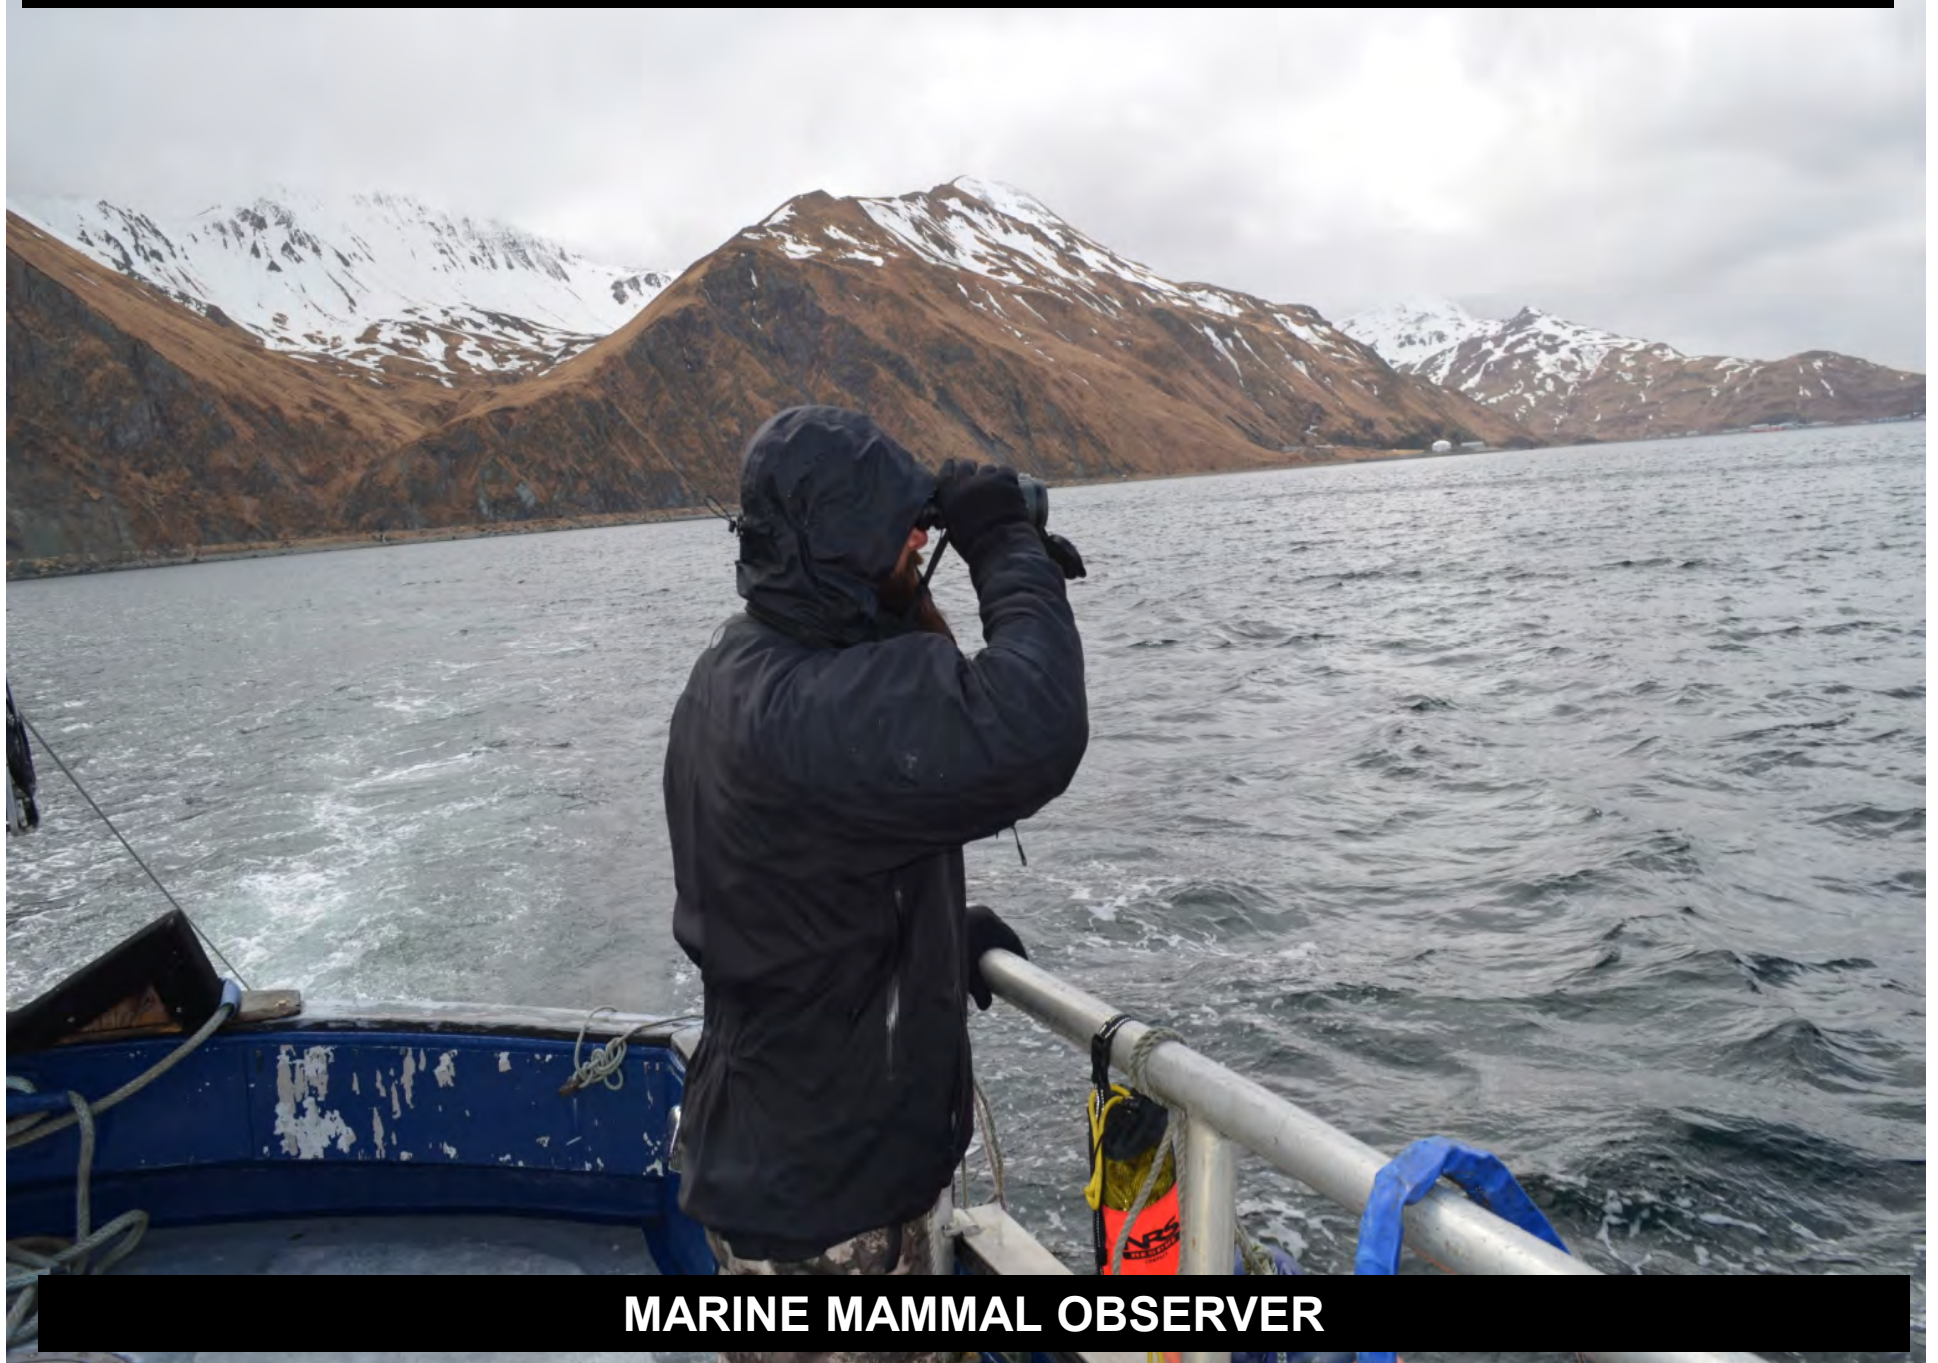
SUBBOTTOM PROFILER OPERATIONS – DUTCH HARBOR – APRIL 2017

MARINE MAMMAL OBSERVER

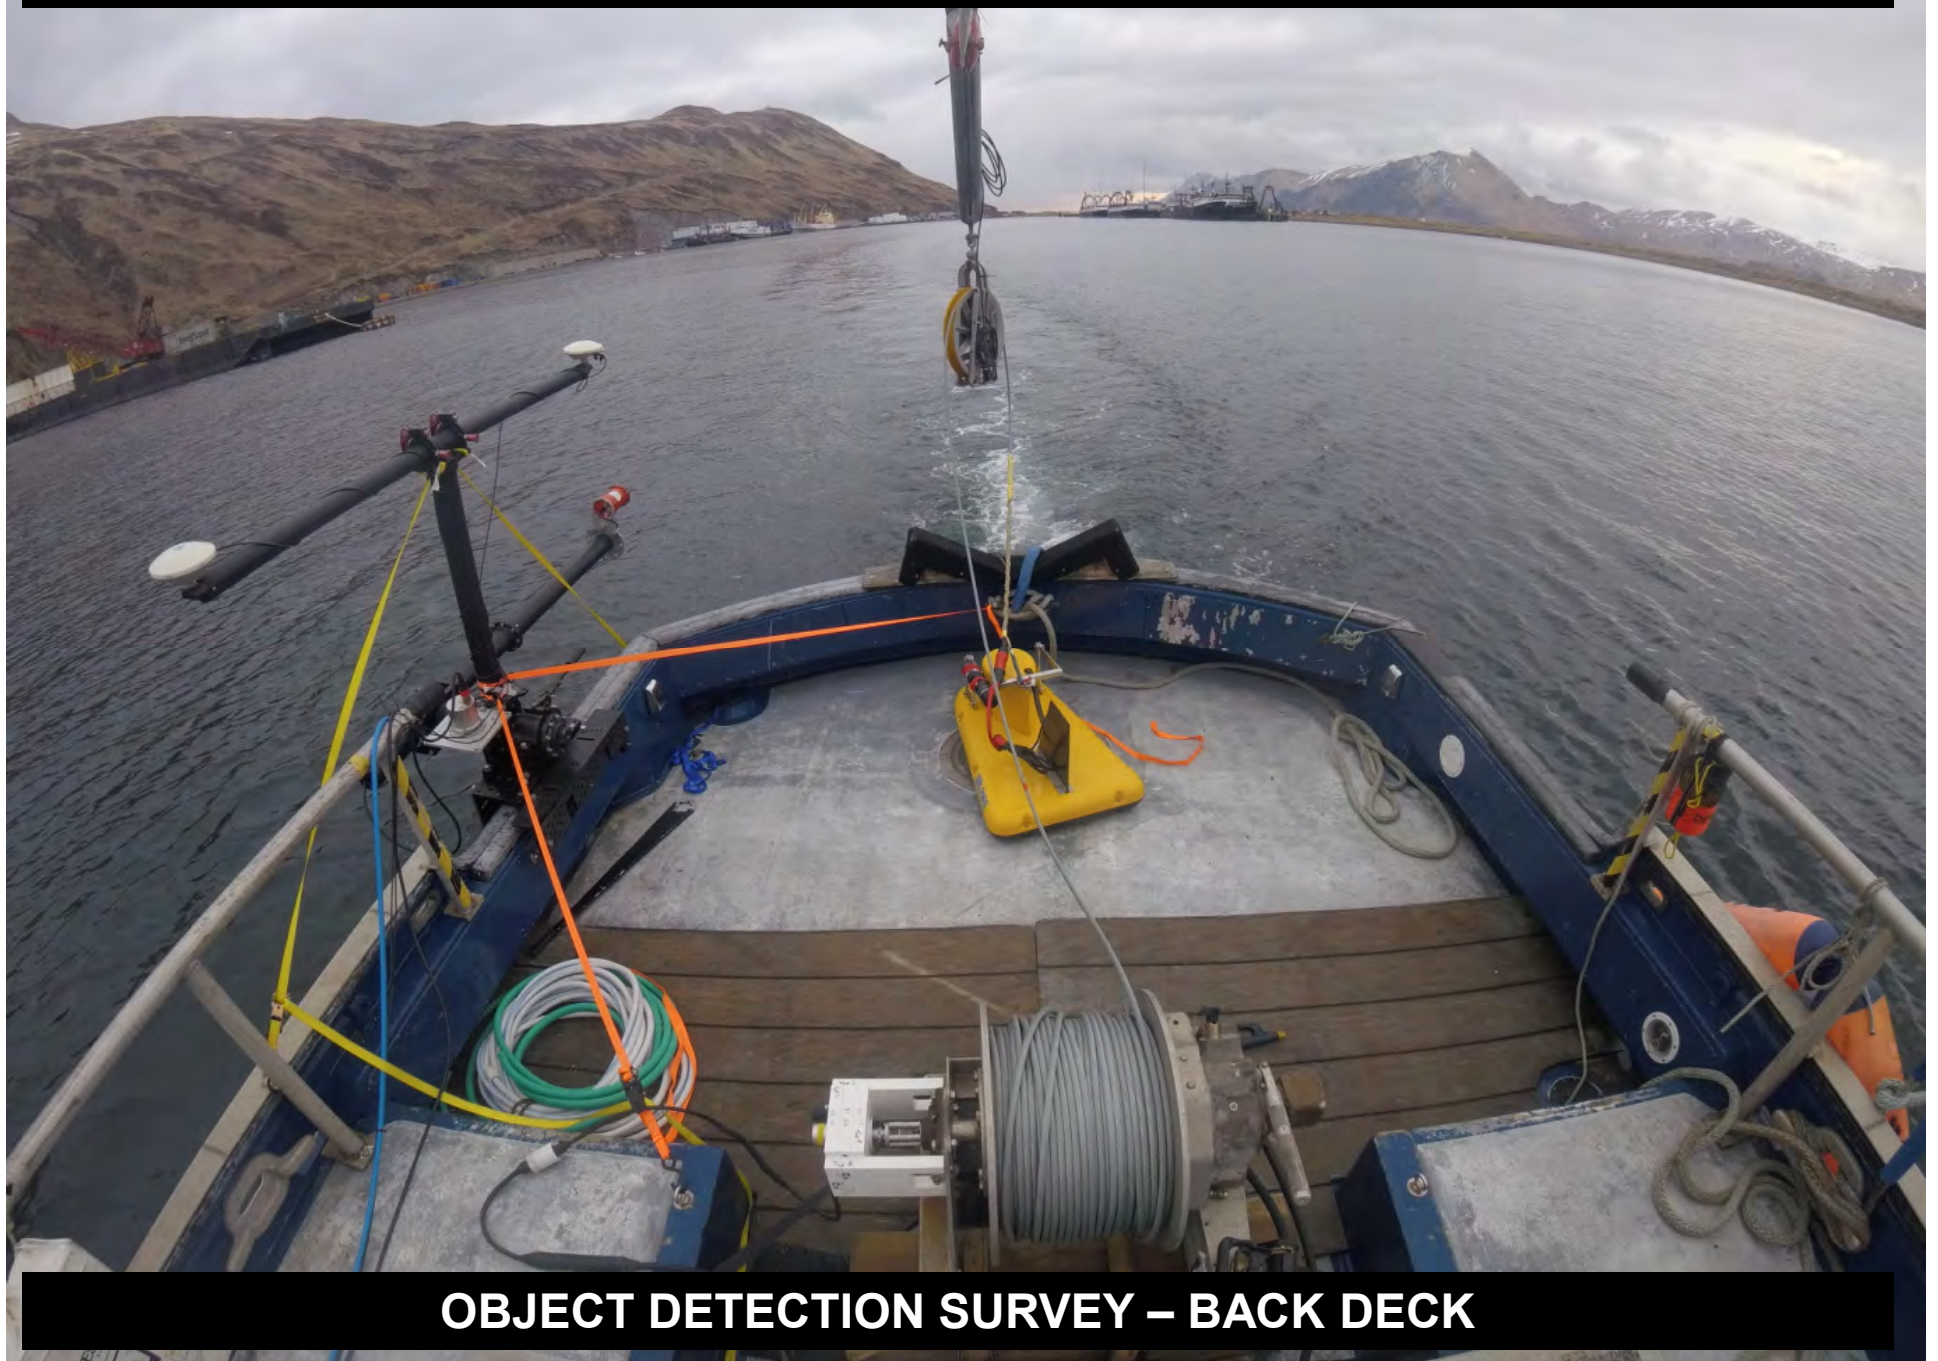
SUBBOTTOM PROFILER OPERATIONS – DUTCH HARBOR – APRIL 2017

OBJECT DETECTION SURVEY – BACK DECK
