Condition of Improvements 31 December 2019 **Talkeetna River, Alaska** (CWIS No. 072746)

Authorization Flood Control Act, 3 July 1958 (House Doc. 34, 85th Congress, 1st Session) as adopted, provides for bank protection by rip-rapping 1,660 feet of river bank downstream from the Alaska Railroad bridge and for construction of an armor rock dike 1,200 feet in length to divert river flow from the bank.

Talkeetna River, Alaska

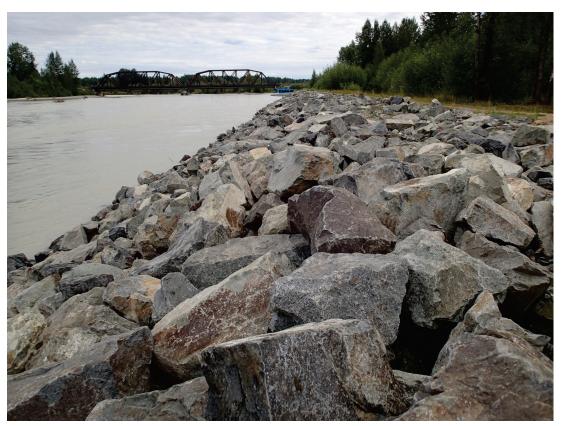
Upstream view of the rock revetment and the railroad bridge, August 2019

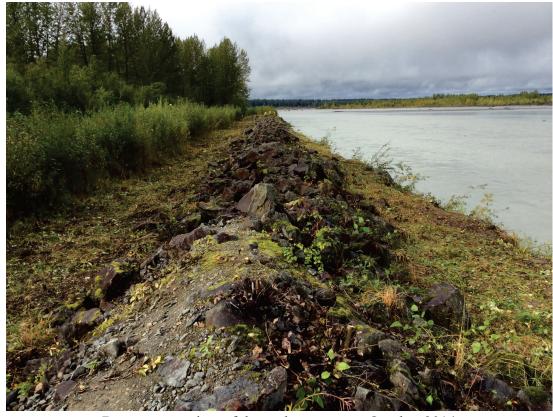
Downstream view of the rock revetment, October 2014

2013	Inspection performed in July notes heavy vegetation growth and damage to facine pilings.
2014	Inspection performed in August notes vegetation removal in progress and active erosion along the entire length of the dike. Armor stone repairs with a weighted toe were recommended.
2017	Inspection performed in September notes no significant change from the previous inspection of dike and revetment. Community repaired dike extension to original extents using the original rock specifications.
2018	Inspection performed in June notes active erosion at end of dike extension repair and scalloping of dike extension at water line. No significant changes in dike and revetment from previous inspection
2019	Inspection performed in August notes movement of armor rock along dike due to boats tying up along dike to bolted D-rings into armor rock, increased erosion at the end of the dike extension repair, and erosion at the toe of the revetment bend. Vegetation had been removed from the crest of the revetment. It was recommended that boat moorage be prohibited along the dike and armor stone repairs performed.
