# **GEOTECHNICAL FINDINGS REPORT**

**Anchorage Harbor Deepening**  
**Port of Anchorage, Alaska**

**June 2008**

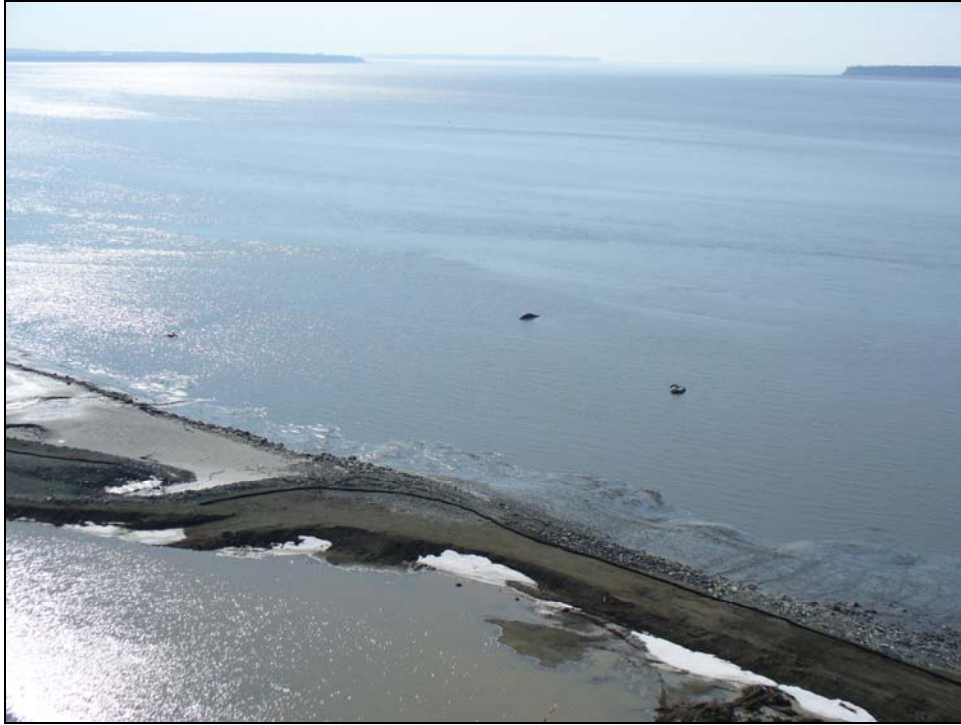
Photograph 3: View of three large boulders during a -0.6 feet MLLW tide just offshore in the northern dredge area.

Large boulders, greater than 10 feet in diameter, are visible on the mudflats at low tide near the edge of the northern dredge area. An example of these boulders can be seen in Photograph 3. This indicates that large boulders are present within the end-moraine deposits of glacial till and outwash-stream deposits which are located in the proposed dredge area.

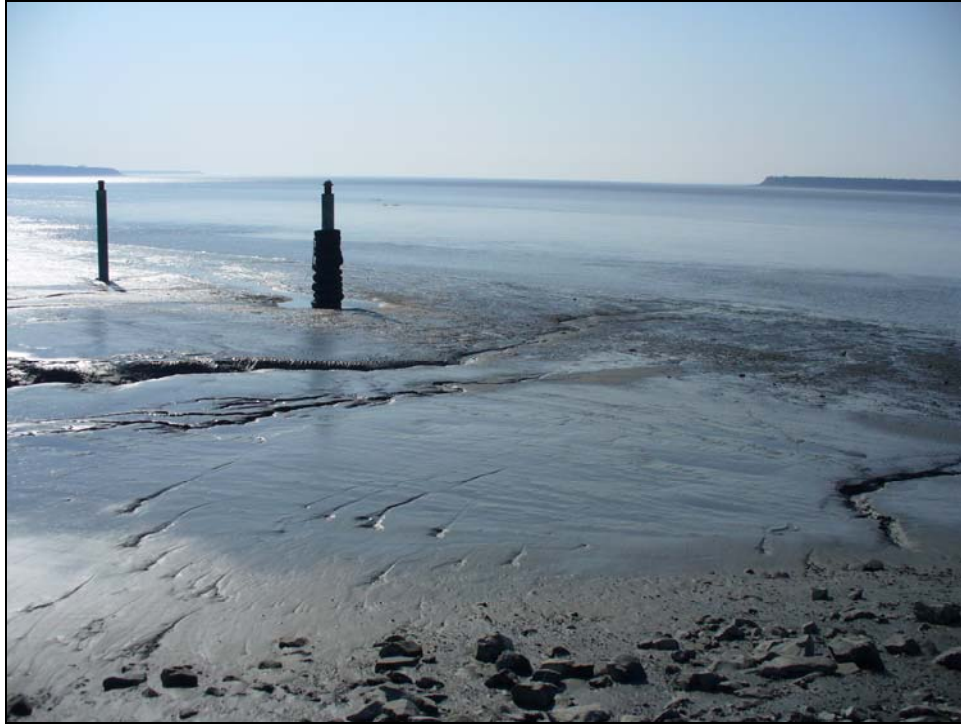
Photograph 4: View looking southwest during a -0.6 feet MLLW tide in the southern dredge area.

The bathymetry of the southern dredge area shows the mudline surface elevations range from five to greater than -45 feet MLLW. This area gently slopes seaward, becoming steeper near the existing dredge boundary. The ground surface, visually seen within the tidal zone, is covered primarily with fine-grained soils with local areas of sand and gravel. Drilling resistance and drill cuttings viewed on the barge deck indicated similar soil conditions at the mudline in the subtidal zones. An example of these soil conditions and potential dredging obstruction numbers “T20” and “T22” can be seen in photograph 4.

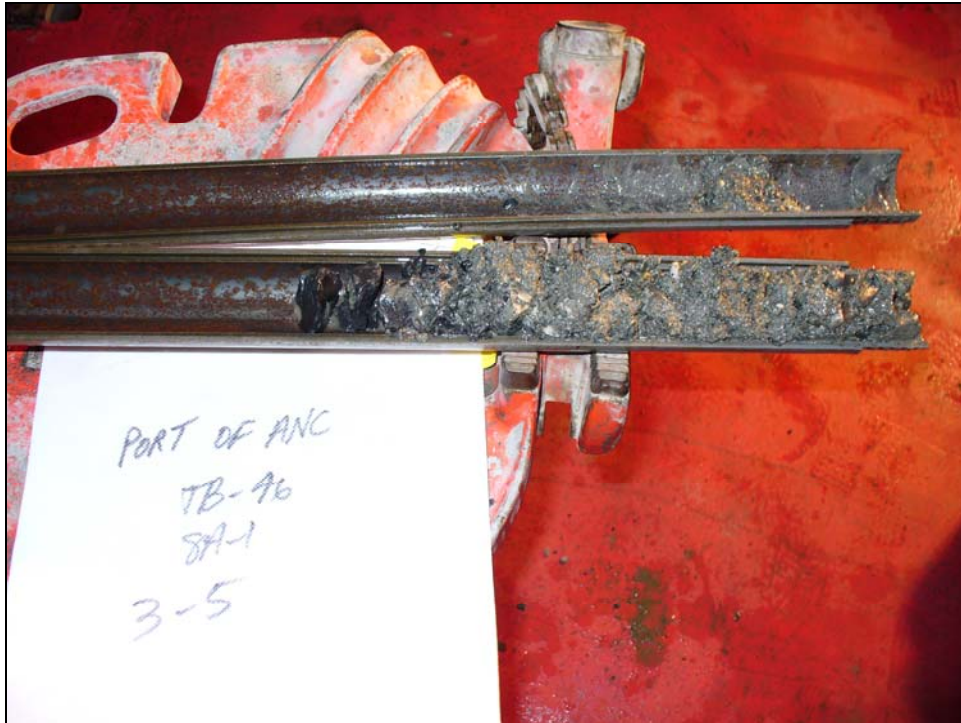
Photograph 5: Sample from test boring AP-4628 taken between 3.0 and 5.0 feet below the mudline.

The subsurface soils in the northern dredge area vary significantly in composition. Generally, end-moraine deposits of glacial till and outwash-stream deposits were found overlying estuarine or lacustrine deposits to the limits of exploration. The glacial till and outwash-stream deposits consisted of sands or gravels with silt or clay and cobbles (SP, SP-SM, SP-SC, SM, SC, GW, GP, GW-GM, GP-GM, GP-GC, GM, GC). This coarse-grained soil unit extended from the mudline to a depth ranging from 2.5 feet to the limits of exploration. Some test borings did not encounter this coarse-grained soil unit near the southern portion of the area. Laboratory results indicate the fines content in these coarse-grained deposits range from four to 49 percent, and a visual-manual description of the soils plasticity range from nonplastic to medium plasticity. Atterberg Limit test results reported on one sample had a liquid limit of 25 percent and a plasticity index of eight. Photograph 5 shows a sample of this coarse-grained soil unit encountered during our exploration.

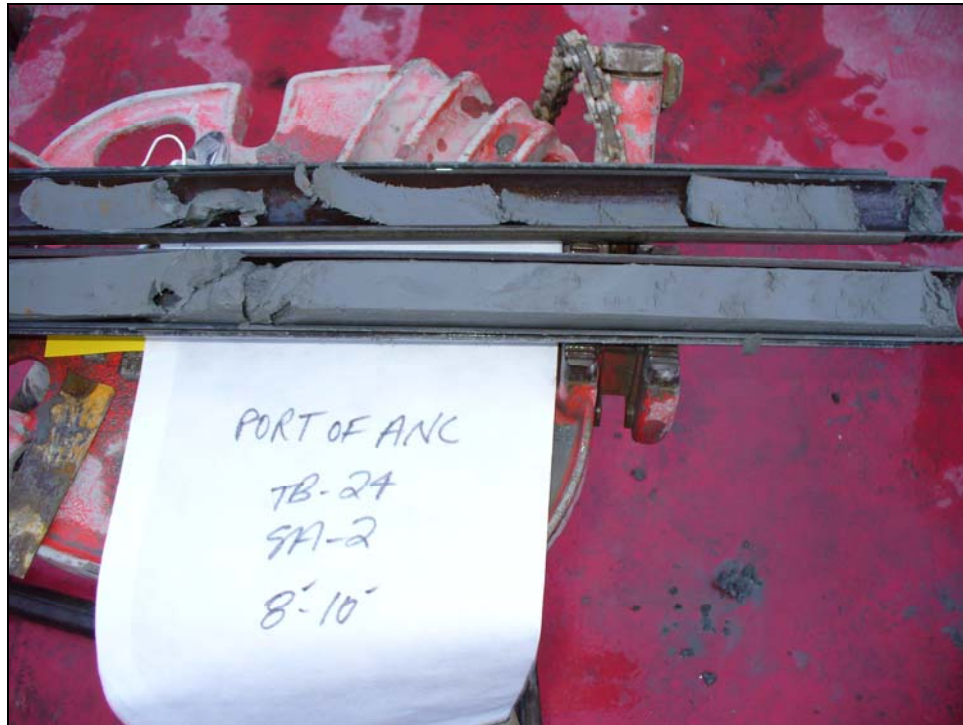
Photograph 6: Sample from test boring AP-4606 taken between 8.0 and 10.0 feet below the mudline.

Below the glacial till and outwash-stream deposits or at the mudline, estuarine or lacustrine deposits consisting of clay and silt with sand and gravel (CL, ML) were encountered to the limits of exploration. Laboratory results indicate the fines content in these deposits range from 80 to 89 percent, moisture contents range from 20 to 36 percent, and a visual-manual description of the soils plasticity range from nonplastic to medium plasticity. Atterberg Limit test results indicate liquid limits range from 21 to 39 percent and plasticity indexes range from nonplastic to 18 percent. Blow counts indicate the consistency of these fine-grained soils range from firm to hard and the unconfined compressive strength approximated by the pocket penetrometer range from 2.0

to greater than 4.5 tons per square foot. Photograph 6 shows a typical sample of these fine-grained soils encountered during our exploration.

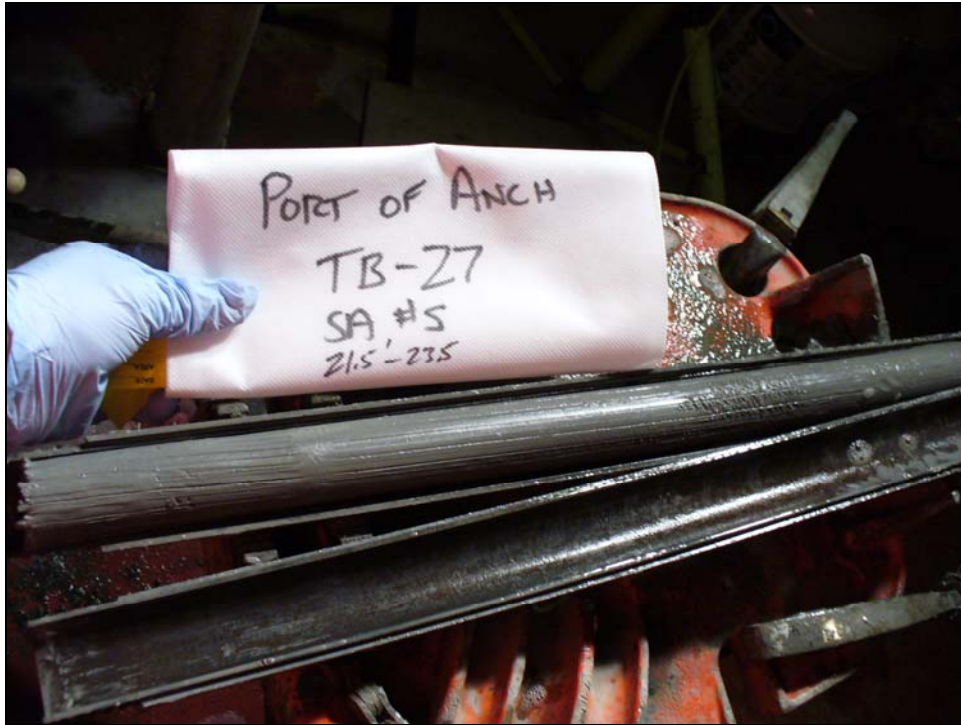
Photograph 9: Sample from test boring AP-4609 taken between 21.5 and 23.5 feet below the mudline.

Below the fluvial deposits, estuarine or lacustrine deposits consisting of clay and silt (CL, ML) were encountered to the limits of exploration. Laboratory results indicate moisture contents range from 23 to 43 percent, and a visual-manual description of the soils plasticity range from nonplastic to medium plasticity. Atterberg Limit test results indicate liquid limits range from 31 to 40 percent and plasticity indexes range from 11 to 18 percent. Blow counts indicated the consistency of these fine-grained soils range from very soft to firm and the unconfined compressive strength approximated by the pocket penetrometer range from 0.5 to 1.25 tons per square foot. Field vane shear testing indicated the undrained shear strengths range from 0.597 to 1.945 kips per square foot (kip/ft<sup>2</sup>), remolded undrained shear strengths range from 0.158 to 0.714 kip/ft<sup>2</sup> and a sensitivity range from 1.8 to 4.3. Photograph 9 shows a sample of this soil unit encountered during our exploration.
