PROSPECTUS for TRILLIUM MITIGATION BANK

El Capitan Passage, North Prince of Wales Island, SE Alaska

March 2014

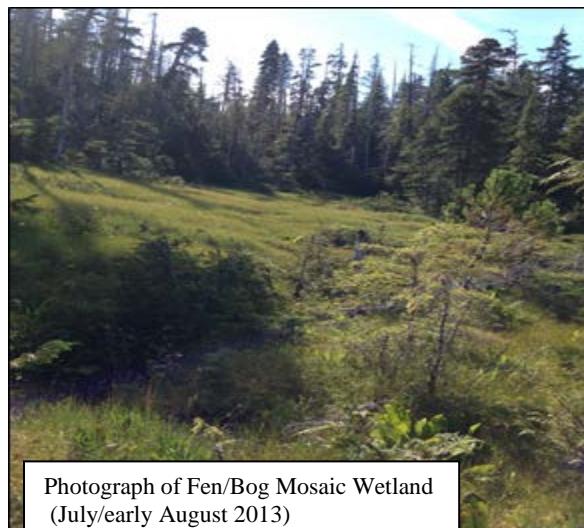
Fen/Bog Mosaic wetlands occur within the upper elevations of the western portion of the Bank site (Appendix A Figure 2). Soils within the fens occurring within the Fen/Bog Mosaic are saturated organic peat soils primarily vegetated with emergent herbaceous obligate wetland (OBL) and facultative wetland (FACW) species such as skunk cabbage (*Lysichiton americanus*, OBL), water sedge (*Carex aquatilis*, OBL), several-flowered sedge/many-flowered sedge (*Carex pluriflora*, OBL), and Grass of Parnassus (*Parnassia fimbriata*, FACW) growing amongst various species of grasses and sphagnum mosses.

Soils within the bogs occurring within the Fen/Bog Mosaic are saturated organic peat soils primarily vegetated with stunted trees that comprise one Cowardin vegetation class, scrub-shrub. The scrub-shrub bogs occurring within the Fen/Bog Mosaic are vegetated with facultative (FAC) tree species such as western hemlock (*Tsuga heterophylla*, FAC), Alaska cedar (*Callitropsis nootkatensis*, FAC), shore pine (*Pinus contorta*, FAC), and facultative upland (FACU) shrub species such as rusty menziesia (*Menziesia ferruginea*, FACU). Green false hellebore (*Veratrum viride*, FAC) and obligate wetland species such skunk cabbage and deer cabbage (*Nephrophyllidium crista-galli*, OBL) occur within the herbaceous stratum along with various species of sphagnum moss.

Photograph of Fen/Bog Mosaic Wetland
(July/early August 2013)

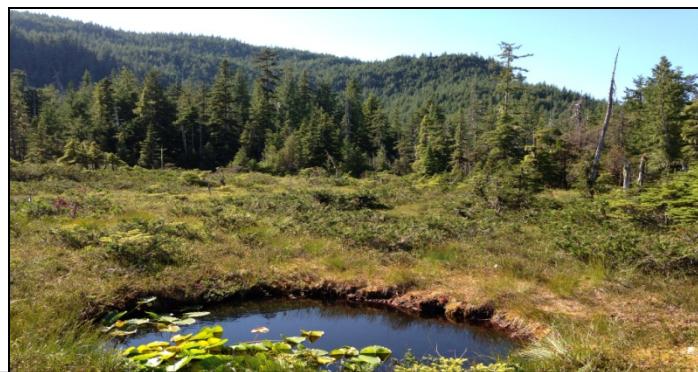
Photograph of Bog Wetland (July/early August 2013)

FS Road 15 runs through a transition zone between the Bog Wetlands upslope to the west and Forested Wetlands downslope to the east. Fill from the road fill cuts off hydrological connections between the wetlands and has disturbed hydrological regimes within the downslope Forested Wetlands. A series of culverts within FS Road 15 is proposed to hydraulically reconnect the Bog and Forested Wetlands and rehabilitate hydrological regimes within the downslope Forested Wetlands (Appendix A Figure 3).

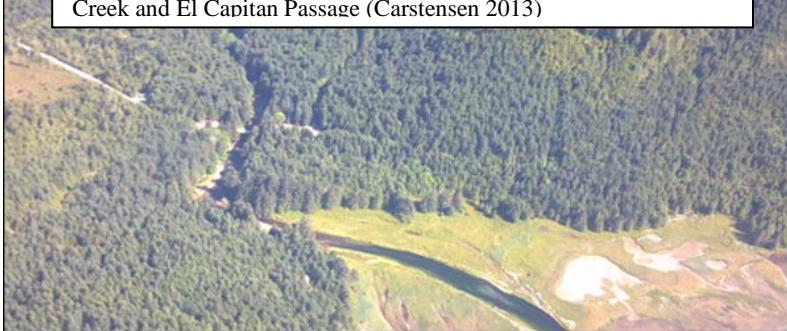
Shoreline oblique photograph taken near confluence of El Capitan Creek and El Capitan Passage (Carstensen 2013)

The High Salt Marsh Wetlands that occur along the Bank site's eastern shoreline at the confluence of El Capitan Creek and El Capitan Passage are mapped as estuarine, intertidal, emergent, persistent, irregularly flooded (E2EM1P) wetlands by the NWI (Appendix A Figures 3 and 6). Soils within the High Salt Marsh Wetlands are permanently saturated anaerobic soils with low chroma soil colors. Salt tolerant obligate wetland and facultative wetland species such as Lyngbye's sedge (*Carex lyngbyei*, OBL) and tufted hairgrass (*Deschampsia caespitosa*, FACW) are dominant. Other salt tolerant species such as seaside arrowgrass (*Triglochin maritime*, OBL) occur sporadically. CRC is in the process of determining whether the Bank site property includes a large portion of the estuarine High Salt Marsh Wetlands through an Alaska State Tideland Survey of the mean high water line. According to Richard Carstensen (2013), productive estuaries, like the one located at the confluence of El Capitan Creek and El Capitan Passage/Dry Pass, are few and far between in the area as neither carbonates nor granitics are optimum for deltaic deposition. Other nearby estuarine wetlands occur further west in Calder Bay.
