Jurisdictional Determination Report
and REV Classification

Portage Reserve Mitigation Bank

Alaska Railroad Corporation

February 2017

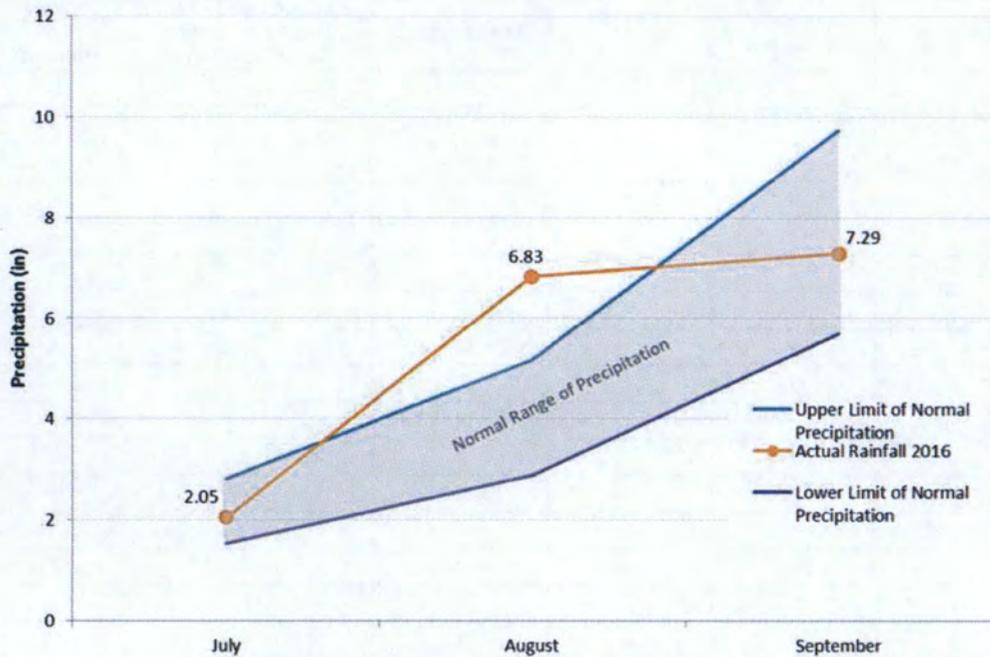
Inset 1: Monthly precipitation totals in Girdwood, Alaska, compared to normal

The monthly precipitation totals preceding the field visit at Alyeska weather station were then compared to normal monthly totals derived from 1971 to 2000 using the NRCS *Engineering Field Handbook* method (NRCS 2014, 1997). This method weights the data by both the amount of precipitation and the relative age of a rainfall event. The results of the comparison are shown in Inset 1. Using the NRCS method, it was determined that the field work occurred during a period with normal antecedent precipitation.

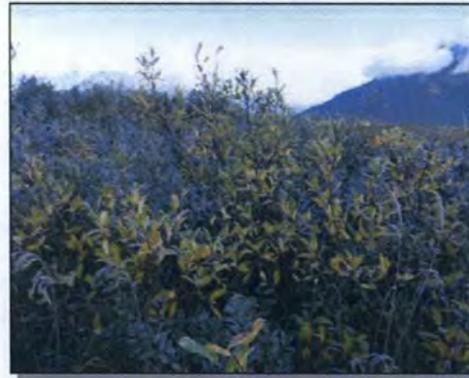
Inset 2: Semipermanently flooded broad-leaved deciduous scrub-shrub/ persistent emergent wetland (PSS1/EM1F) at Site 001

Broad-leaved deciduous scrub-shrub (PSS1) wetlands occupy 98.5 acres (approximately 32 percent) of the PRMB area (Inset 2). These wetlands are found throughout the PRMB area, particularly in the southern half, adjacent to the rail line.

Scrub-shrub wetlands mapped within the project area typically have a semipermanently flooded, seasonally flooded, or permanently flooded hydrologic regime. Soils are typically composed of at least 16 inches of organic material (Histosol) or contain mineral soil displaying Alaska Redox or Alaska Gleyed without Hue 5Y or Redder Underlying Layer. Soils with Alaska Gleyed without Hue 5Y or Redder Underlying Layer also had at least one primary indicator of wetland hydrology, hydrophytic vegetation, and were in an appropriate landscape position.

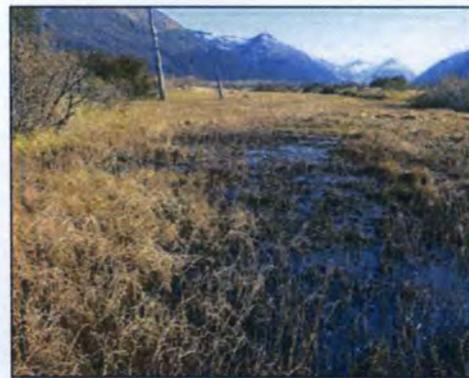
Inset 3: Permanently flooded persistent emergent wetland at Site 65 (PEM1H)

Approximately 92 percent of emergent wetlands mapped within the PRMB area have a semipermanently flooded or permanently flooded hydrologic regime (Inset 3). These areas are typically wetter than the immediately surrounding scrub-shrub vegetation communities. Hydric soil

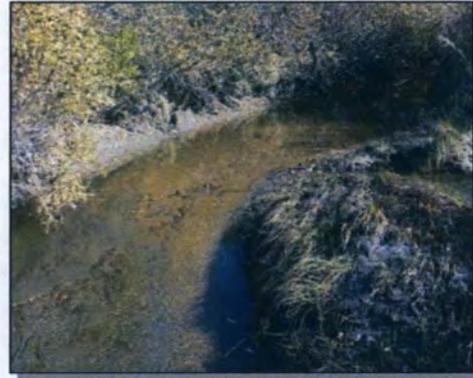
Inset 4: Permanently flooded upper perennial unconsolidated bottom stream at Site 16 (R1UBV)

Streams within the PRMB area are both perennial and tidally influenced. Portage is located at the head of Turnagain Arm, which has a mean tidal range of 30 feet, the fourth largest tidal range in the world. These tides result in a fluctuating water level at the mouth of the Placer River and some of the surrounding streams within the PRMB area. These tidally influenced streams are relatively deep, with steep banks. They are permanently flooded with a silty unconsolidated bottom similar to the mudflats adjacent to Turnagain Arm (Inset 4). Perennial streams in the PRMB area are either permanently or seasonally flooded with an unconsolidated bottom or shore. Several streams flow through culverts beneath the rail line. These culverts connect the wetlands and streams within the PRMB area to the Placer and Portage Rivers as they flow into Cook Inlet.

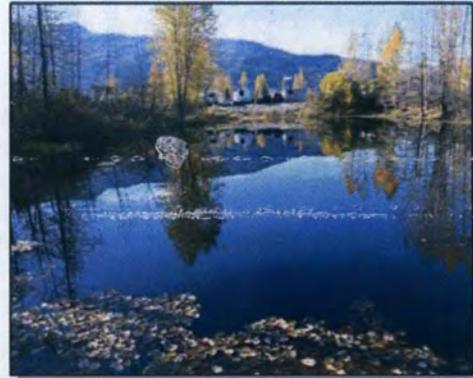
Inset 5: Excavated permanently flooded unconsolidated bottom pond at Site 70 (PUBHx)

Ponds within the PRMB area are permanently flooded waterbodies with either unconsolidated bottoms or aquatic beds. One small pond (Site 70; PUBHx) adjacent to the Portage Section House at the northern end of the PRMB area appears to be excavated out of uplands.

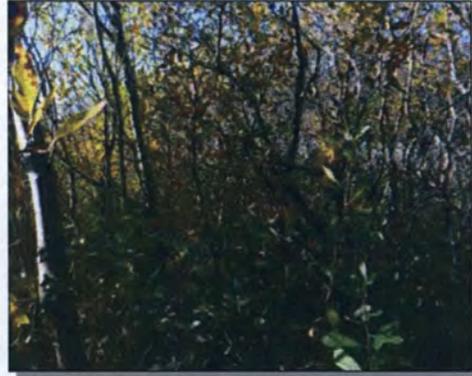
Inset 6: Upland tall closed willow shrub (Site 6)

Local topography is a major factor influencing wetland/upland status, with uplands present on elevated ground surfaces, above the influence of the water table. Common trees and shrubs in upland areas include Sitka alder, white spruce (*Picea glauca*), cottonwood (*Populus balsamifera*), diamond-leaf willow (*Salix pulchra*), and squashberry. Common herbs found include narrow-leaf fireweed (*Chamaenerion angustifolium*), bluejoint reedgrass, and spreading wood fern (*Dryopteris expansa*). Soils at upland sites were generally well-drained and sandy, with no indicators of hydrology.
