APPENDIX B
ECONOMIC ANALYSIS
EMERGENCY BANK STABILIZATION
DILLINGHAM, ALASKA

Economic Analysis for City of Dillingham Shoreline Emergency Bank Stabilization

Alaska District

U.S. Army Corps of Engineers

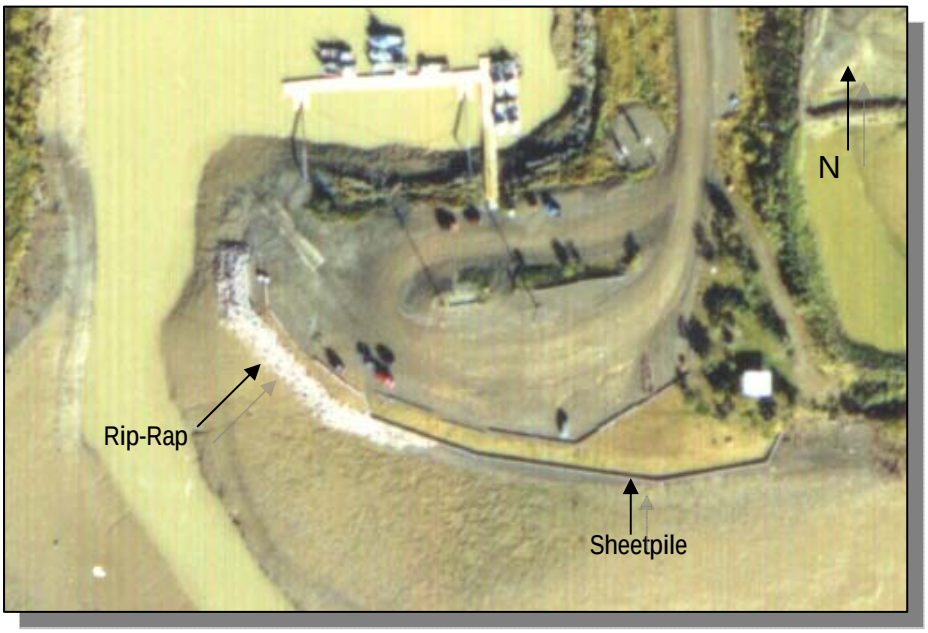
Figure 24: Existing Harbor Shoreline Protection (2001) – City Dock Side

The Corps constructed a shoreline protection project in 1999 to protect Dillingham Harbor and the public parking lot from expected erosion damages as shown in **Figure 24** (photo from 2001). The east terminus of the sheetpile wall was outflanked during a September 2005 storm and erosion occurred to the east and behind the eastern end of the wall (see **Figures 16-18**).

Erosion is expected to continue in this area with no action and it is estimated that the structural integrity of the sheetpile wall would be lost in 2015. The design life of the sheetpile wall was 25 years. The construction cost of the sheetpile seawall in current prices is $1,561,400.[2] Given the 25-year design life of the sheetpile, the fact that the existing sheetpile failed within ten years of construction, and the 50-year period of analysis, it is expected that the sheetpile will continue to fail every ten years or five times during the period of analysis. Under normal design life conditions the sheetpile would need replacement twice during this same time. The present value of the difference between accelerated sheetpile replacement and the normal design life is $2,536,900.
