**Community Erosion Assessment
Kwigillingok, Alaska
27 January 2009**

1. Community: Kwigillingok, Alaska

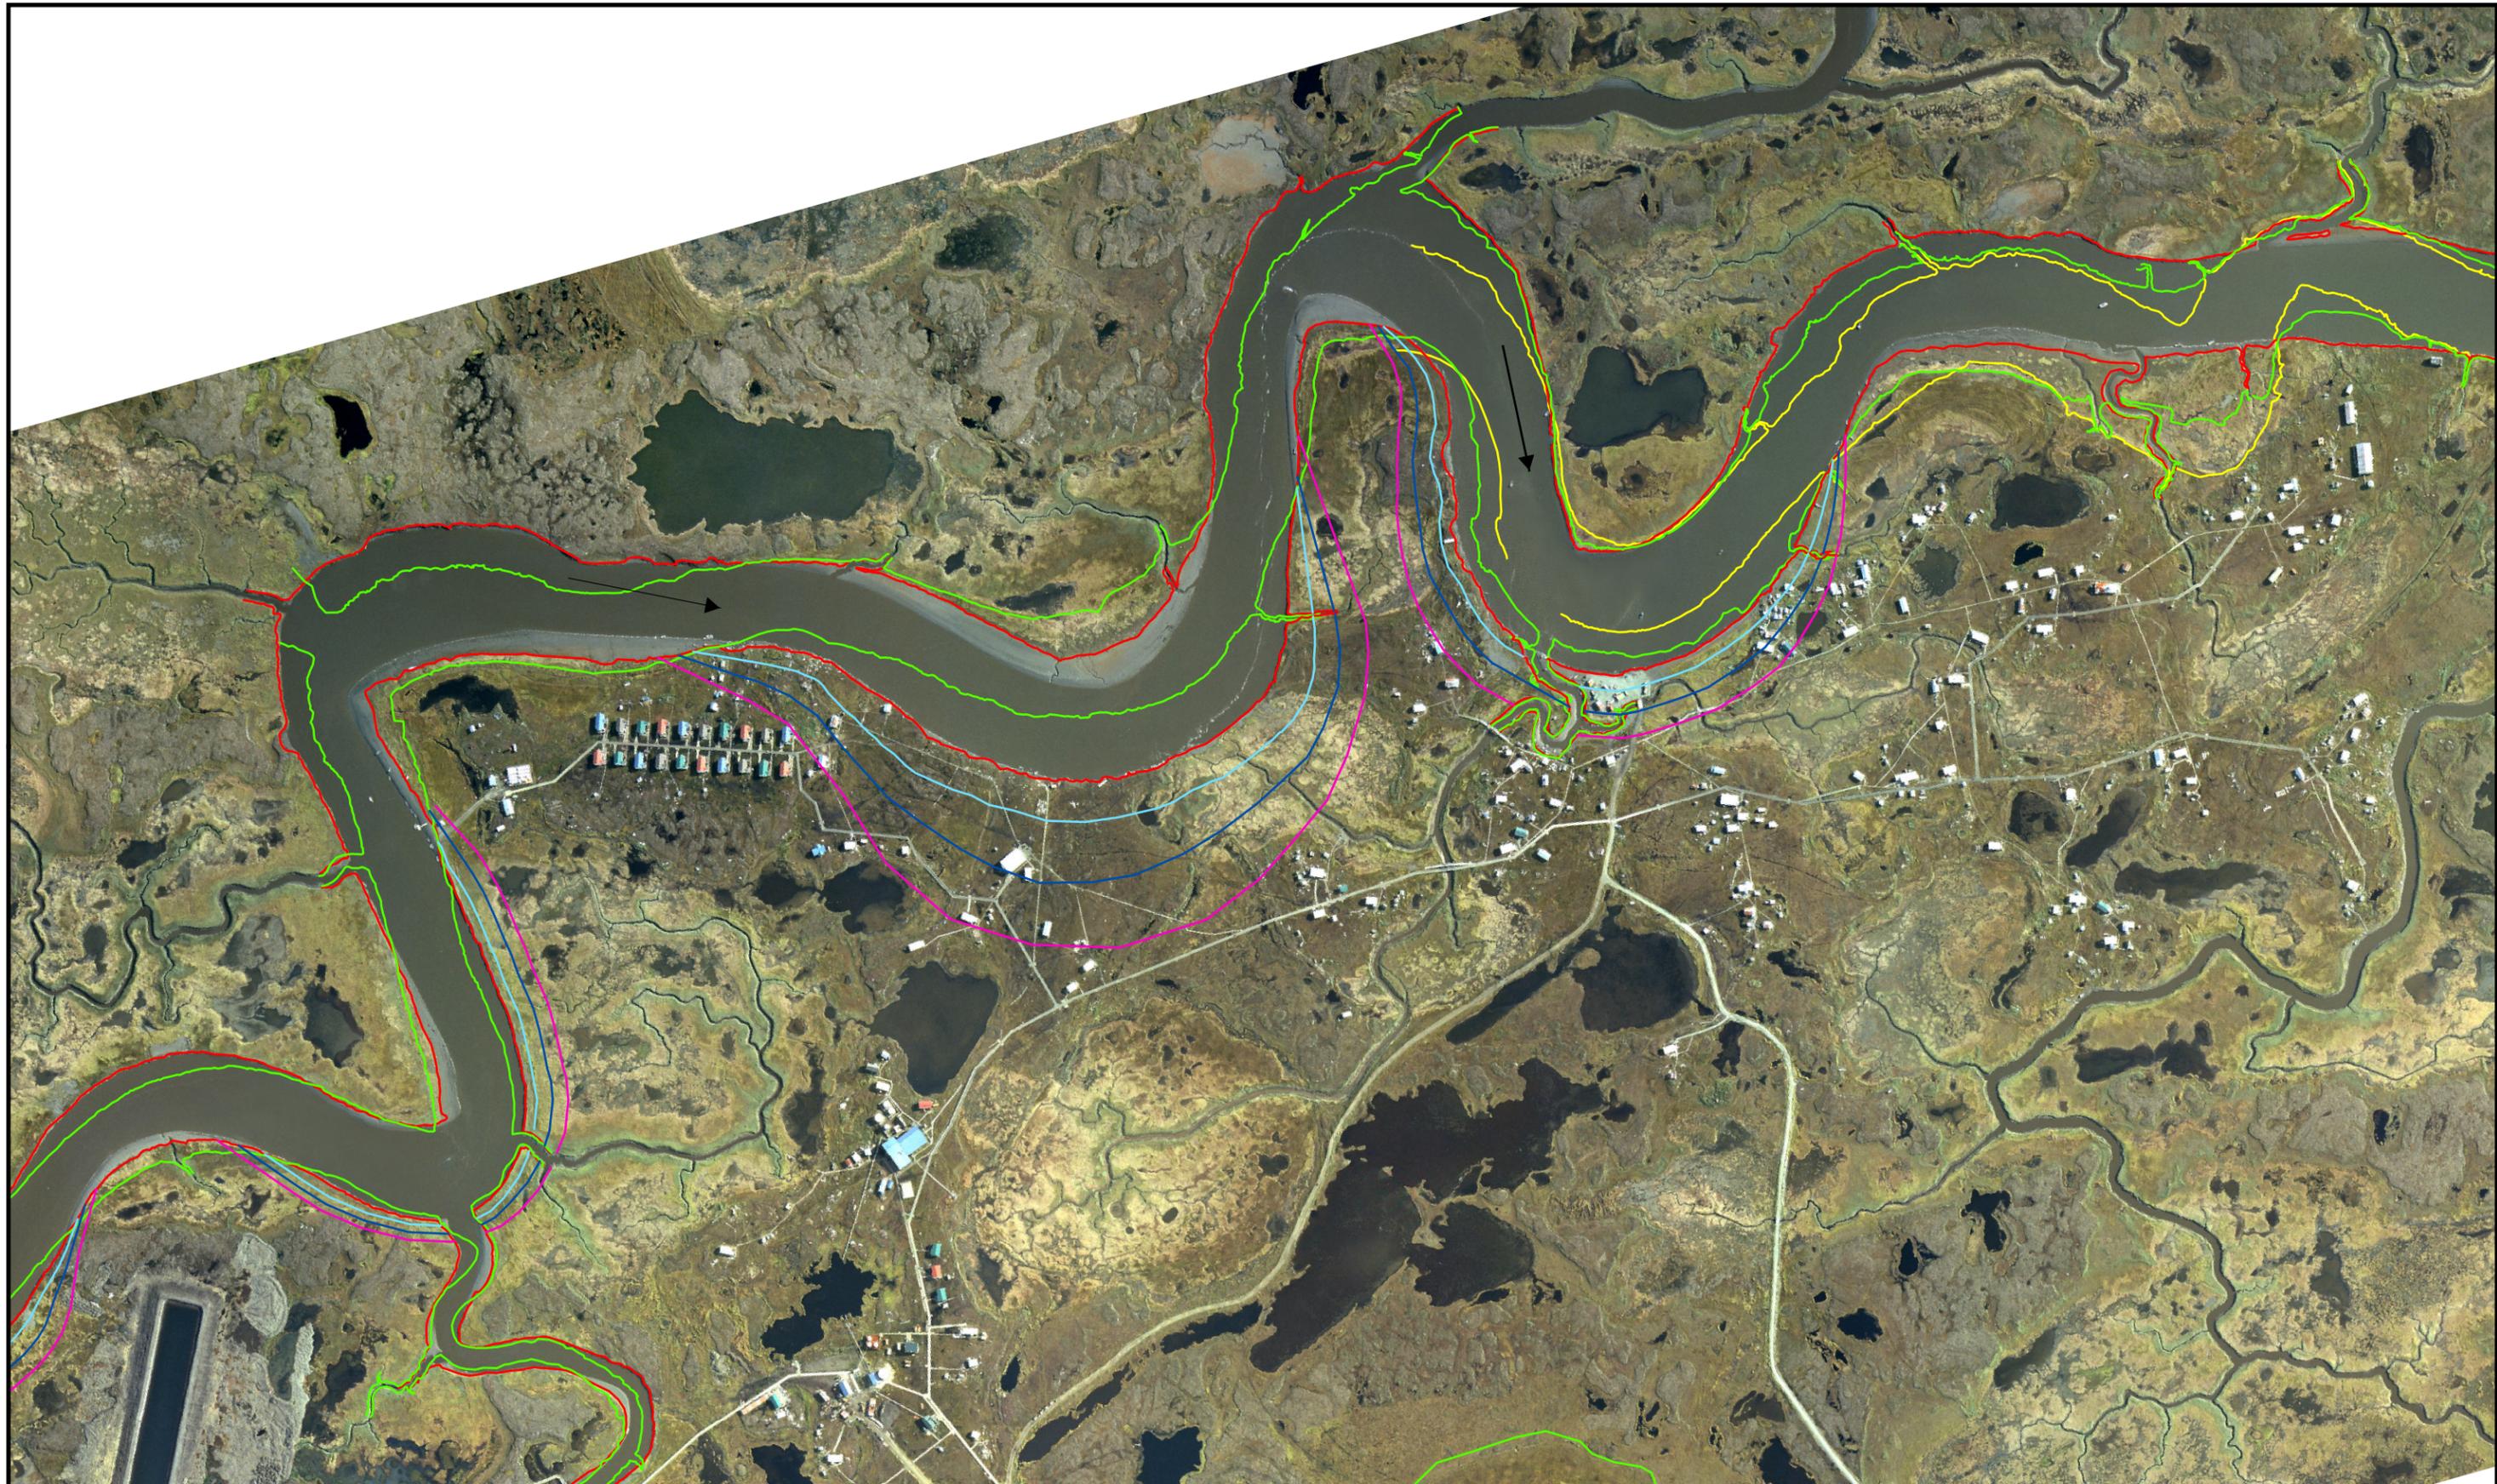
For this study the area was divided into four reaches. Reach 1 is a 3,150-foot portion of riverbank that fronts the community and is eroding at a rate of 4.0 feet per year. Reach 2 is a 3,500-foot portion of riverbank directly upstream (and north) of Reach 1 and is eroding at a rate of 7.7 feet per year. Reach 3 is a 2,750-foot portion of riverbank upstream of Reach 2 and is eroding at a rate of 2.0 feet per year. Reach 4 is a 1,000-foot portion of riverbank upstream of Reach 3 and is eroding at a rate of 3.0 feet per year. There is an area near the store that is eroding at a rate of 13 feet per year.

Erosion at Kwigillingok is episodic, occurring primarily during spring breakup and fall storm season. Ice in the spring is also a particular problem as it physically degrades the bank while the soil is soft. Fall storm events act in a similar manner as south winds because storm surges come up the Quillingok River to saturate the soils in the same manner as in the spring.
